December 20, 2017

Re: **Snap Lake Mine**
Land Use Permit – MV2010D0053, Water License MV2011L2-0004
Follow-Up Report on Spill Report # 17-440

BACKGROUND

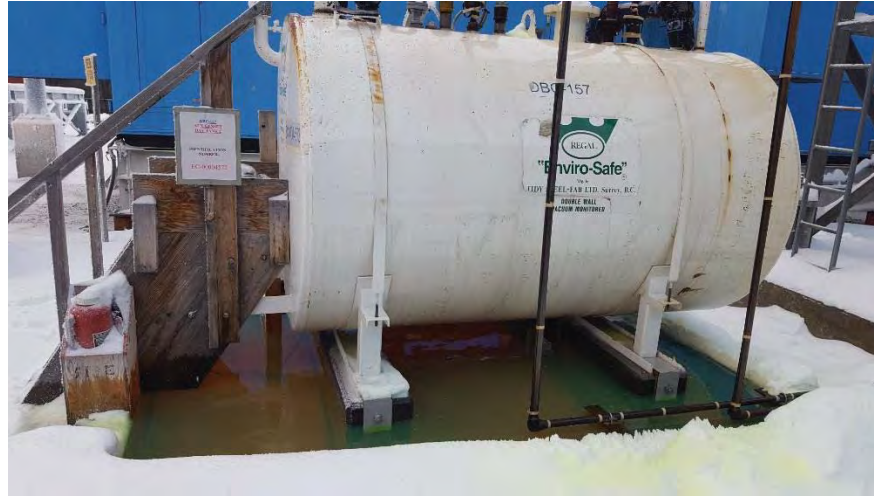
At approximately 13h00, a spill of diesel was discovered around Day Tank 2 at the auxiliary generators at the power house. The outlet valve had been left open to gravity fill the day tank but the attendant forgot to return to close it as the crew was preparing for a shift change. At the time of the spill event, volumes were estimated to be at least 500 liters outside of containment based on visual observation, and the initial spill report was provided to the GNWT Spill Line within 24 hours of the event. During clean up and upon reconciliation of available information, a more accurate volume estimate was determined.

i) After Valve was shut, before clean up operation commenced

The outlet valve was immediately closed upon discovery and the spill cleanup commenced. Approximately 7,500 L of reusable diesel was immediately recovered from the containment by pumping it into the fuel truck. An additional 1,500 L of diesel contaminated with snow was pumped from the containment into totes. A maximum of approximately 5,903 L of diesel is estimated to have been released outside containment into the surrounding snow and gravel.

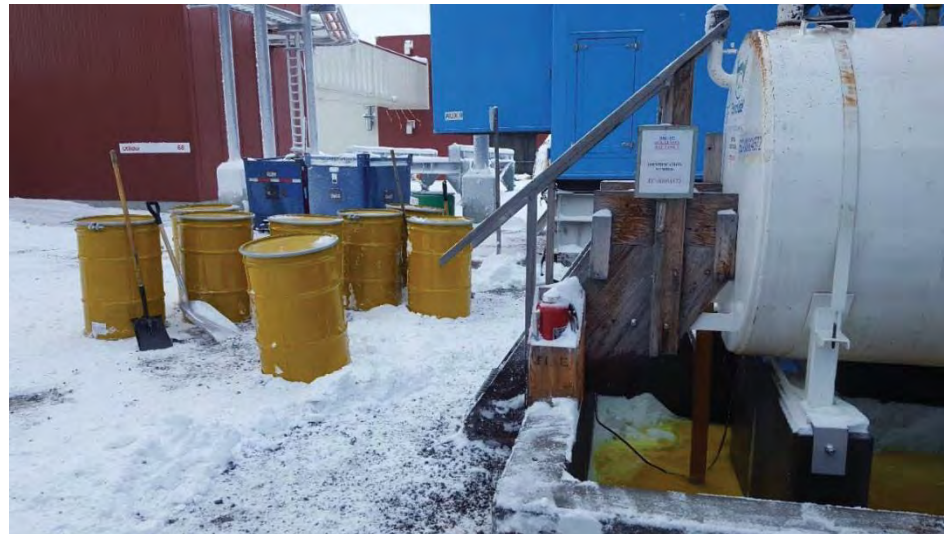
ii) After contaminated snow was removed

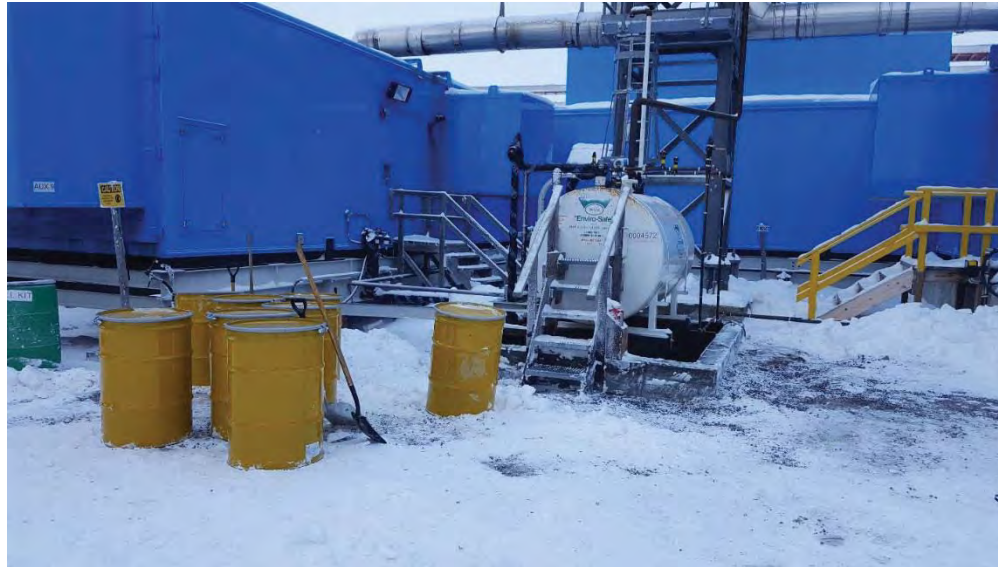
Impacted snow and contaminated non frozen ground outside the containment was shoveled into drums, which are labeled and stored in the waste management area. The ground around the containment berm is solidly frozen, so removal by hand shoveling is not practical at this time.

iii) Drums of snow recovered after clean up

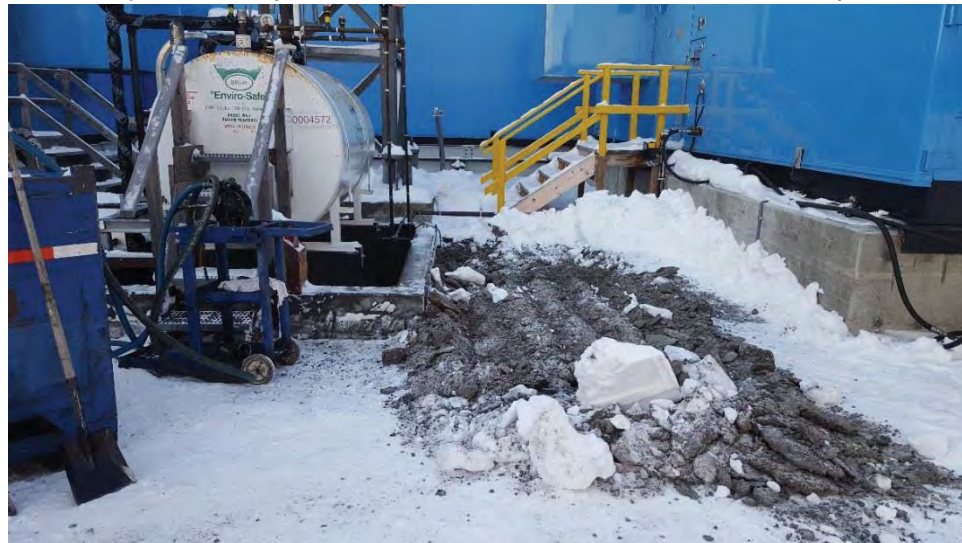
The use of an excavator was attempted, but due to lack of safe space to maneuver the excavator, work with the equipment was stopped. Four drums of contaminated ground was removed during follow-up cleaning. No free diesel product or pooling could be detected during visual inspection and it is assumed that rapid vertical infiltration occurred, resulting in a limited surface area and potentially deeper vertical penetration.

iv) Follow-up : Excavated soil to determine extent of spill

Soil profiling and determination of vertical pollution plume will resume in summer. A comprehensive remedial approach shall be implemented during the decommissioning of Day Tank 2 as part closure planning.

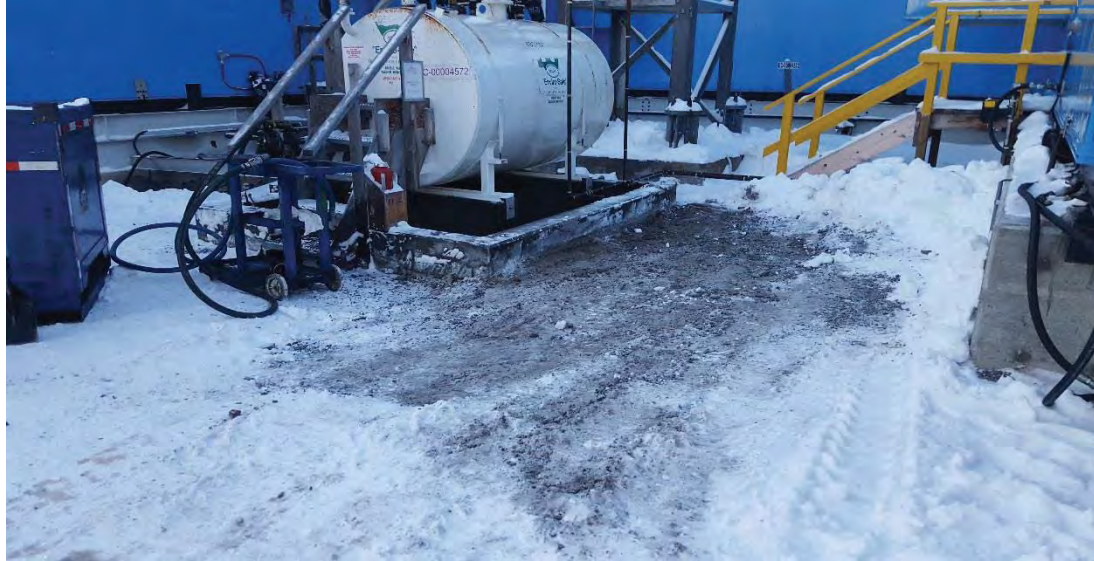
v) Follow- up: Excavated area closed up after inspection and removal of contaminated soil
