<b>File Number</b>	<b>MV2013P0011</b>
<b>Type of Operation</b>	<b>PIPELINES (existing)</b>
<b>Location</b>	Liard River Ferry Landing to Blackwater River

## ENVIRONMENTAL INSPECTION REPORT

<b>Permittee:</b>	Enbridge Pipelines (NW) Inc	<b>Permit Expiry Date:</b>	July 17, 2018
<b>Land Use Permit No.</b>	MV2013P0011	<b>Previous Inspection:</b>	February 27, 2017
<b>Quarrying Permit No.</b>		<b>Inspection Date:</b>	March 22, 2017
<b>Contractor:</b>		<b>Subcontractor:</b>	
<b>Location(s) Inspected:</b>	Liard River Ferry Landing to Blackwater River		
<b>Current Stage of Operation:</b>	Completion of 2016/2017 Winter Work Season		
<b>Program Modifications Approved:</b>

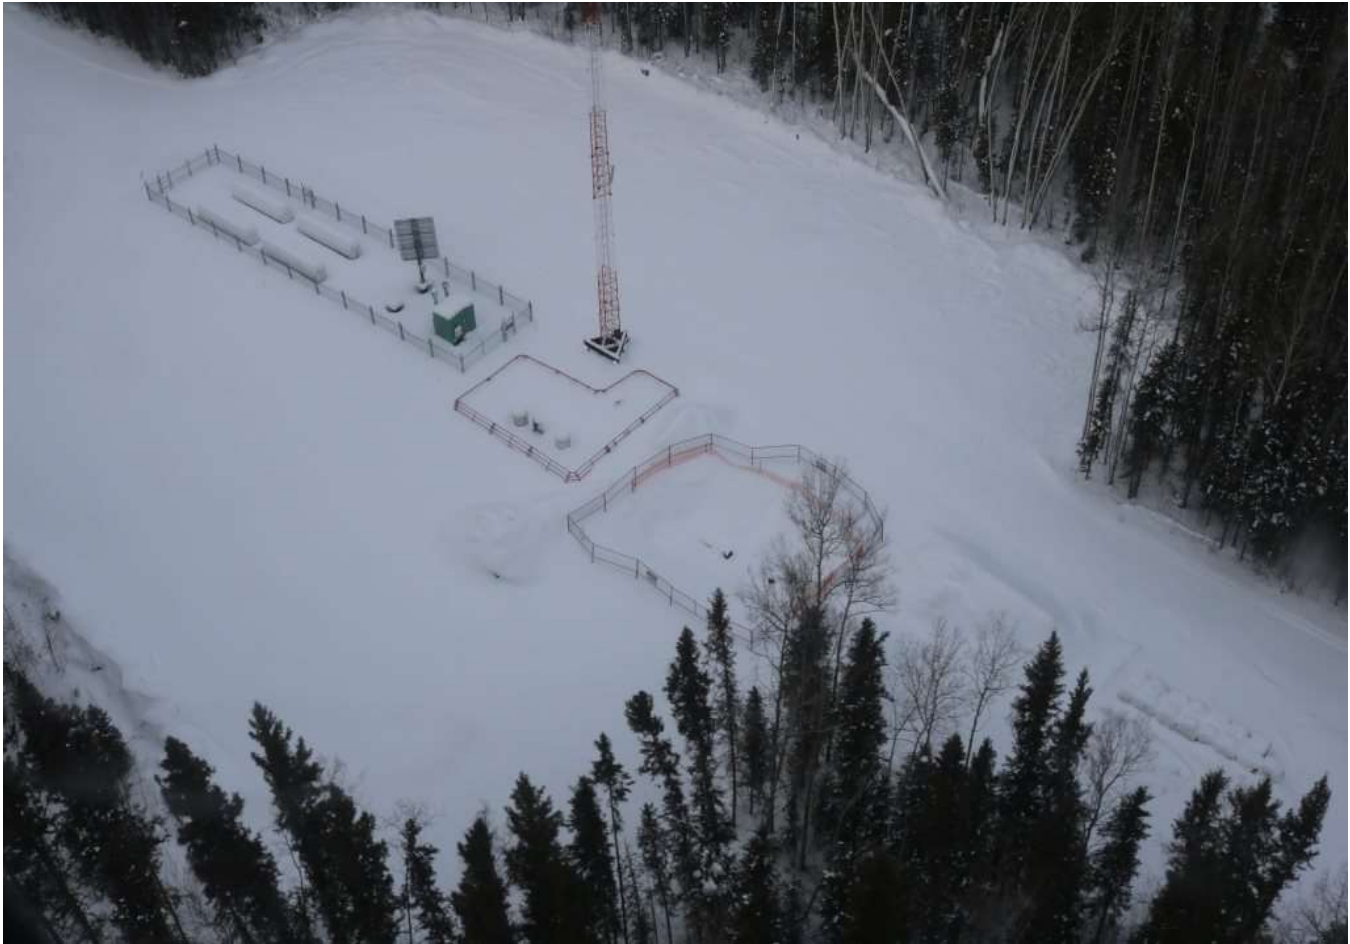
**Figure 1**

**Fire guard around valve site.**

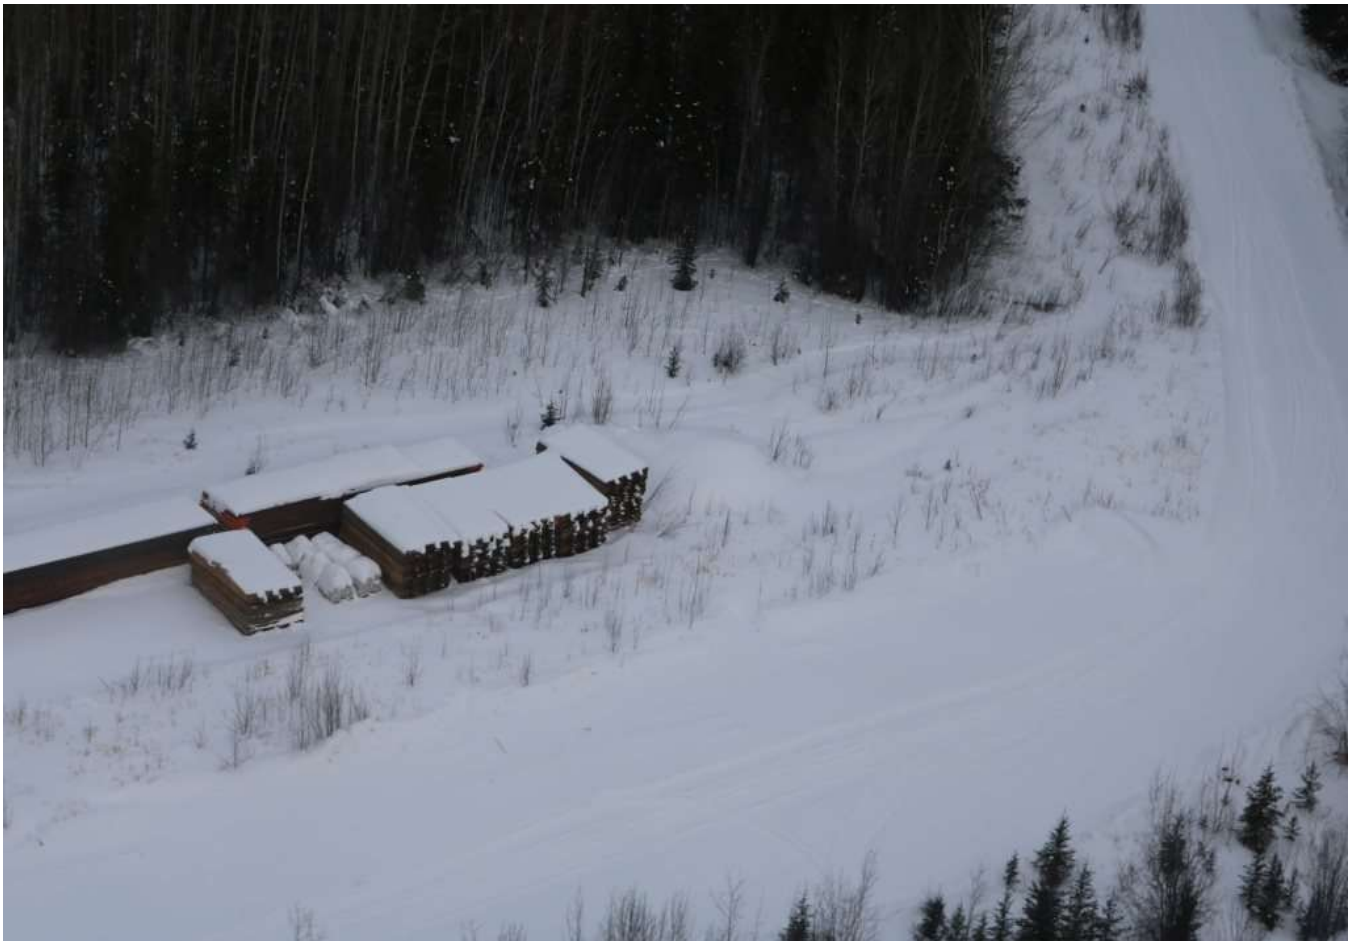
**Figure 2**

**5 meter workspace next to ROW where rig matting is being stored on the Mackenzie North slope.**

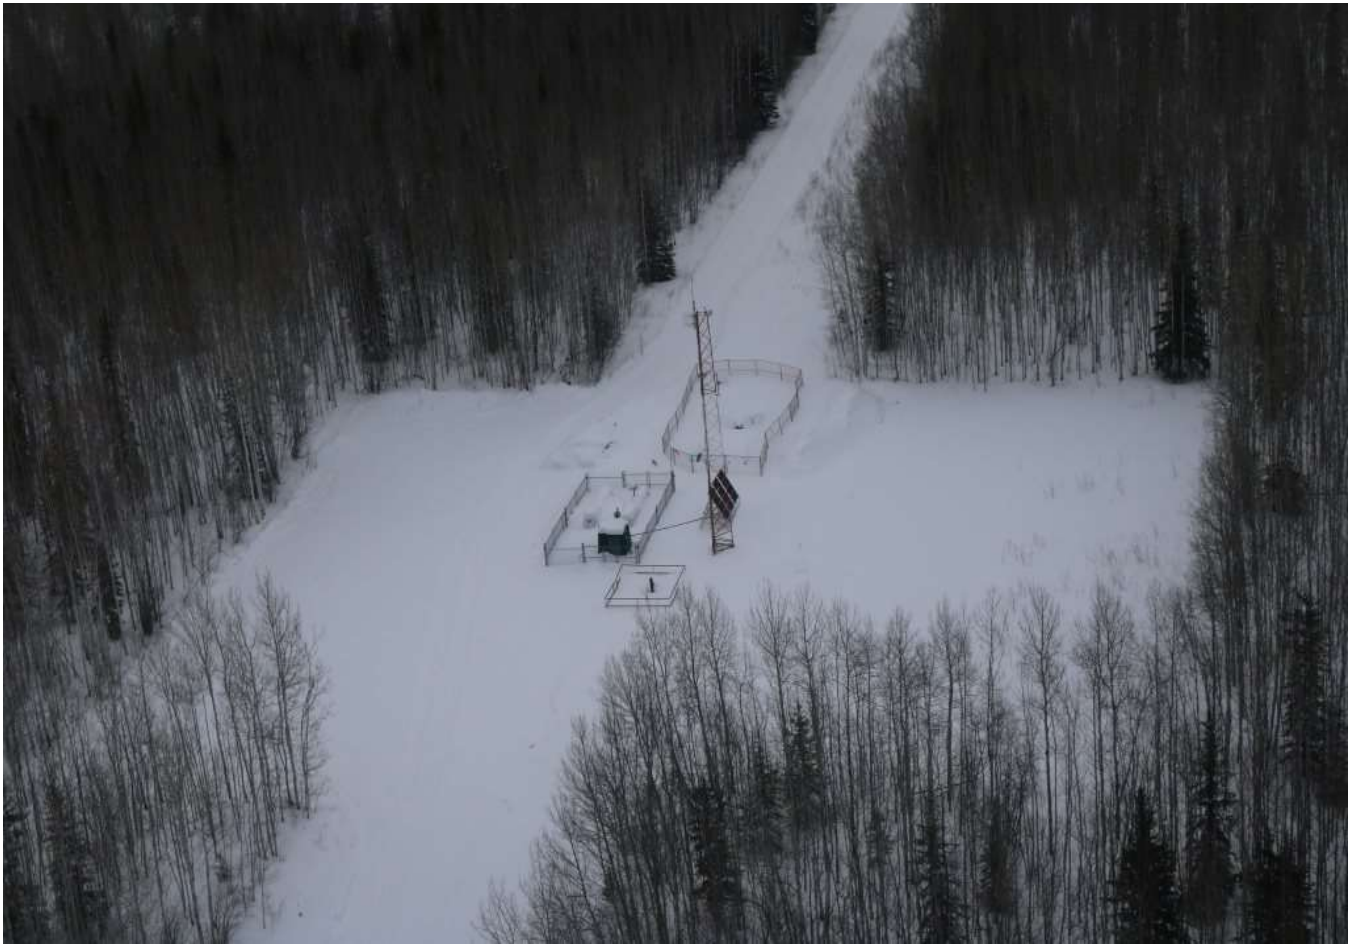
**Figure 3**

**Fire guard at KP 523 valve site with no equipment or debris.**

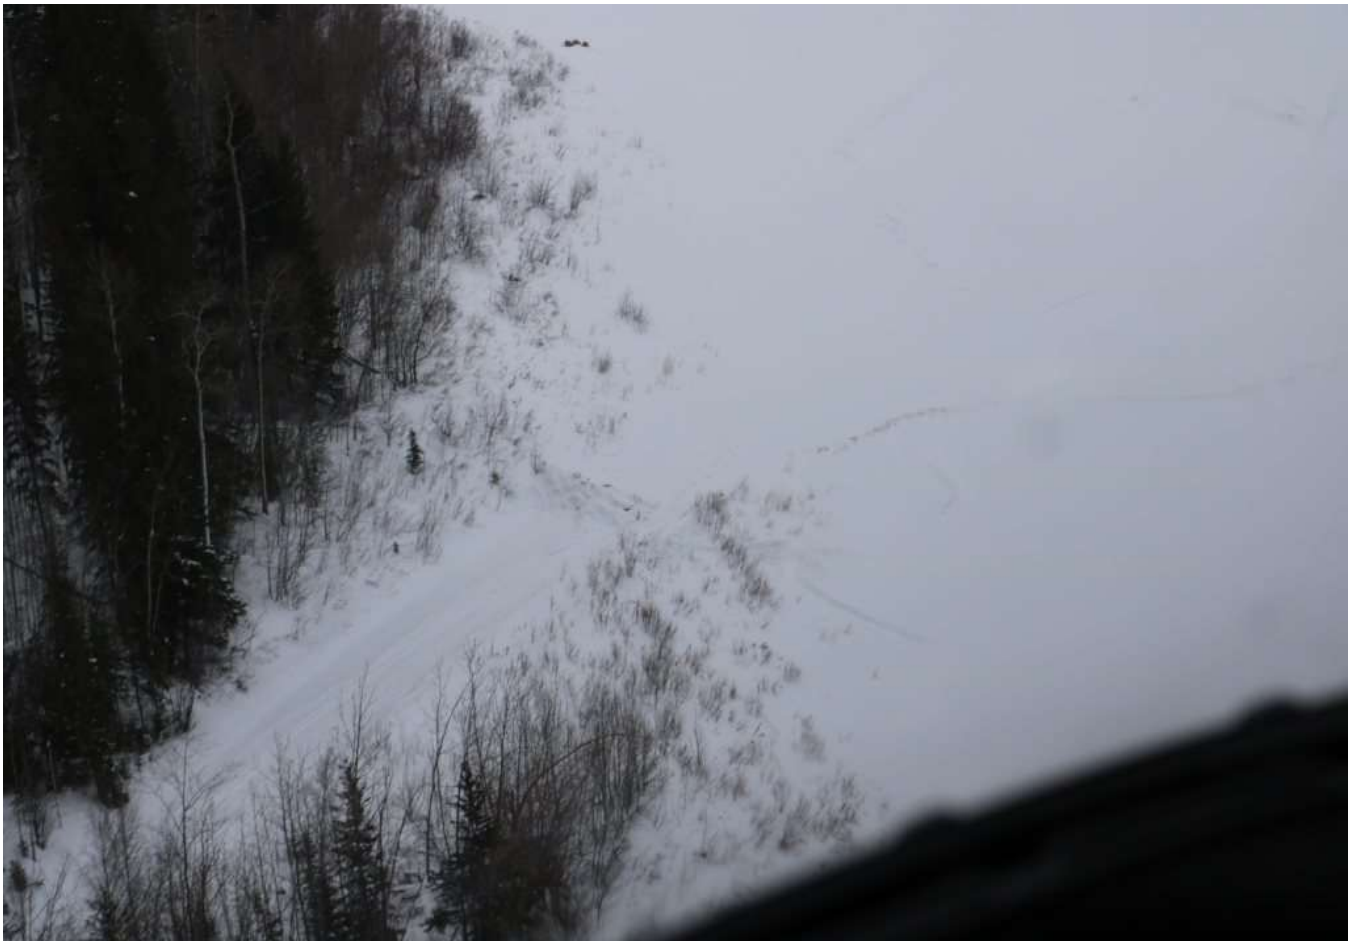
**Figure 4**

**Snow that was utilized to block access from Mackenzie River ice crossing onto shoofly.**

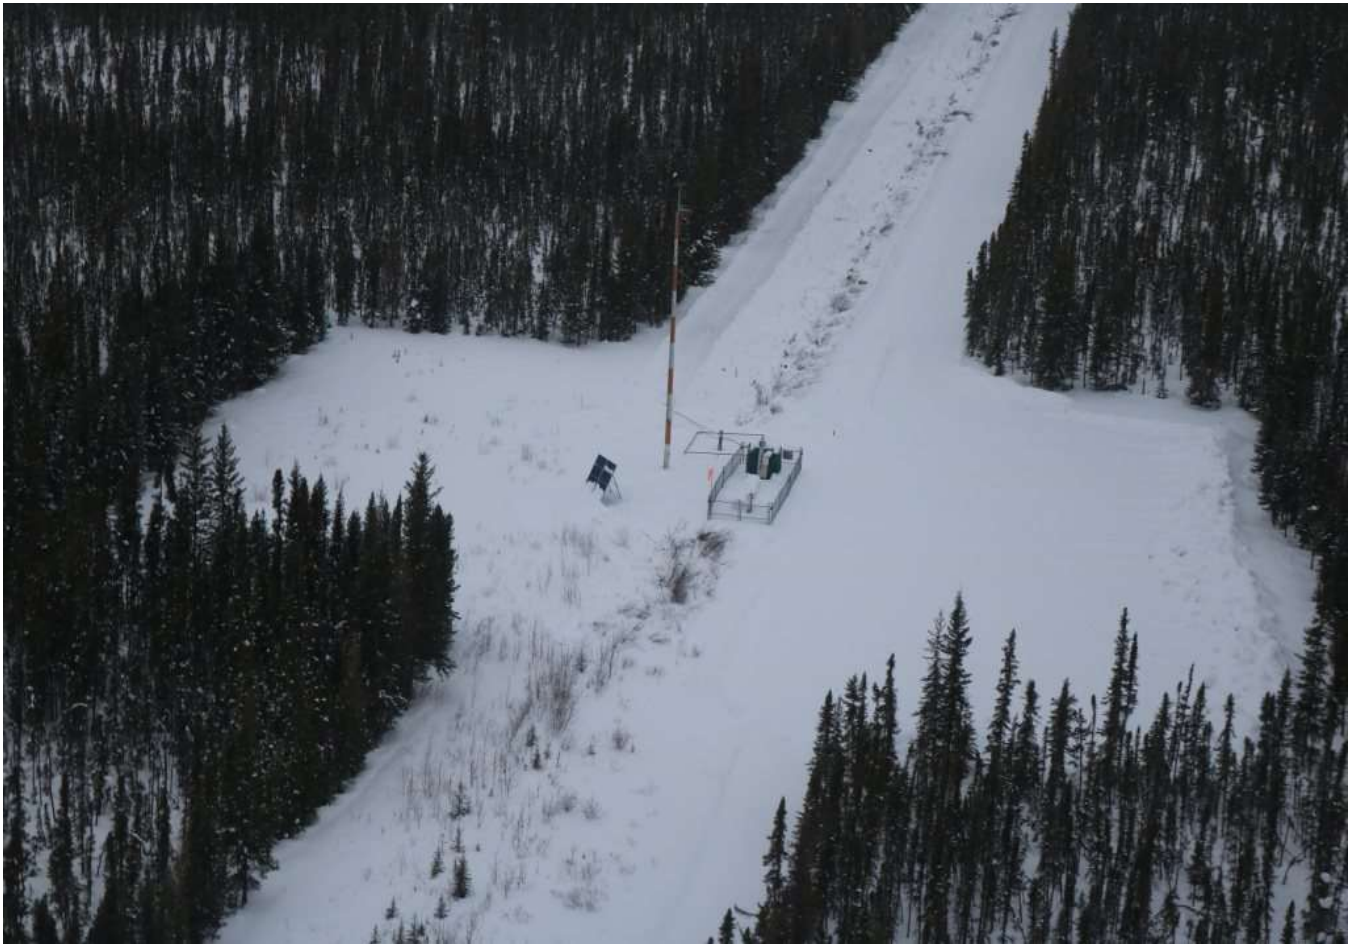
**Figure 5**

**Fire guard where snow was cleared and pushed close to tree line.**

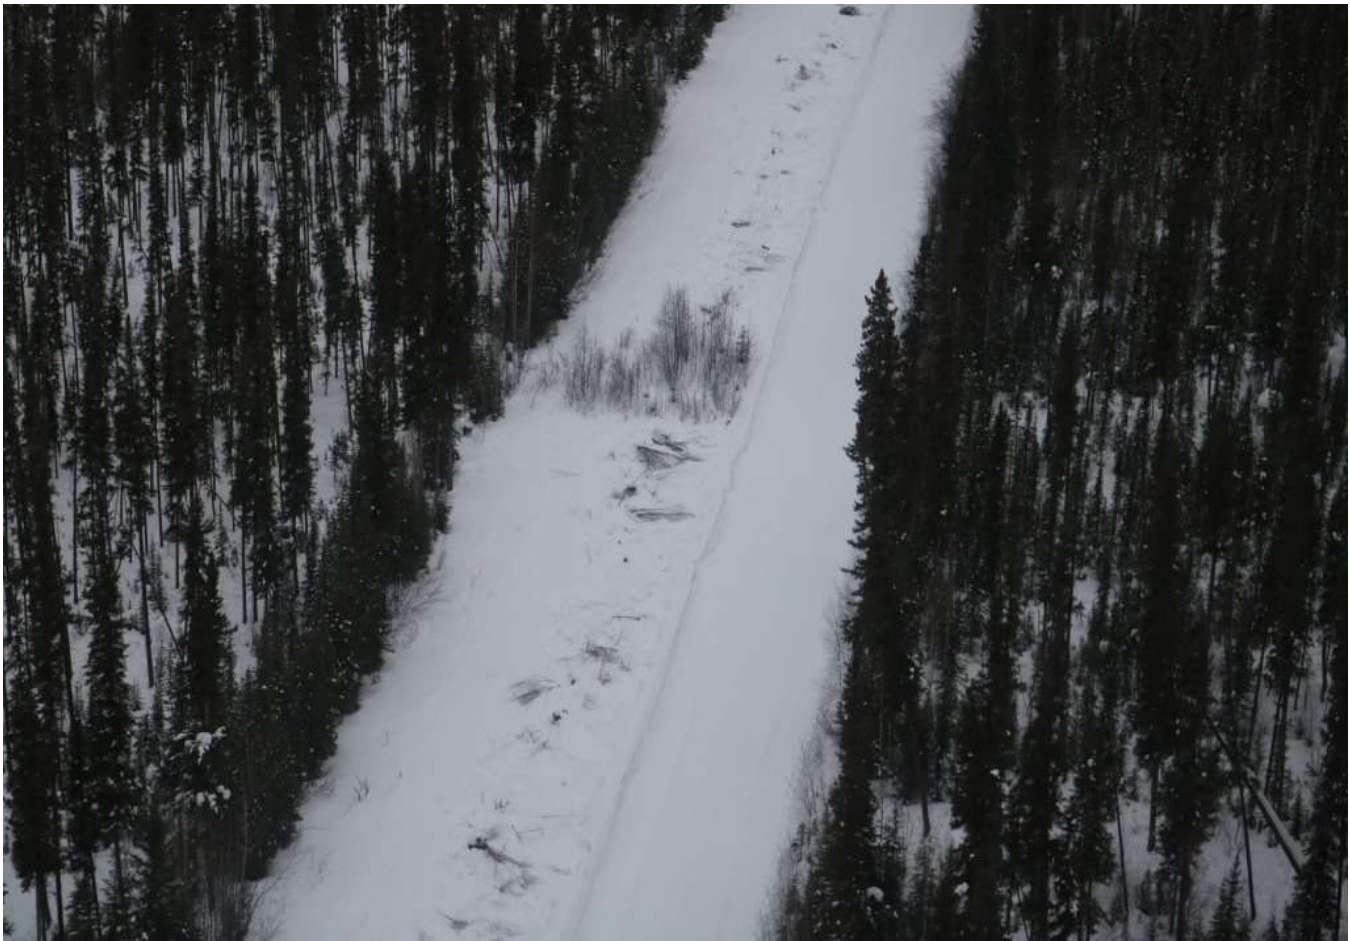
**Figure 6**

**Section where brushing occurred and wildlife blind was left intact.**

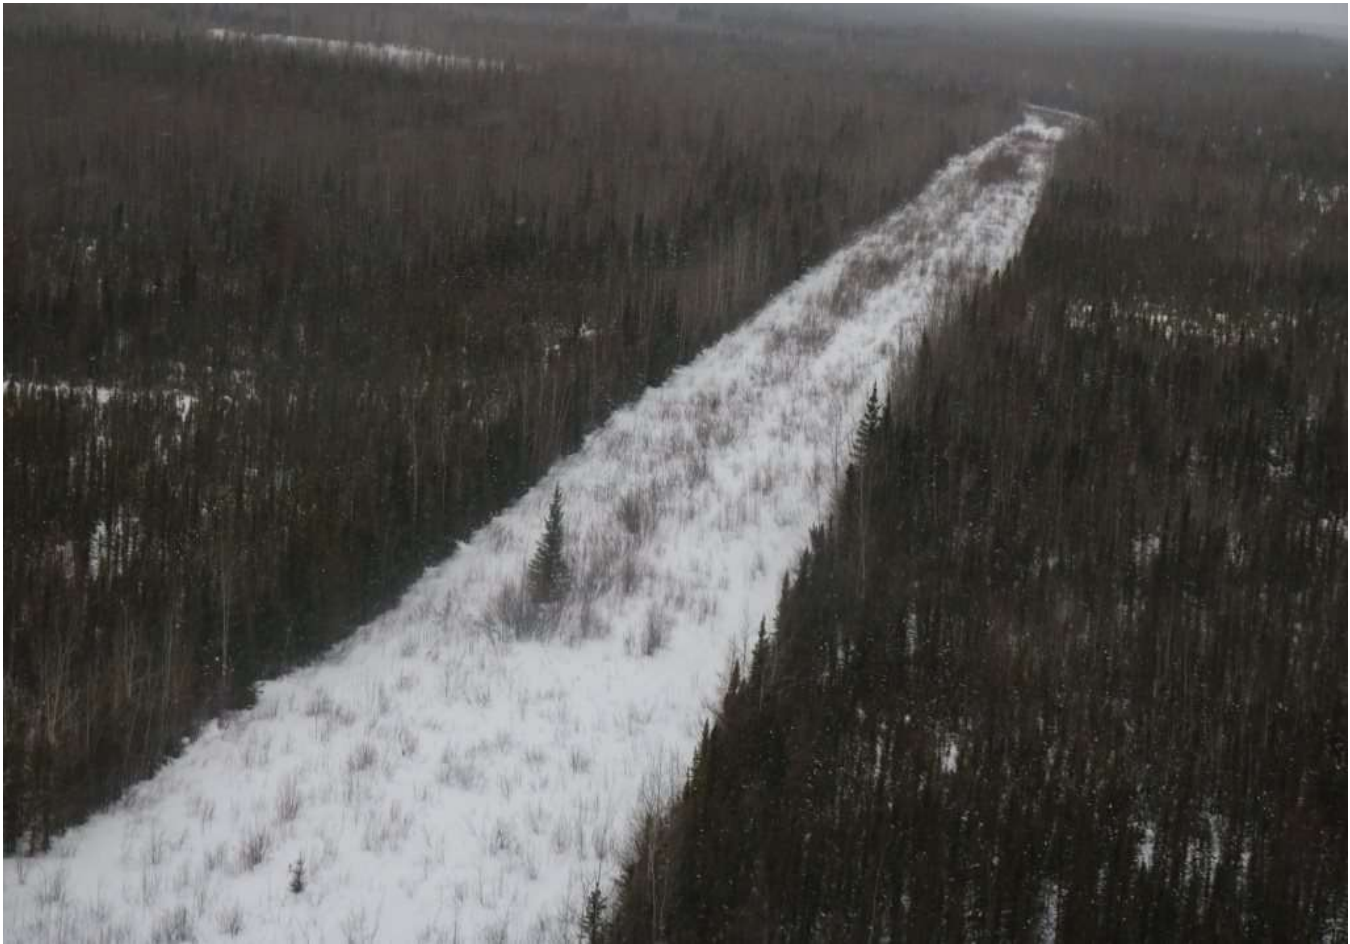
**Figure 7**

Section where no brushing or access occurred.

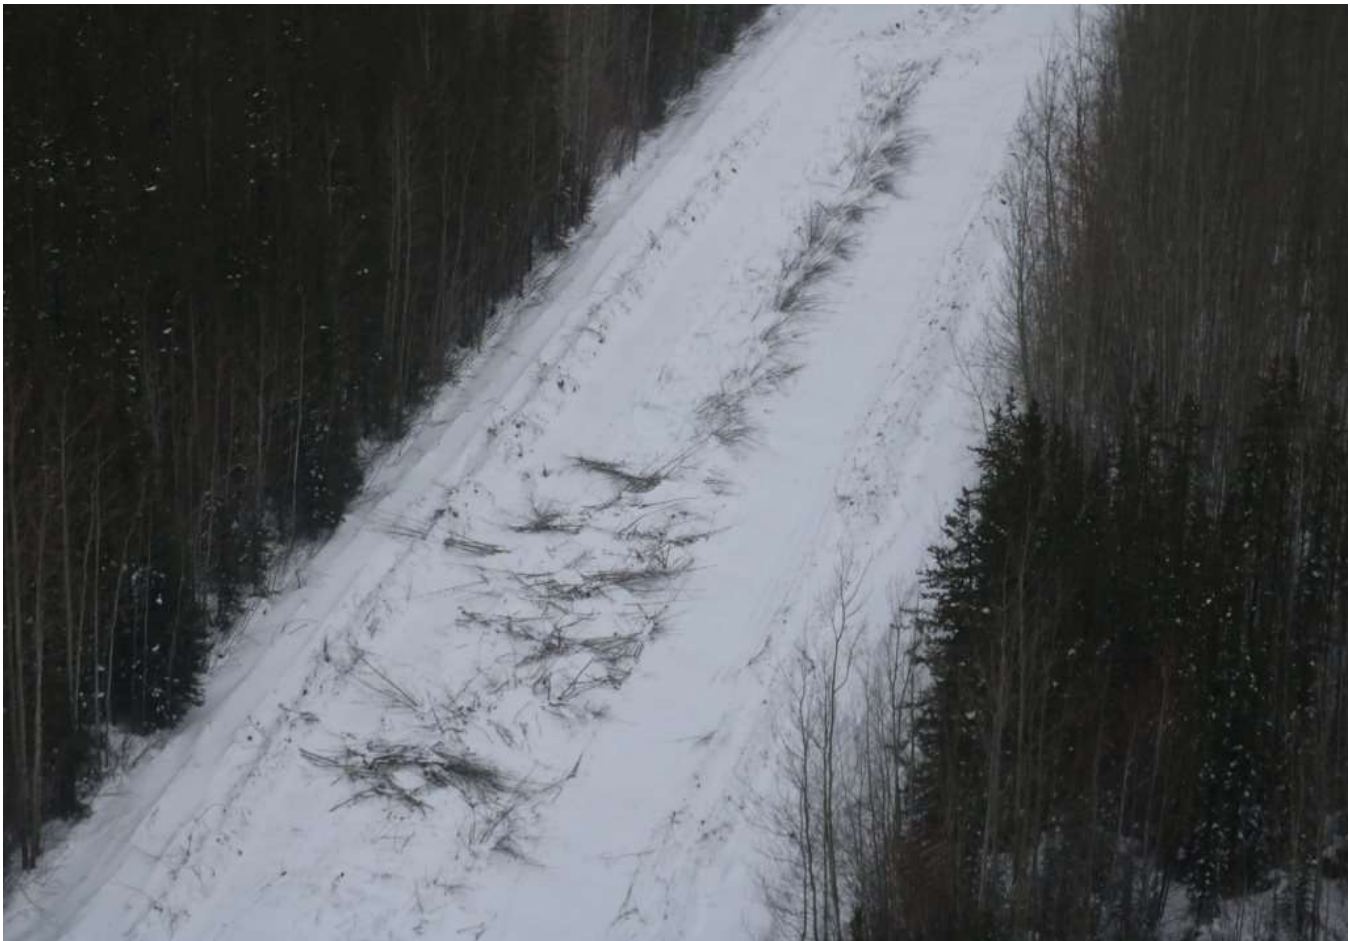
**Figure 8**

Section where winter brushing was spread over ROW.

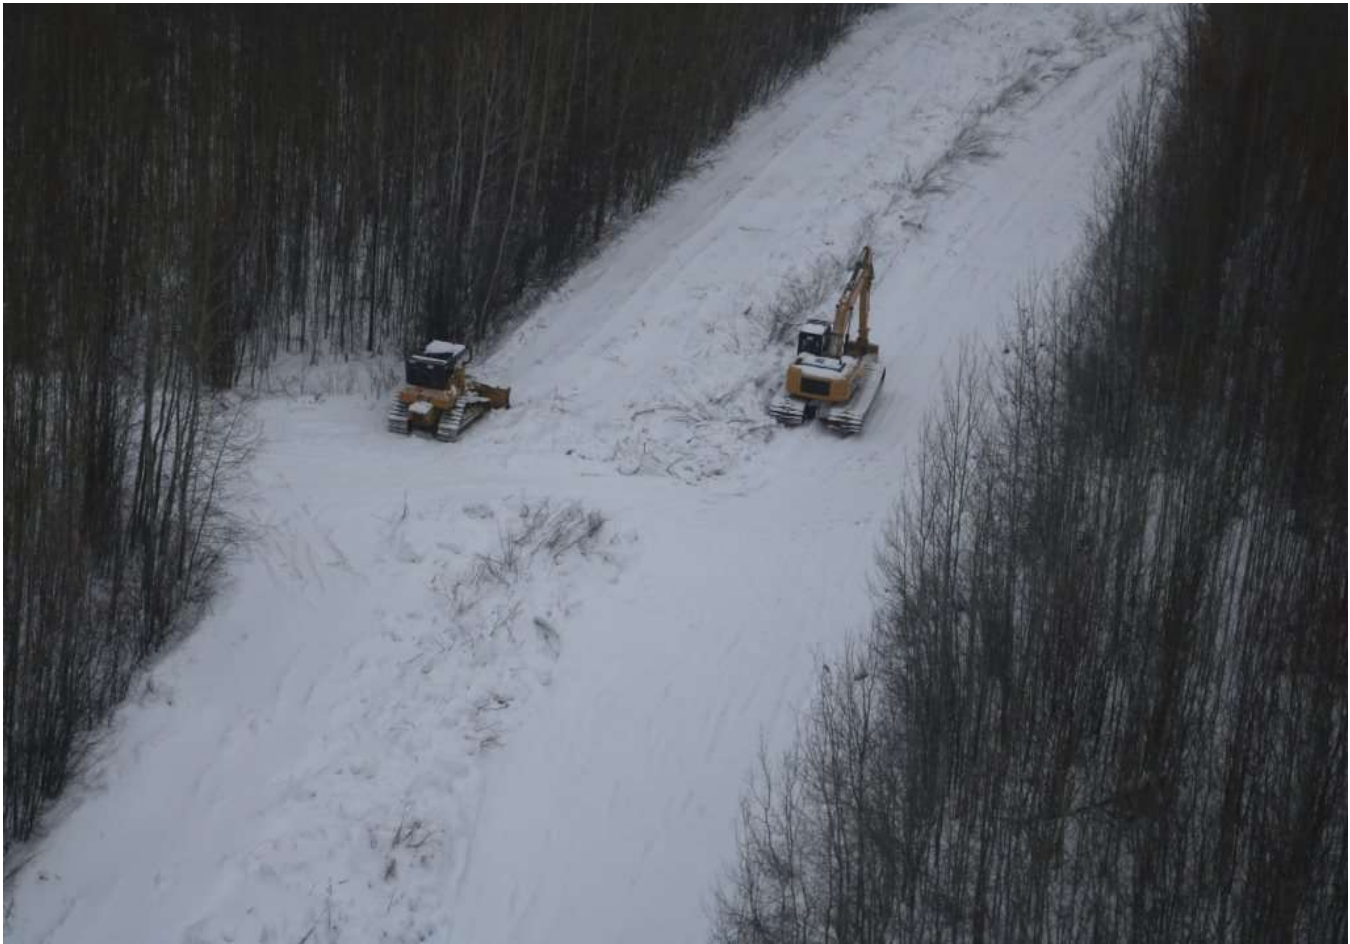
**Figure 9**

**Machinery that was used for brush clearing. To be removed off-site by March 24, 2017.**

season. Inspectors were informed that the equipment was to be demobilized by March 24, 2017.

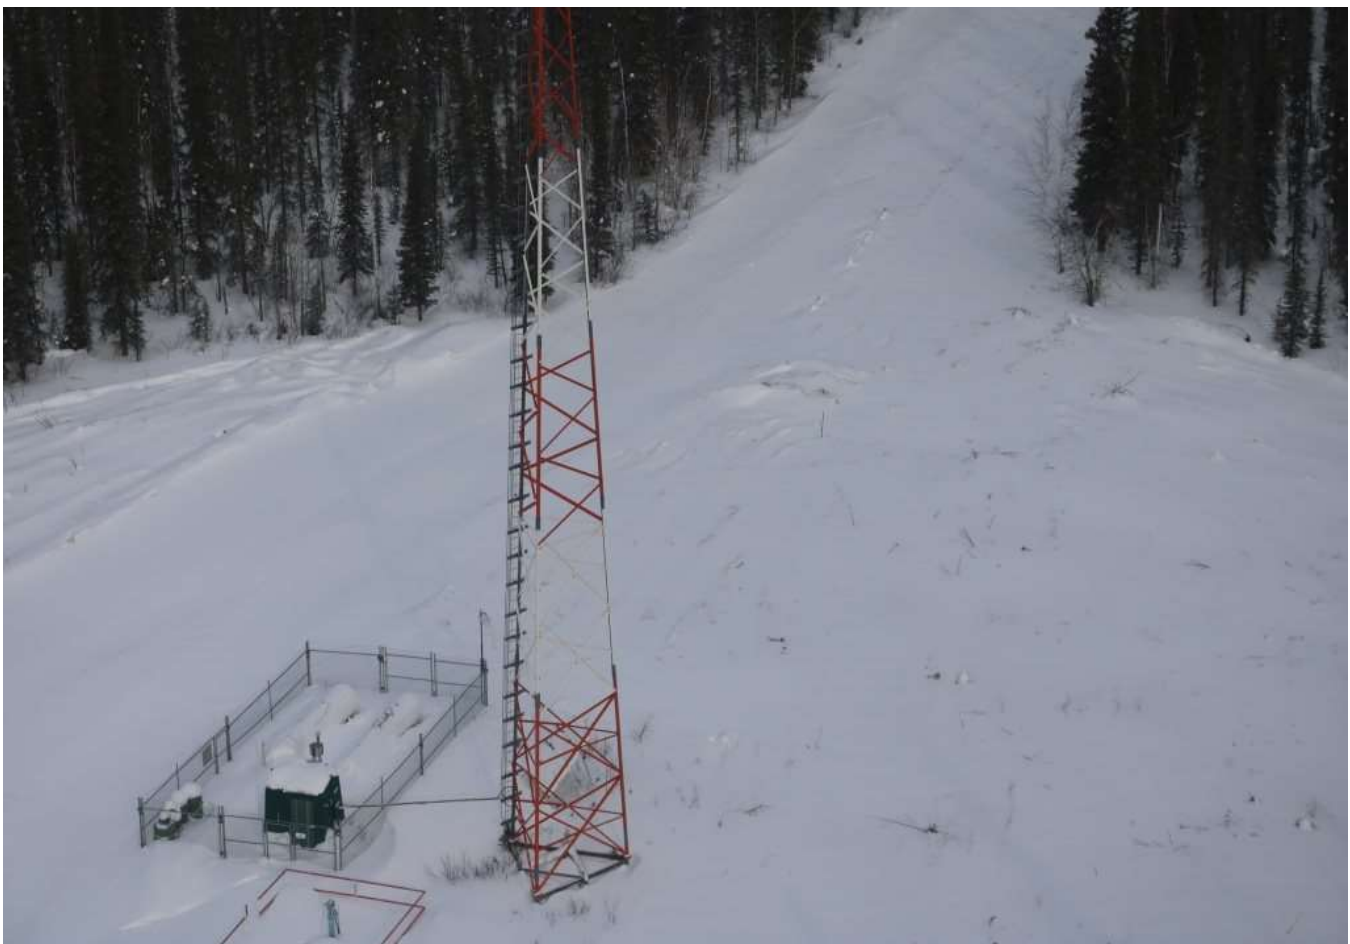
**Figure 10**

**Fire guard where brushing occurred during winter season.**

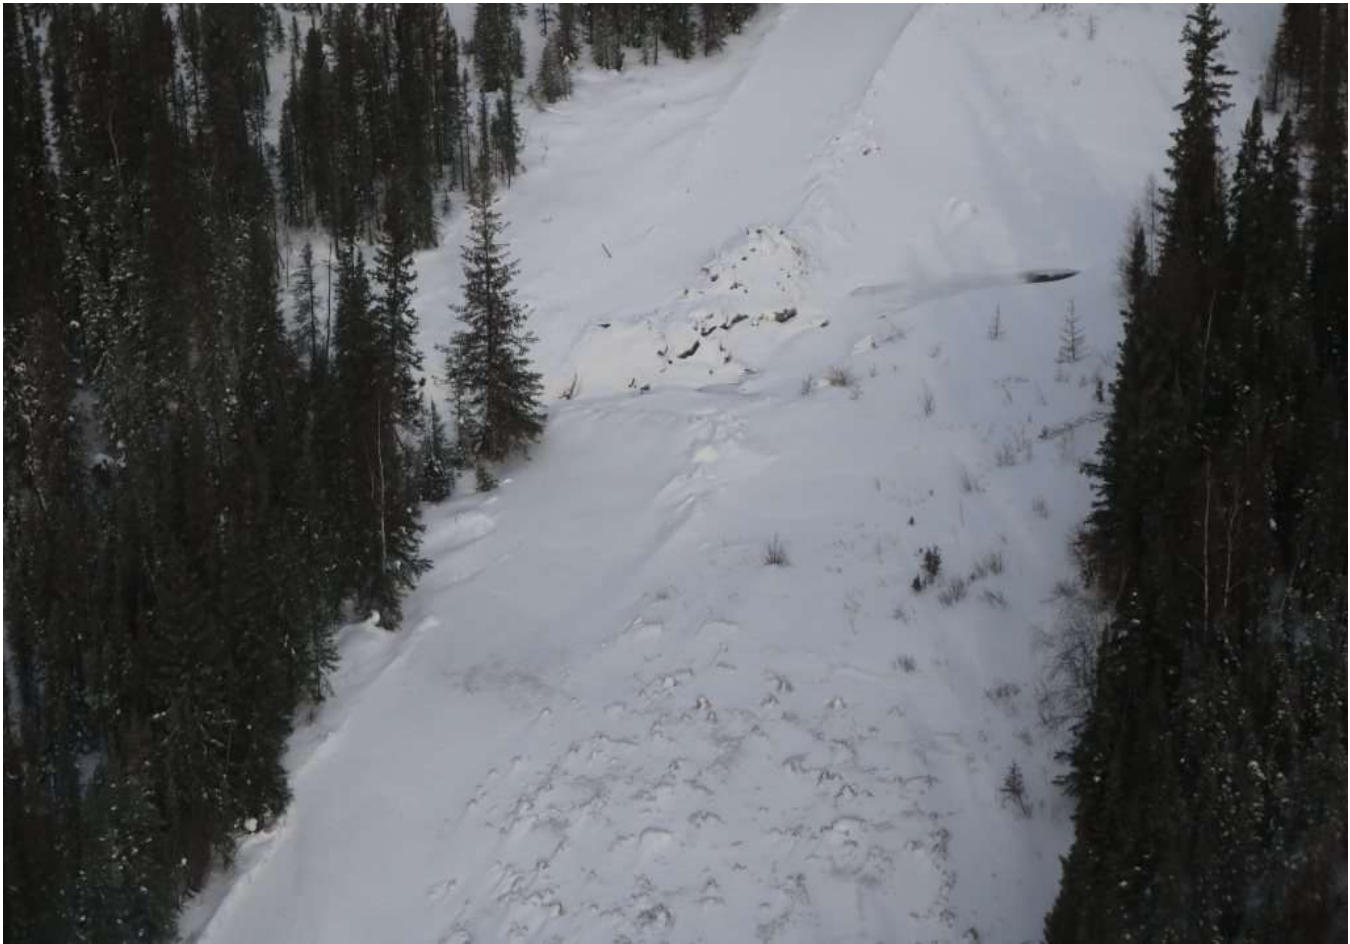
**Figure 11**

**Snow-fill which was removed.**

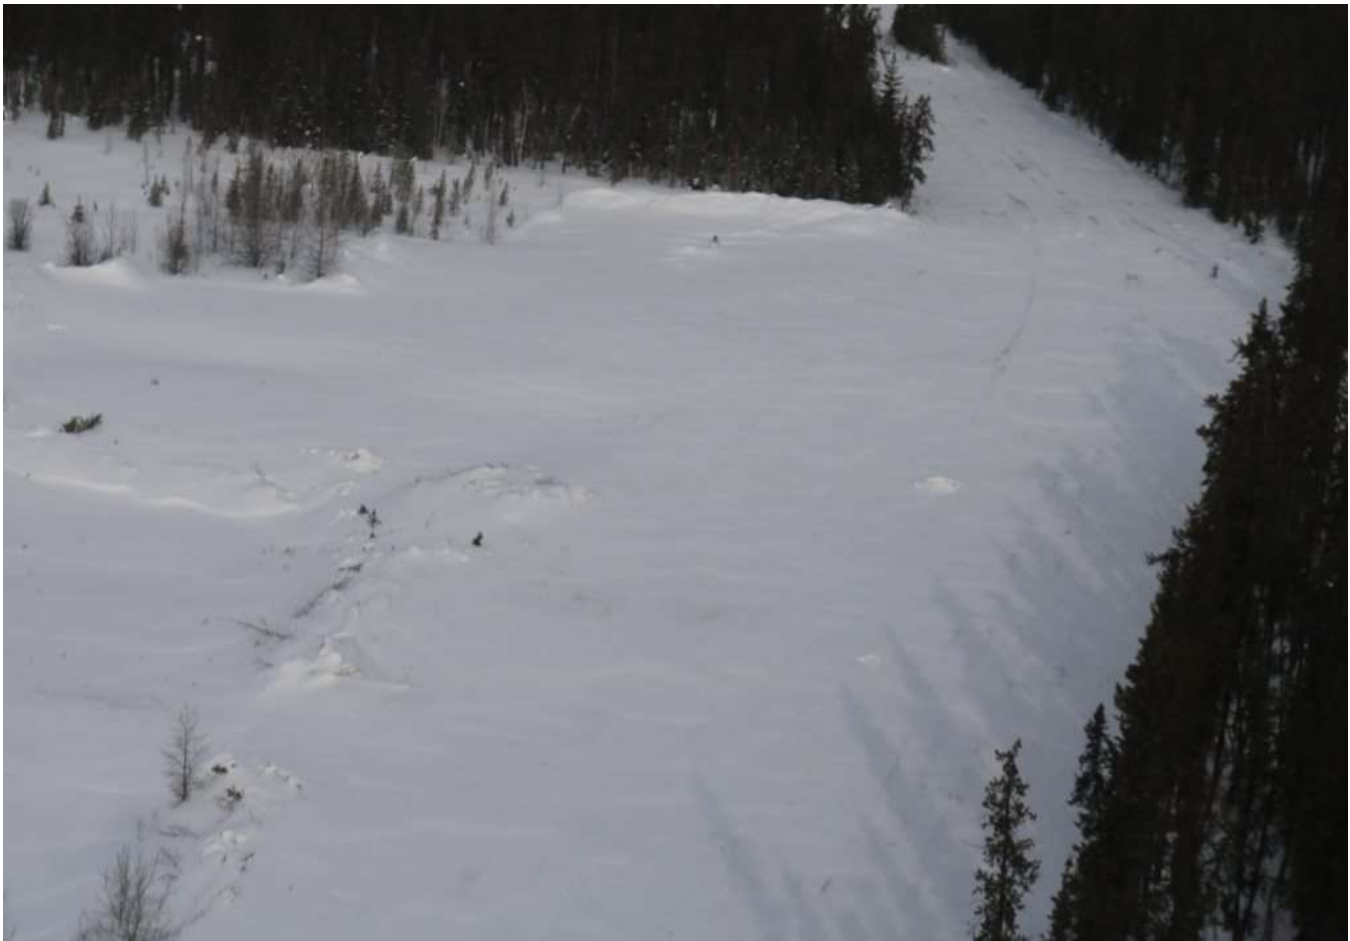
**Figure 12**

**Area where equipment for the KP 303 pipe replacement was stored.**
