**RE: Land Use Permit MV2013P0011  
PIPELINES (existing)  
KP 385 Camp Integrity Dig site KP 387**

## ENVIRONMENTAL INSPECTION REPORT

<b>Permittee:</b>	Enbridge Pipelines (NW) Inc	<b>Permit Expiry Date:</b>	July 17, 2018
<b>Land Use Permit No.</b>	MV2013P0011	<b>Previous Inspection:</b>	New
<b>Quarrying Permit No.</b>		<b>Inspection Date:</b>	March 04, 2014
<b>Contractor:</b>	Ledcore	<b>Subcontractor:</b>	
<b>Location(s) Inspected:</b>	KP 385 Camp Integrity Dig site KP 387		
<b>Current Stage of Operation:</b>	Active		
<b>Program Modifications Approved:</b>	None

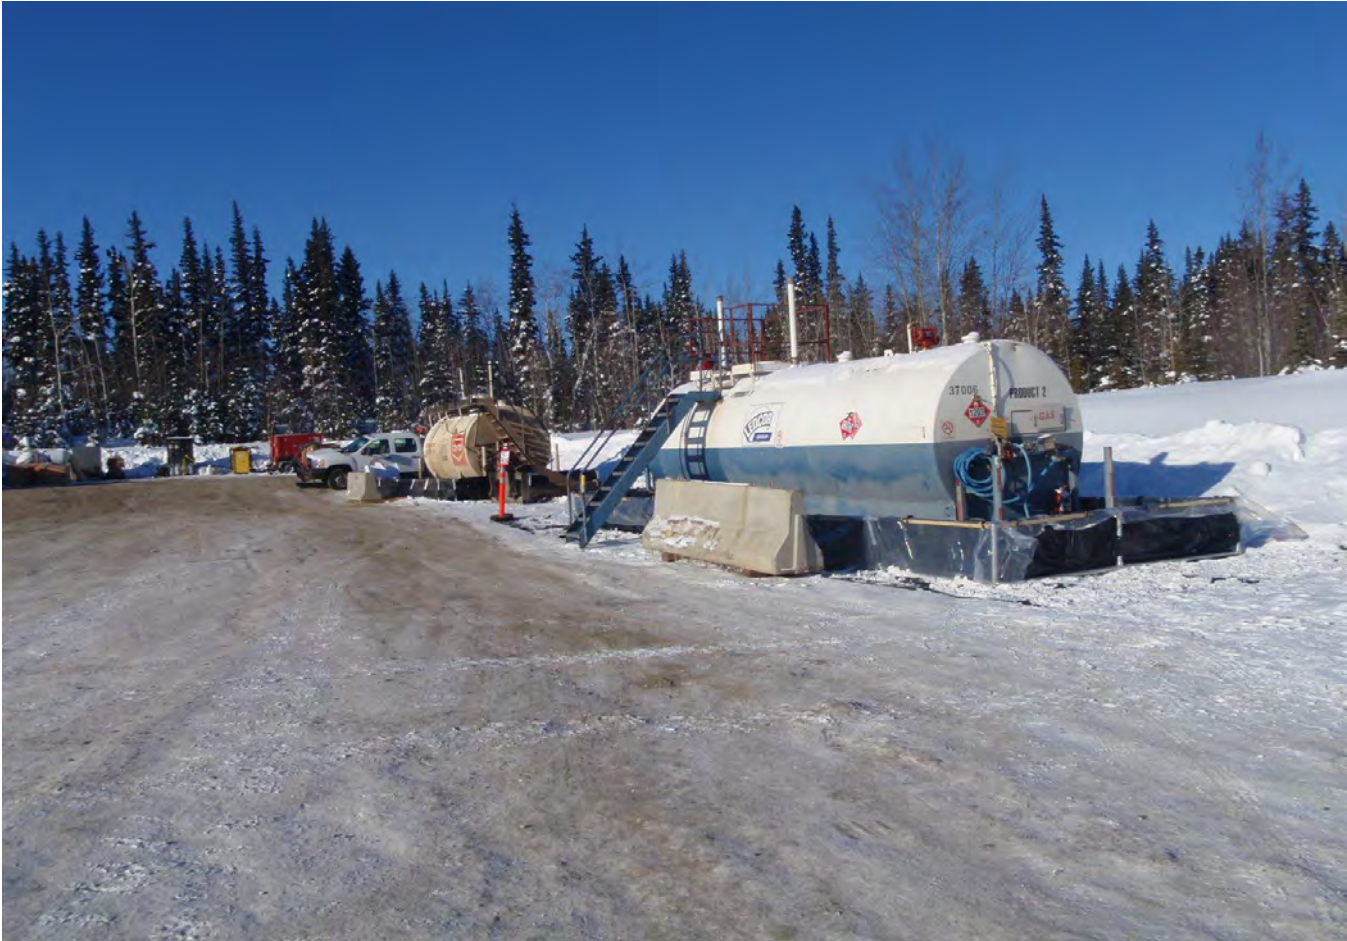
### Figure 1

Smith Creek Camp fuel properly stored with secondary containment and double walled top feeding tanks

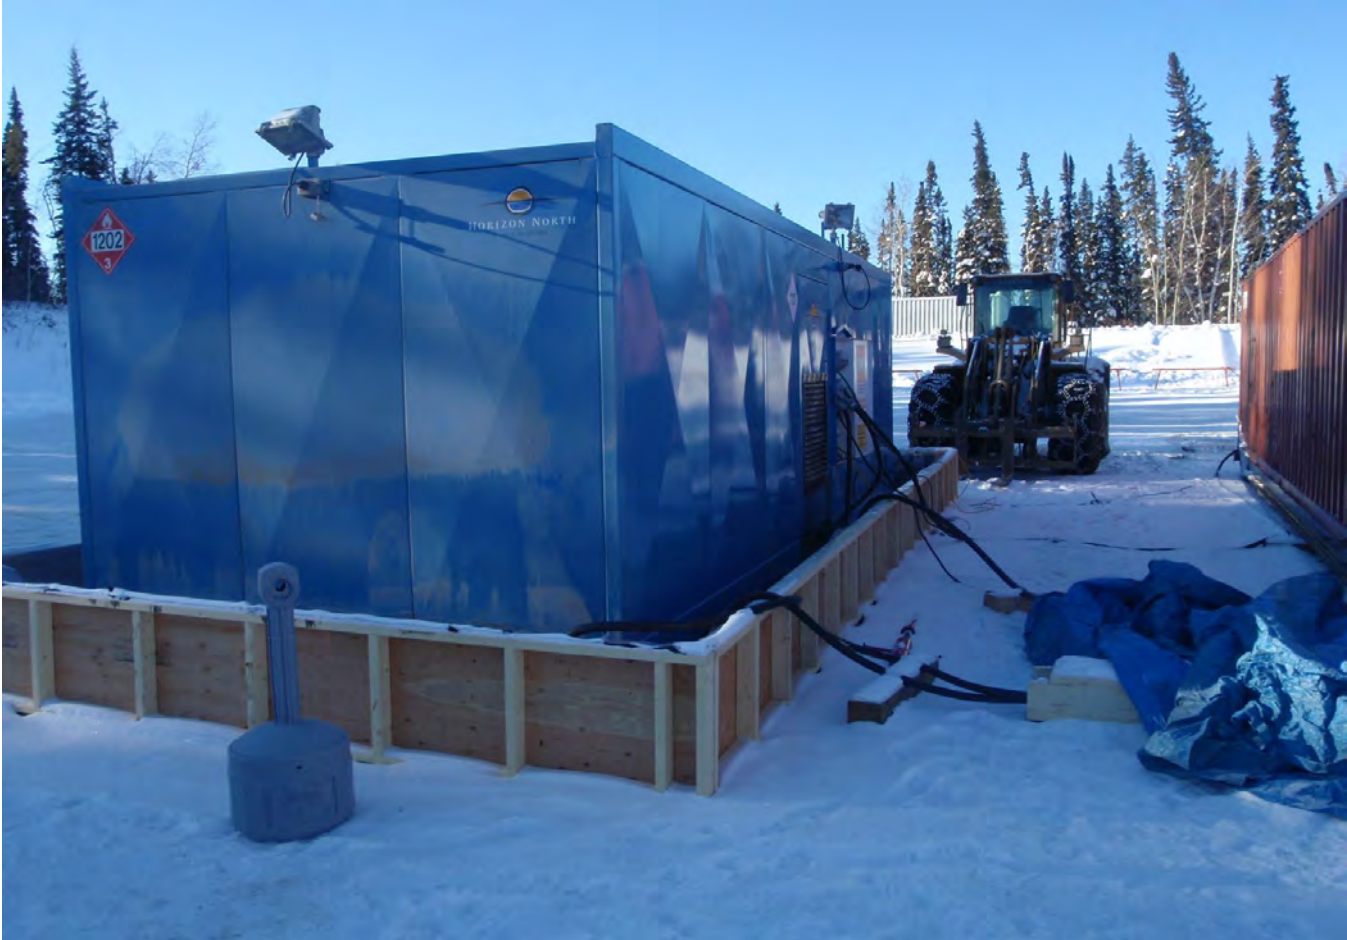
**Figure 2**

**Smith Creek Camp Sewage treatment facility with all solids being transported to the Hay River Sewage Facility**

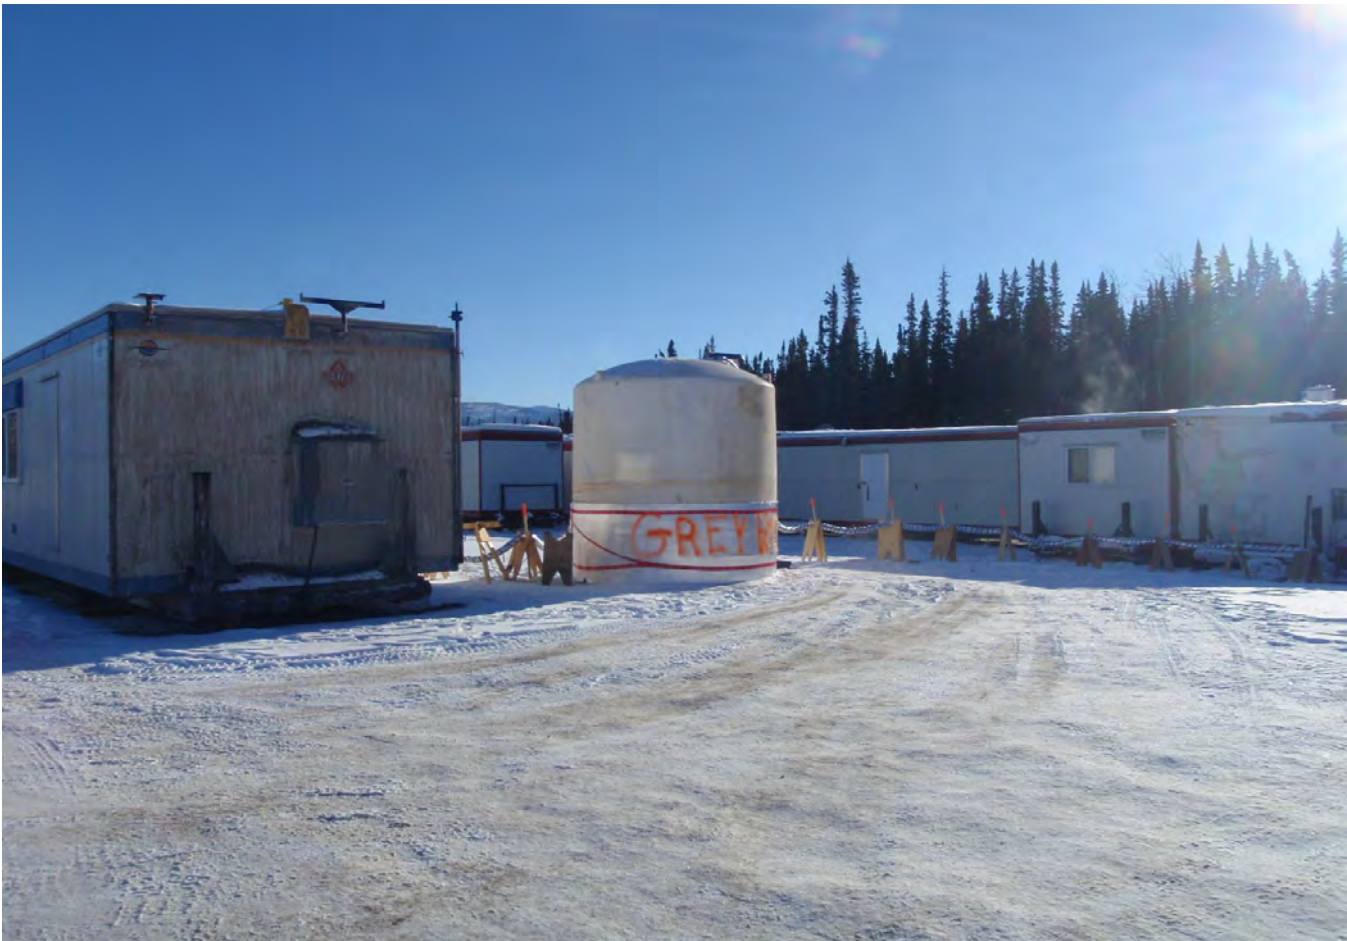
**Figure 3**

**Smith Creek Camp water supply**

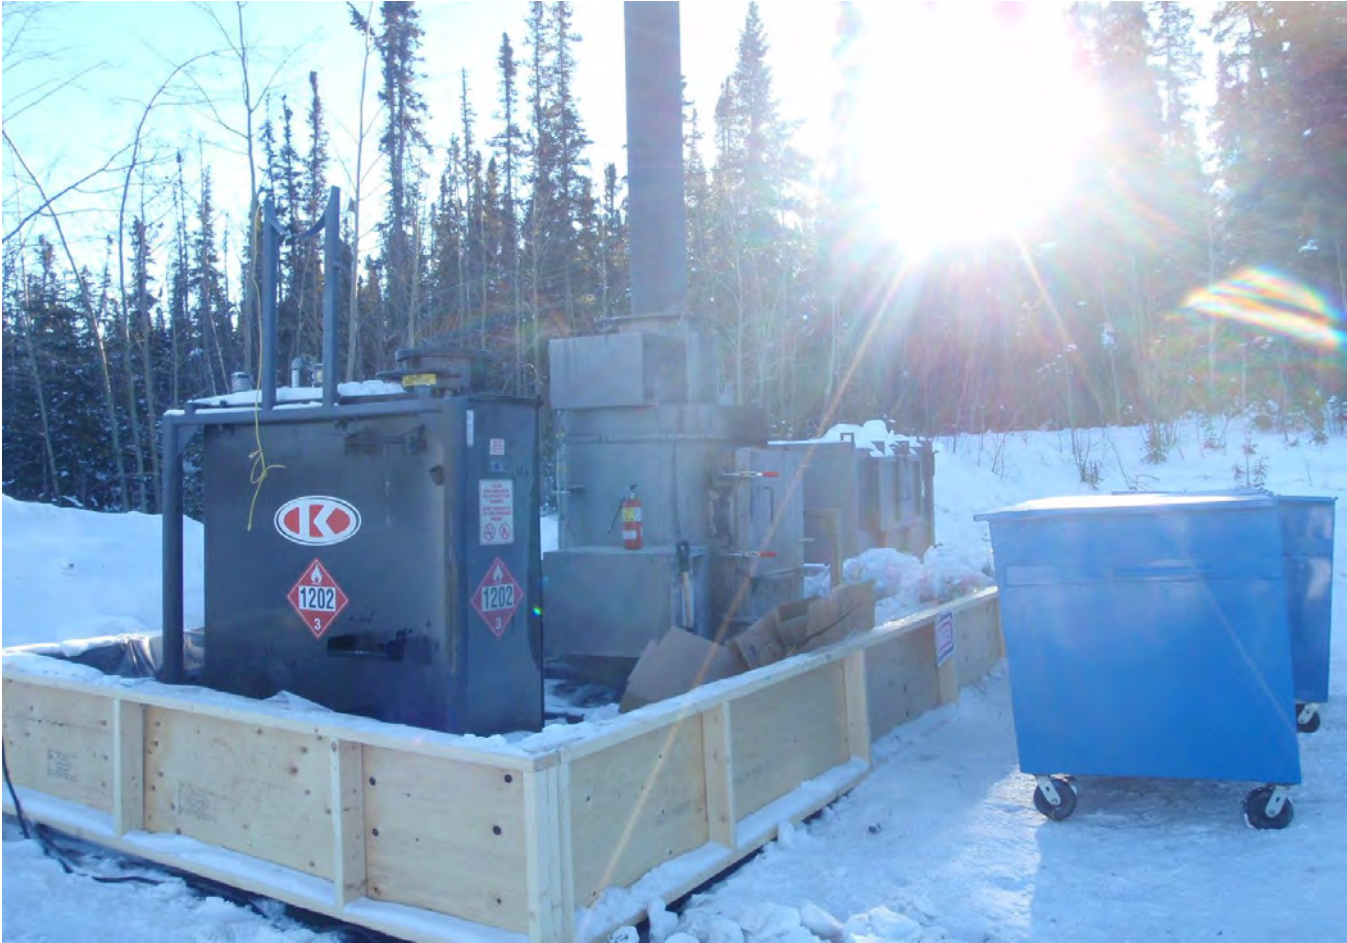
**Figure 4**

This camp site was kept very clean and well laid out. The Inspector had no concerns at the time of this inspection.

**Smith Creek Camp forced air incinerator. Site was very clean and well kept.**

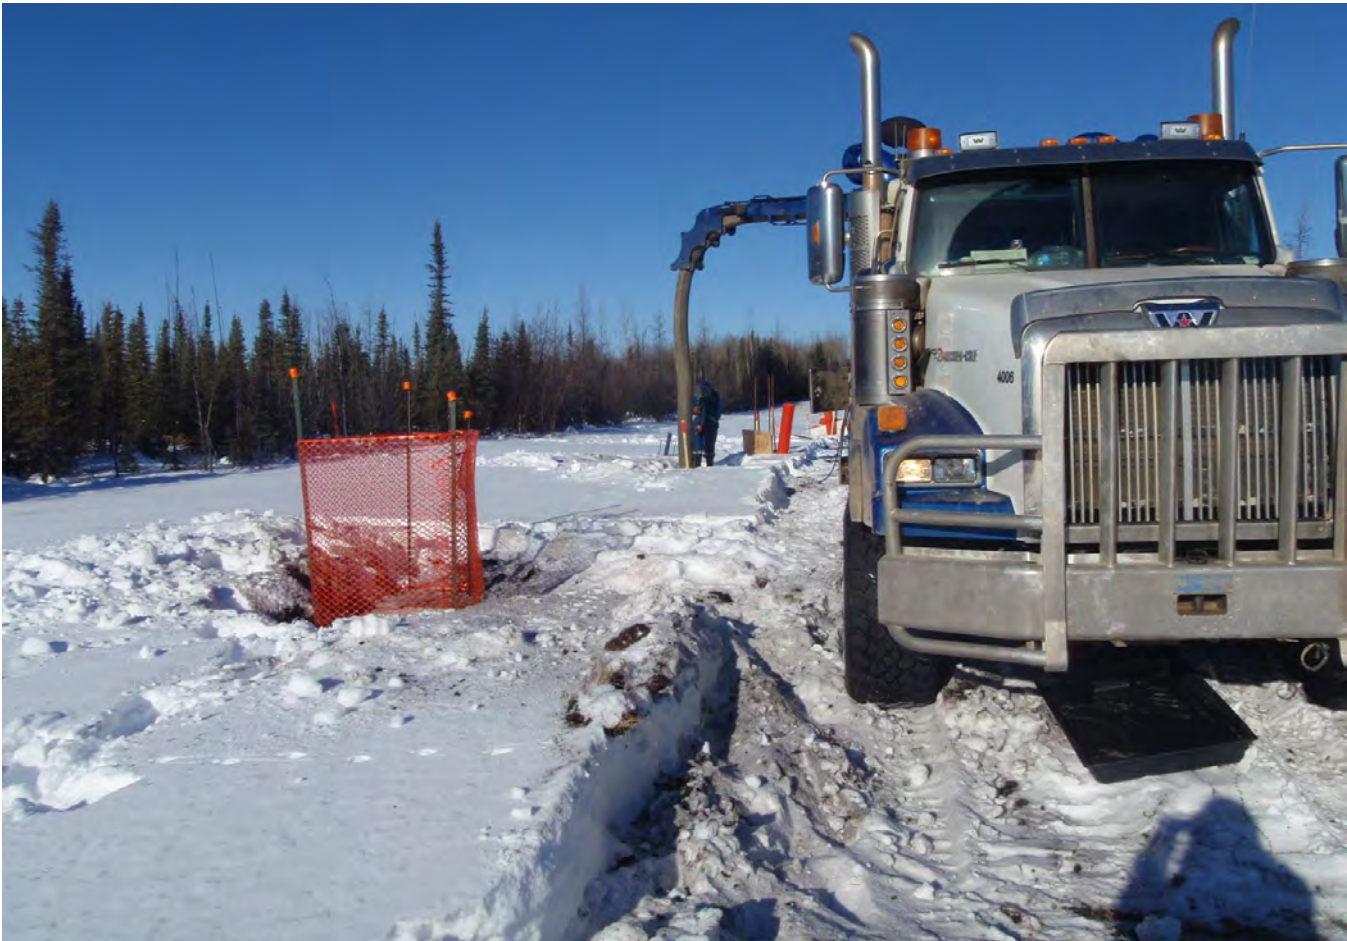
**Figure 5**

This dig site was clean and tidy. The Inspector had no concerns at the time of this inspection

**Integrity dig site. Very little disturbance during this phase of the exposure.**
