**RE: Land Use Permit MV2013Q0017  
QUARRY SITE - New  
Sites A & C, Km 34.1, NWT Highway No. 5**

## ENVIRONMENTAL INSPECTION REPORT

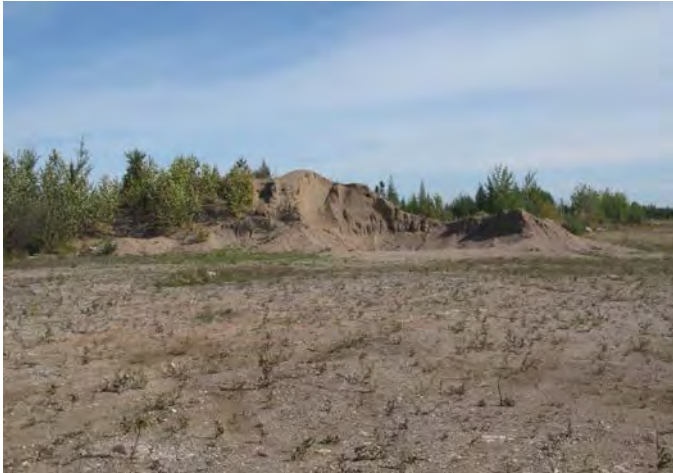
**Figure 1**

A large amount of material has been quarried from the two stockpiles at Site A. **Please ensure that this material is reported in your monthly quarry report to this office as per Condition 11 of your quarry permit.**

Site A stockpile - a large amount of material has been removed this season.

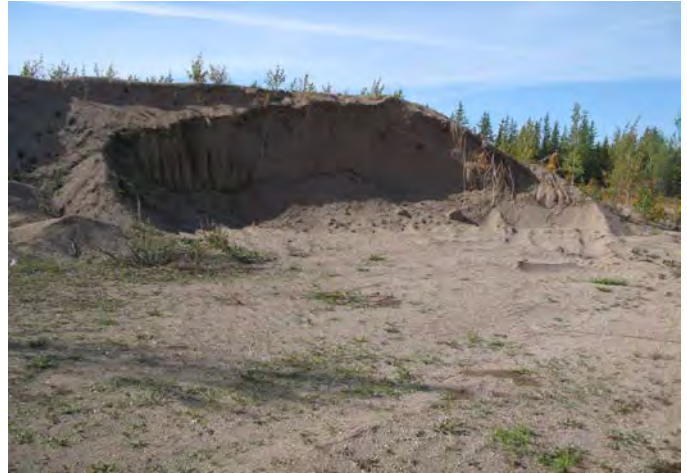
**Figure 2**

Stockpile at the entrance to Site A - material has been removed this season.

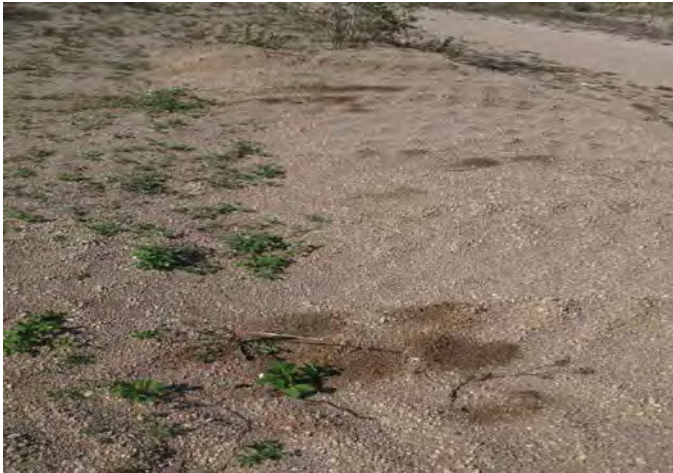
**Figure 3**

**Condition 36:** There are several fuel stains near the stockpile at the entrance to Site A. The contaminated soil must be cleaned up and taken to an authorized disposal area. See comments for Site C regarding repairing leaking equipment and using drip-trays.

Fuel stains near the stockpile at the entrance to Site A.

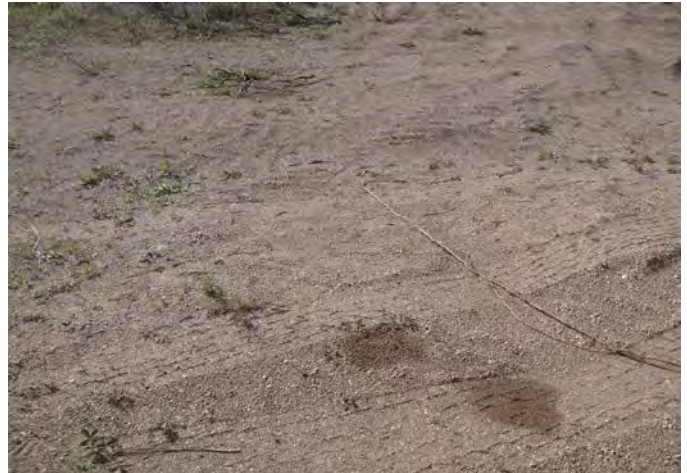
**Figure 4**

More fuel stains near the stockpile at the entrance to Site A.

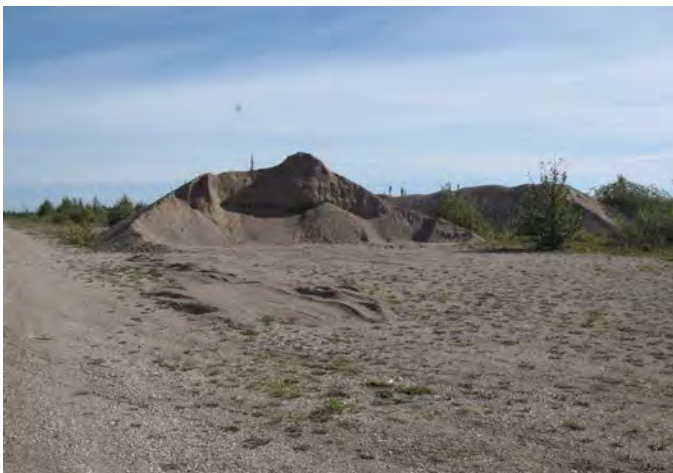
**Figure 5**

A large amount of granular material has been removed from the stockpiles at Site C this season. **Please ensure that this material is reported in your monthly quarry report to this office as per Condition 11 of your quarry permit.**

Site C - material has been removed from this stockpile this season.

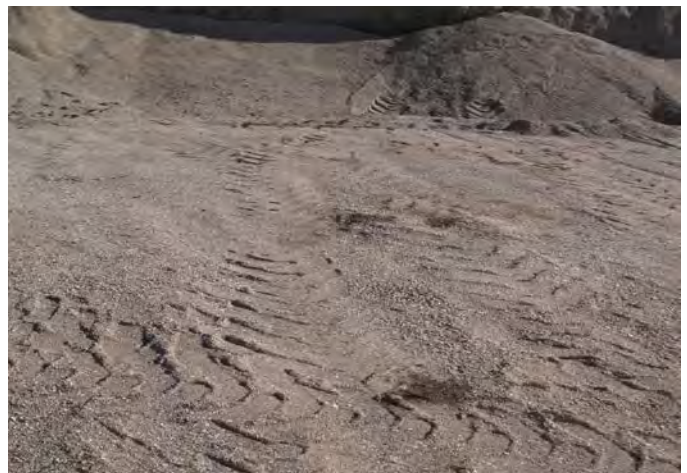
**Figure 6**

**Condition 32 and 36:** There are several fuel stains near the large stockpile which must be cleaned up and taken to an authorized disposal area. Repairs must be made to your loader to prevent further spills from happening.

Site C - fuel stains near the stockpile.

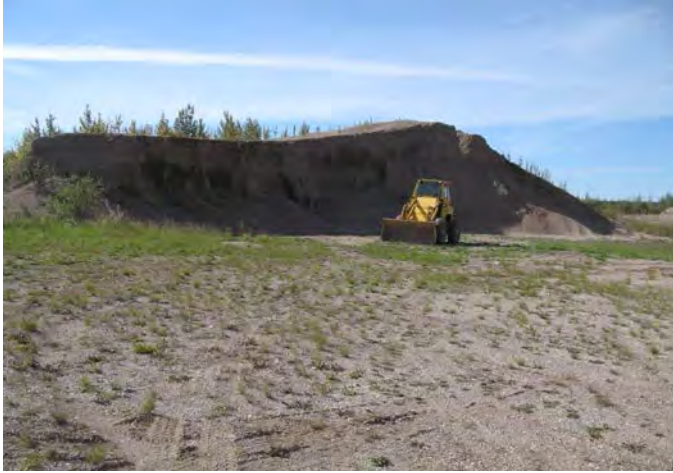
**Condition 35** of your land use permit requires "All equipment that may be parked for 2 hours or more, should have a haz-mat/drip tray under it or be sufficiently diapered. (Leaky equipment should be repaired immediately)." There was no haz-mat/drip tray under the loader at the time of inspection.

**Figure 7**  
**Site C - loader parked at large stockpile.**

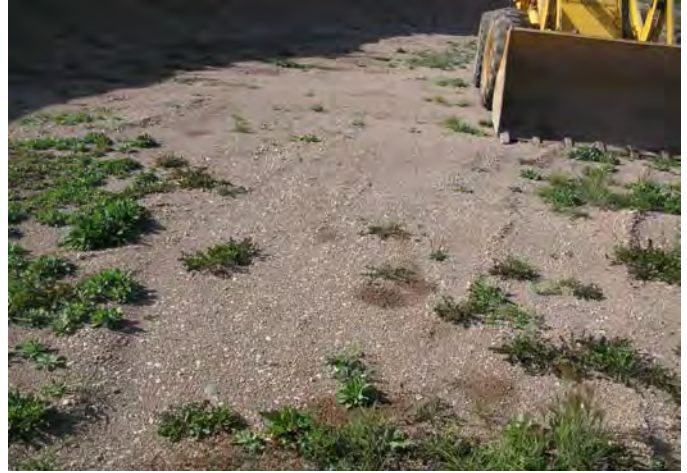
**Figure 8**  
**Site C - fuel stains on the ground near the large stockpile.**

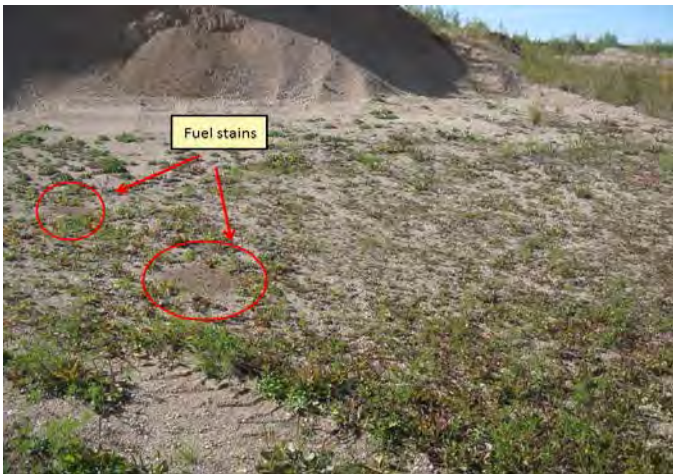
**Figure 9**  
**Site C - more fuel stains near the large stockpile.**

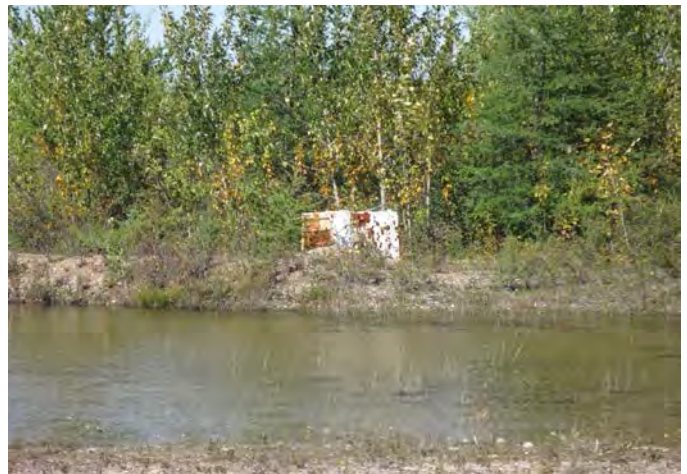
**Condition 25 and 11:** As identified in the previous inspection reports, the old dryer still has not been removed from territorial lands and taken to an authorized disposal area.

**Figure 10**  
**Site C - old dryer remains on site.**
