<b>File Number</b>	<b>MV2013Q0017</b>
<b>Type of Operation</b>	<b>QUARRY SITE - New</b>
<b>Location</b>	<b>Km 34.1, Site A &amp; C, NWT Highway No. 5</b>

## ENVIRONMENTAL INSPECTION REPORT

<b>Permittee:</b>	ProCore Drilling Ltd.	<b>Permit Expiry Date:</b>	May 21, 2019
<b>Land Use Permit No.</b>	MV2013Q0017	<b>Previous Inspection:</b>	June 20, 2018
<b>Quarrying Permit No.</b>	2017QP0025	<b>Inspection Date:</b>	September 28, 2018
<b>Contractor:</b>		<b>Subcontractor:</b>	
<b>Location(s) Inspected:</b>	Km 34.1, Site A & C, NWT Highway No. 5		
<b>Current Stage of Operation:</b>	Site C quarry has been active this season.		
<b>Program Modifications Approved:</b>

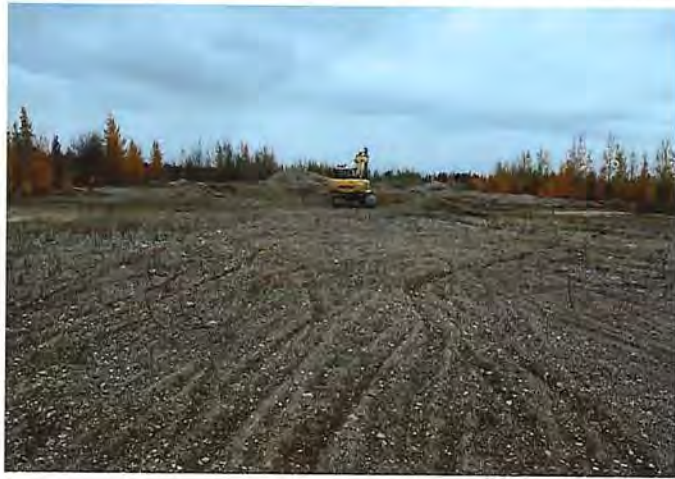
**Figure 1**

**Site C: Excavator parked at the west end of pit.**

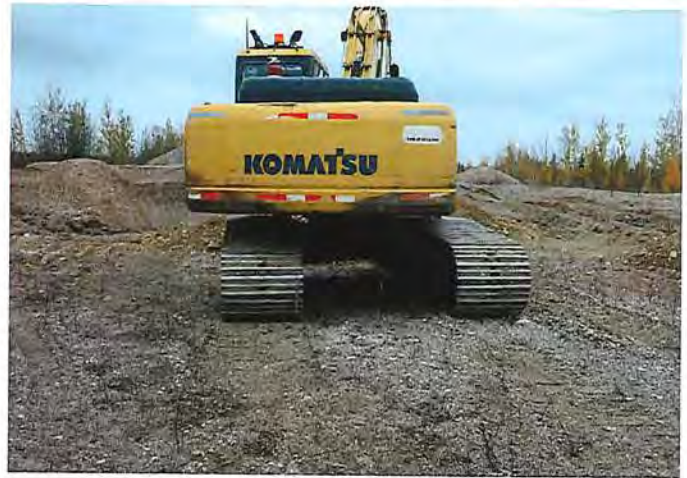
**Figure 2**

An excavator is located at the west end of the quarry and has been digging in this area. The excavator has been parked without a drip tray which is in contravention of land use permit **Condition 35** which states "All equipment that may be parked for two hours or more, should have a haz-mat/drip tray under it or be sufficiently diapered. Leaky equipment must be repaired immediately." Please ensure that drip trays are being used under parked equipment at the quarry site.

**Site C: No drip tray under the Excavator.**

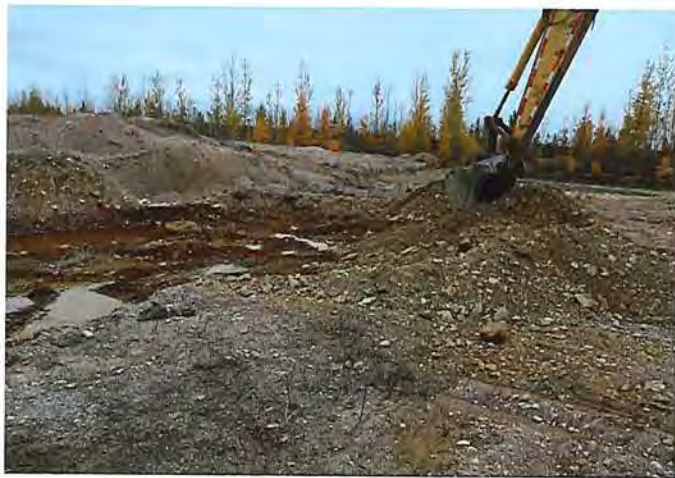
**Figure 3**

**Site C: Permittee has been quarrying at the west end of the pit.**

Contouring work will be required at west end of the quarry once the Permittee has depleted this area.

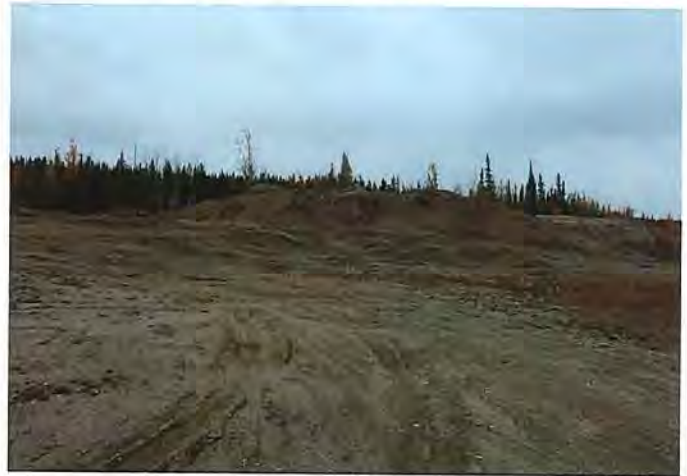
**Figure 4**

The Permittee has been quarrying in Site C this season under the authority of quarry permit # 2017QP0025. Quarrying activity has taken place at the west end of the pit and from the large stockpile in the central part of the pit. The slopes on the large stockpile have been reduced which will prevent swallows from nesting in the stockpile in the spring.

**Site C: A large amount of granular material has been removed from Site C. Slopes have been reduced at the large stockpile.**

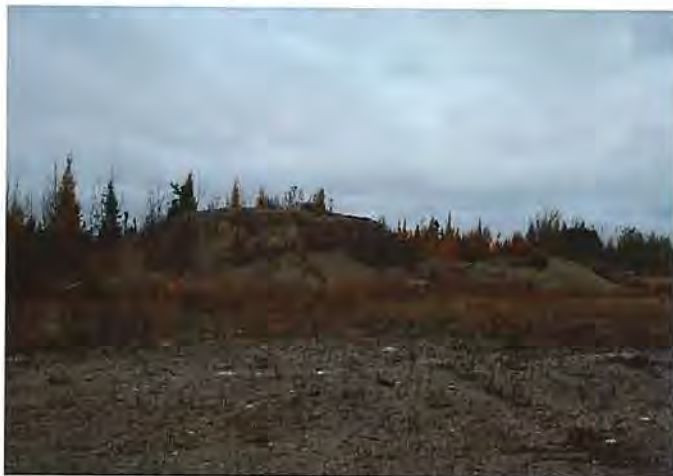
**Figure 5**

**Site A: No activity this season.**
