<b>File Number</b>	<b>MV2015Q0003</b>
<b>Type of Operation</b>	<b>QUARRY SITE - Existing</b>
<b>Location</b>	<b>Km 44.5, NWT Highway No. 5 - HR34-6 &amp; HR34-9</b>

## ENVIRONMENTAL INSPECTION REPORT

<b>Permittee:</b>	Carter Industries Ltd.	<b>Permit Expiry Date:</b>	April 22, 2020
<b>Land Use Permit No.</b>	MV2015Q0003	<b>Previous Inspection:</b>	November 10, 2016
<b>Quarrying Permit No.</b>	16/0031	<b>Inspection Date:</b>	January 26, 2017
<b>Contractor:</b>		<b>Subcontractor:</b>	
<b>Location(s) Inspected:</b>	Km 44.5, NWT Highway No. 5 - HR34-6 & HR34-9		
<b>Current Stage of Operation:</b>	The crushing operation is ongoing. Processed material continues to be hauled to Km 136 and 162, NWT Highway No. 5 in Wood Buffalo National Park.		
<b>Program Modifications Approved:</b>

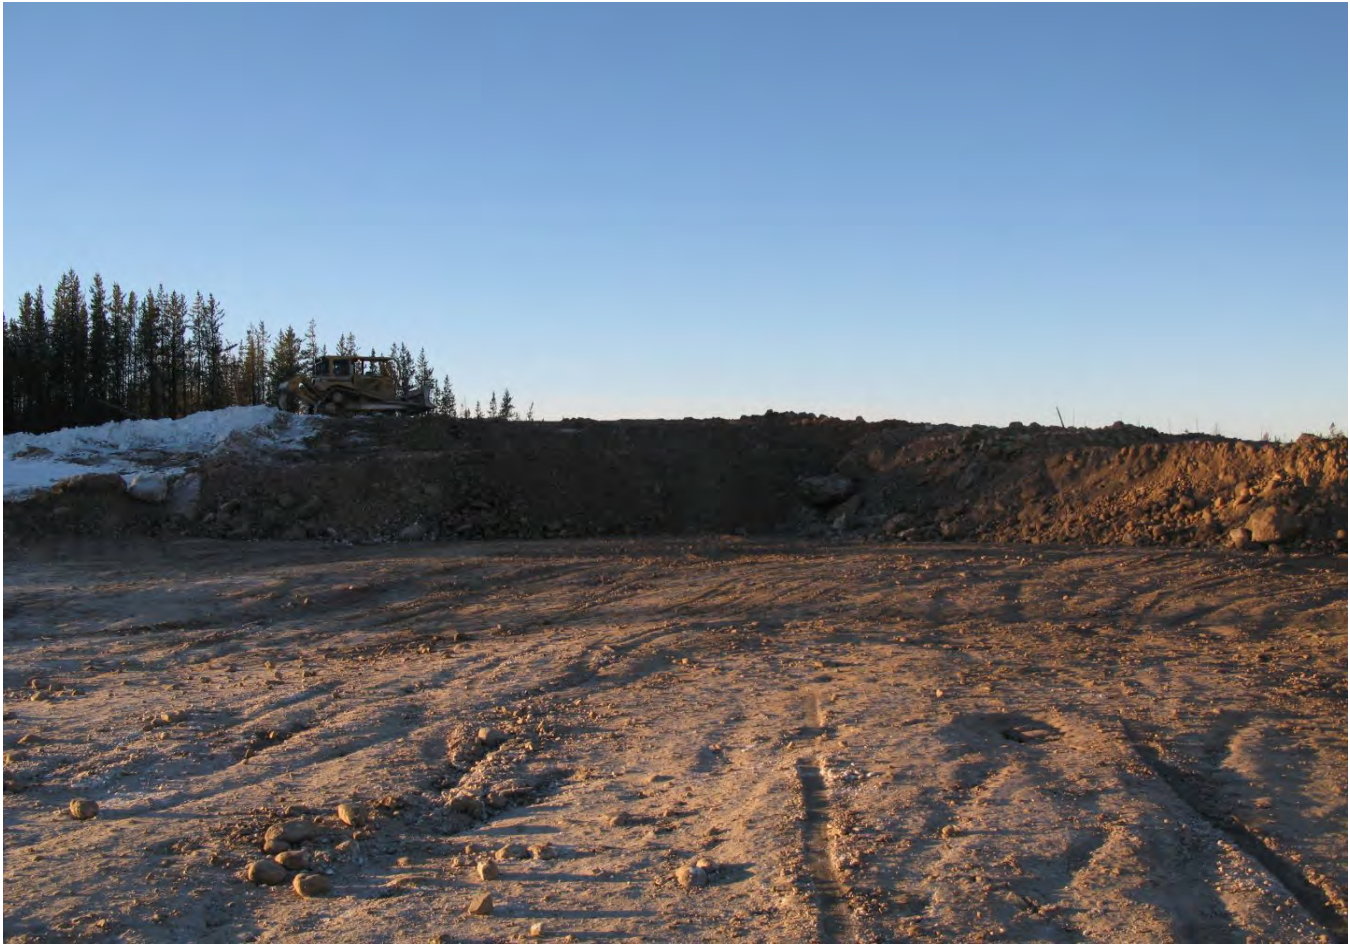
**Figure 1**

At the time of the inspection, granular material was being excavated from the east side of HR34-9. Reclamation of the depleted portion of the HR34-9 will take place in the summer. The area will be contoured and overburden will be spread to foster vegetation

**Granular material is being excavated on the southeast side of the pit.**

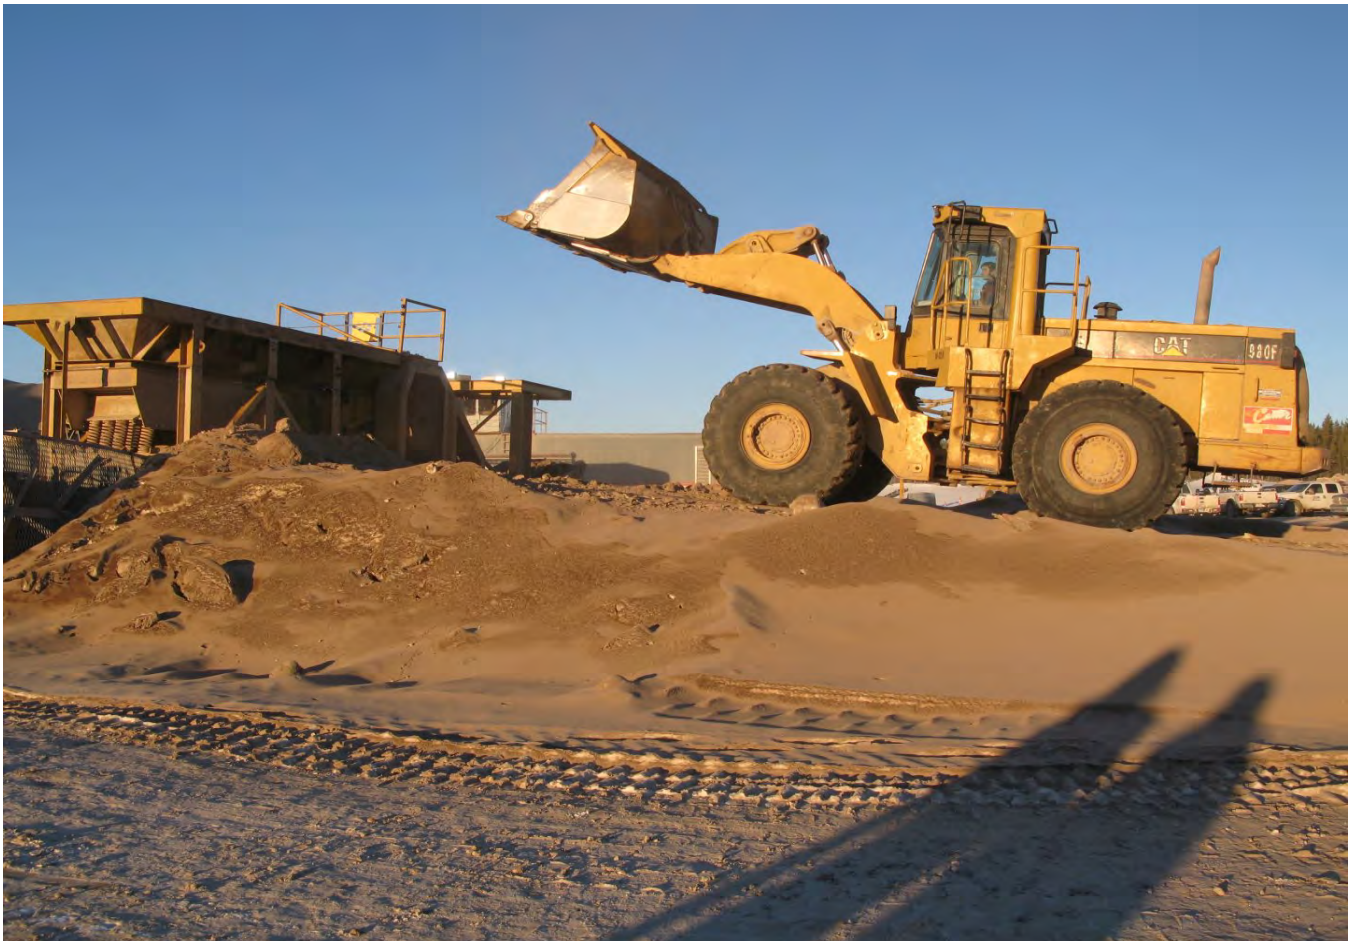
**Figure 2**

**Loader feeding pitrun into the crusher.**

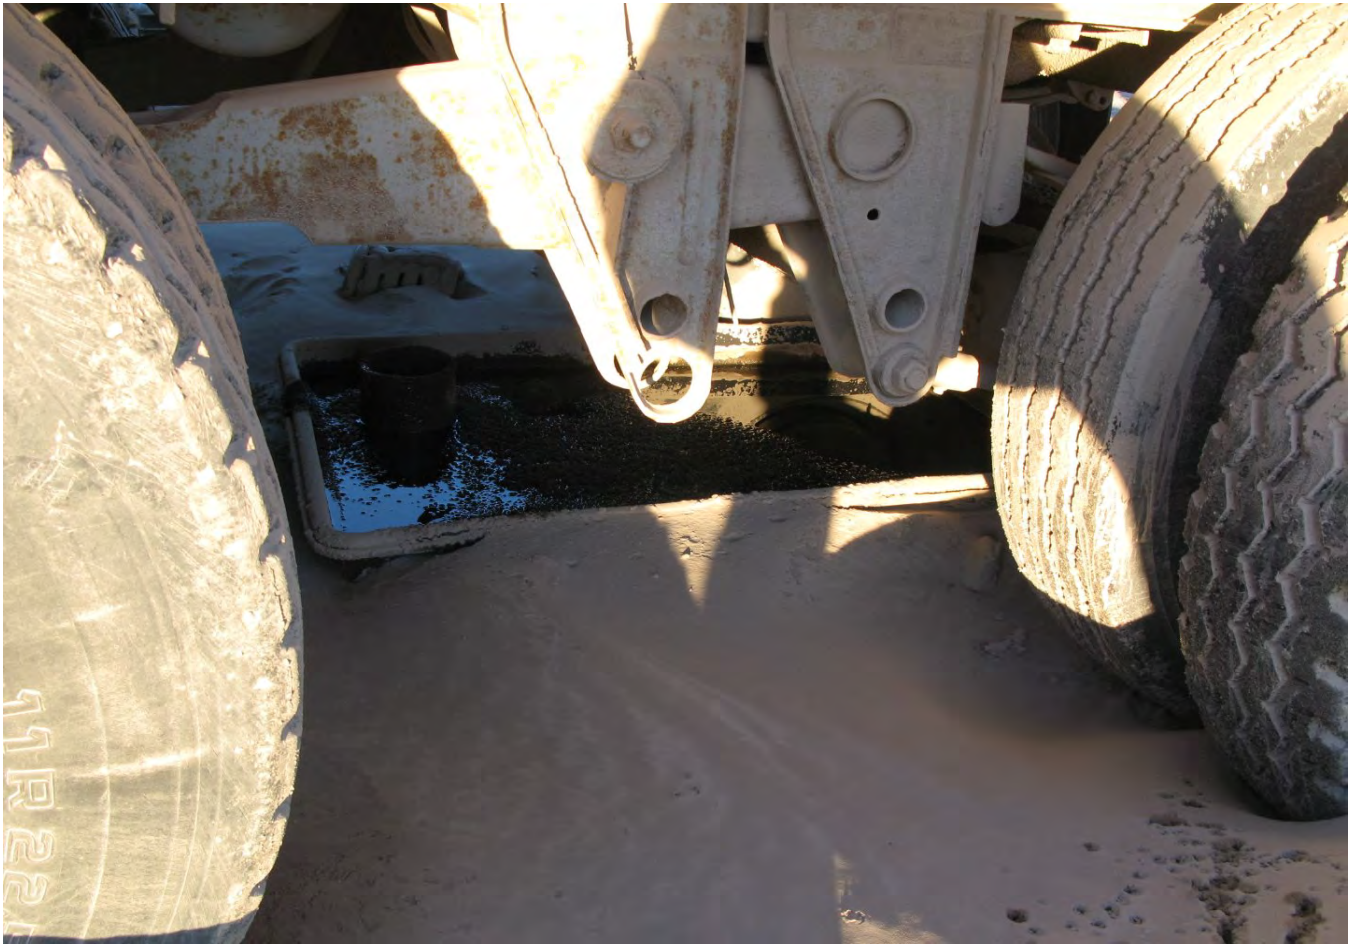
The Inspectors were pleased to see that drip trays have been placed under the crusher generator and the light plant as requested in the previous inspection.

**Figure 3**  
**Drip tray under the crusher generator.**

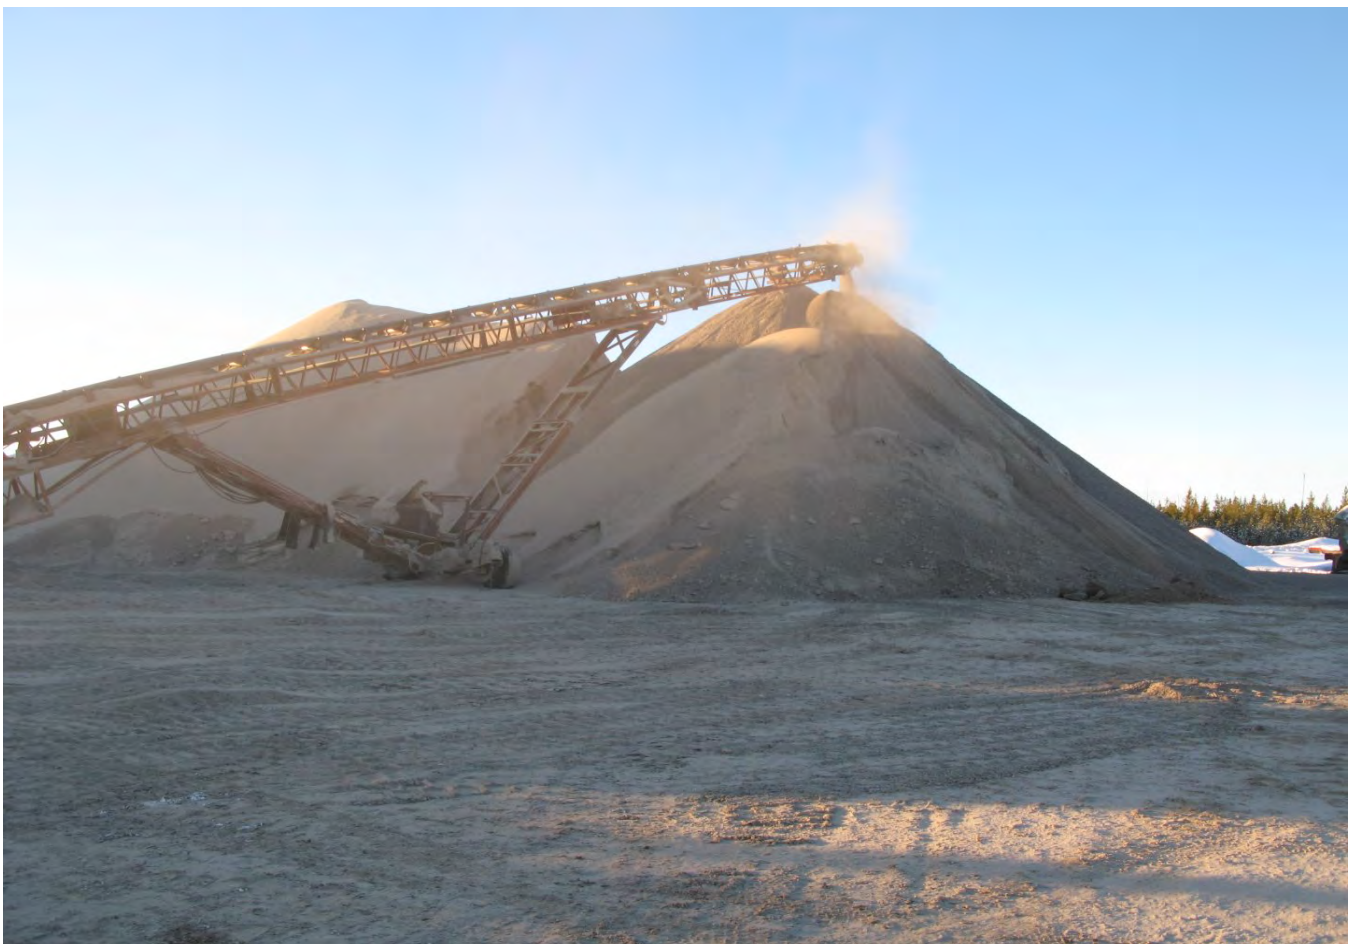
**Figure 4**  
**Stockpile of 3/4" material.**

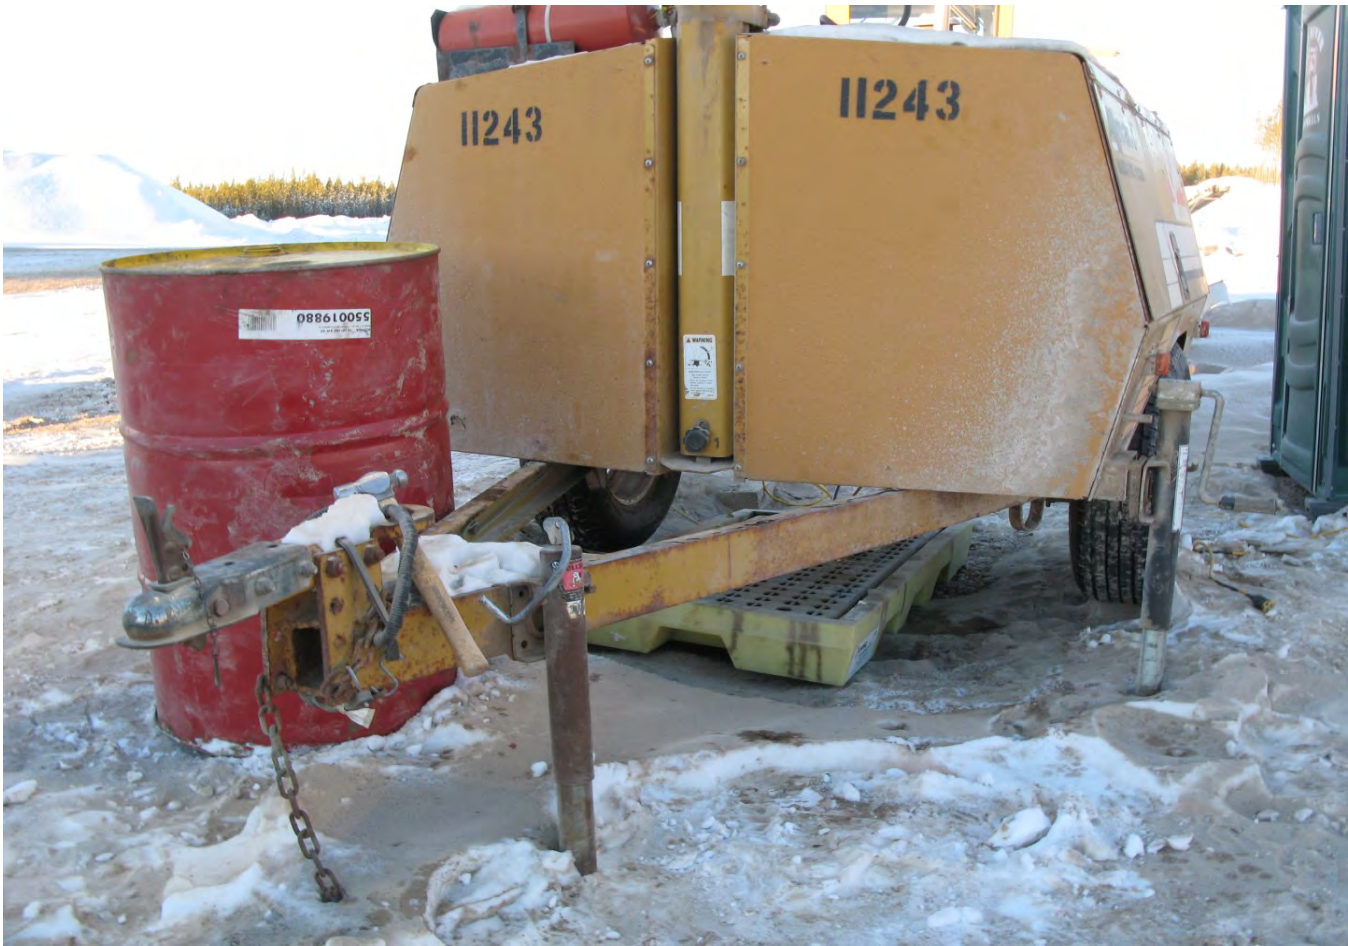
**Figure 5**  
Drip tray has been placed under the light plant.

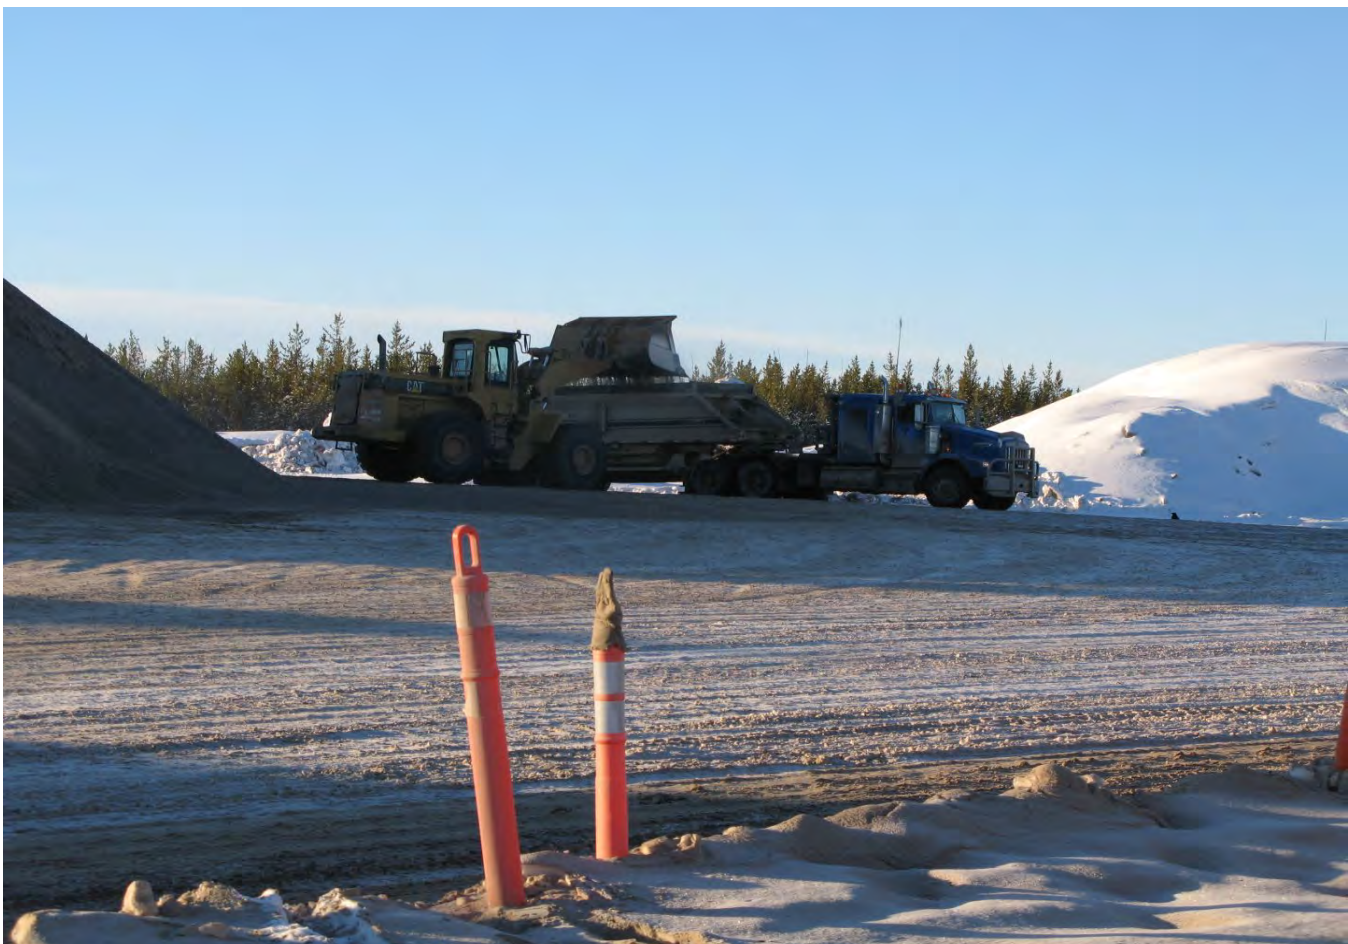
**Figure 6**  
Granular material being loaded into a truck.
