INAC-CARD Giant Mine – Geotech Drilling

RE: Land Use Permit MV2016S0016 - Giant Mine Completed Geotech Drilling Locations

ENVIRONMENTAL INSPECTION REPORT (MV2016S0016)

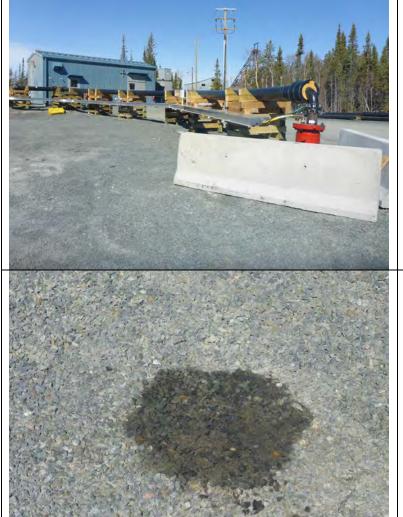
There were numerous small hydrocarbon stains located around the Akaitcho pumping station (Photo #6). All of the contaminated material must be removed and stored in sealed drums until the final remediation of the site takes place.

Photo #6: Multiple small hydrocarbon stains located around the Akaitcho pumping station.
