INAC-CARD Giant Mine – Akaitcho Pumping Station – Well Drilling

RE: Land Use Permit MV2016S0016 – Giant Mine Akaitcho Pumping Station Well Drilling

ENVIRONMENTAL INSPECTION REPORT (MV2016S0016)

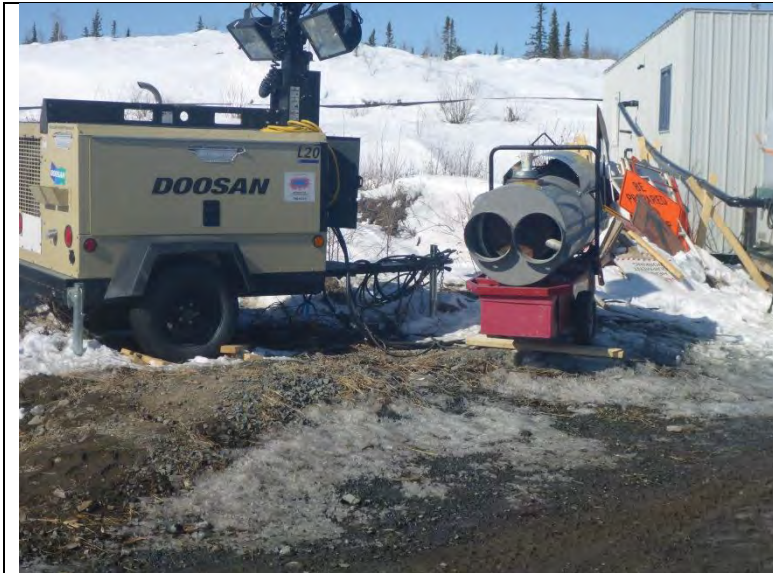
Photo #1: Overview of the camp setup near the drilling site. Note the lack of drip trays present under the equipment.

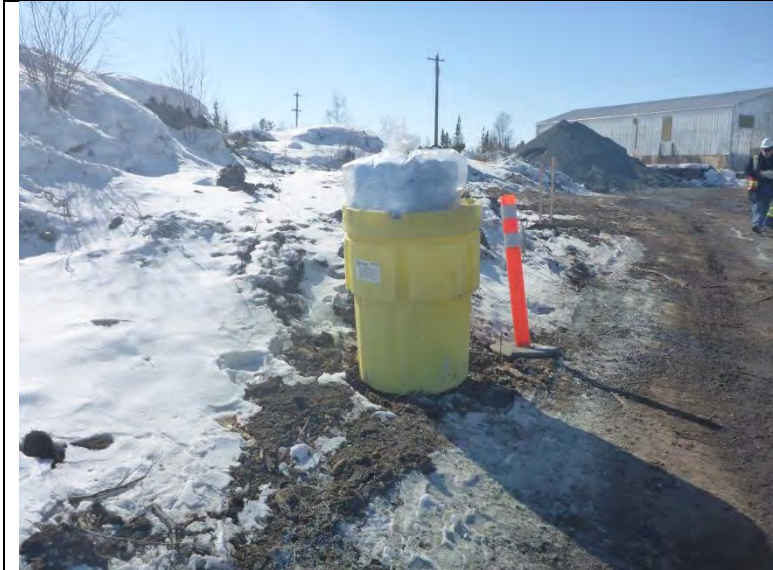
Photo #2: Spill response kit located near the drilling site.

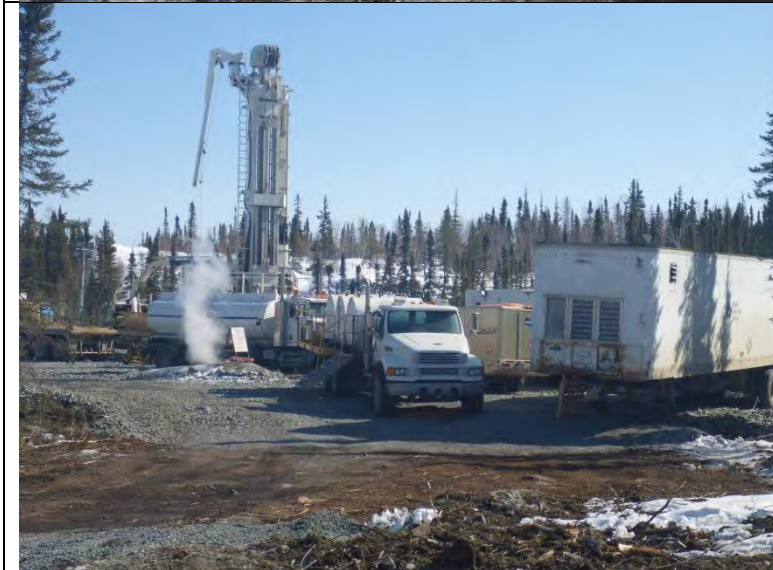
Photo #3: Overview of the drilling operation.

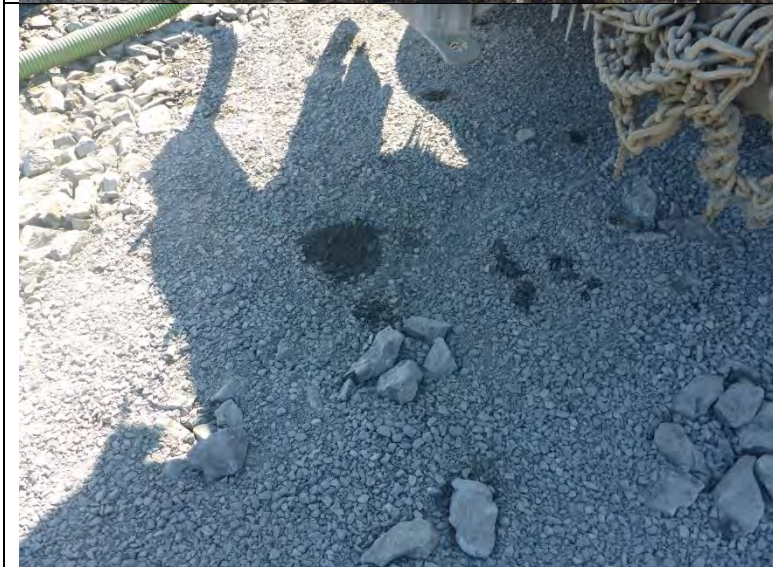
There were numerous small hydrocarbon stains located throughout the drilling area. Photo's #4 and #7 are two examples of the hydrocarbon stains that the Inspectors noted during the inspection. These areas of contamination must be cleaned up and disposed of in accordance with the approved waste management plan. The Inspectors expect that the operators follow the approved spill contingency plan and the procedures listed within it. It is also requested that the record of spills required under the land use permit be submitted to the Inspector as soon as possible.

Photo #4: One of multiple small hydrocarbon leaks throughout the site.

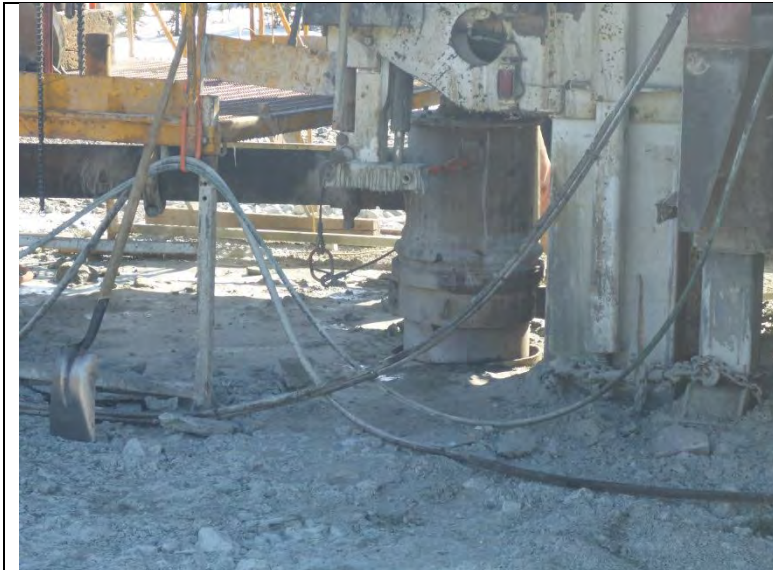
Photo #5: Close up of the drilling rig.

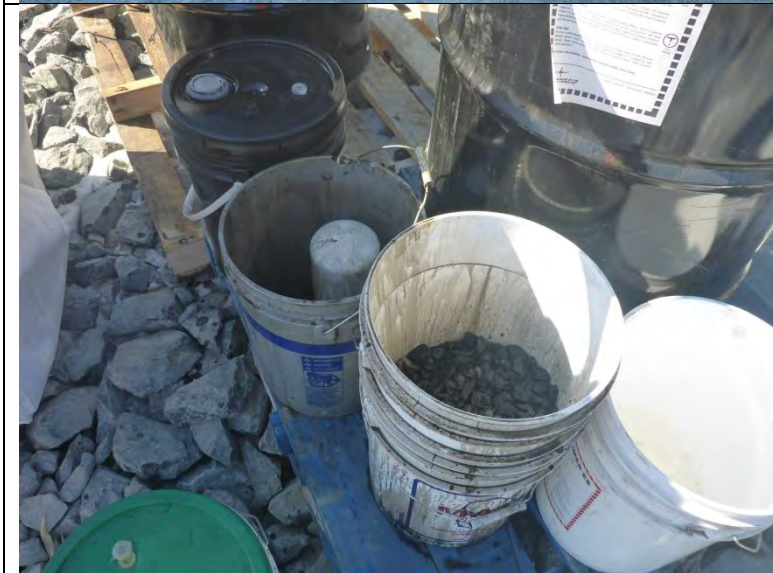
There were multiple containers and drip trays containing waste oil that was not sealed throughout the drill site (Photos #6 & #7). This waste must immediately be sealed and disposed of in accordance with the approved waste management plan. There were numerous pieces of equipment that did not have drip trays placed under it as required by condition #34 of the land use permit (Photo #1 & #8). The Permittee must ensure that all parked equipment has drip trays placed underneath and ensure all leaking equipment is repaired immediately.

Photo #6: Multiple 5 gallon pails without lids containing waste oil and rocks covered in hydrocarbons.

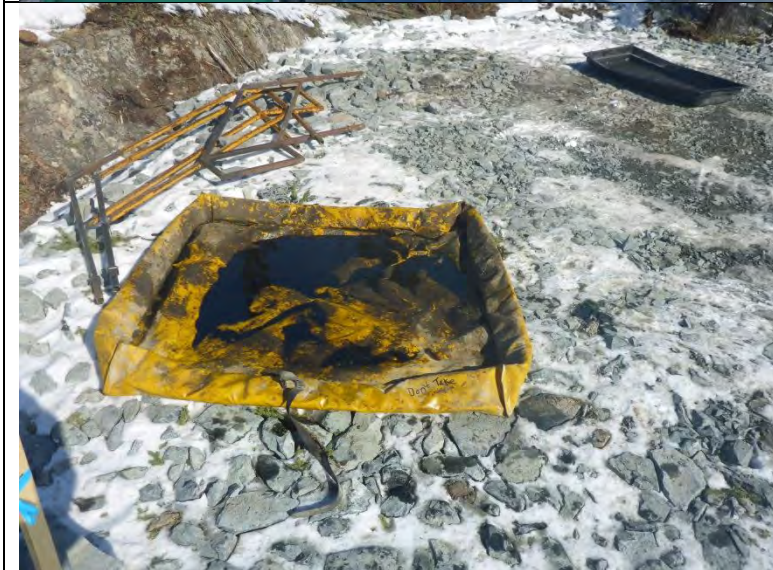
Photo #7: Drip tray containing waste oil. Note that some of this oil had spilled over to the surrounding environment.

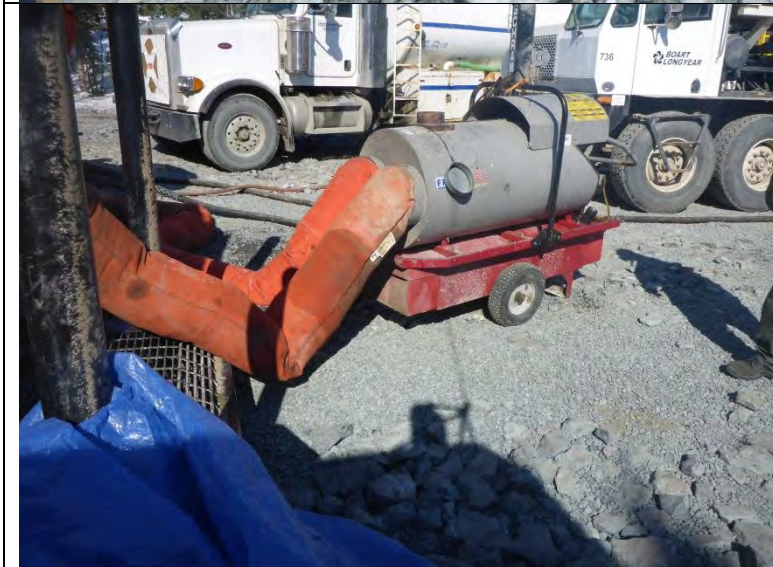
Photo #8: Frost fighter without secondary containment.

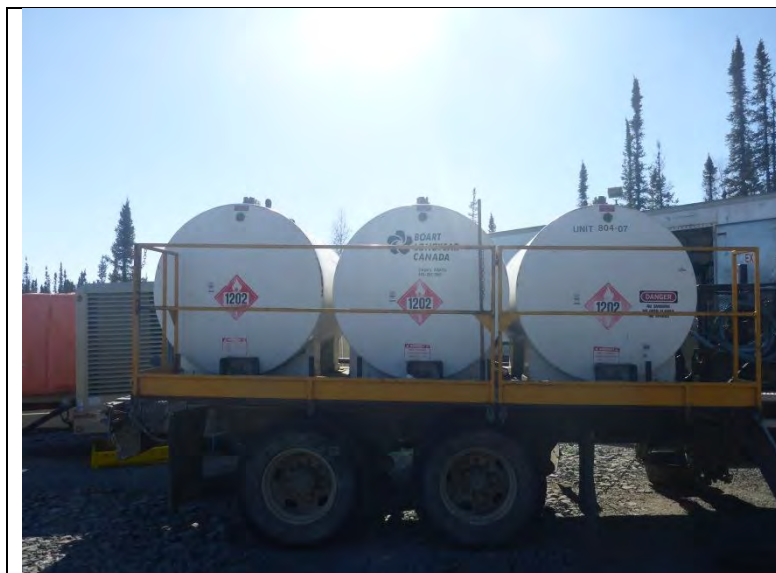
The drilling contractor, Boart Longyear Canada was currently setup on the second drilling location at the time of the inspection. The Inspectors noted that the drilling contractor had three large double walled storage tanks located on the back of a flatbed truck (Photo #9). The project description contained within the application for land use permit MV2016S0016 states that only fuel from tidy tanks and the existing 100,000 liter tanks located within the GIANT Mine site would be used. The land use permit does not have any requirements for secondary containment given that no new fuel storage systems would be used for the project. The Inspector expects that all fuel containers with the exception of the fuel systems listed within the original application are placed within secondary containment.

Photo #9: Three large storage tanks all connected and placed on the back of a flatbed truck.
