INAC-CARD Bullmoose/Ruth Remediation Project

RE: Land Use Permit MV2016X0013 – Bullmoose/Ruth Remediation Project

INSPECTION DATE – March 28th 2018

ENVIRONMENTAL INSPECTION REPORT (MV2016X0013)

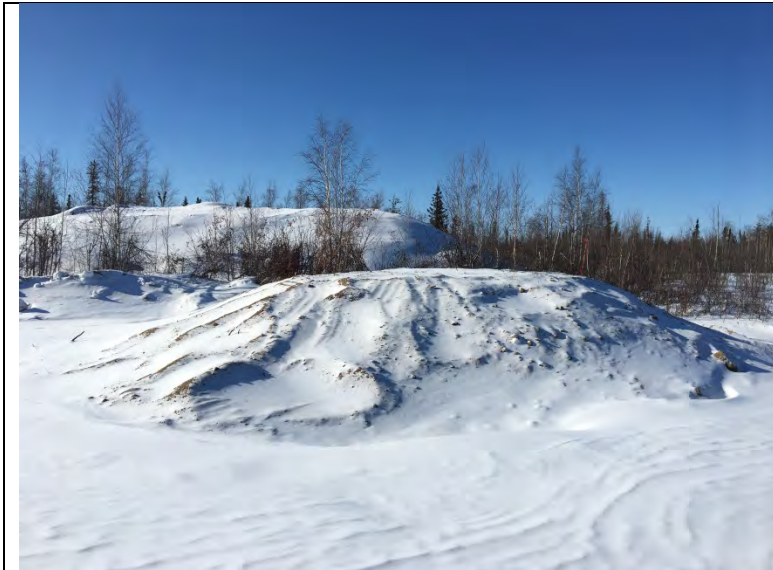
Photo #1: Sand piled around a concrete structure at Beaulieu Mine Site. This has been done to prevent injury to animals.

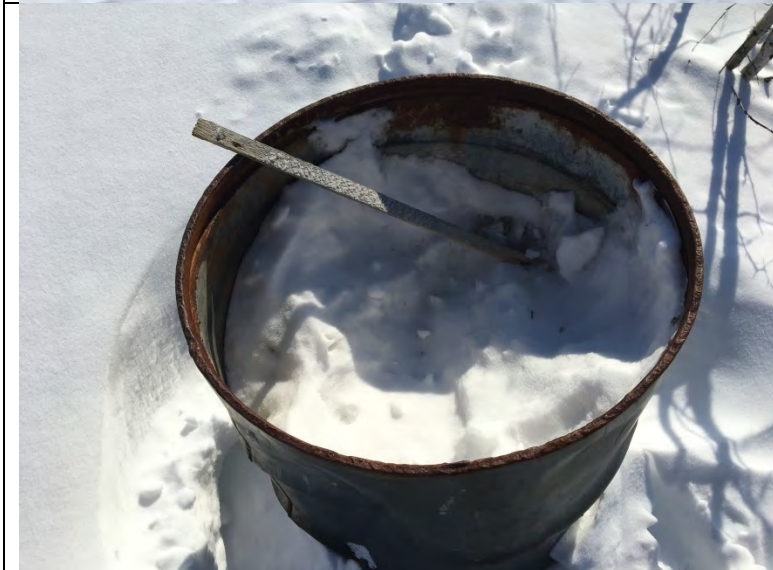
Photo #2: One drum remaining at June mine containing ore belonging to Robert Carroll. The removal of these drums are outside of the scope of the project.

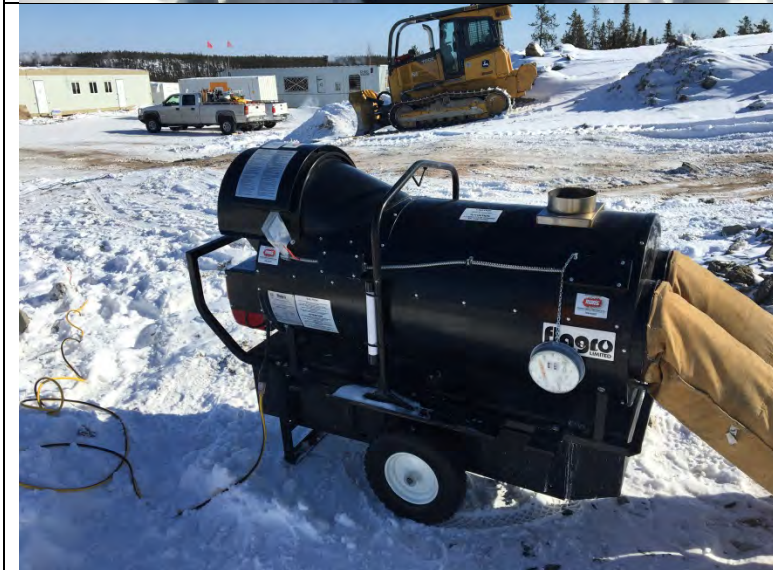
Rowes Construction was constructing concrete caps to seal the shafts/portals at the Bullmoose mine site during the inspection. The inspector noted that two of the frost fighters (used to heat the concrete pads) did not have secondary containment (photo's 3 and 7). This was communicated to Rowes and immediately addressed (Photo's #4 & #8). The fuel drum connected to the parts van was not within adequate secondary containment (Photo #5). Site personnel immediately addressed the secondary containment concern (Photo #6).

Photo #3: Frost Fighter at Alimak that does not have proper secondary containment.

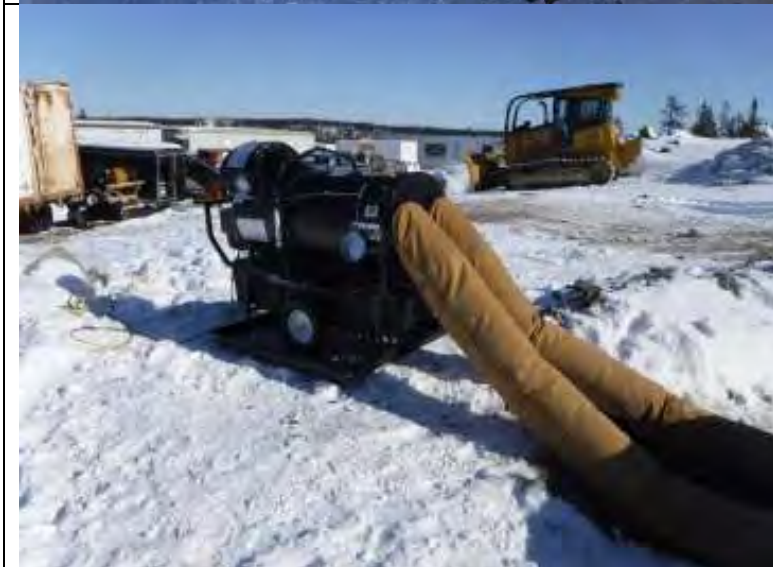
Photo #4: Frost Fighter at Alimak placed in secondary containment post inspection.

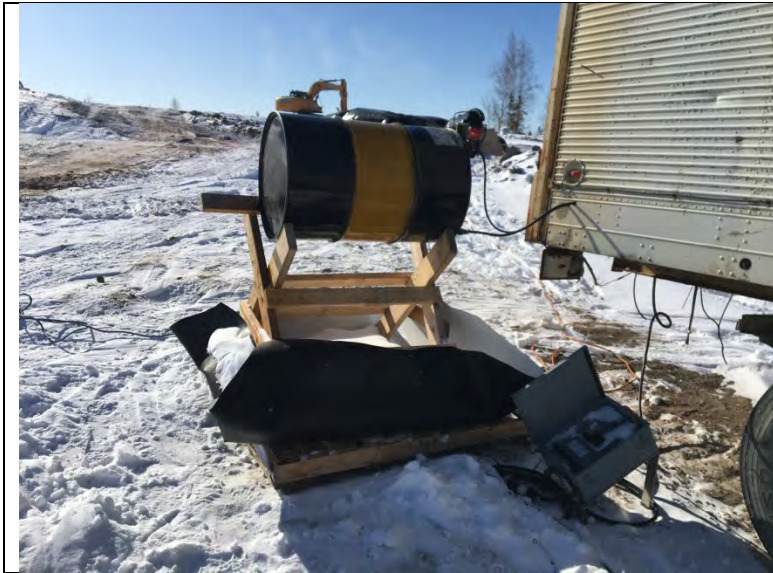
Photo #5: Fuel drum for parts van at Alimak does not have adequate secondary containment.

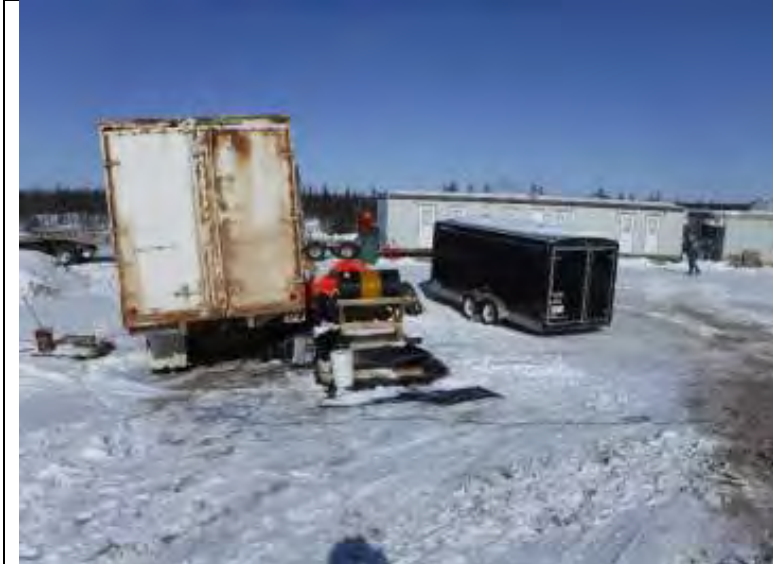
Photo #6: Photo 5 mitigation post inspection.

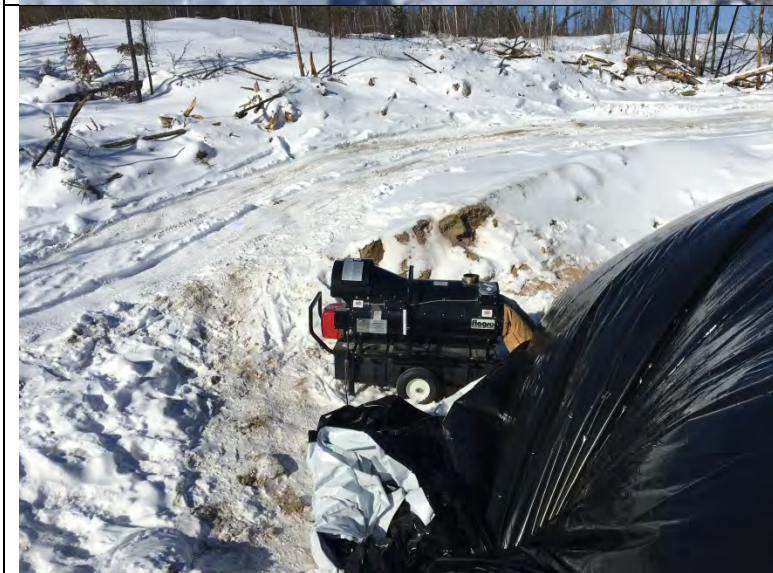
Photo #7: Frost Fighter at Mainway without secondary containment.

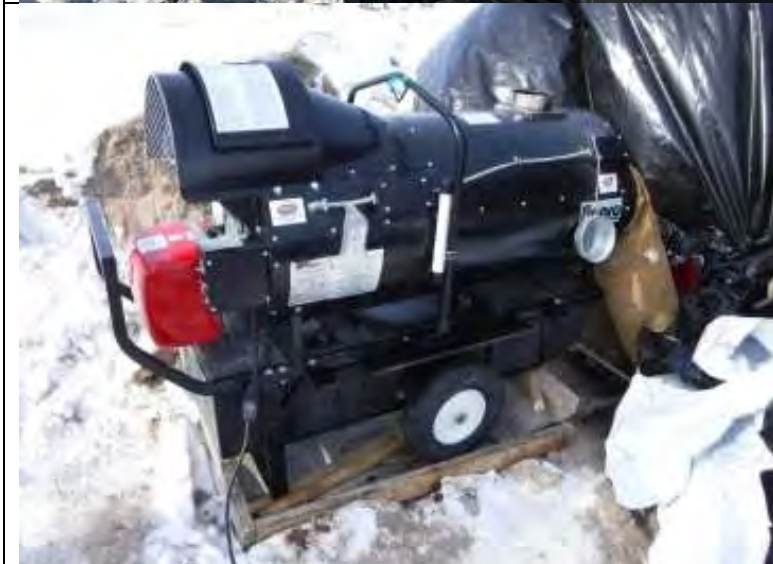
Photo #8: Photo 7 mitigation post inspection.

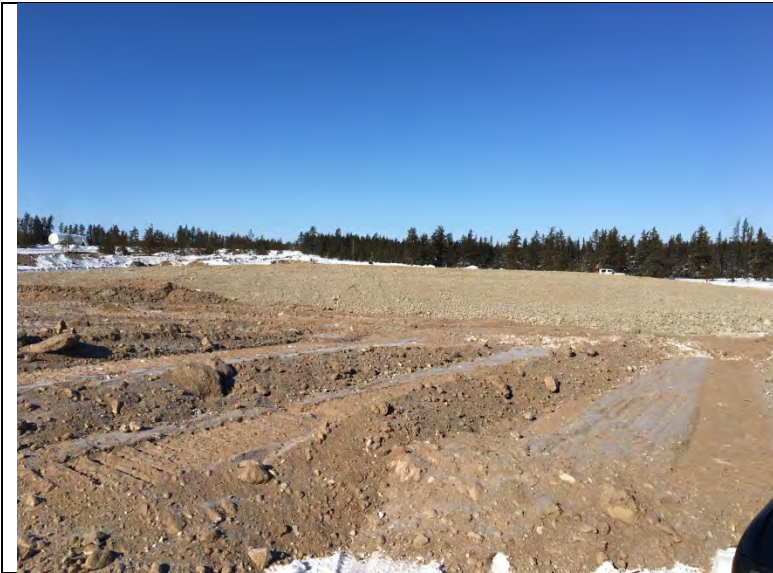
Photo #9: Bullmoose landfill in final stages.

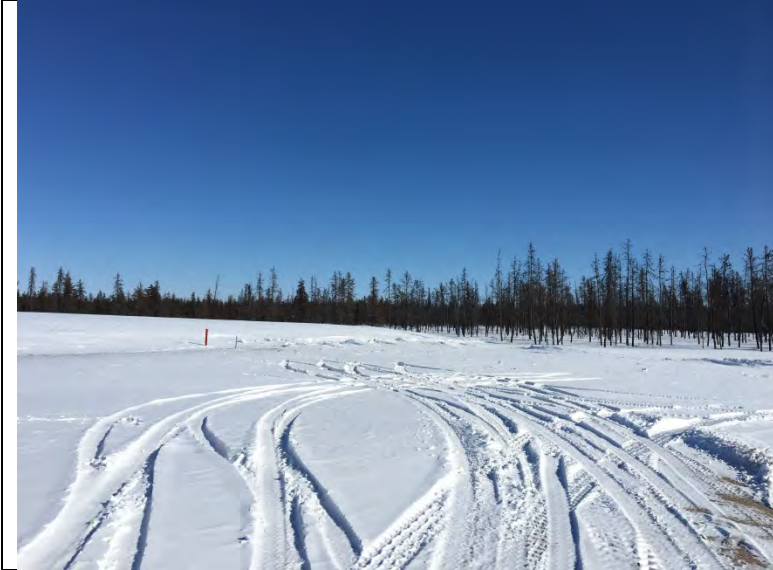
Photo #10: All Equipment has been removed from Ruth mine.

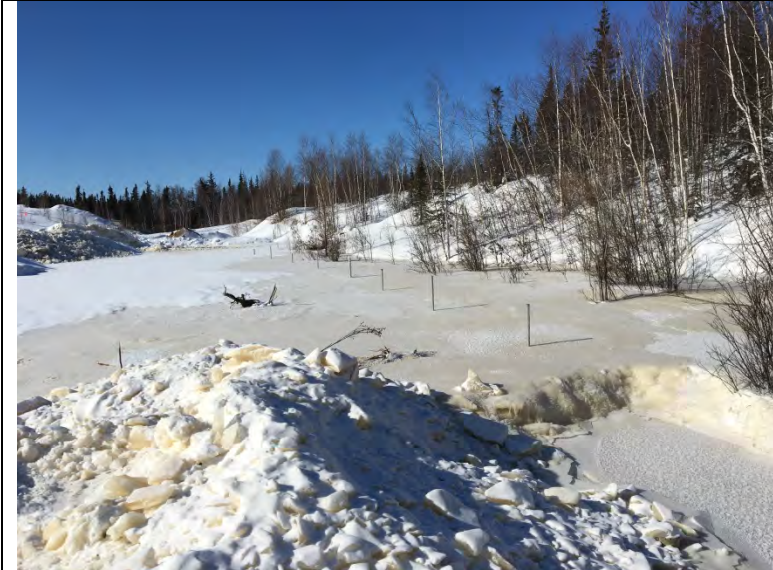
Photo #11: Posts that remain encapsulated in ice at the Bullmoose creek.

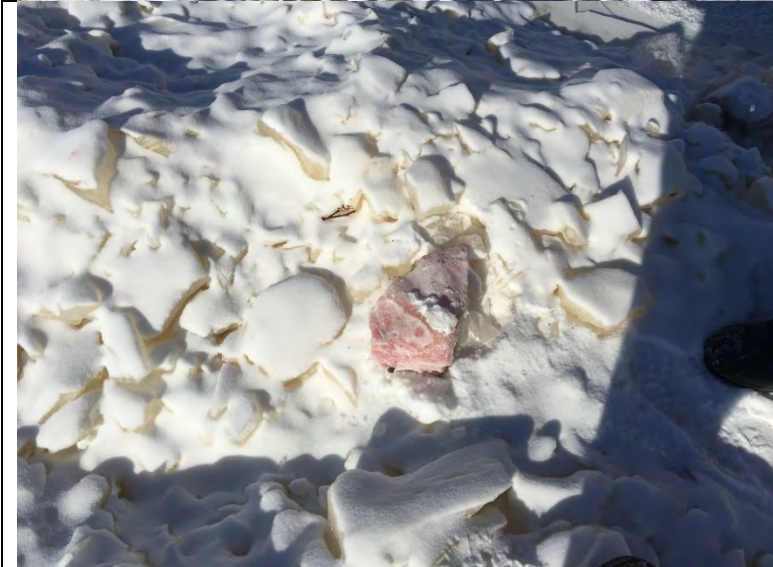
The Inspector noted that some debris remained on the ice at the Bullmoose Creek. (photo12). A row of steel posts also remained erect and encapsulated in the ice. Since the time of the inspection these posts have been removed and the debris collected and removed as per the waste management plan (Photo #13).

Photo #12: Debris on the ice at the Bullmoose creek.

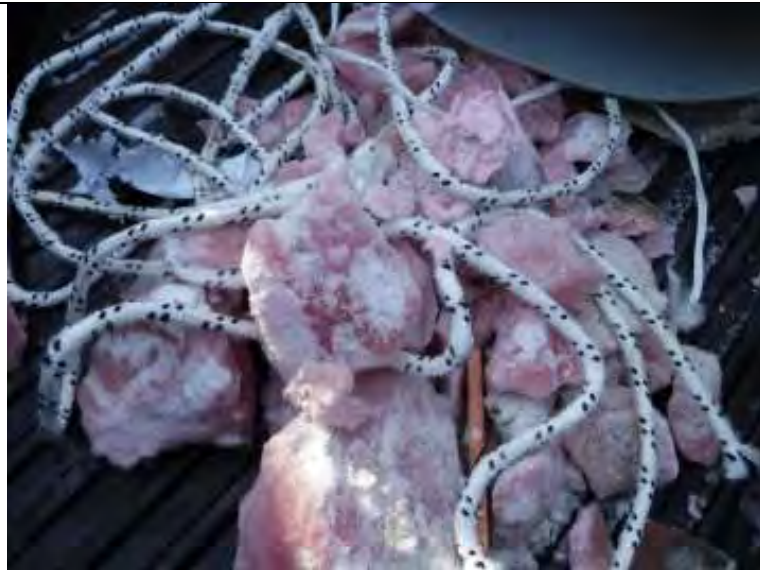
Photo #13: Debris picked up at the Bullmoose creek post inspection.

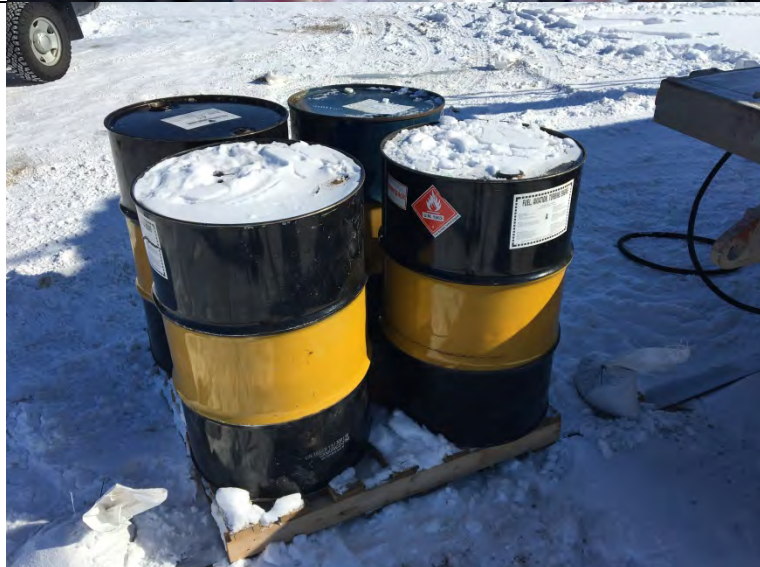
There were multiple drums at the Bullmoose airstrip that did not have adequate secondary containment (Photo #14). This issue was communicated to Rowes construction and mitigated immediately (Photo #15).

Photo #14: Fuel drums at the Bullmoose airstrip without adequate secondary containment.

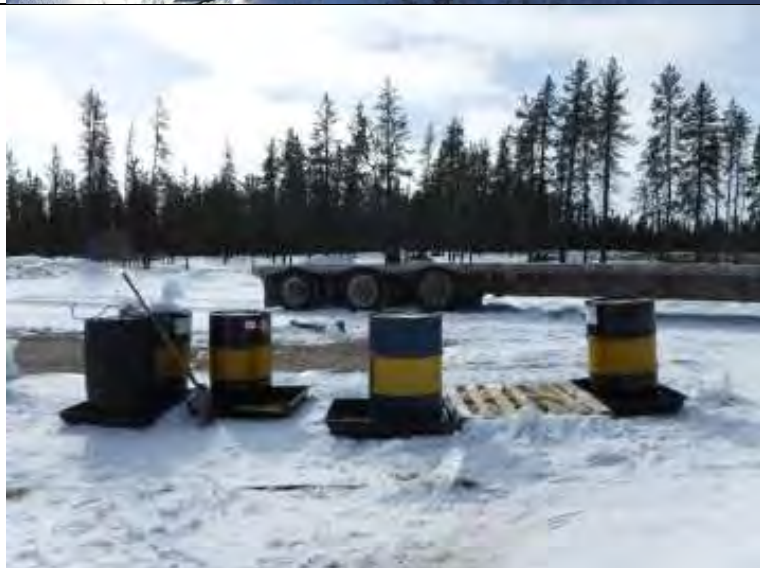
Photo #15: Secondary containment for fuel drums mitigated post inspection.

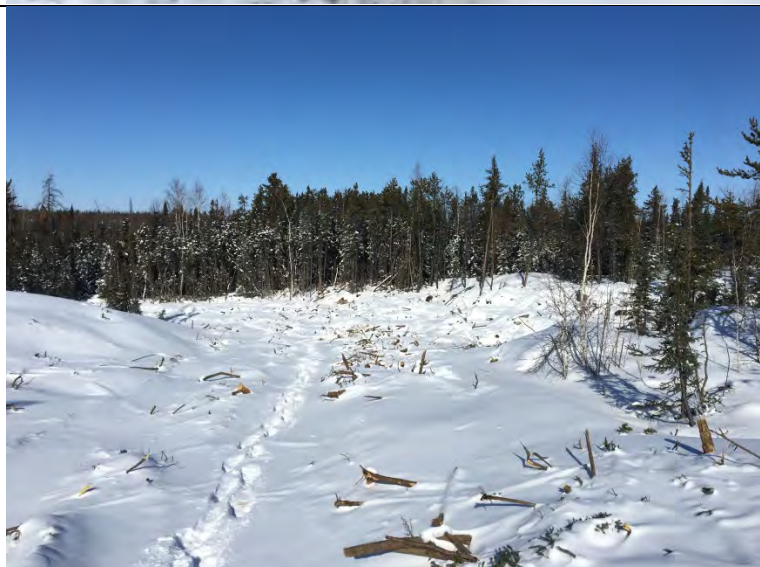
During the previous inspection, site personnel explained that the timber throughout the backfiled excavation 2-4 area between the Bullmoose camp and creek area had been spread out and disposed of. It was very difficult to verify if this had been done during this inspection due to the amount of fresh snow cover. Photo # 16 shows a lot of debris sticking straight up which could be dangerous to animals however this will be assessed further once the snow melts and the debris settles.

Photo #16: Scattered organic debris between Bullmoose camp and Bullmoose creek. There are still a lot of wooden debris sticking up but will be reassessed after freshette.
