INAC-CARD Bullmoose/Ruth Remediation Project

**RE: Land Use Permit MV2016X0013 – Bullmoose/Ruth Remediation Project**

INSPECTION DATE – March 1st, 2017

**ENVIRONMENTAL INSPECTION REPORT (MV2016X0013)**

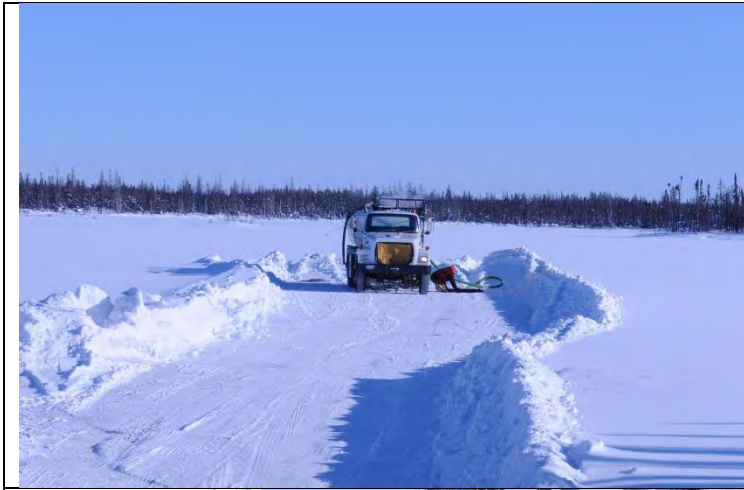
A hydrocarbon leak was discovered by the inspectors on one of the water trucks photo #'s 1, 2 and 3. Inspectors communicated to personnel that the truck should be parked with a drip tray underneath to collect the dripping fluid due to contravention of conditions 55, 64, 65 of the LUP. Site personnel informed inspectors that the truck would not be used until the mechanic could fix the leak and the remaining residual fluid was cleaned up and disposed of according to the approved waste management plan.

Photo #1: Water truck on unknown lake at coordinates 12 V 403293N , 6921961E inside the federal Joon Mine area. This Truck was leaking Hydrocarbons from what appeared to be an hydraulic oil filter.

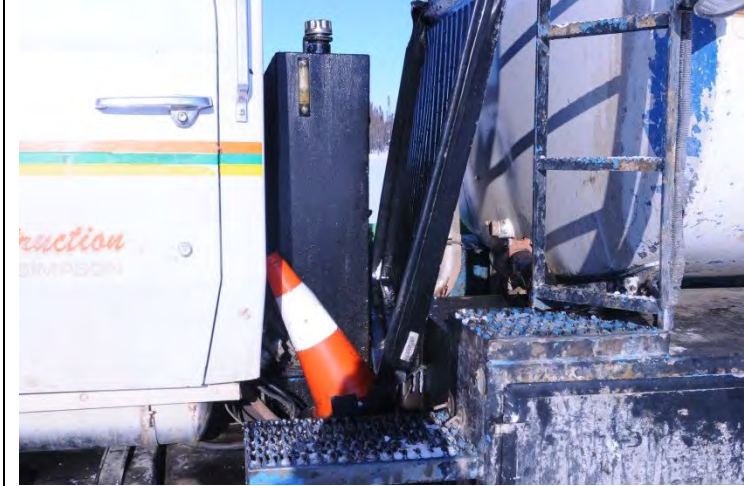
Photo #2. View of the back of the truck in Photo #1 showing hydrocarbon residue on the spill tray and spillage on the reservoir.

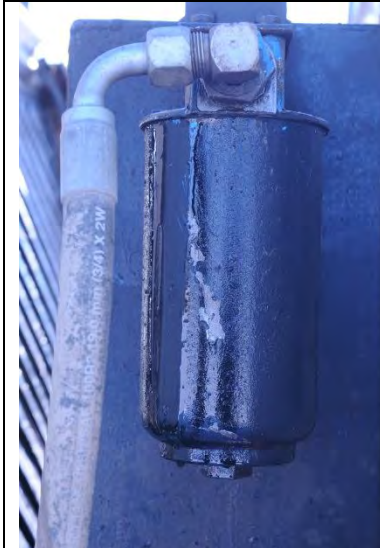
Photo #3. This is the filter on the truck in Photo #1, showing fluid leaking out of the bottom of the filter and on the ground.

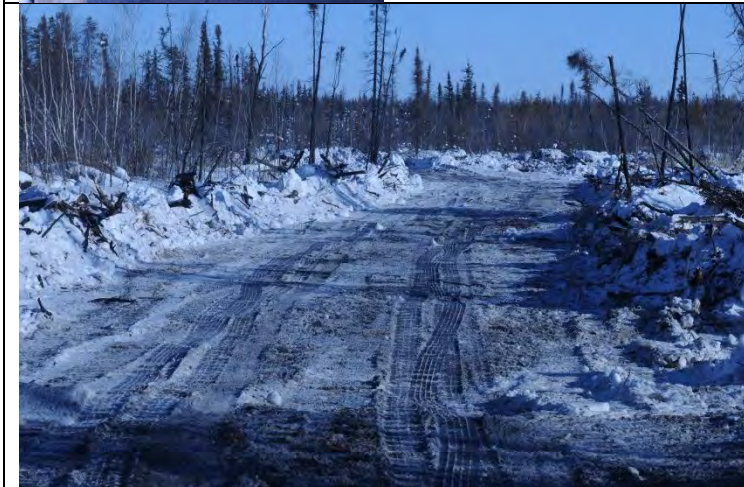
At the time of the inspection, access roads were pushed into Ruth, Bullmoose, Beaulieu, Spectrum, and Joon Mines. The majority of the ice road work satisfied condition # 15 as there was a minimum of 10 cm's of snow/ice cover, however some of the access roads that were being constructed were did not have the require snow/ice cover (Photos #4 & #5). These roads were in the initial stages of construction and further work will be needed to satisfy condition #15 prior to mobilization of equipment.

Photo #4. A view of the newly pushed road into the June Mine historic buildings. This road does not meet condition # 15 of the Land Use Permit.

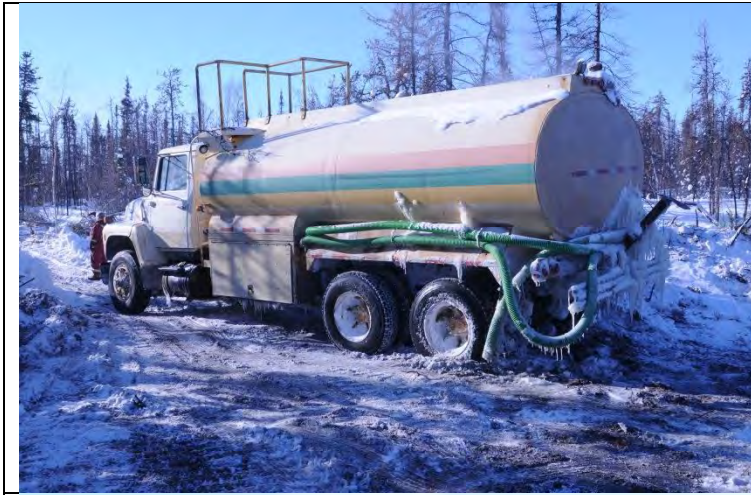
Photo #5. Water truck stuck on the newly pushed road into June Mine.

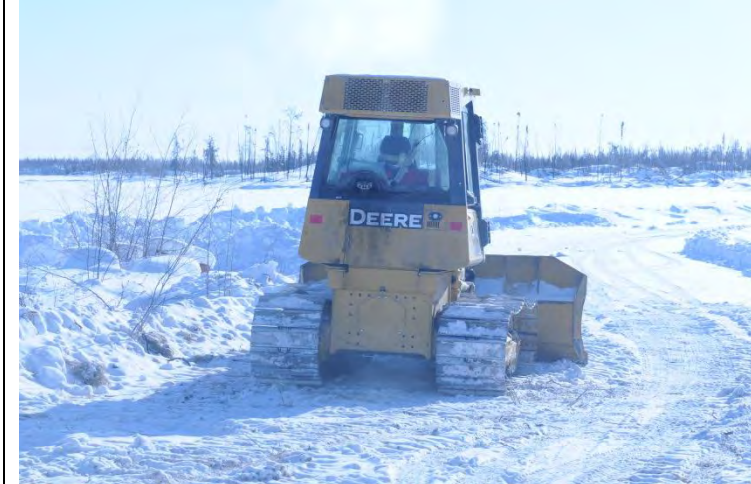
During the inspection multiple pieces of machinery were parked without drip pans placed underneath as required by condition #64 of the land use permit (Photos #6 to #10). All equipment that is parked for longer than two hours **MUST** have drip trays placed under to catch the leaks that may occur.

Photo #6. Dozer parked without drip trays.

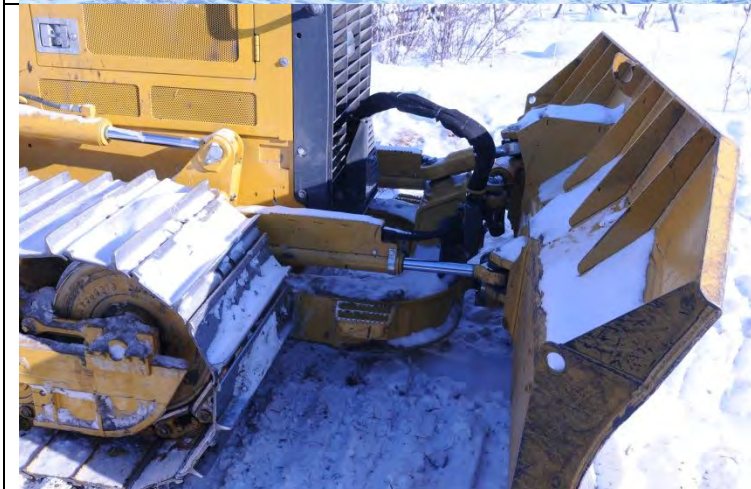
Photo #7. Close up of Dozer in Picture # 6.

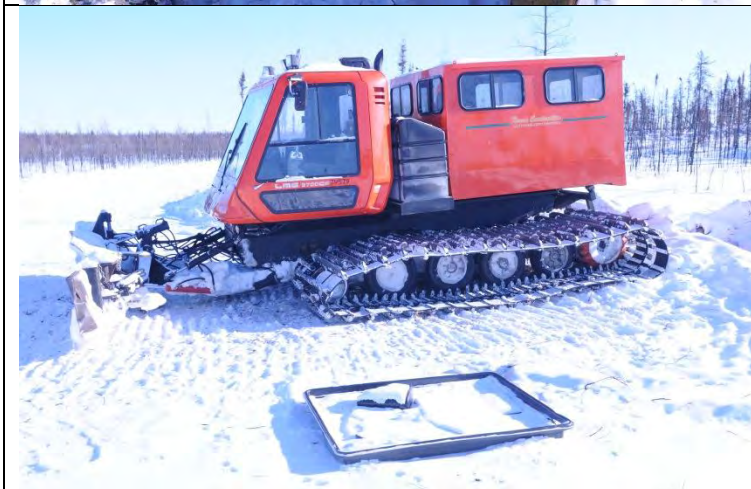
Photo #8. Hagglund parked without drip trays underneath. Coordinates 12 V 419754EN 6922982E.

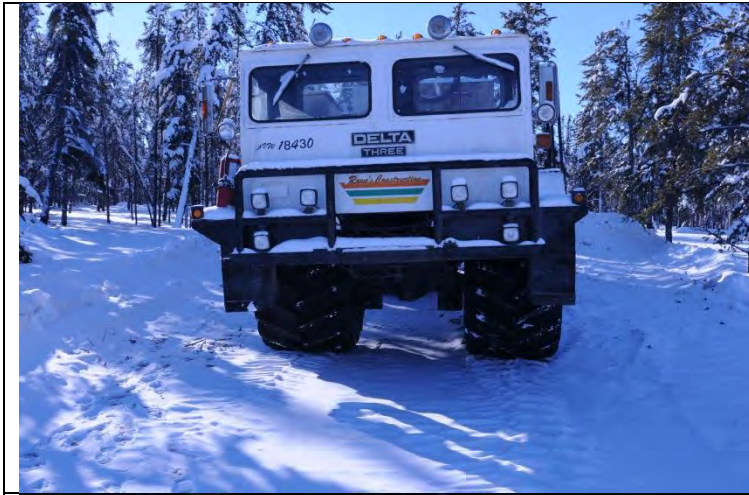
**Photo #9. Delta Three Wheeled Carrier parked west of Bullmoose Airstrip.**

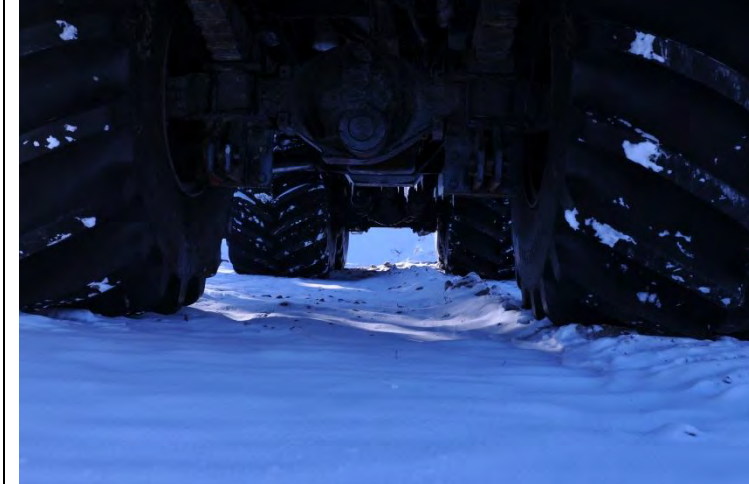
**Photo #10. Image showing no drip trays under the Delta Three Wheeled Carrier in photo # 9**
