INAC-CARD Bullmoose/Ruth Remediation Project

RE: Land Use Permit MV2016X0013 – Bullmoose/Ruth Remediation Project

INSPECTION DATE – June 21st 2017

ENVIRONMENTAL INSPECTION REPORT (MV2016X0013)

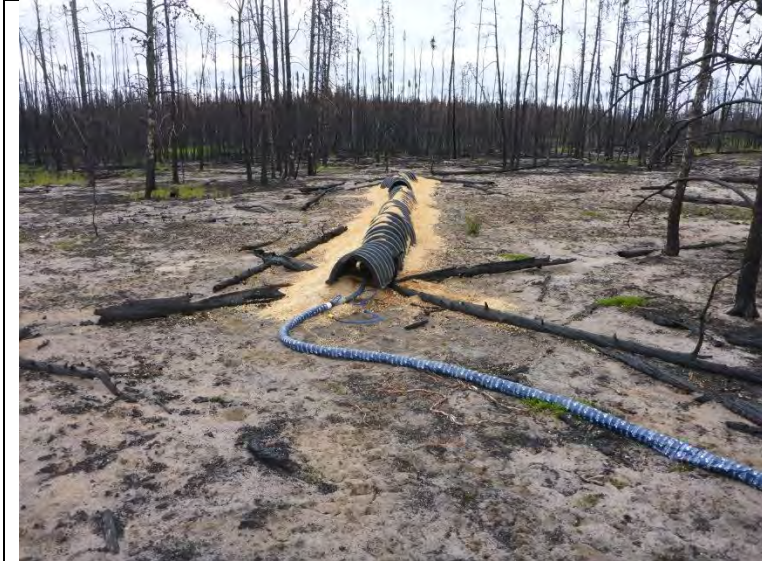
Unlike the previous inspection, the camp was in operation and there were personnel on site. As such, wastewater was being discharged. The wastewater was being discharged after treatment through a pipe at multiple points and into the surrounding area, which was covered by wood shavings (Photo #1). A point had been set up on the pipe just prior to discharge where samples of the sewage could be taken (Photo #2). As required by Order condition #3, a site presence had been established at all project locations associated with the land use permit.

Photo #1: Set-up of sewage discharge system. The discharge pipe is covered and slowly discharges into the sawdust.

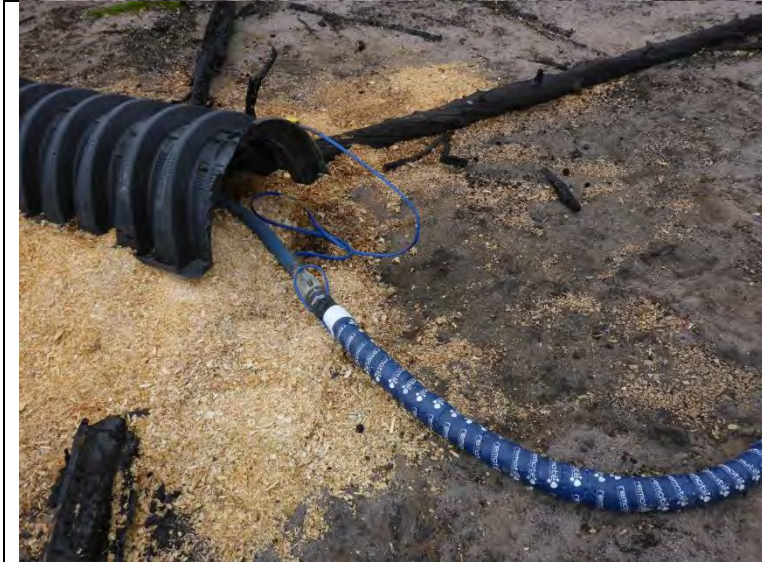
Photo #2: Close up of sewage discharge system. Note the electrical cord marking where sewage samples can be taken.

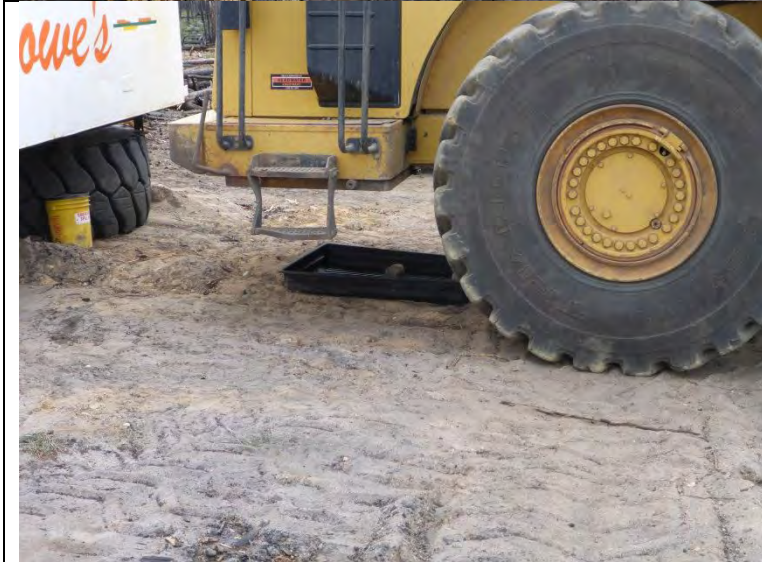
Photo #3: Drip tray placed underneath stationary vehicle.

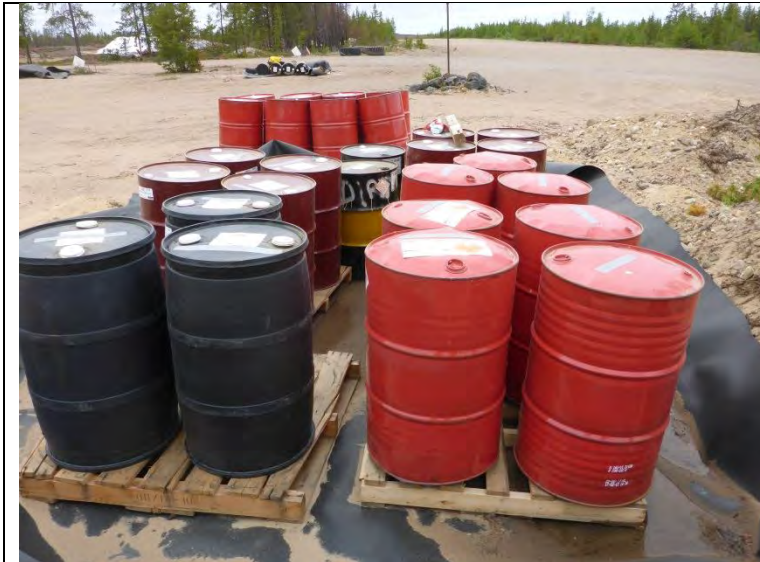
Most of the hydrocarbons stains located around the Bullmoose camp and airstrip had been cleaned up, in compliance with condition #65 of the land use permit. All the equipment parked at the Bullmoose, Ruth, Spectrum, and Beaulieu sites now had drip trays as required by permit condition #64 and Order condition #12, an improvement from the last inspection where most parked equipment lacked drip trays (Photo #3). One parked vehicle was found to be leaking and site personnel were notified that this would need to be fixed and the resulting stained areas removed. The fuel drums located around the land use area were now being stored in compliance with permit conditions #53, #57, and #58. Several drums were bulging from increased internal pressure and these drums need to be kept upright to minimize spillage in the event of a release (Photo #4). In general, the site was much cleaner and well-kept.

Photo #4: Barrels of fuel. Note the visible bulging of several drums.

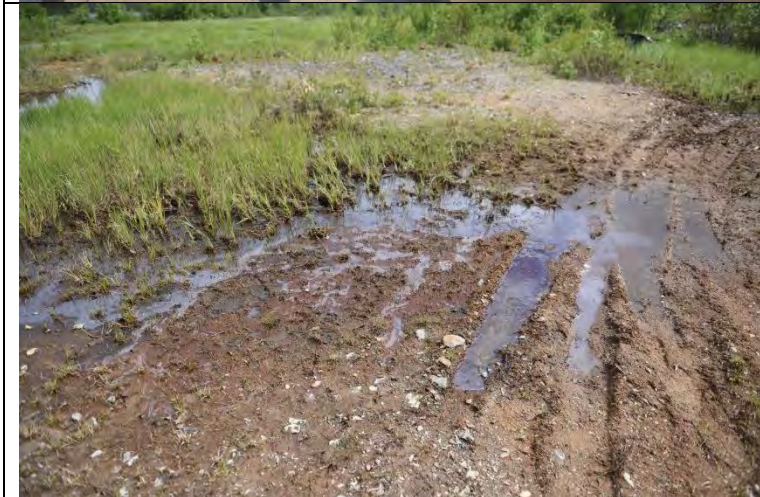
A bridge had been built at Bullmoose site across Bullmoose Creek. The Inspectors observed that there were recent tire tracks running through the river and reminded site personnel that vehicles should be restricted to crossing the creek at the bridge (Photo #5).

Photo #5: Recent tire tracks cutting through Bullmoose Creek.

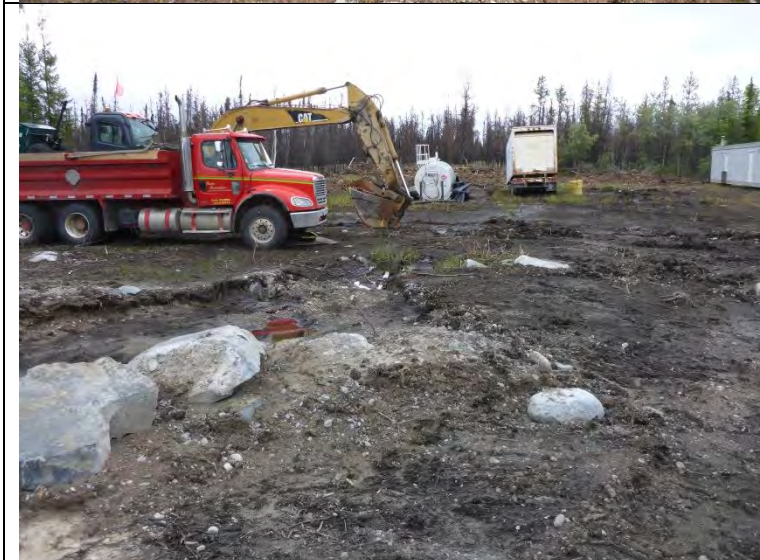
Photo #6: Beaulieu Site. Note that most of the water has been drained.

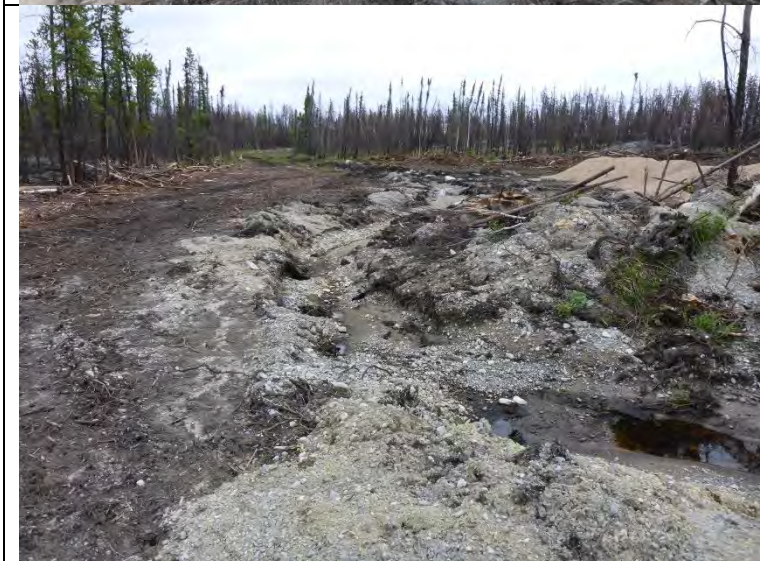
Photo #7: Trench dug at Beaulieu Site to facilitate dewatering.

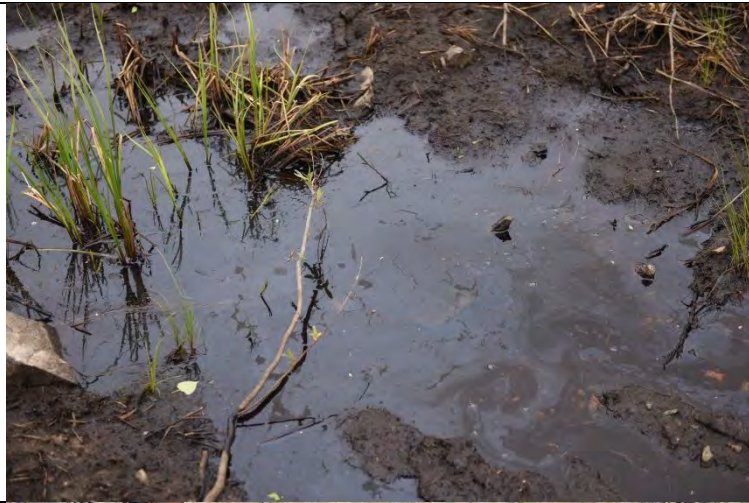
A trench had been constructed at Beaulieu site to facilitate dewatering of the flooded areas (Photo #6). This site was no longer flooded but numerous large puddles of water were present and there was water pooled in the trench (Photo #7). Unknown sheens, potentially hydrocarbons were observed in these bodies of water; the Contractor must sample these waters and submit results to the Inspectors prior to discharge (Photo #8). Once the site is fully dewatered, the camp and other associated support equipment must be moved to higher durable grounds as stated in Order condition #5.

Photo #8: Potential hydrocarbons in the remaining water at Beaulieu Site.

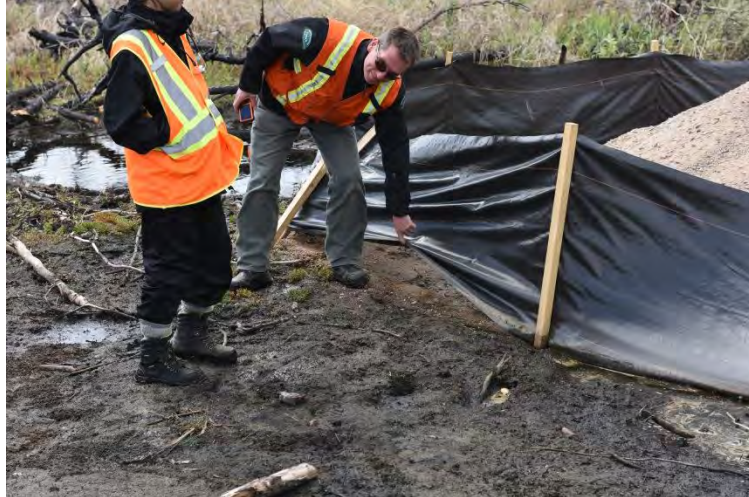
There was considerable flooding at Joon site, resulting in marshy conditions. A silt fence had been constructed around the stockpiled quarry material near Strike Lake to prevent erosion but it was not tied into the ground. The silt fence will need to be properly tied down into the ground in order to be effective (Photo #9). The Joon Mine fuel tank was unmoved and remained within 100 meters of the OHWM of Strike Lake, contrary to condition #52 of the land use permit. Transport of the tank however,

Photo #9: Silt fence at Joon Site. The silt fence was not properly tied into the ground.

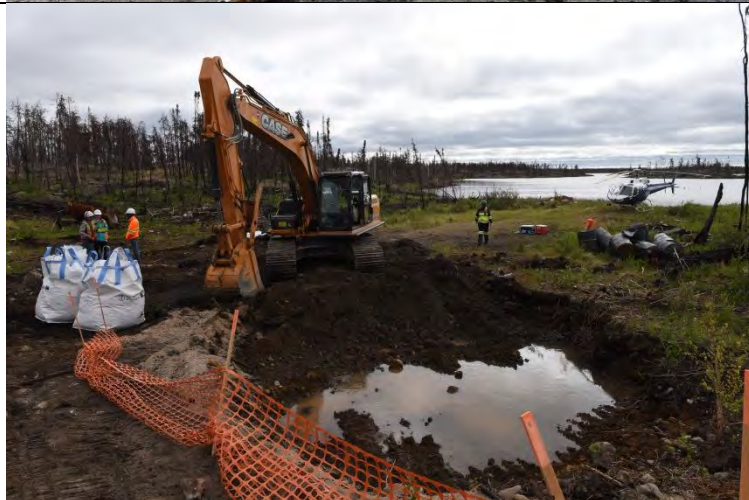
As per Order conditions #6 and #7, the large hydrocarbon spill at Spectrum site was being cleaned up at the time of the inspection and was being supervised by Stantec (Photo #10). The old fuel drums had been removed and an excavator was lifting contaminated soil into mega bags (32 bags had been filled at this time). These mega bags and fuel drums were stored in a containment area further into the site (Photo #11). Site personnel were also cleaning up the burned material on Spectrum site and grinding down damaged metal (Photo #12).

Photo #10: Clean up contaminated soil at Spectrum site.

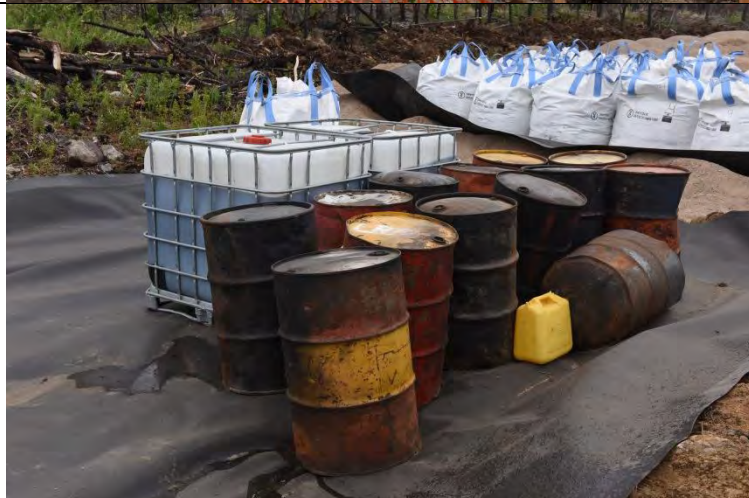
Photo #11: Storage of contaminated earth and old fuel barrels at Spectrum site.

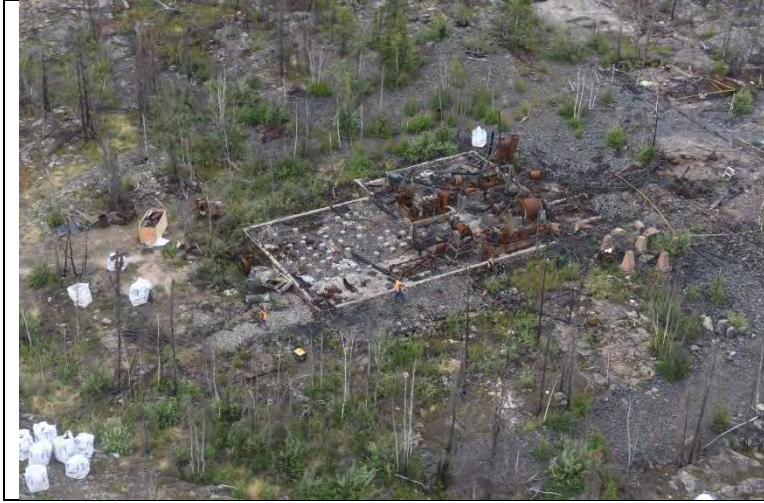
Photo 12: Clean-up of refuse at Ruth Mine site.
