April 11, 2022

File Number MV2018C0023
Type of Operation Mineral Exploration
Location Walsh Lake (Mispickel Area), NT

ENVIRONMENTAL INSPECTION REPORT

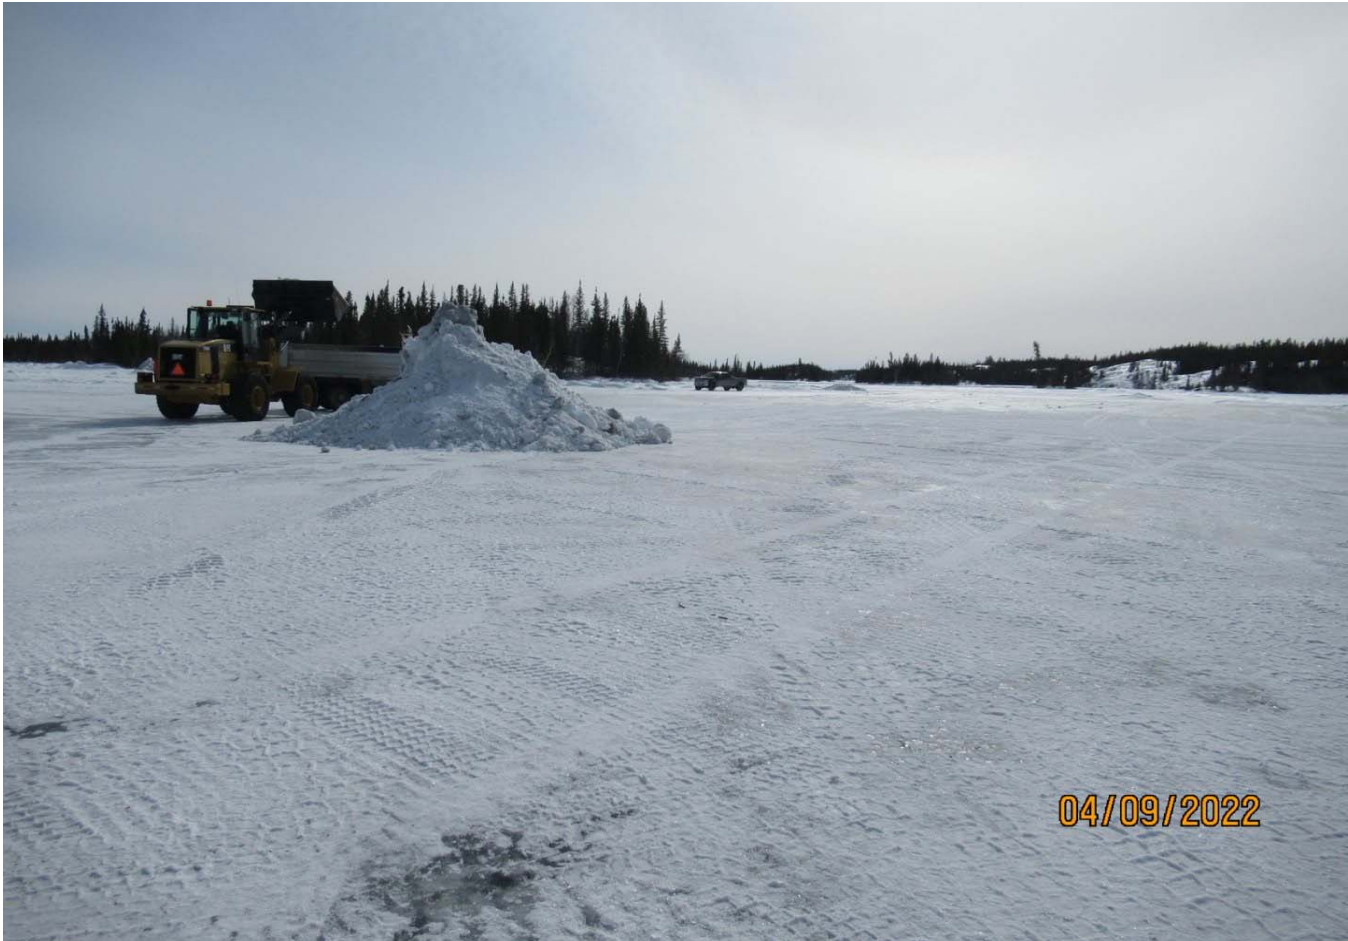
Figure 1

The ice surface has been scarified and the Contractor was actively loading out snow for off-site disposal.

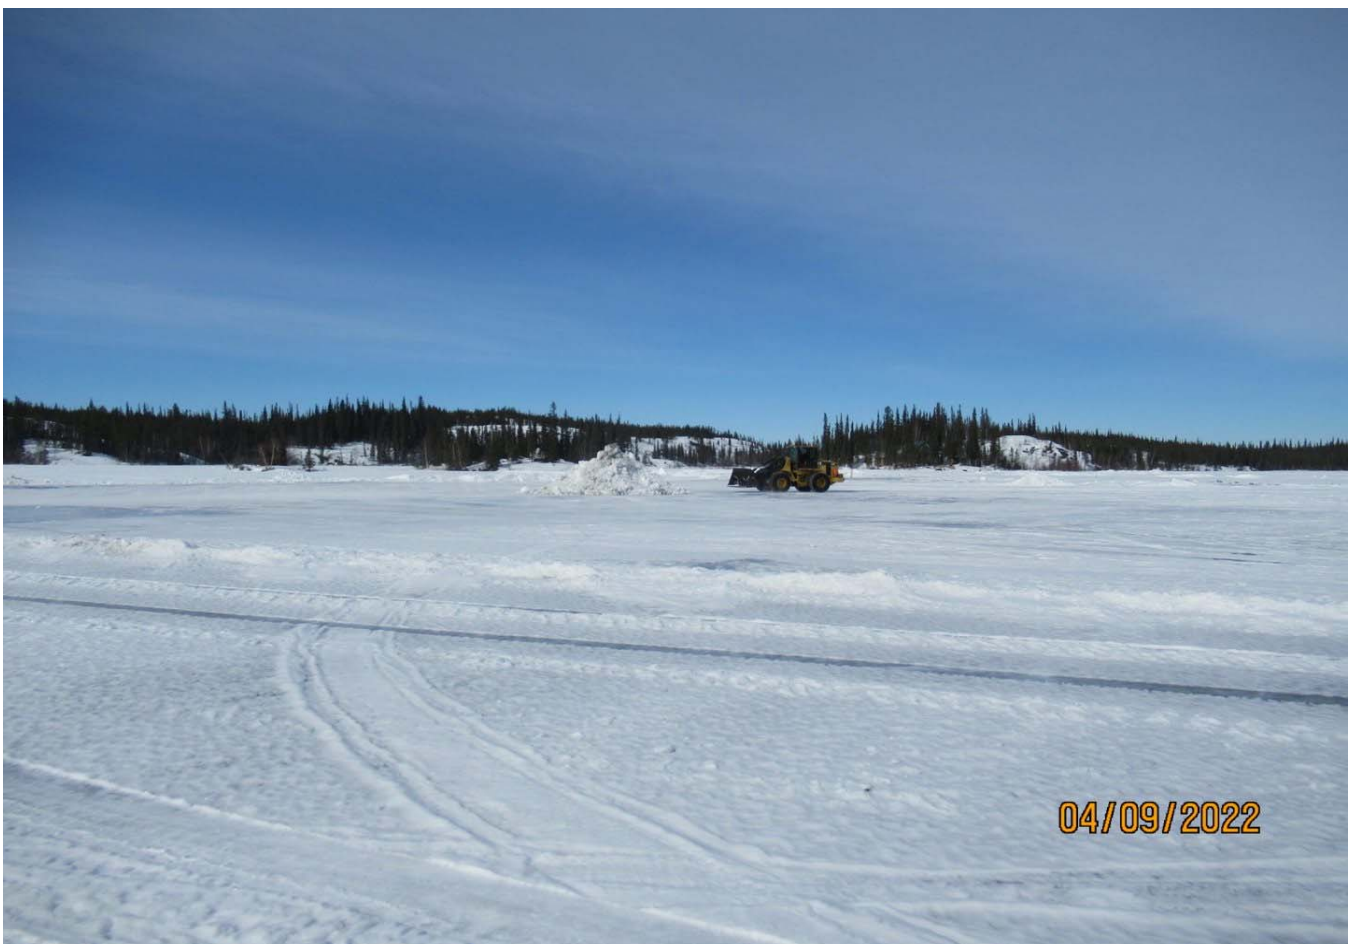
Figure 2

Another view of the ice surface where drilling occurred on the north end of Walsh Lake.

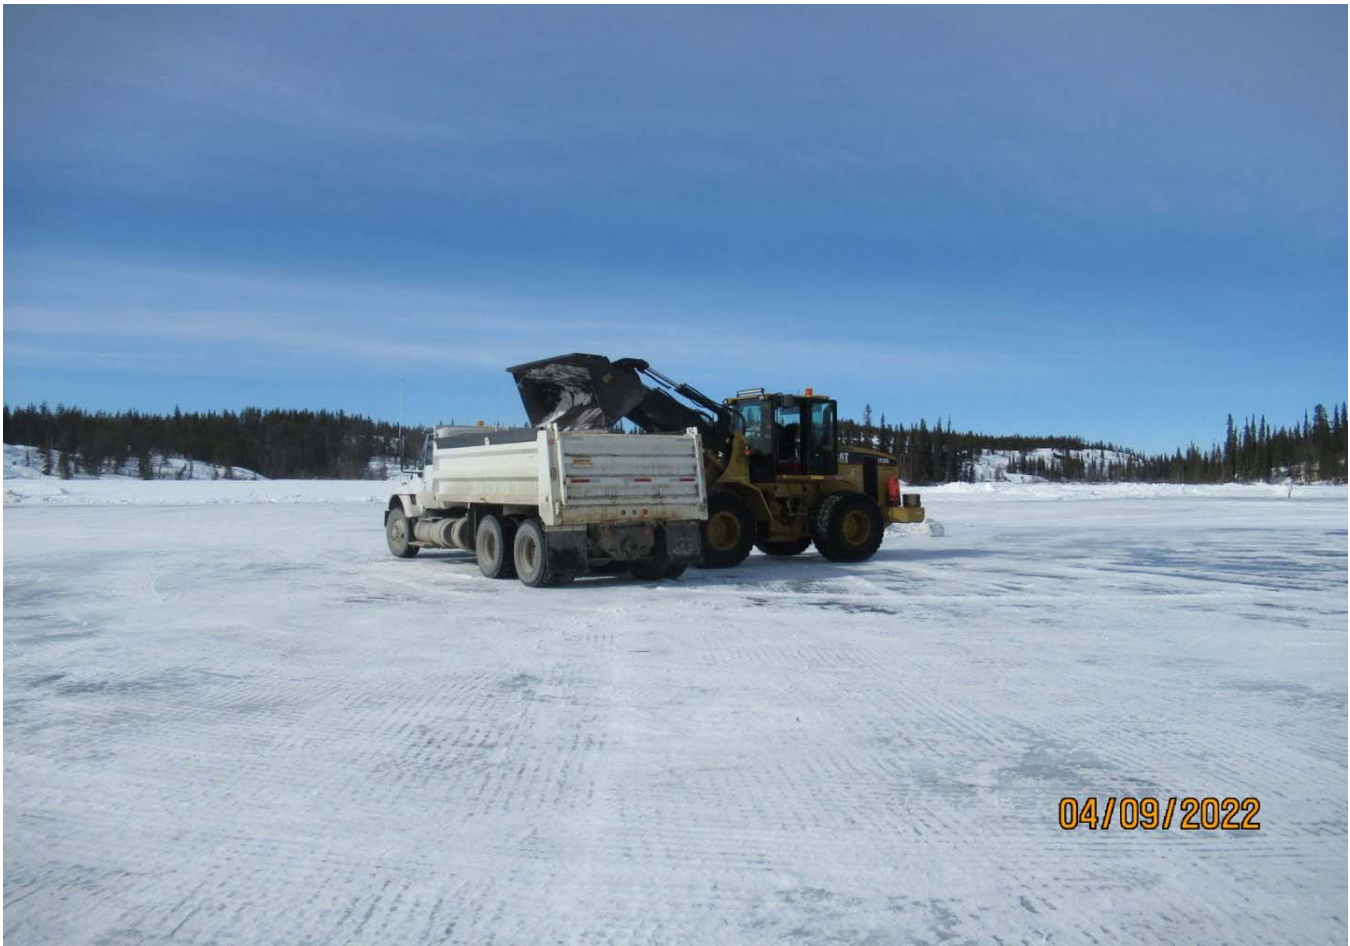
Figure 3

Equipment actively loading snow impacted with drill waste into a tandem.

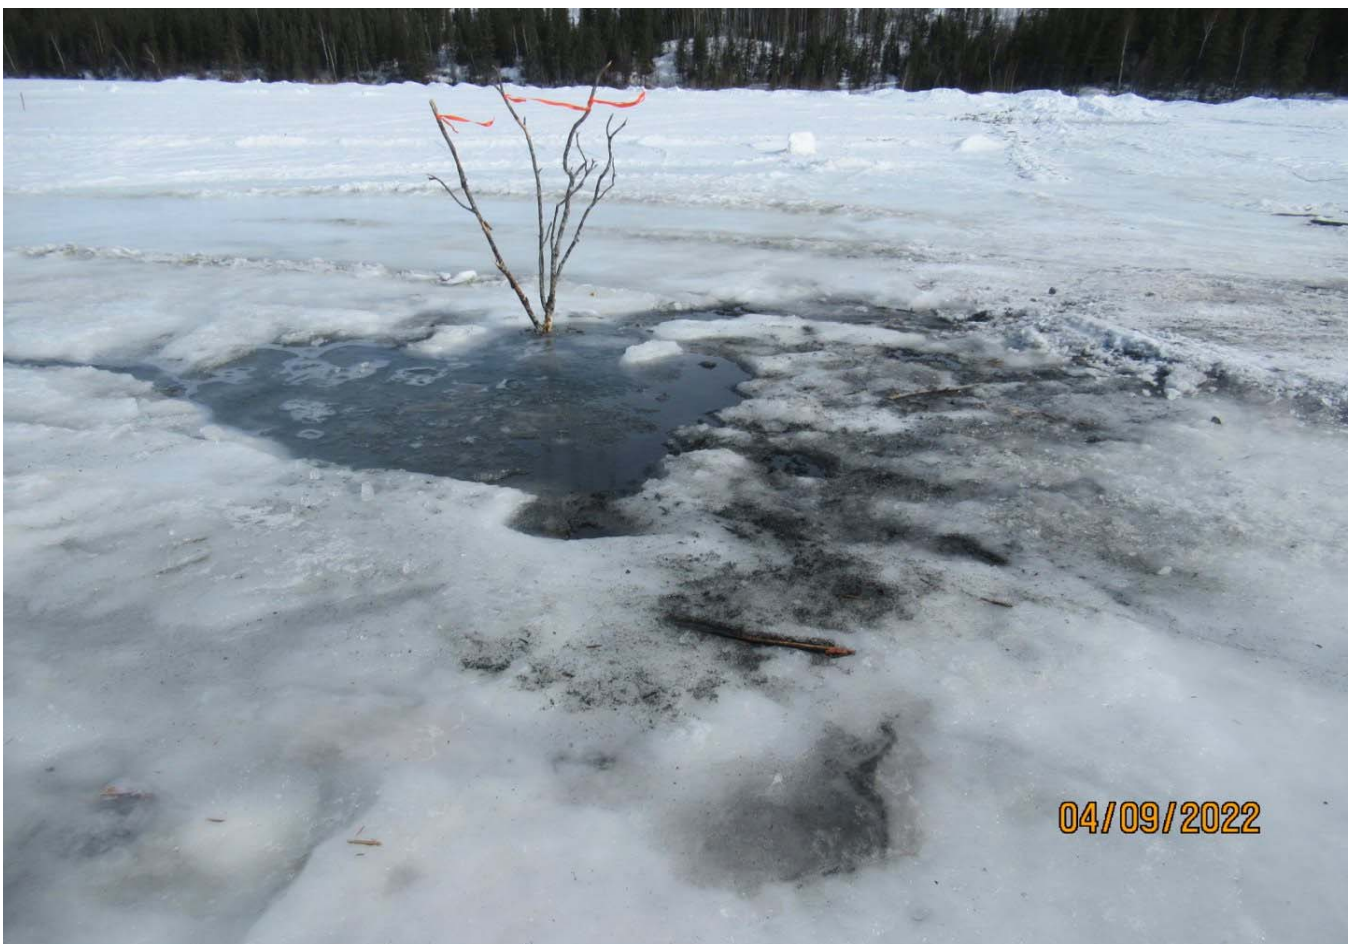
Figure 4

Completed drill site that will be scarified and cutting impacted snow removed for proper off-site disposal.

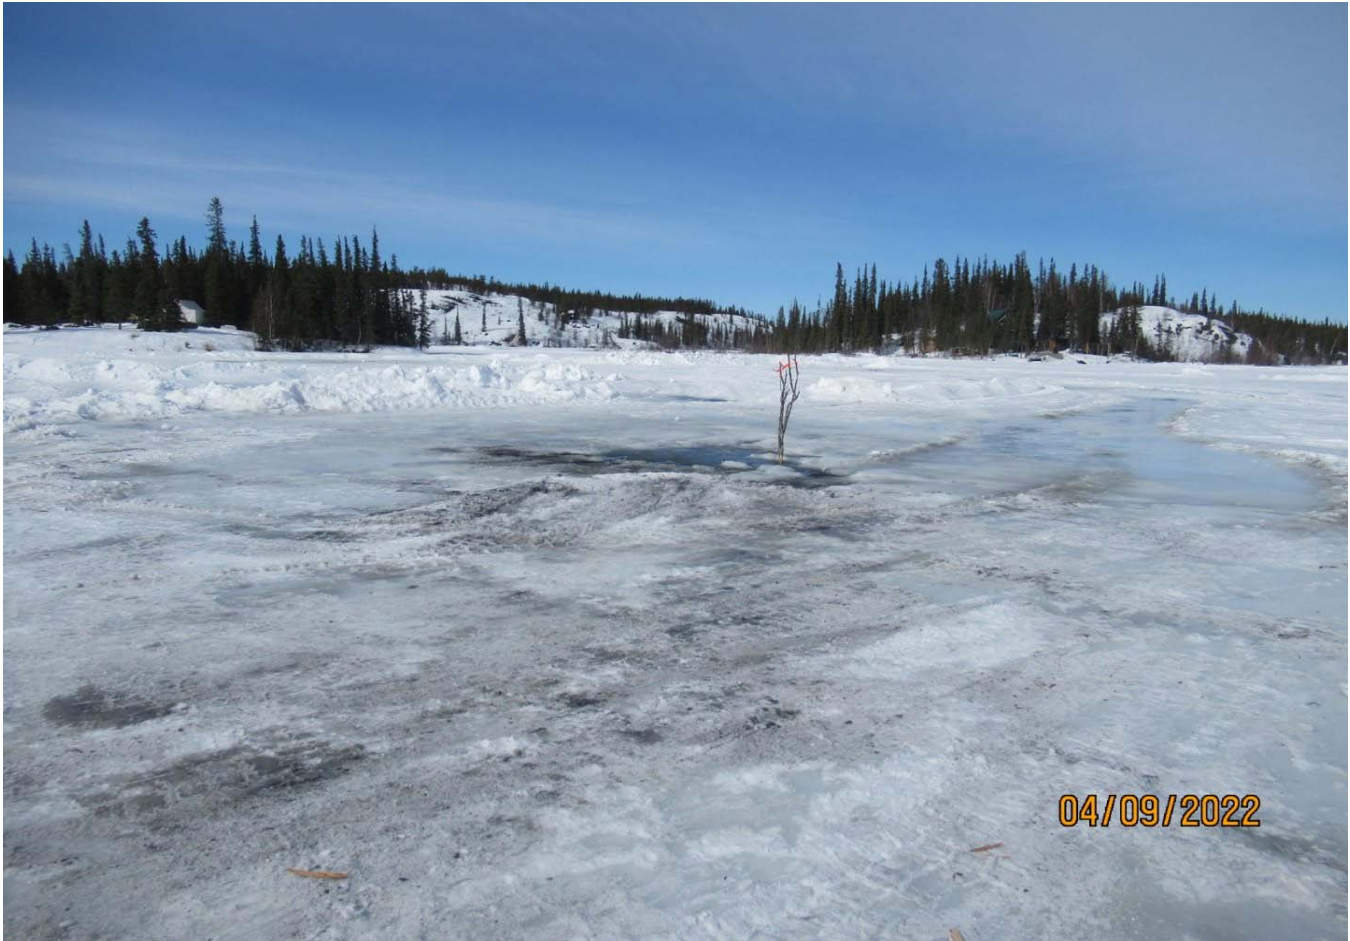
Figure 5

Completed drill site that will be scarified and cuttings impacted snow removed for proper off-site disposal.

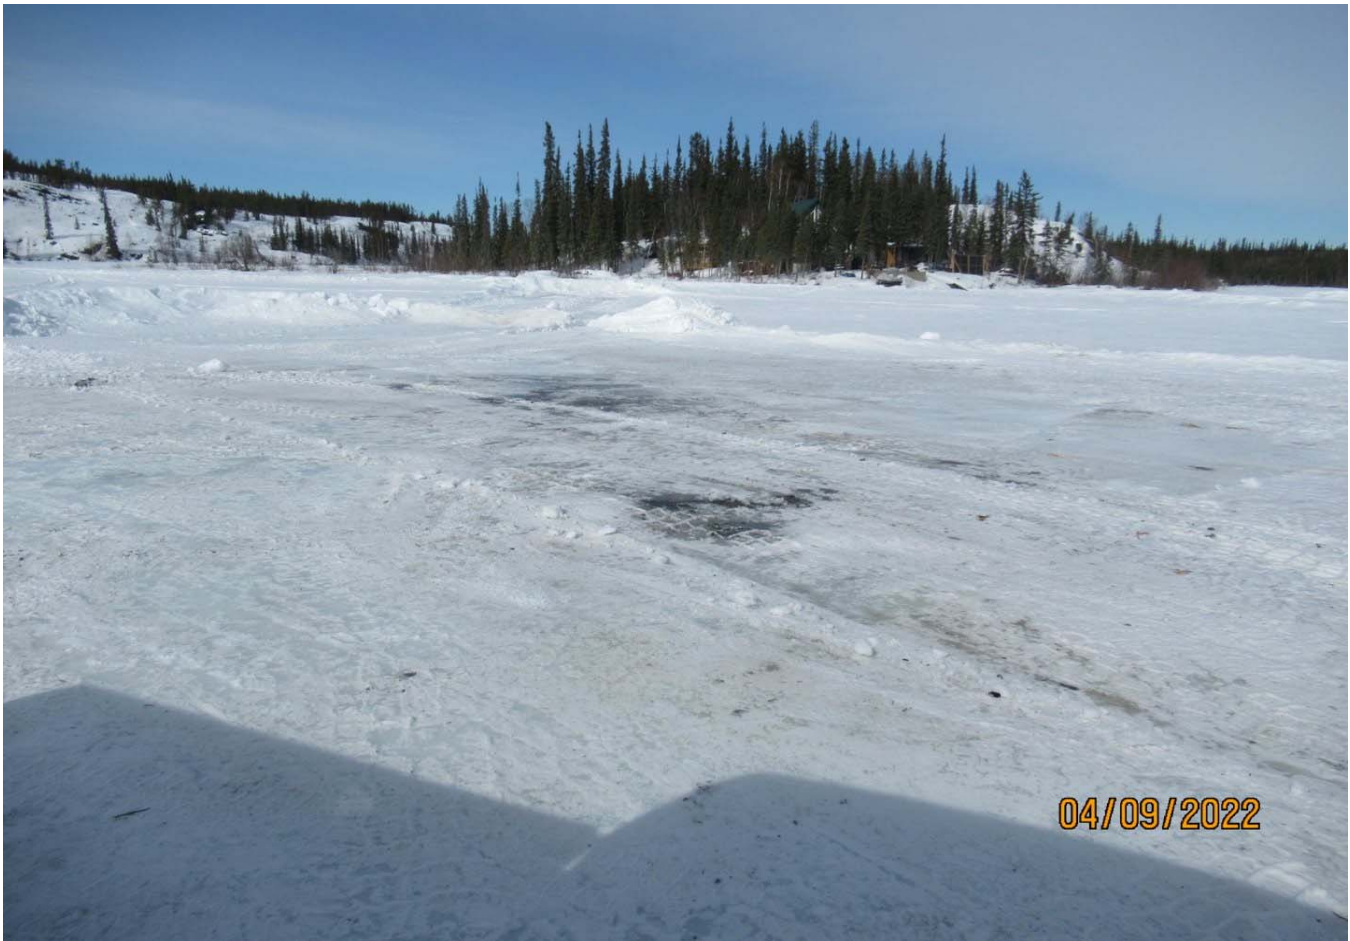
Figure 6

Another completed drill site that will be scarified and cuttings impacted snow removed for proper off-site disposal.

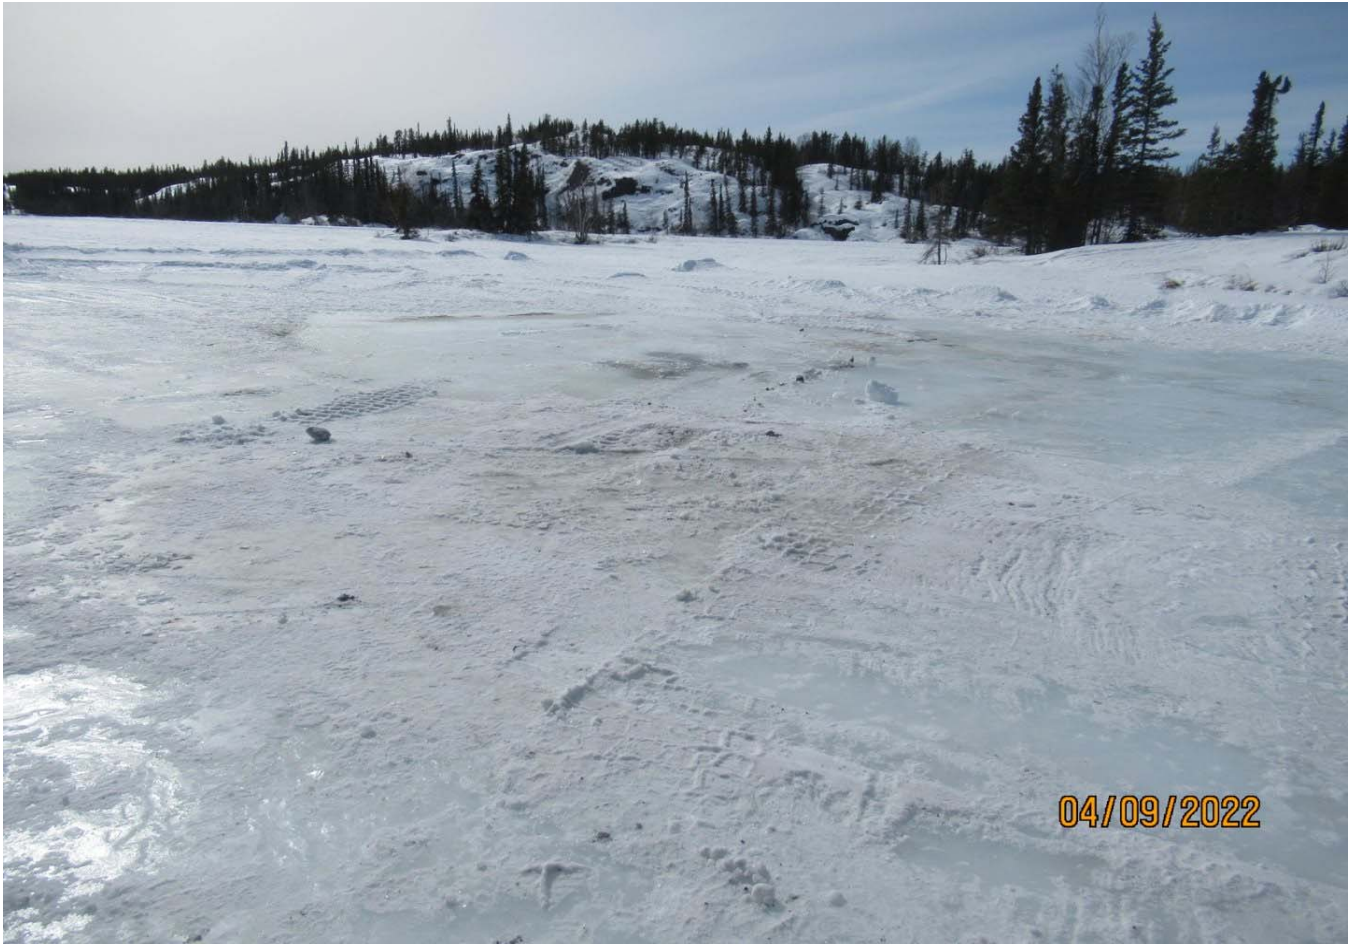
Figure 7

Scarification with removal of cuttings impacted snow and ice will occur at this completed target.

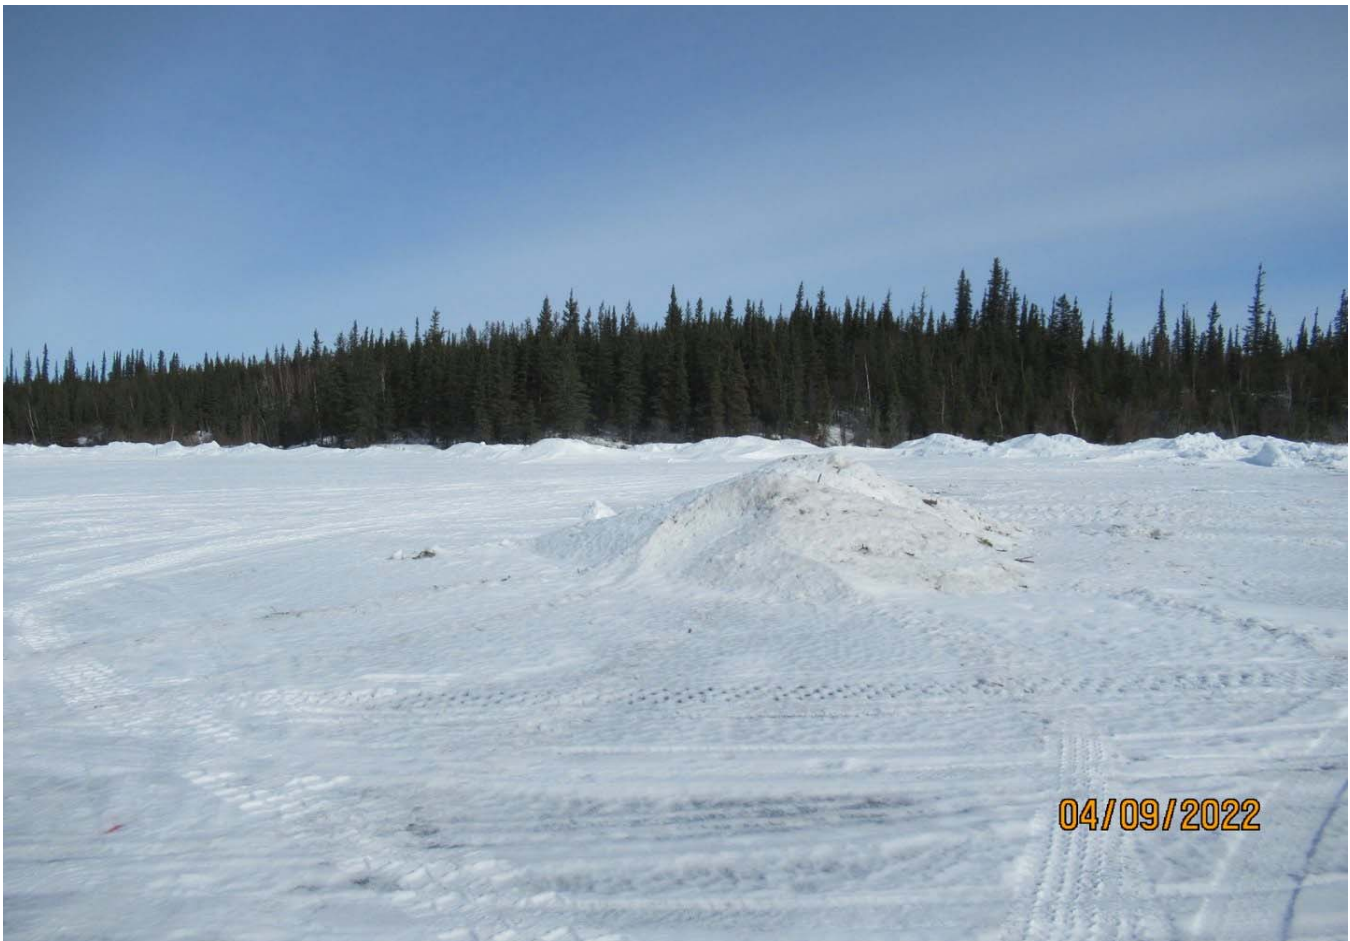
Figure 8

A few piles of pushed up snow require removal for offsite disposal.
