File Number MV2019X0027
Type of Operation MISC.
Location KM 6 Camp and KM 27.4 Dempster Highway

ENVIRONMENTAL INSPECTION REPORT

Permittee:	Yukon Government Department of Highways and Public Works	Permit Expiry Date:	August 30, 2025
Land Use Permit No.	MV2019X0027	Previous Inspection:	September 27, 2023
Quarrying Permit No.		Inspection Date:	October 18, 2023
Contractor:		Subcontractor:	
Location(s) Inspected:	KM 6 Camp and KM 27.4 Dempster Highway		
Current Stage of Operation:	On-going		
Program Modifications Approved:

Dempster Fibre Project:

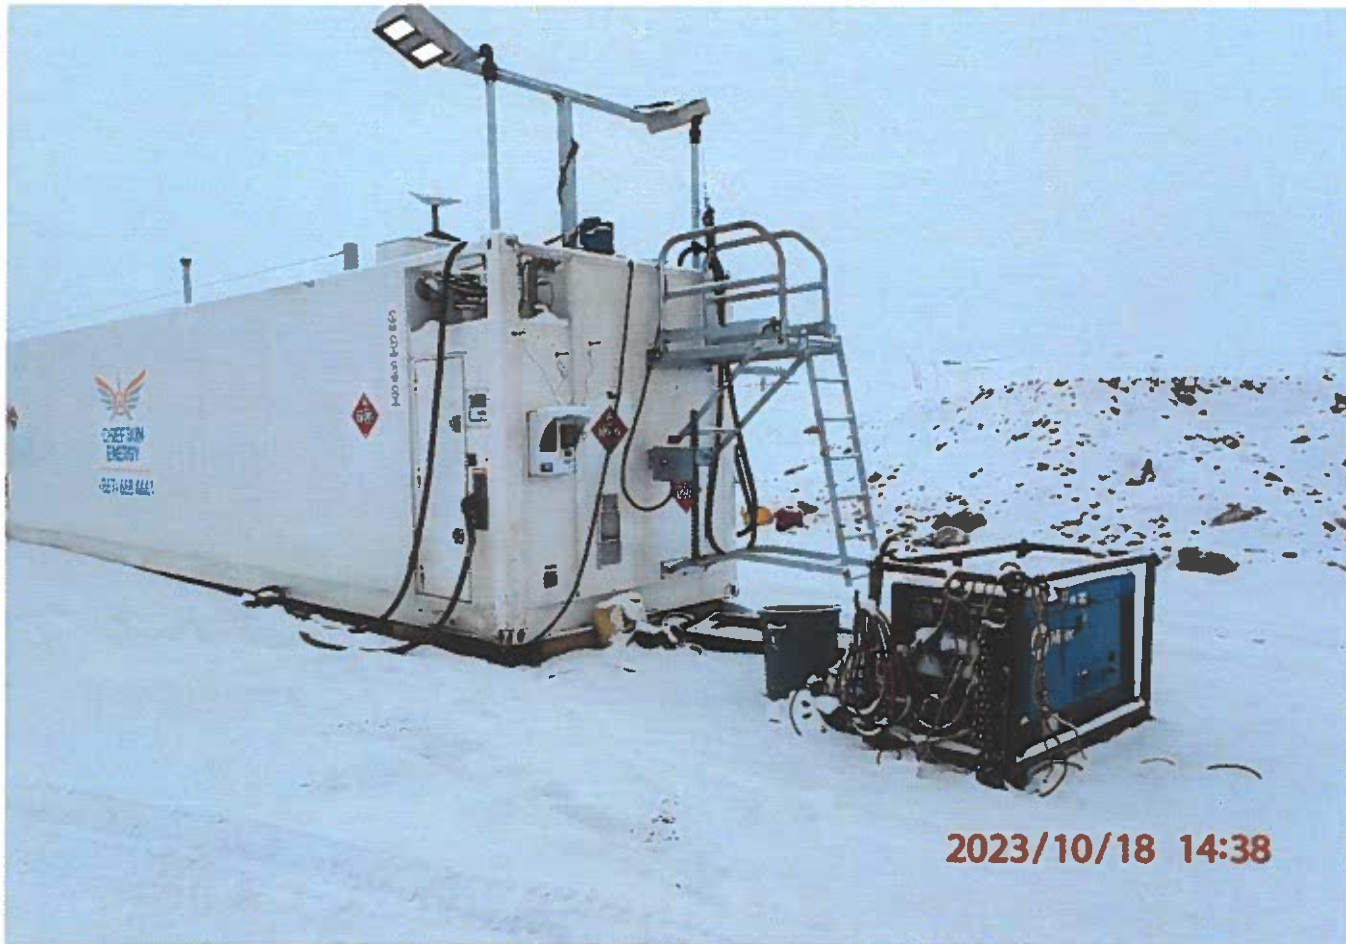
Figure 1

During the inspection at the KM 6 camp along the Dempster Highway there were no issues observed by the inspectors. Rohl (herein referred to as the contractor) was preparing to demobilize the site and anticipating to be out by the end of October 2023. See photos 1-4.

The refueling station.

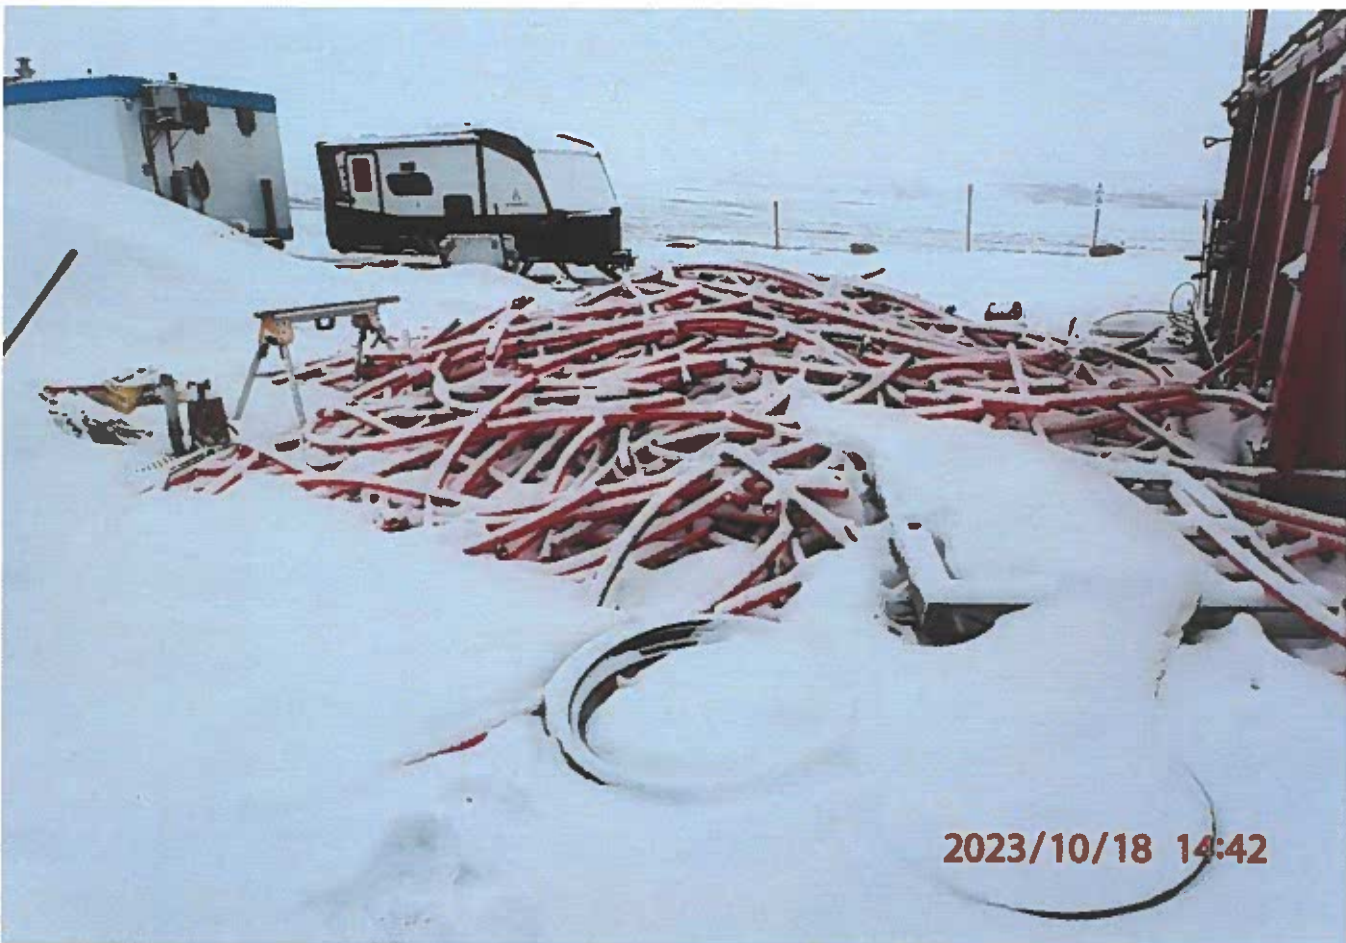
Figure 2

Some scrap material from the project.

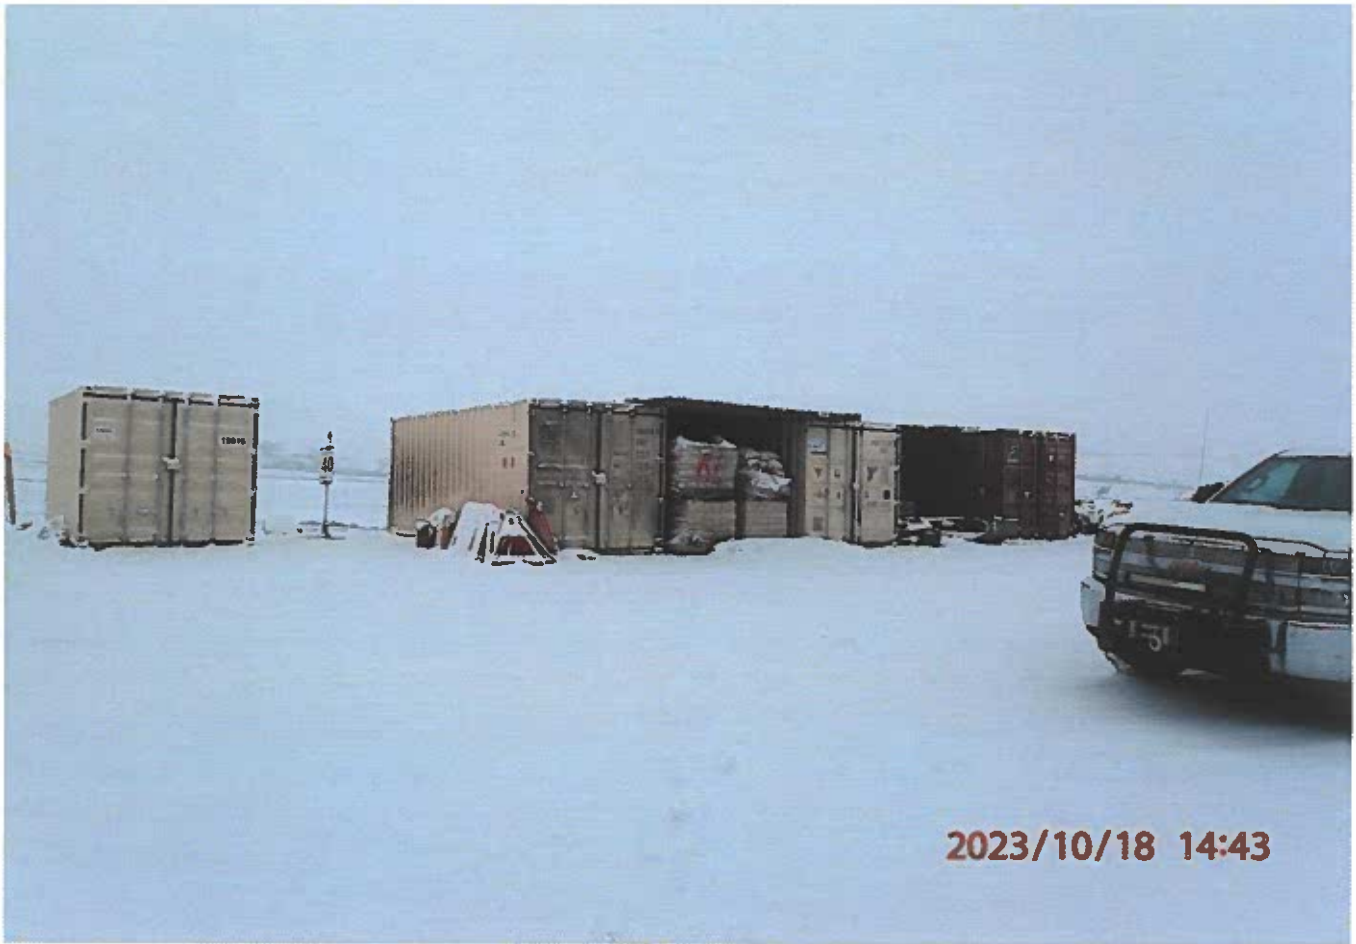
Figure 3

Storage containers to protect the materials from the elements.

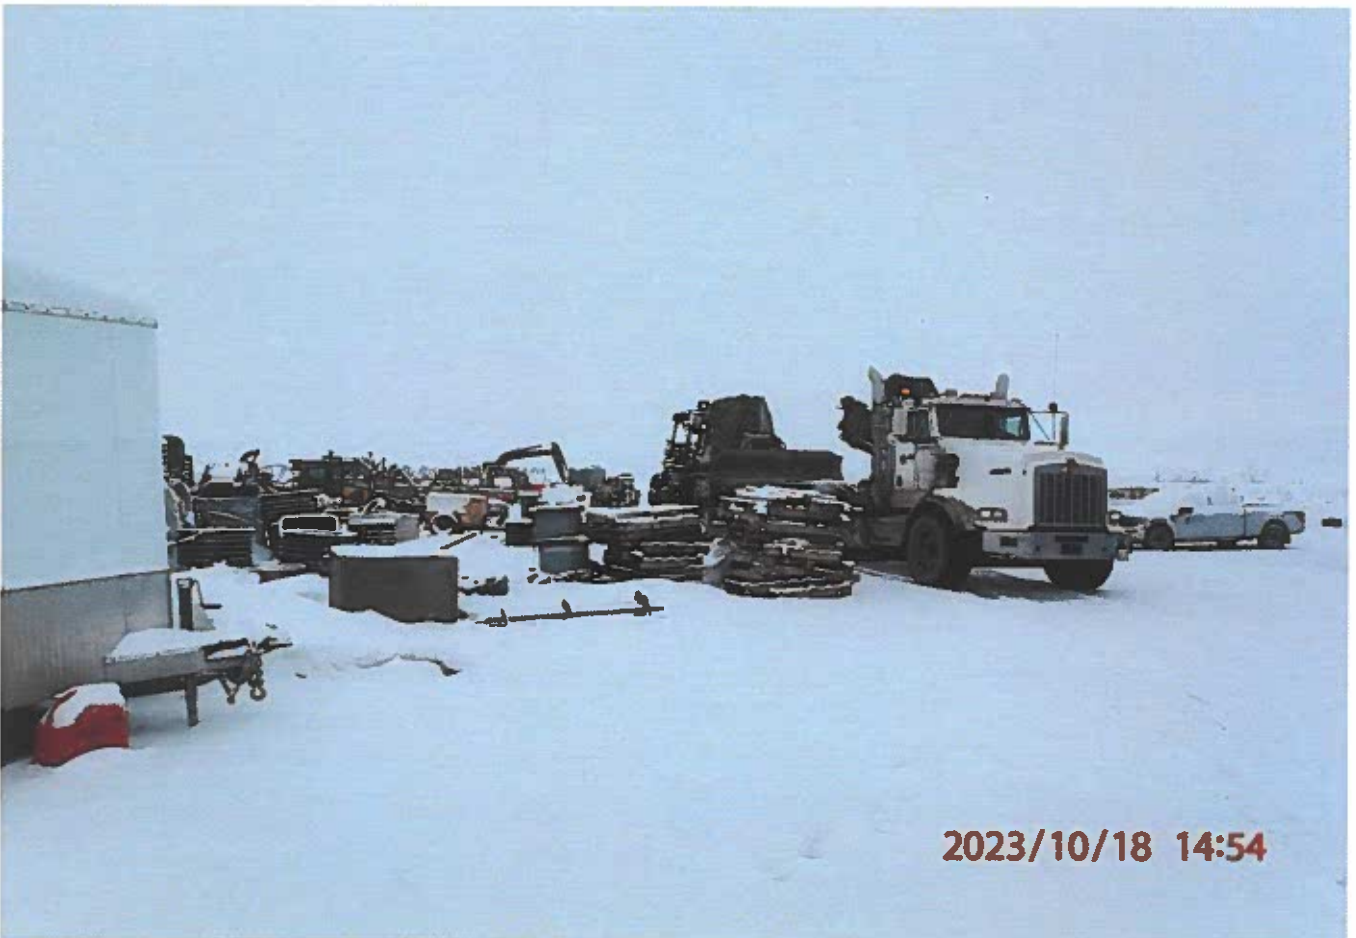
Figure 4

Some of the heavy equipment loaded for transport.

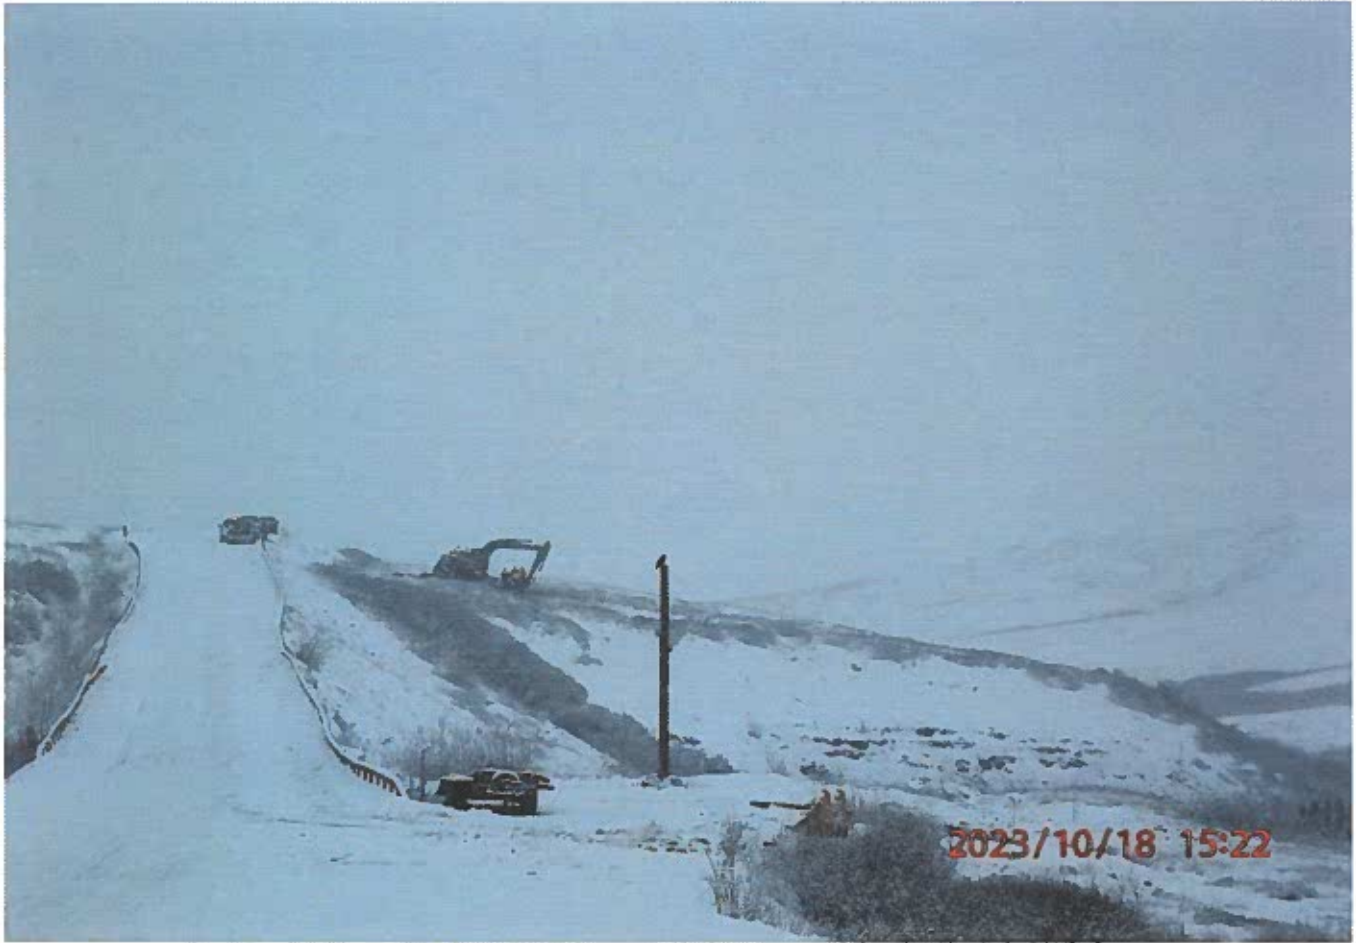
There was also an inspection conducted around KM 27.4 where the contractor was drilling a hole to install a pole for the cable when the drill failed and caused a hydraulic fluid spill approximately 45 liters in volume. Part of the spill was immediately cleaned up using absorbent pads and placed into plastic bags for disposal. The contractor said Matt from EDI

Figure 5
Drilling at KM 27.4.

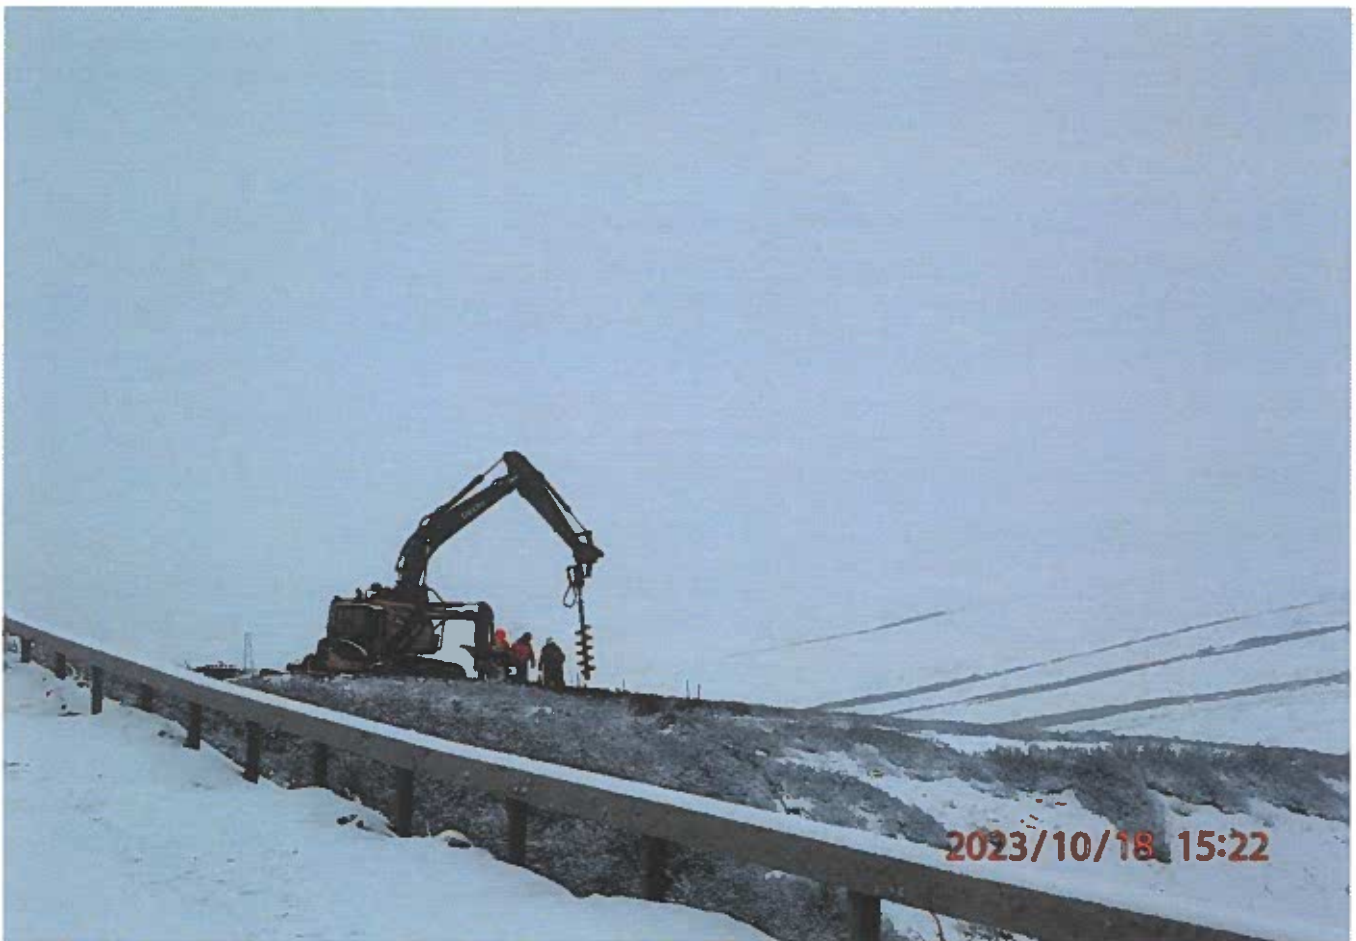
Figure 6
The excavator with drill attachment that caused the spill.

was contacted and supposed to come up with a remediation plan for the rest of the spill. See photos 5-9.

KM 27.4 - Occurrence October 18, 2023 - Currently waiting for remediation plan from EDI

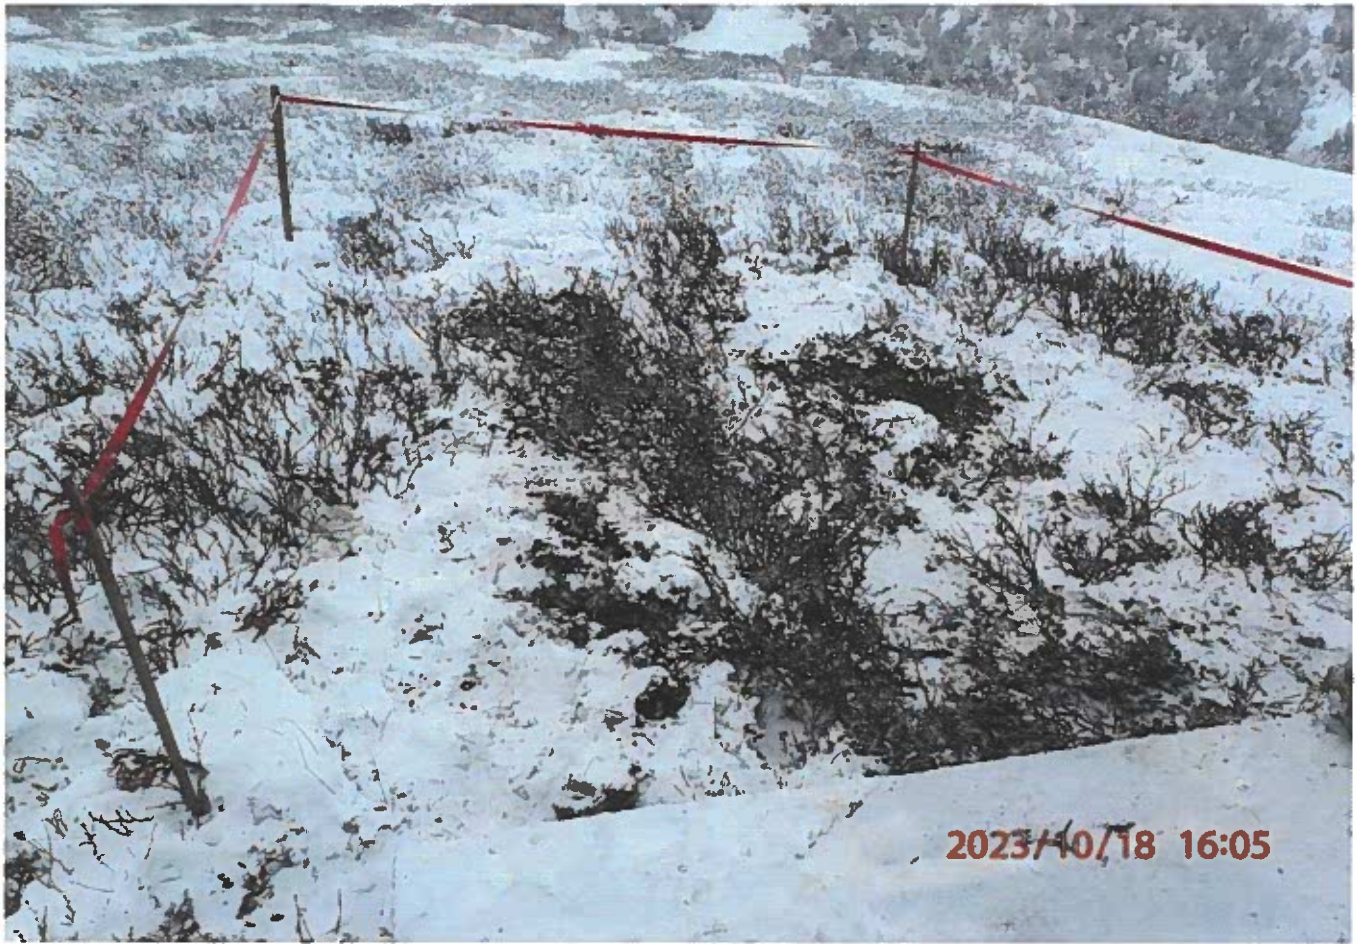
Figure 7

One of the contaminated depressions that have been flagged off by the contractor.

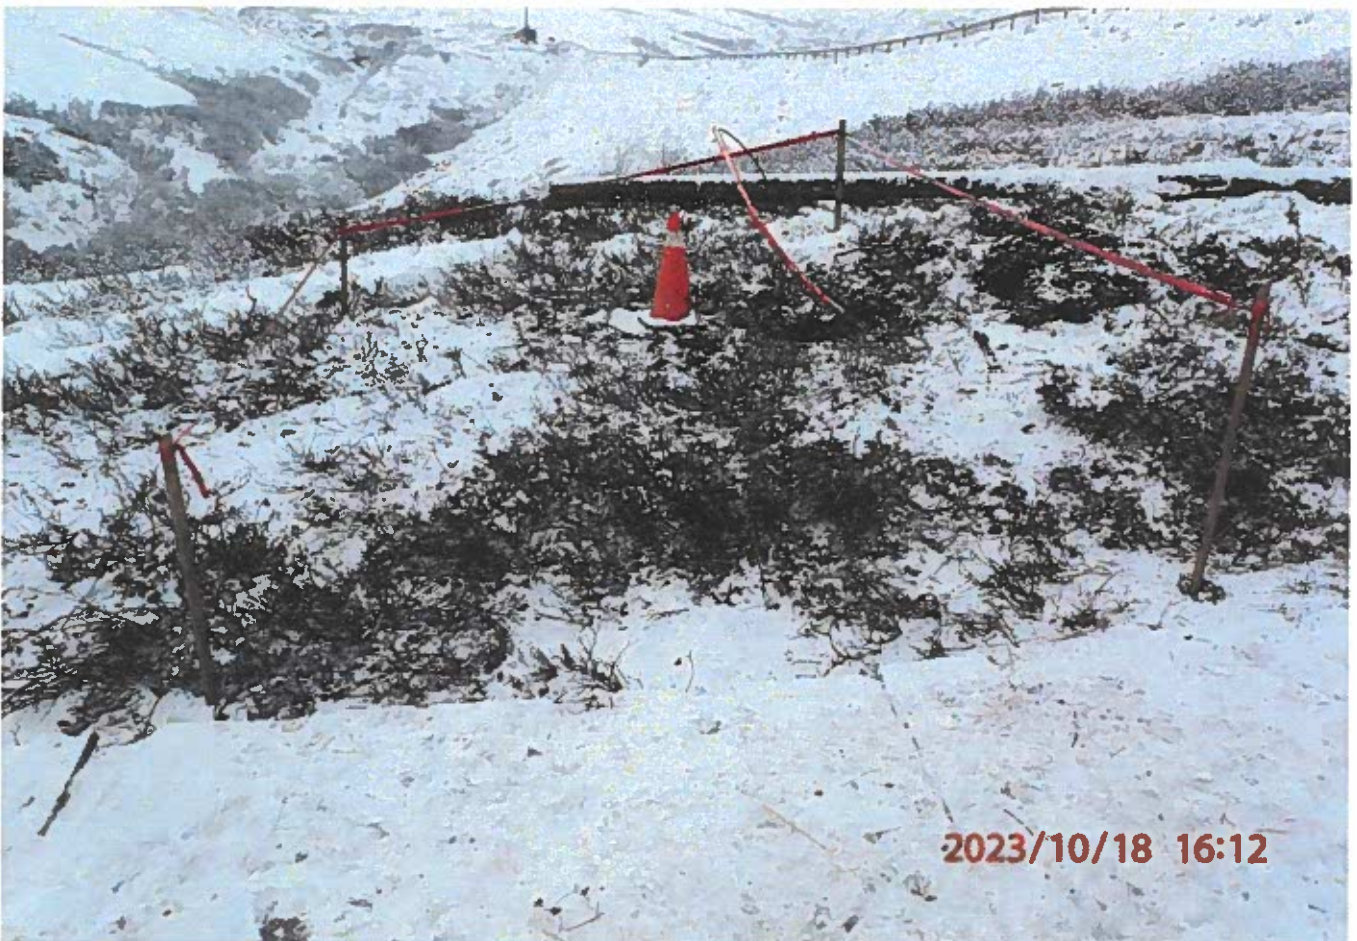
Figure 8

The other contaminated area.

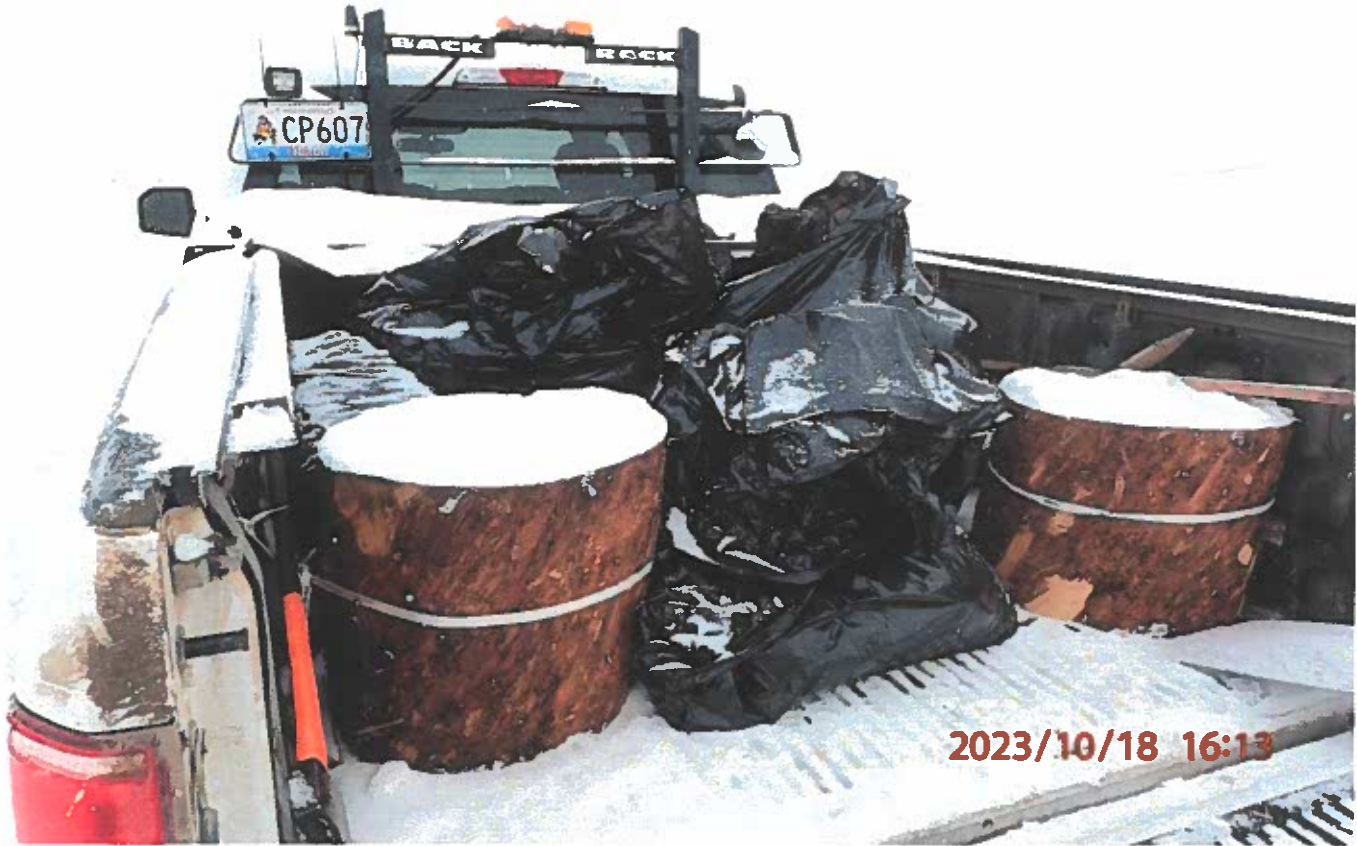
Figure 9

The contaminated material that was placed in plastic bags.
