September 19, 2023

**File Number** MV2019X0027  
**Type of Operation** MISC.  
**Location** KM 6 Camp Site and KM 24 Dempster Highway

## ENVIRONMENTAL INSPECTION REPORT

**Dempster Fibre Project:**

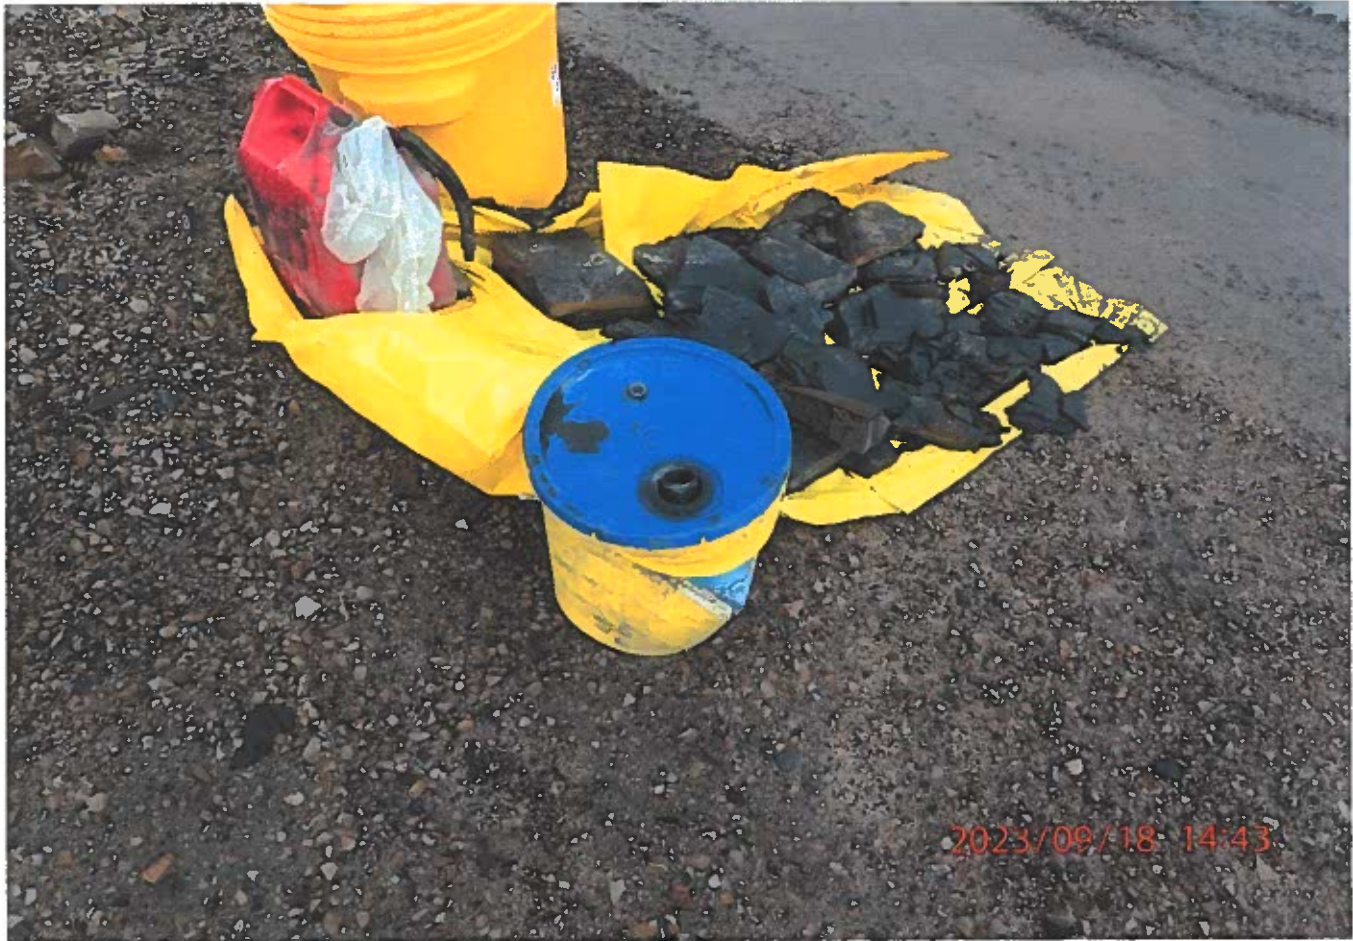
**Figure 1**

Near the camp location at KM 6 there were pails of hydrocarbon containers scattered throughout the site that did not have any secondary containment, proper covers and labels. Also, there was some used oil on top a 205-liter drum that was leaking down the side and onto the ground that require clean-up. See figure 1, 2, 3 and 4.

**A pail of hydrocarbon with no secondary containment, label and cover.**

- Ensure spills are cleaned up
- Drip trays at refueling locations
- Secondary containment, labels and proper lids/covers for hydrocarbon containers
- Rutting at KM 24

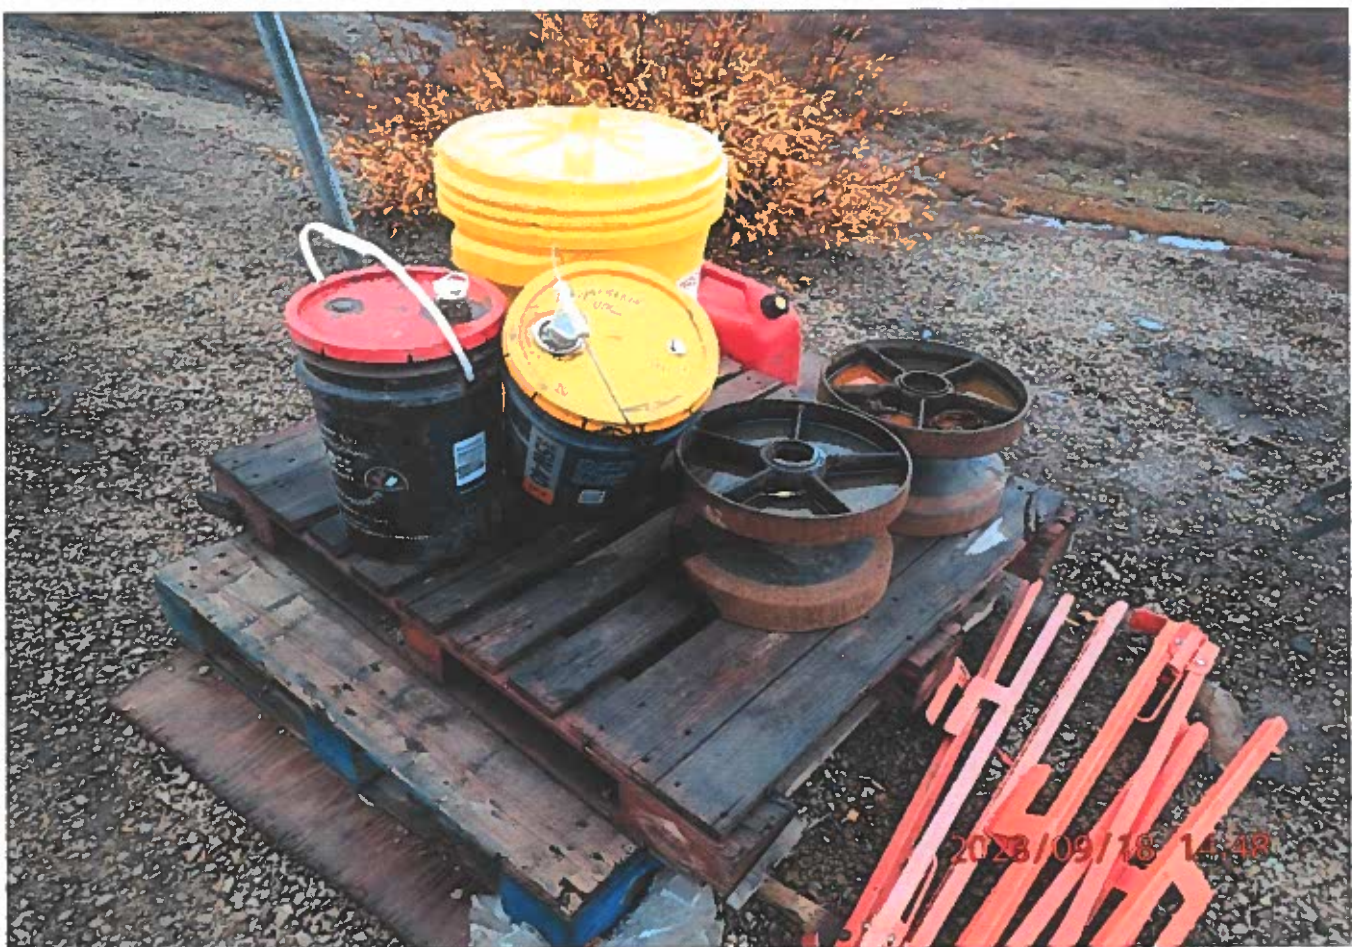
**Figure 2**

**A few more pails with no secondary containment.**

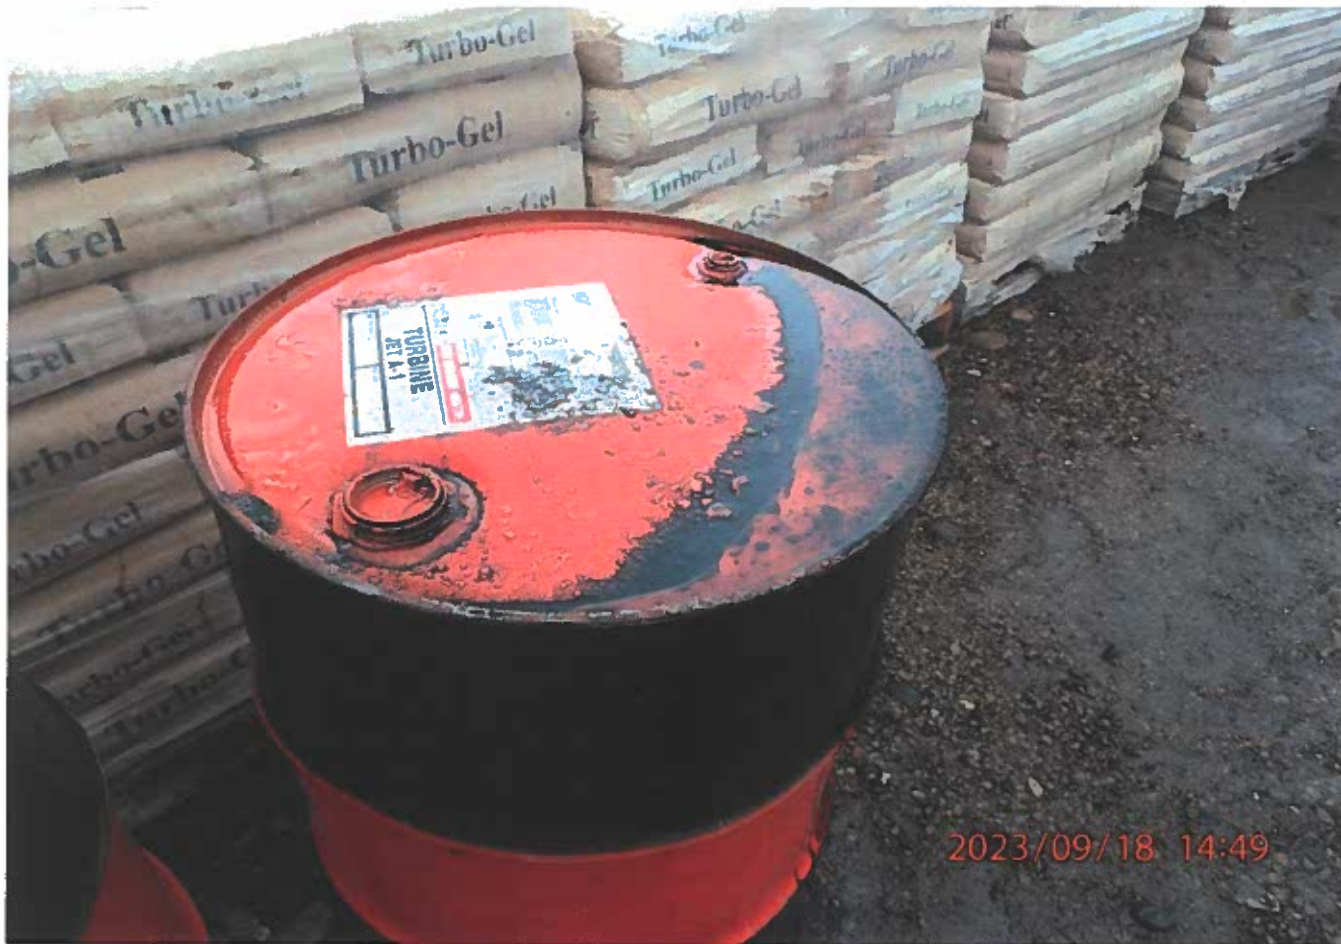
Figure 3

The used oil on top a 205 liter drum.

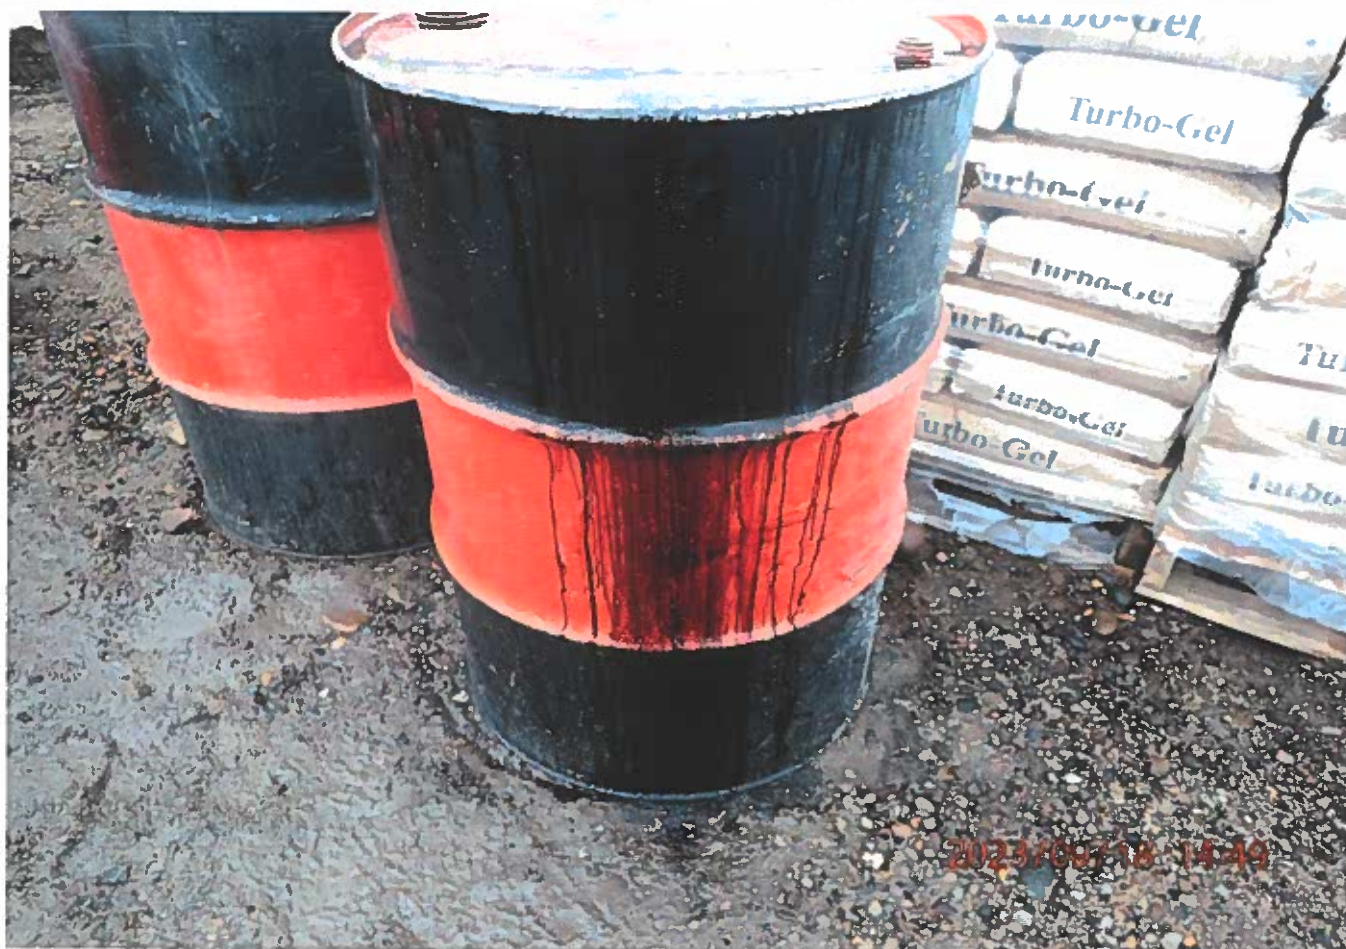
Figure 4

Notice the oil running down the side of the drum and onto the ground, due to rain displacing it from the top.

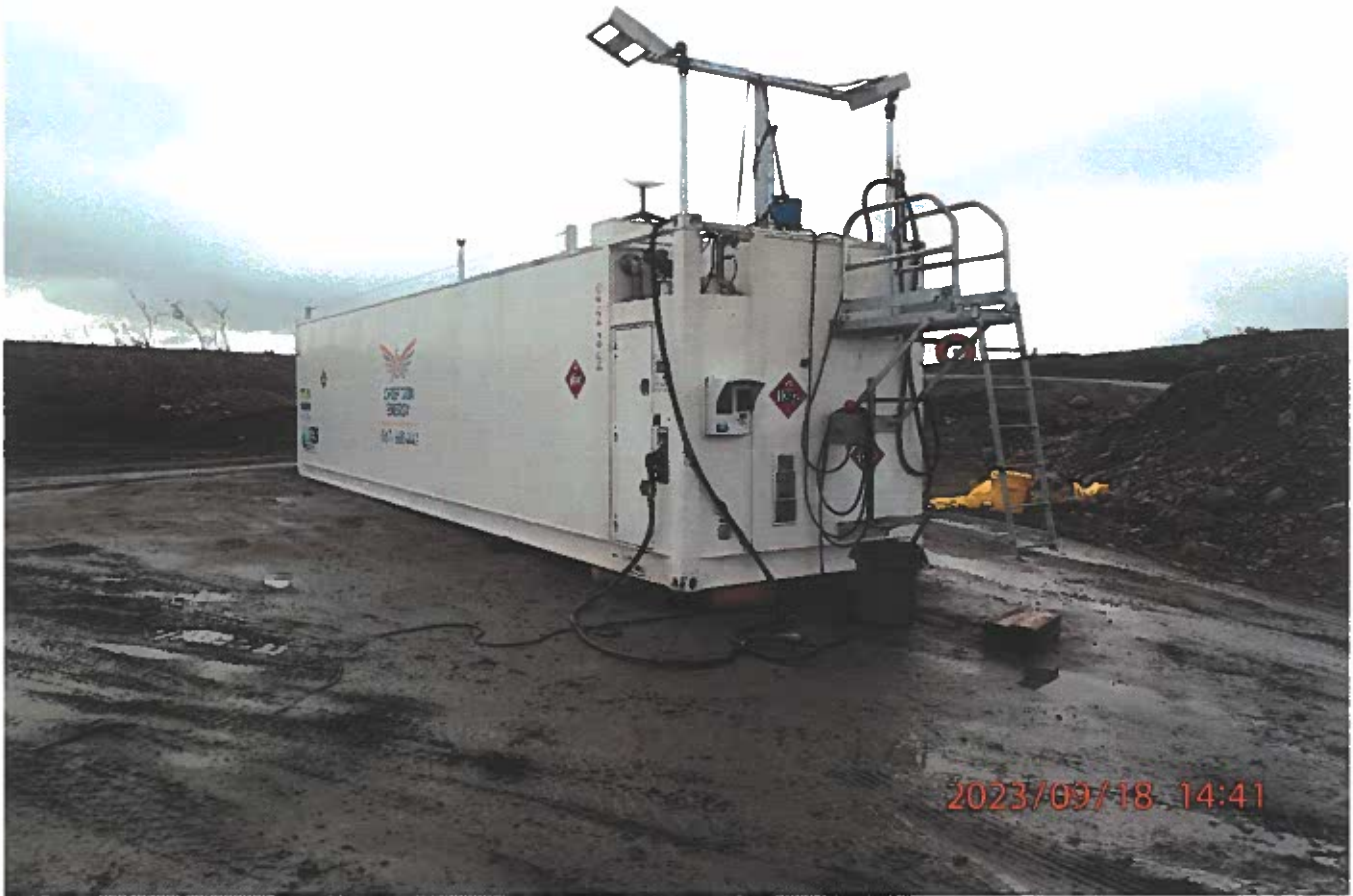
Figure 5

At the fuel storage location there were no secondary containment or drip trays observed for

refueling machinery. Also, there was a petroleum sheen observed near the pumps that require clean-up. See figure 5 and 6.

The fuel storage location with no secondary containment for refueling machinery.

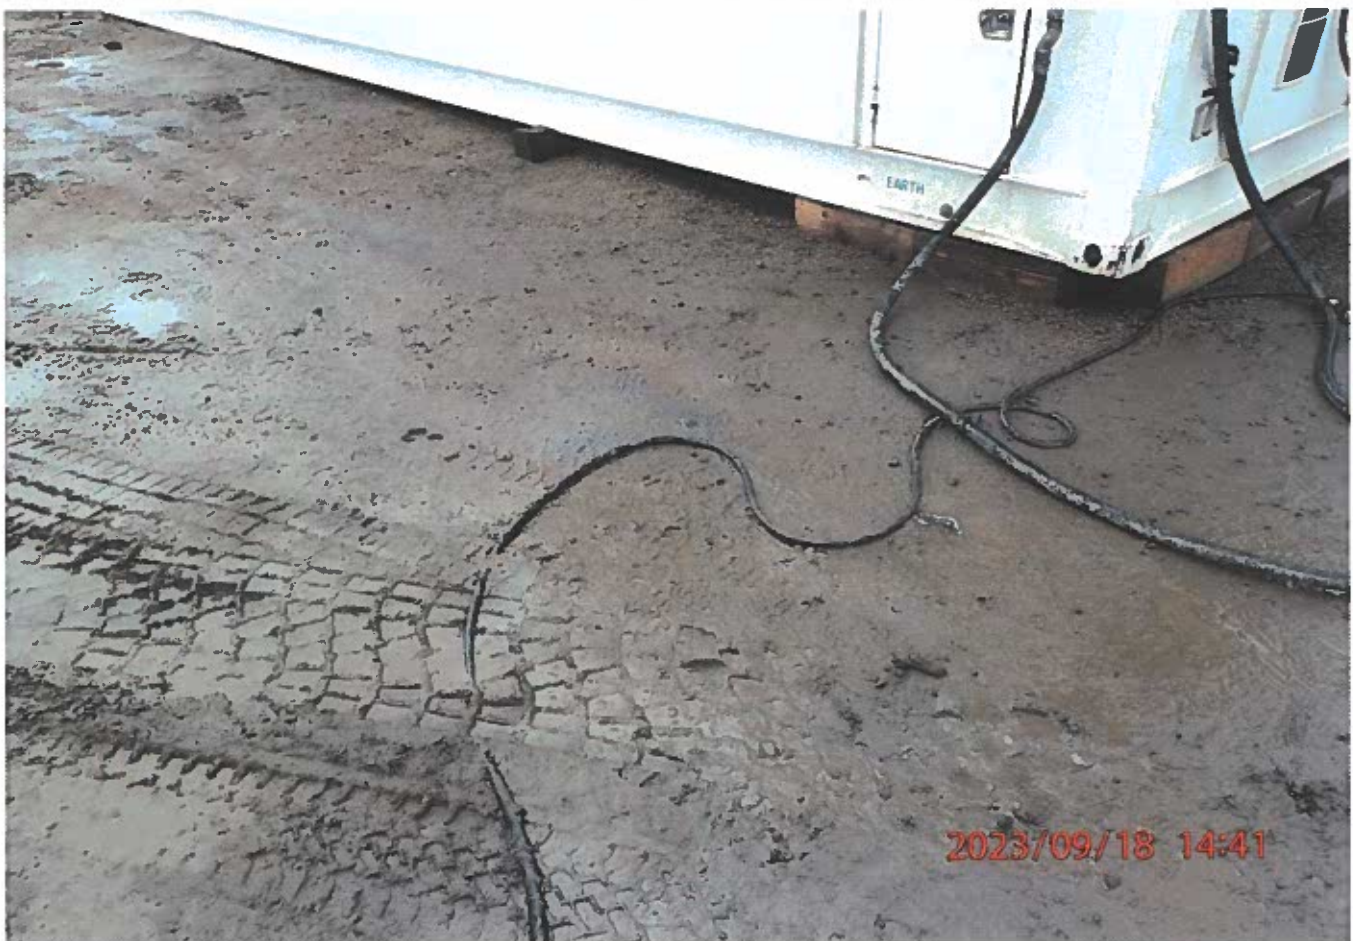
Figure 6

Barely noticeable in the photo, but there is a petroleum sheen near the hose on the ground. Rain is causing to spread.

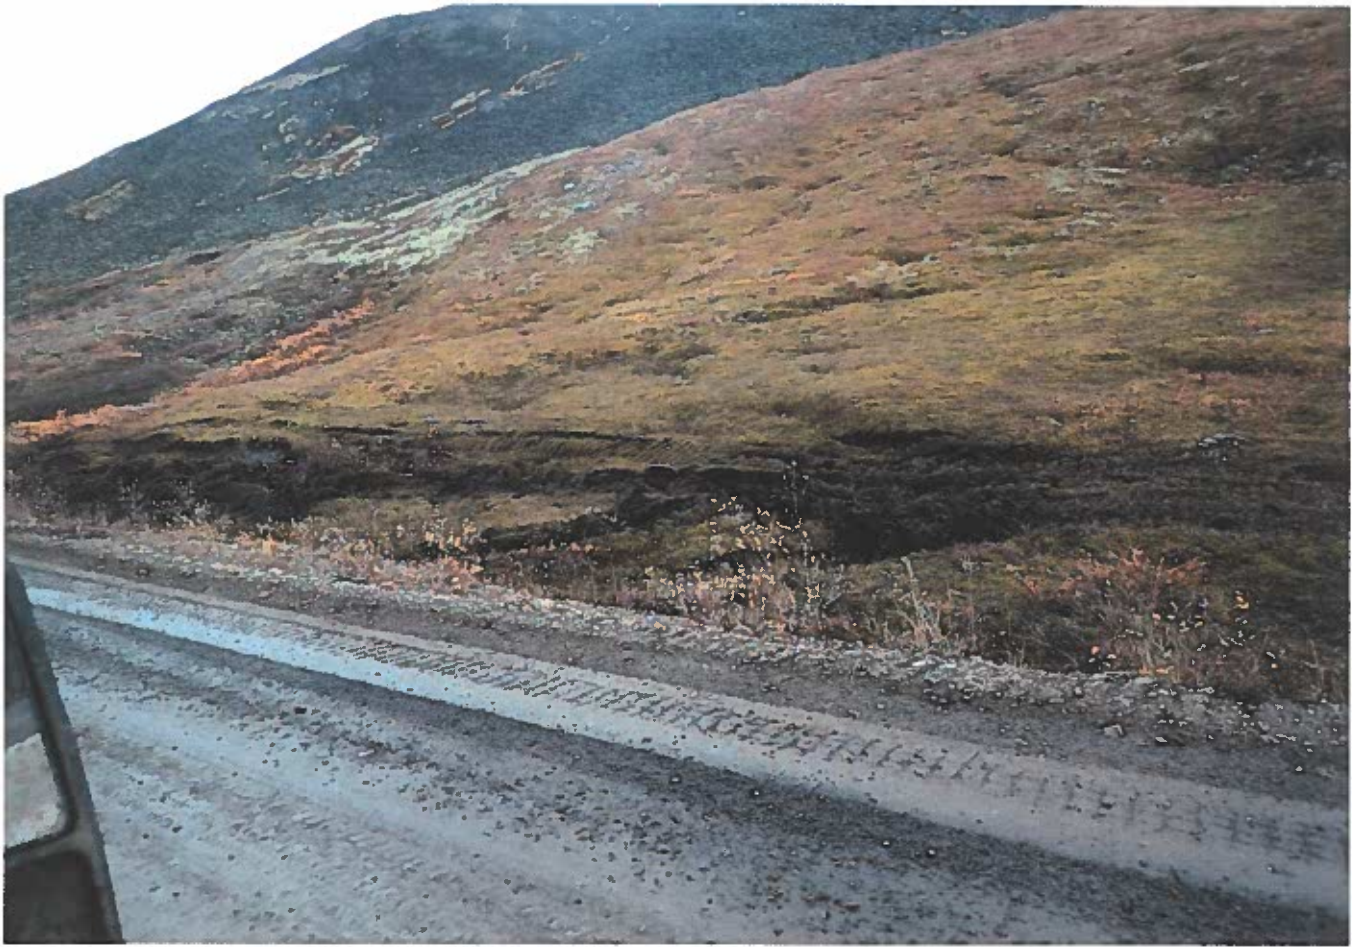
**Figure 7**

The Inspectors also observed rutting along the Right-of-Way where heavy equipment was placing the fibre line at approximately KM 24 of the Dempster Highway #8. See Figure 7 and 8.

The rutting observed near KM 24.

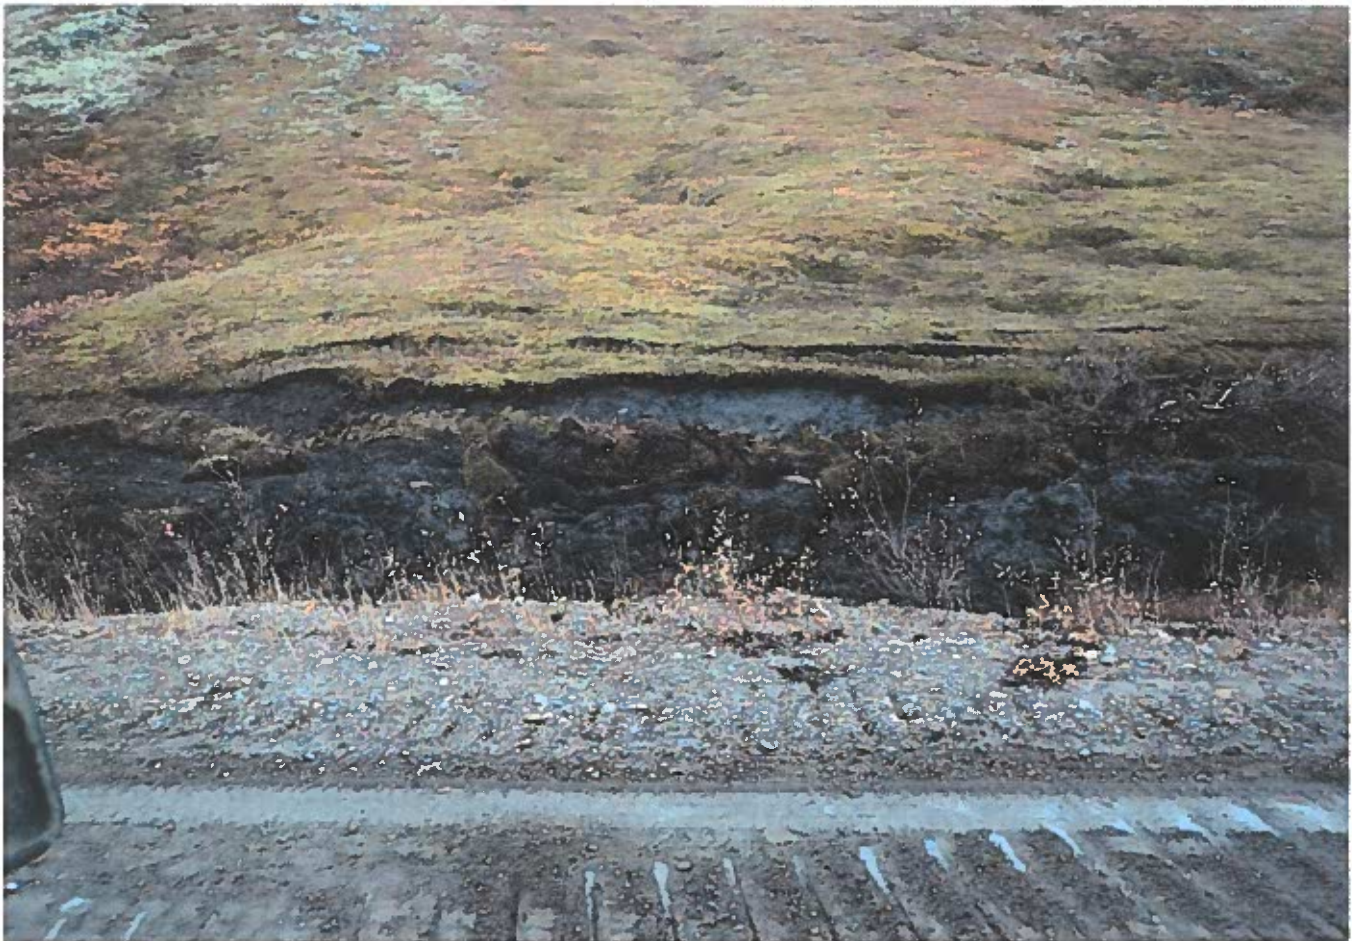
**Figure 8**

Another photo of the rutting caused by heavy equipment.
