Subject: Follow-Up Spill Report – Black Water – Gahcho Kué Mine – June 08, 2024 (GNWT Spill #2024216)

Pursuant to Part H Condition 3(d) of Water License MV2005L2-0015, De Beers Canada Inc. (De Beers) is submitting this follow-up spill report for GNWT Spill #2024216, which occurred at the Gahcho Kué Mine at 12:30 on June 08, 2024.

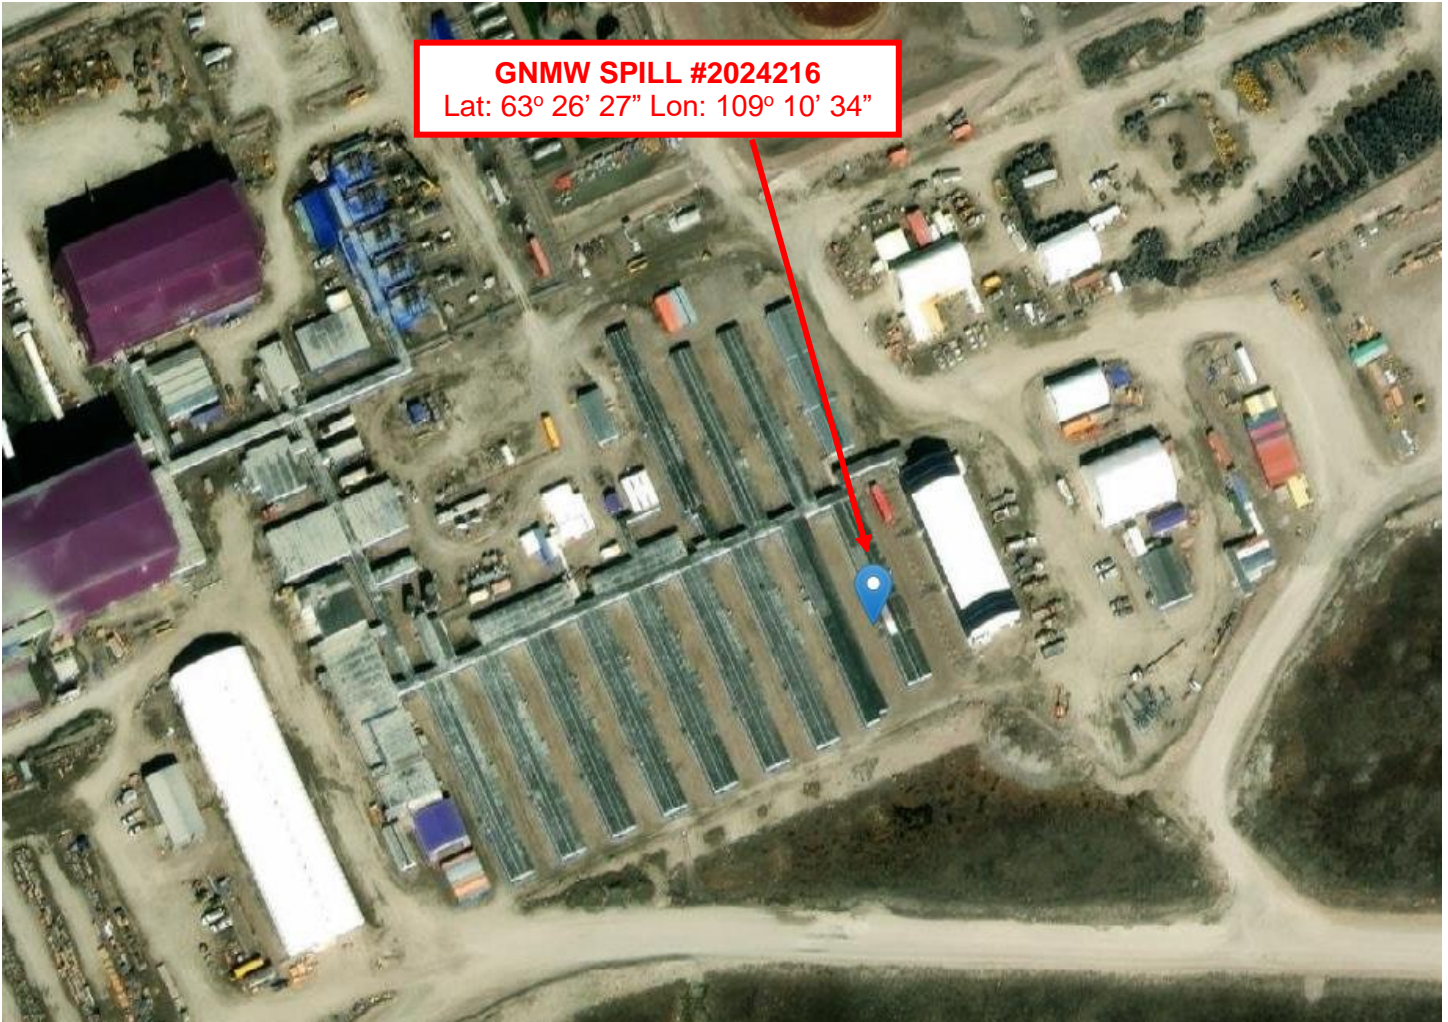
Figure 1. Location of GNWT Spill #2024216

Site Services personnel were replacing the lift station at camp accommodation dorm A11. This location within the camp footprint is presented in Figure 1. The sewer lines were disconnected from the old lift station and during the course of the commissioning of the new lift station a small volume (10 litres of black water) leaked from the pipe onto the ground. Environment staff were notified and a spill report was filed the following day. Due to the small volume and the area in which this event occurred, it is considered to have created an insignificant environmental risk. This spill is displayed in Figure 2

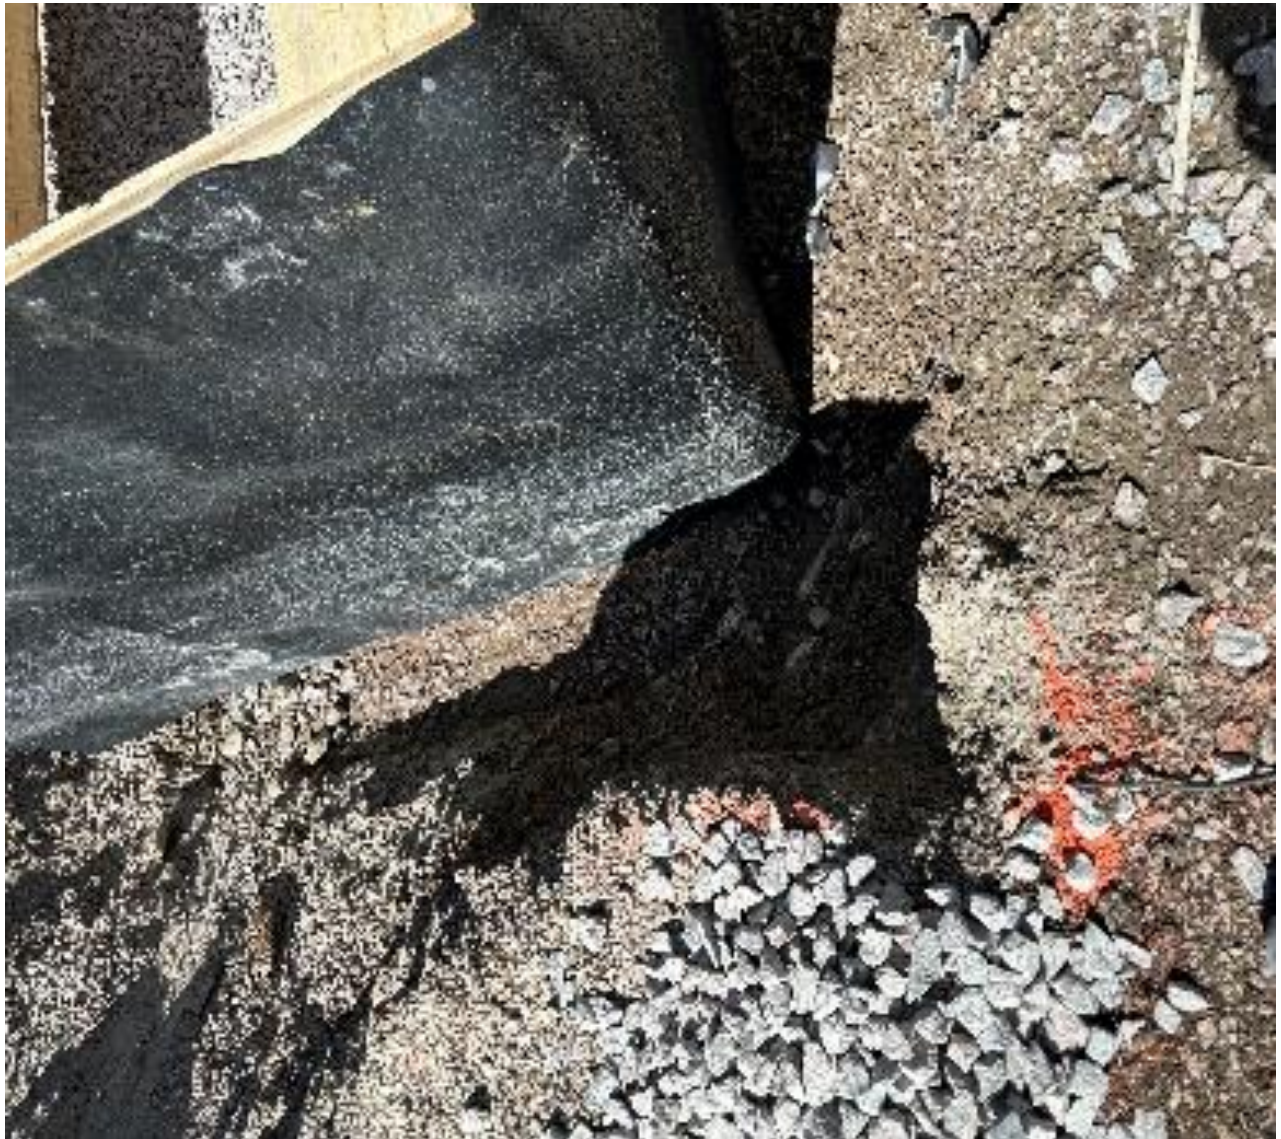
Upon investigation it was determined that organizational factors were the leading cause of the spill. The safe work plan (SWP) failed to include information about the need to install the check valve immediately after switching over line from old lift station, or installing a cap at the end of the disconnected line as a secondary safety. It was also determined that a check valve between dorms A12 & A11 had failed, which resulted in the

backflow from black water in A12 flowing into the A11 system. This was the direct source of the blackwater which was discharged from the unprotected pipe at the A11 lift station undergoing maintenance.

Figure 2. Spill at Dorm A11 Lift Station, GNWT Spill #2024216

1. DeBeers has added a control valve to the end of the A11 dorm sewer pipe.
2. DeBeers has updated the SWP regarding lift station maintenance to include direct instruction adding check valve to end of reporting pipe and ensuring its completion as soon as a lift station is disconnected.
3. DeBeers will inspect and replace the failed check valve between A12 and A11 dorms.

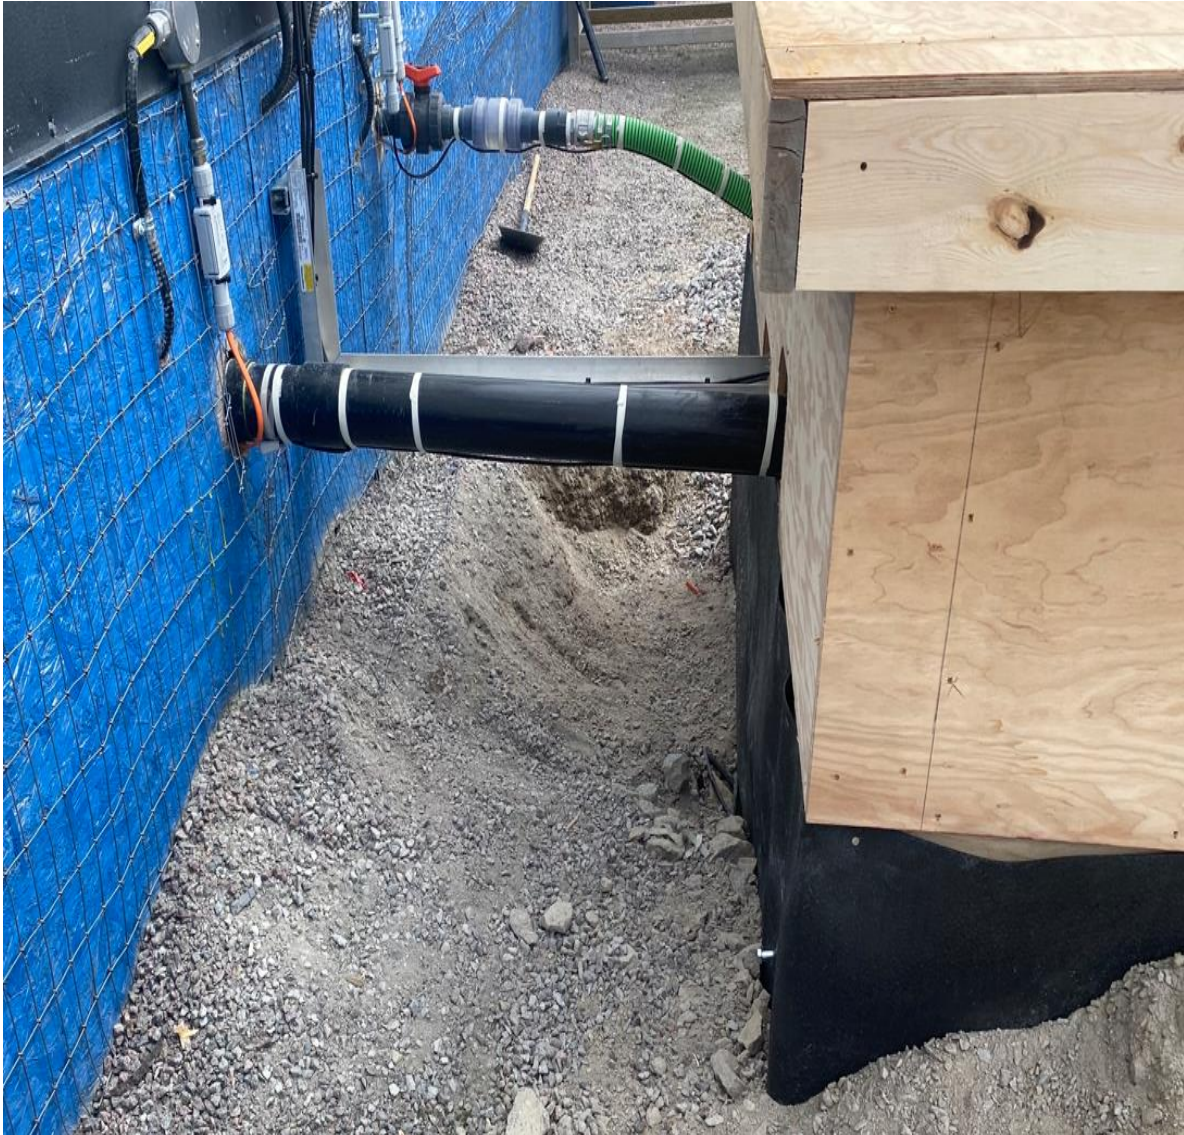
Figure 3. Verification of spill clean up, GNWT Spill #2024216

Upon discovery of the spill, the personnel immediately contained the contaminated material and removed it to a tote. This was then taken to the waste water treatment plant for proper disposal. To contain any additional release from the exposed pipe a new check valve was placed at the A11 lift station. The impacted spill area was verified to be clean of all contaminants after remediation efforts (Figure 3).
