DE BEERS GROUP

May 4, 2022

Subject: Follow-Up Spill Report – Hydraulic Oil – Gahcho Kué Mine – April 4, 2022 (GNWT Spill #2022116)

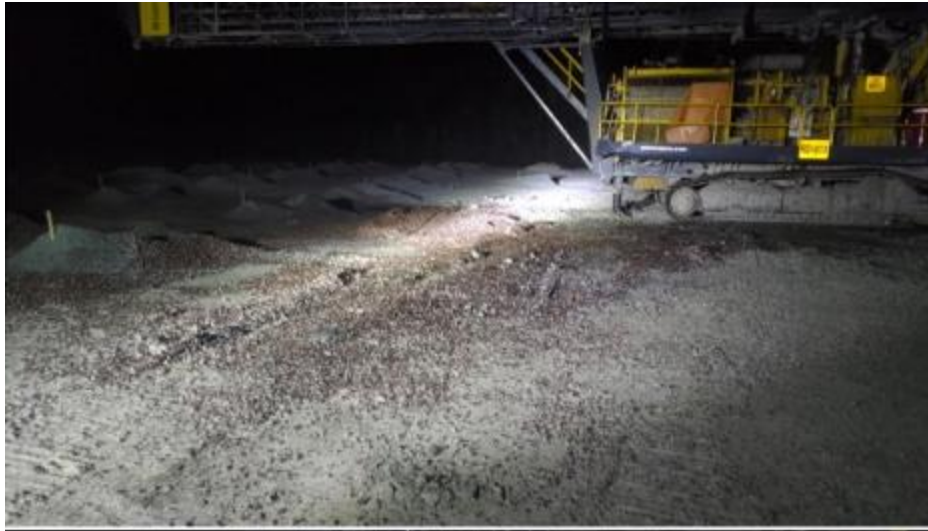
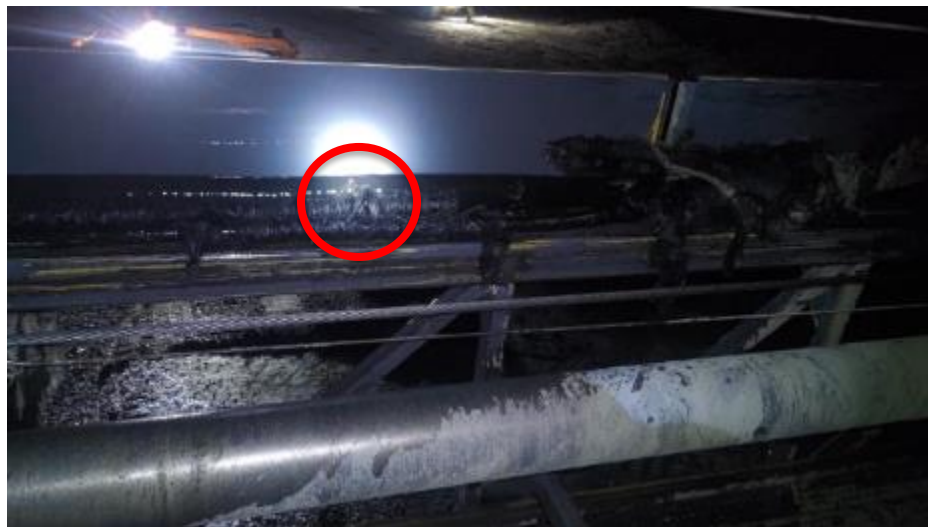
Figure 2. Photos of GNWT Spill #2022116

271 Pit viper Drill “RD-003” was drilling on a kimberlite pattern in Hearne Pit when at approximately 8:30pm. The operator stated the hole drilled down extremely quick (possible void), then noticed the hose bundle was twisted and some fluid leaking onto the deck. Operator then pulled the drill head back up to remove the drill steel out of the hole. The operator then got out of the cab and noticed a hydraulic leak spraying from the bundle.

Due to the void within the drill hole, hydraulic lines had become “bundled” and kinked, which resulted in wear against moving drill steel. This went unnoticed by the operator until the line ruptured resulting in a spill.

1. Review of operating procedures with crew, emphasising the need to note unusual conditions in the field that could result in malfunctions. If these conditions are noted, equipment must be shut down and inspected prior to a spill or malfunction occurring.
