DE BEERS GROUP

Subject: Follow-Up Spill Report – Diesel – Gahcho Kué Mine – August 19, 2021 (GNWT Spill # 2021357)

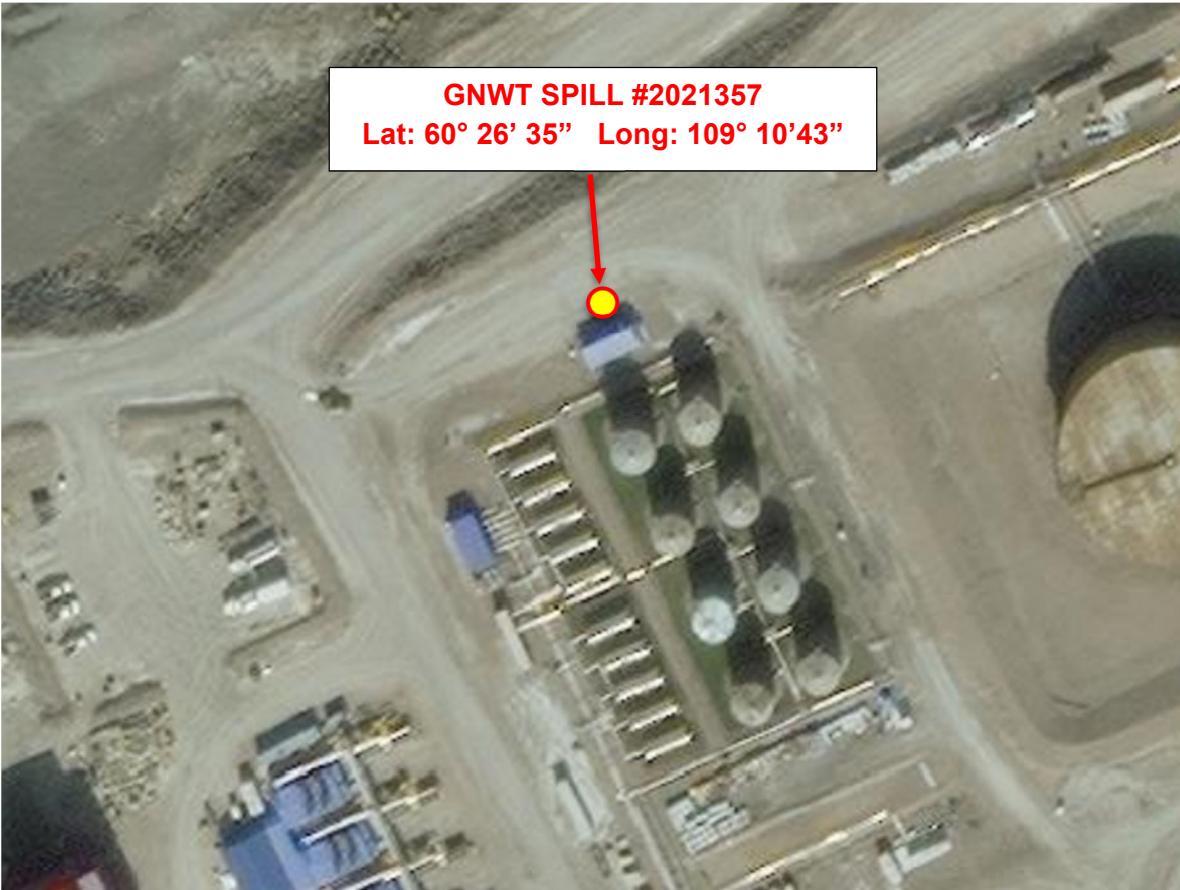
Figure 1. Location of GNWT Spill #2021357

On August 19, 2021, a fuel truck operator began refueling LV-017 (Lube Truck) at the light vehicle fueling module. While the unit was filling, the operator began to hear the sound of running liquid and observed fuel running out of the top of the fuel truck tank. The operator got out of truck and turned off the refueling line. The fueling meter was noted at reading 9124 litres, with the truck capacity being rated at 9000 litres.

The operator immediately froze the scene, contacted the shop lead hand and started to put down some spill tubes / pads to help contain the fuel spill. The contaminated gravel was disposed of in the Type 3 area of the West Mine Rock Pile, and fresh material was placed within the impacted area.
