Subject: Follow-Up Spill Report – Hydraulic Oil – Gahcho Kué Mine – December 2, 2021 (GNWT Spill #2021484)

Pursuant to Part H Condition 3(d) of Water License MV2005L2-0015, De Beers Canada Inc. (De Beers) is submitting this follow-up spill report for GNWT Spill #2021484, which occurred at the Gahcho Kué Mine at 11:04 on December 2, 2021.

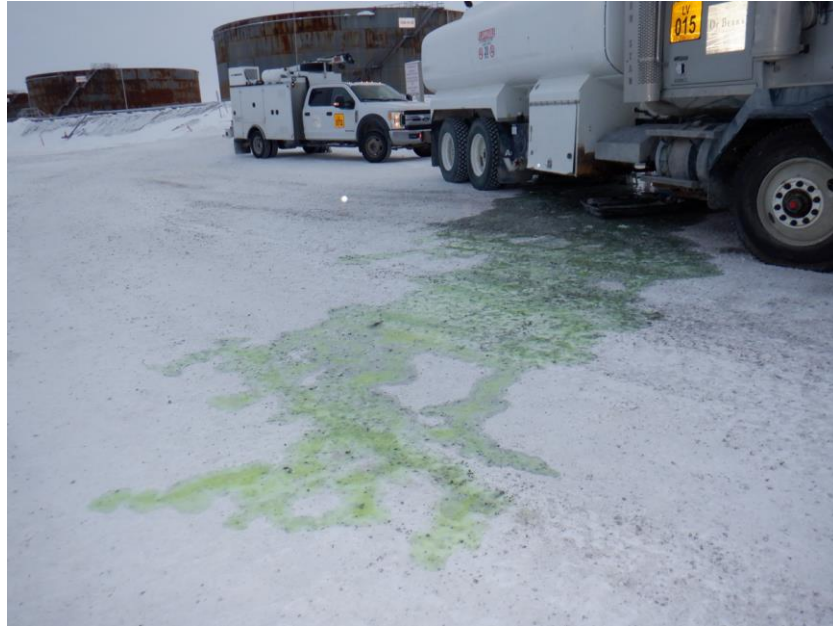
Figure 2. Photos GNWT Spill #2021484

On December 2, 2021 at approximately 11:04am, the operator of Fuel Truck LV-015 began refueling the bulk storage tank of their vehicle. As the operator was filling out paperwork in the cab of their vehicle, they noticed fuel spilling on the ground coming out of the overflow pipes located between the cab and the tank. The operator immediately closed the main valve and stopped the pump. Approximately 150L of diesel was spilled.

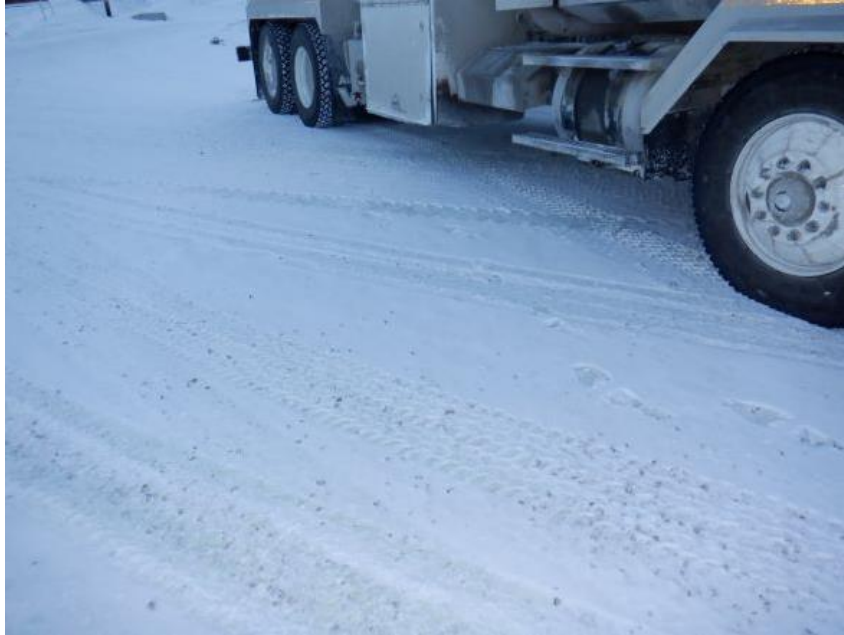
Figure 4. Clean Up Photos GNWT Spill #2021484

Spill pads and booms were immediately deployed, and all spilled fuel was contained within the established lined transfer area containment. Contaminated material was then removed and loaded out to the Type 3 Area of the West Mine Rock Pile.
