DE BEERS GROUP

Subject: Follow-Up Spill Report – Hydraulic Oil – Gahcho Kué Mine – November 25, 2021 (GNWT Spill #2021479)

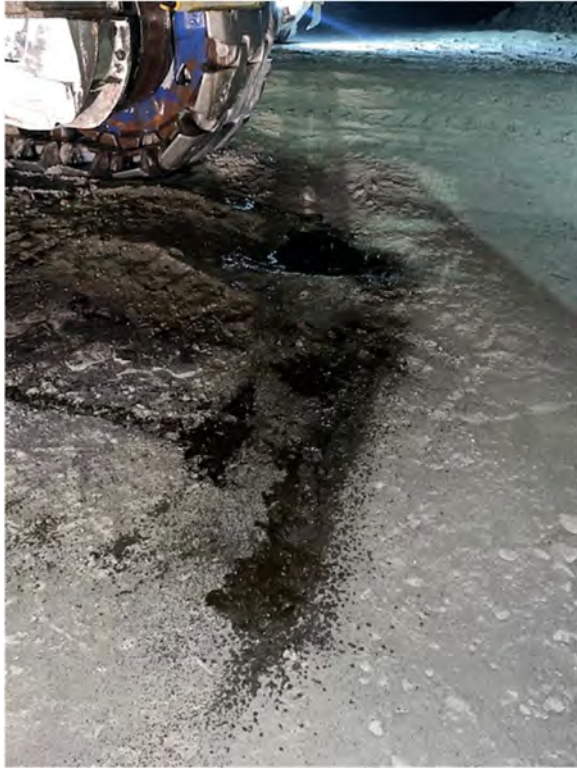
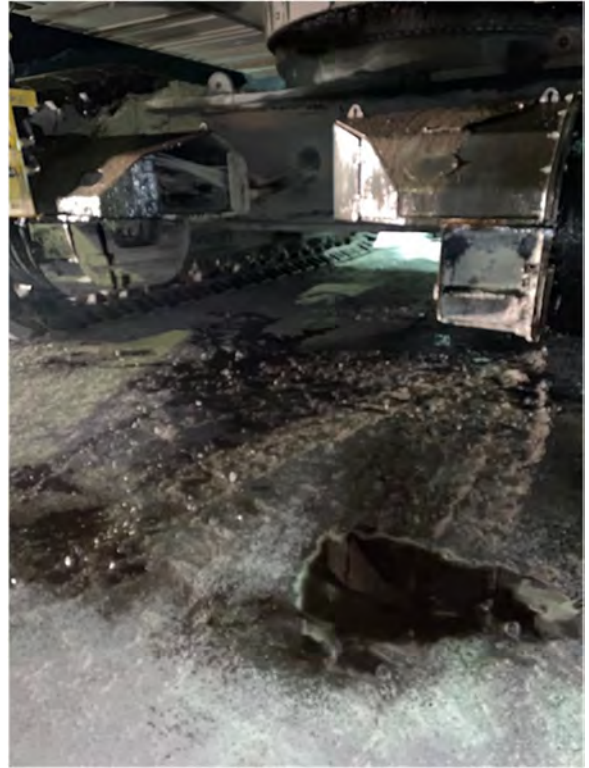
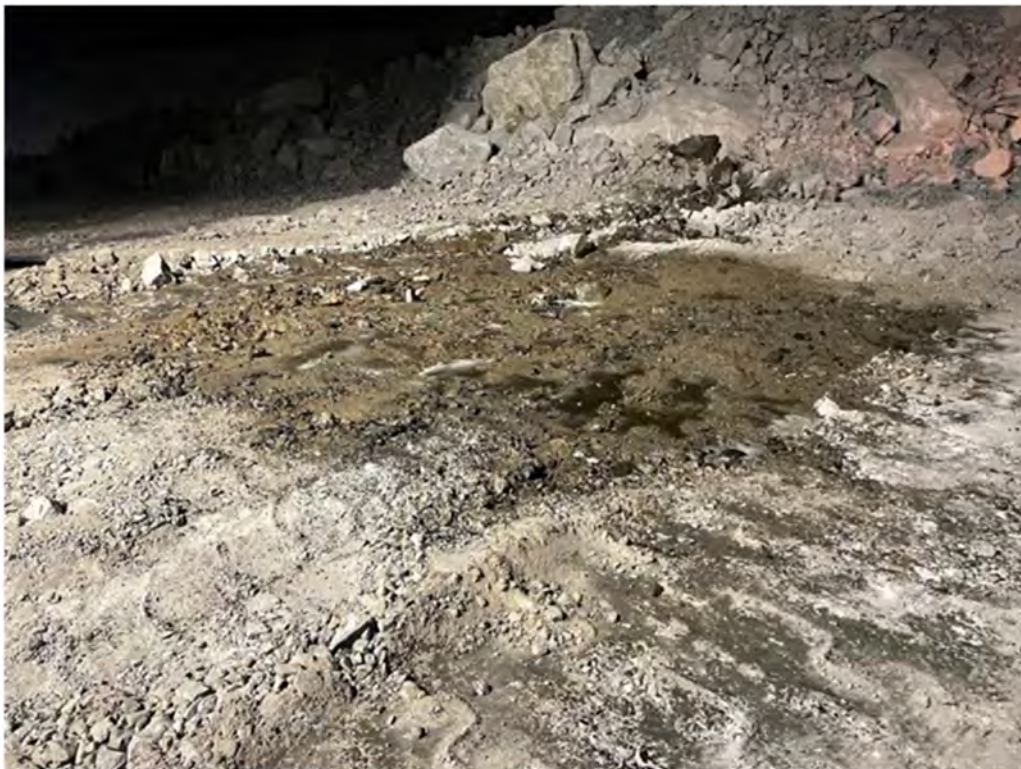
Figure 2. Photos GNWT Spill #2021479

On November 25, 2021 at approximately 2:45 am, SH-003 was digging in the Tuzo Pit. The operator noticed sign of an oil leak on the tracks there were no audible or visual low hydraulic warnings from VHMS, he backed away from the dig face, shut the unit down and called for the running repair tech to come and have a look for the source of the leak. Upon arriving at SH-003 in the Tuzo Pit the technician identified that the source of the hydrocarbon release was a loose fitting in the hydraulic pump room. The fitting is located at or behind PTO 1 and connects directly to the pilot pressure filter head. The fitting was tightened, and the unit was filled with 750 litres of AST 20 hydraulic oil.

The low hydraulic level warning was not functional and testing of this circuit was not included in recent PM packages. The fitting that came loose was not identified as a risk during the last PM outage.

Ensure that electrical check sheets are included in electrical PM package for 1000-hour PM.

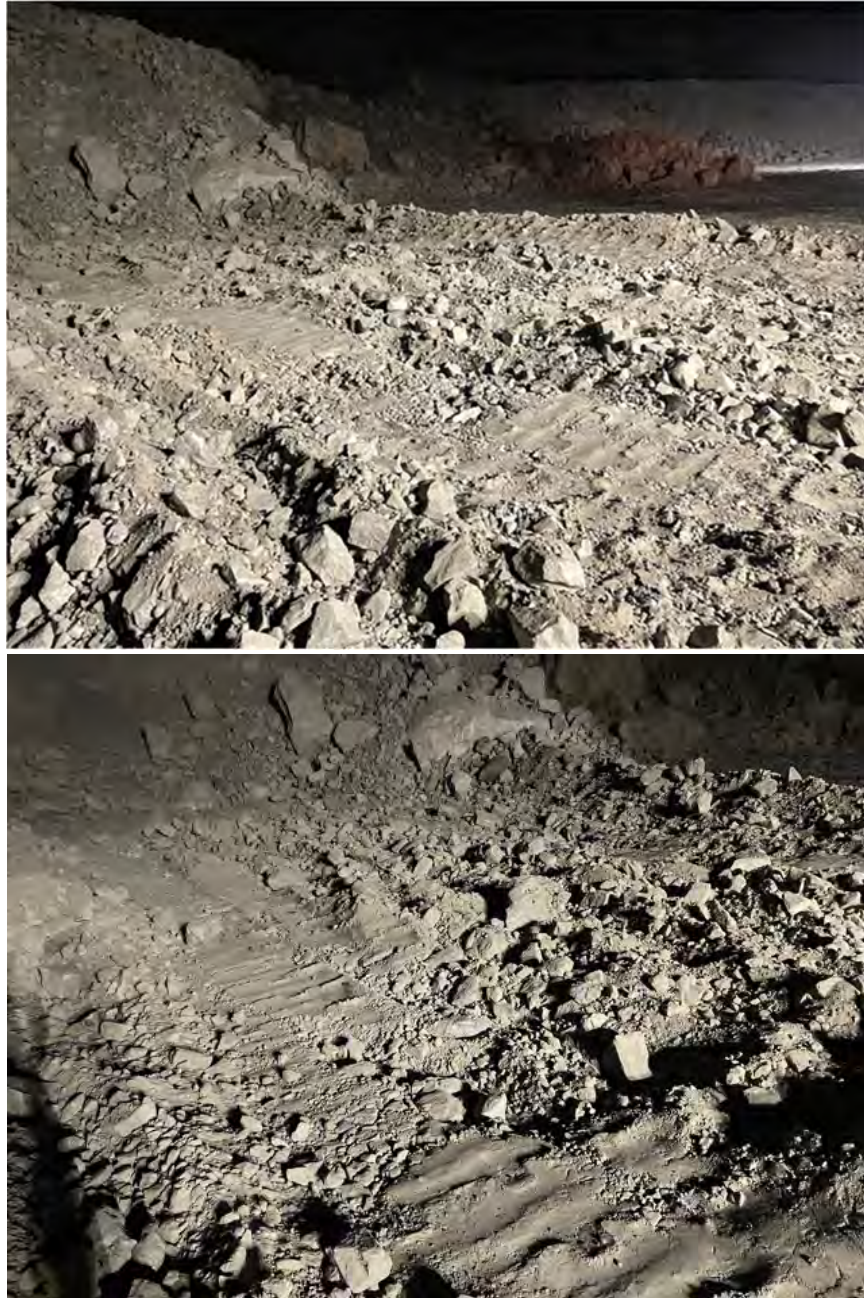
Figure 3. Clean Up Photos GNWT Spill #2021479

The shovel (SH-003) was shut down, source of release was identified and spill remediation was started. On board clean up of hydrocarbons was completed and unit was returned to service. The contaminated material was removed and loaded out to the Type 3 Area of the West Mine Rock Pile.
