DE BEERS GROUP

**Subject: Follow-Up Spill Report – Hydraulic – Gahcho Kué Mine – September 2, 2021
(GNWT Spill #2021378)**

Pursuant to Part H Condition 3(d) of Water License MV2005L2-0015, De Beers Canada Inc. (De Beers) is submitting this follow-up spill report for GNWT Spill #2021378, which occurred at the Gahcho Kué Mine at 00:00 on September 2, 2021.

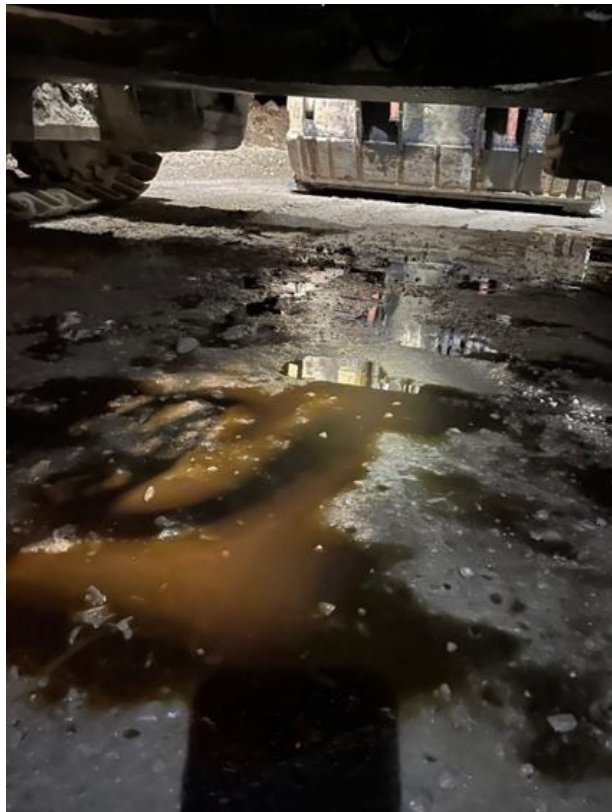
Figure 2. Initial Impact of GNWT Spill #2021378

A Komatsu PC 5500 Shovel (Unit #: SH-002) was walking into the 5034 pit, after being returned to service post maintenance, when the operator noticed a leak on the boom from then boom hydraulic system. The operator then moved the unit out of the 5034 ramp entrance intersection and completed the shutdown procedure. At this point the operator deployed spill pads and booms, as well as informing his supervisor of the incident. Upon the field investigation, it was discovered that the root cause was the result of a O-ring failure on the boom side of the boom hydraulic manifold. The maintenance technician replaced the damaged o-ring, then re-filled the hydraulic system. Upon refilling the hydraulic system it was determined that approximately 500 litres of Hydraulic fluid were lost. Clean up of the contaminated area was then completed with the help of mine operations and the unit was returned to service.

Upon shutdown, the operator deployed the unit's spill kit materials and informed their supervisor of the incident. A mobile maintenance shovel technician was called to the scene to repair the unit and determine the cause of the leak. Once repaired the unit was returned to service. The contaminated gravel was disposed of in the Type 3 area of the West Mine Rock Pile, and fresh material was placed within the impacted area.

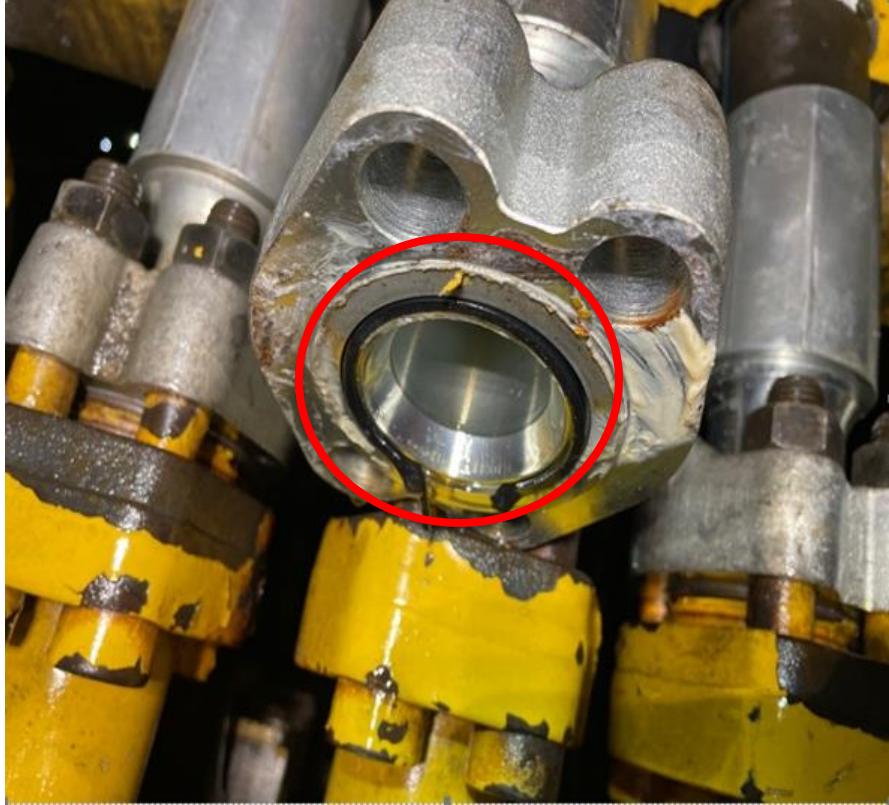
Figure 3. Failed O-ring Found upon Investigation of Failure Resulting in GWNT Spill #2021378

Upon investigation it was determined that an o-ring within the "H" position of the boom hydraulic manifold had failed, resulting in a spill. This failure was caused by to improper installation during the preceding maintenance earlier in the shift. This improper installation was not corrected by maintenance technicians and was returned to service in a damaged condition.

- Additional training of maintenance technicians to ensure that the proper work standard is observed and maintained throughout all maintenance activities.
- Ensure that additional checks are completed by the senior technician prior to the commissioning of equipment after maintenance.
