File Number	S04A-006
Type of Operation	OIL AND GAS DRILLING - WELLSITE
Location	Wellsite L-71

ENVIRONMENTAL INSPECTION REPORT

Permittee:	Husky Oil Operations Limited	Permit Expiry Date:	September 11, 2009
Land Use Permit No.	S04A-006	Previous Inspection:	July 05, 2016
Quarrying Permit No.	N/A	Inspection Date:	July 10, 2019
Contractor:	N/A	Subcontractor:	N/A
Location(s) Inspected:	Wellsite L-71		
Current Stage of Operation:	Remediation		
Program Modifications Approved:	None

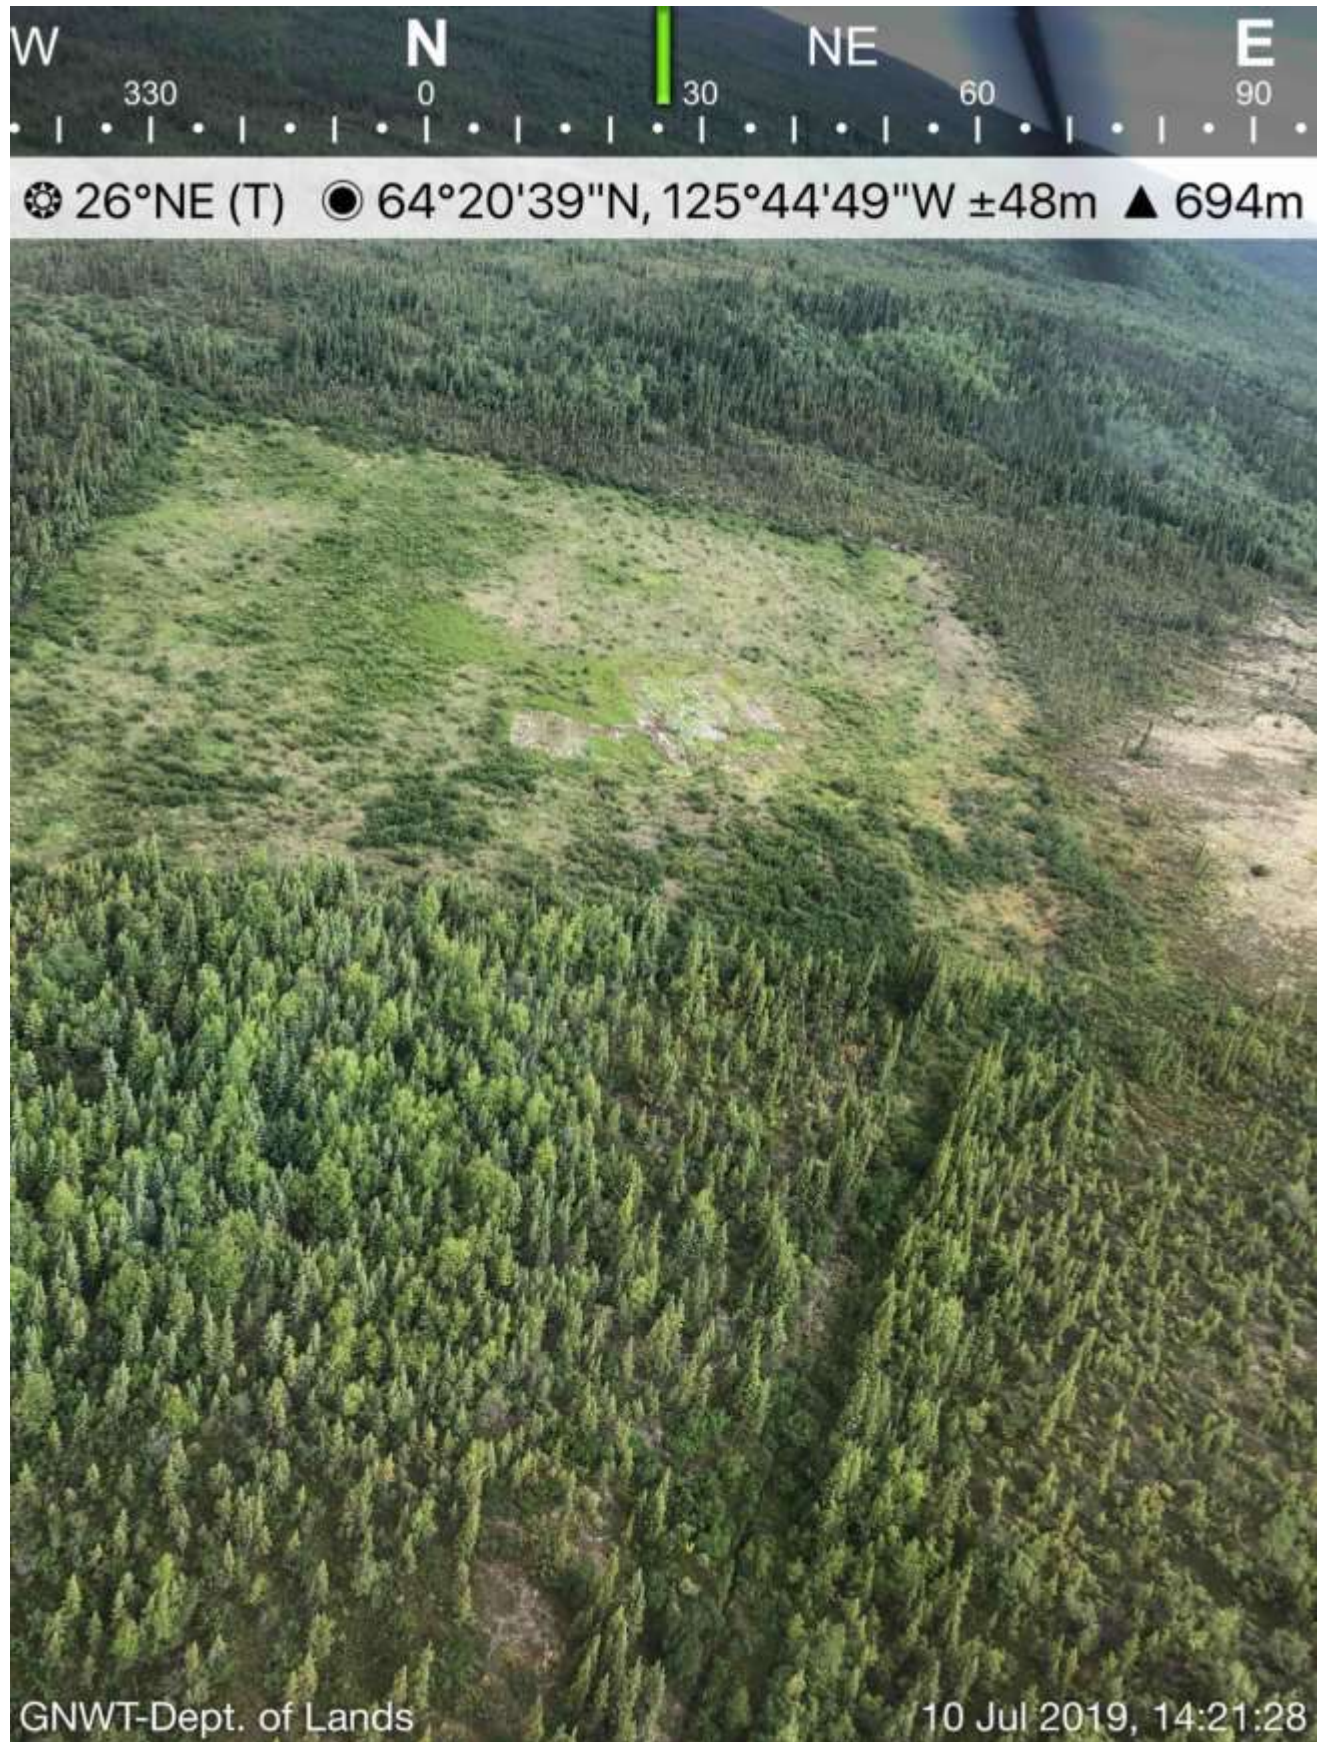
Figure 1

As seen in Figure 1, The wellsite has vegetated well. There are a few areas with sparse vegetation (well center and remediated soil). Inspectors were glad to see the water was not pooling at the well center and all equipment as requested in the last inspection report was removed. Figure 2 shows a portion of the remediated soil. Areas within this zone are sparsely vegetated. Figure 3 also displays sparse vegetation growth.

Aerial view of wellsite L-71.

Inspectors wish to retain this permit and continue monitoring the vegetation growth in this area. Once Inspectors are comfortable with this success of the remediation, a discussion of file closure will occur.

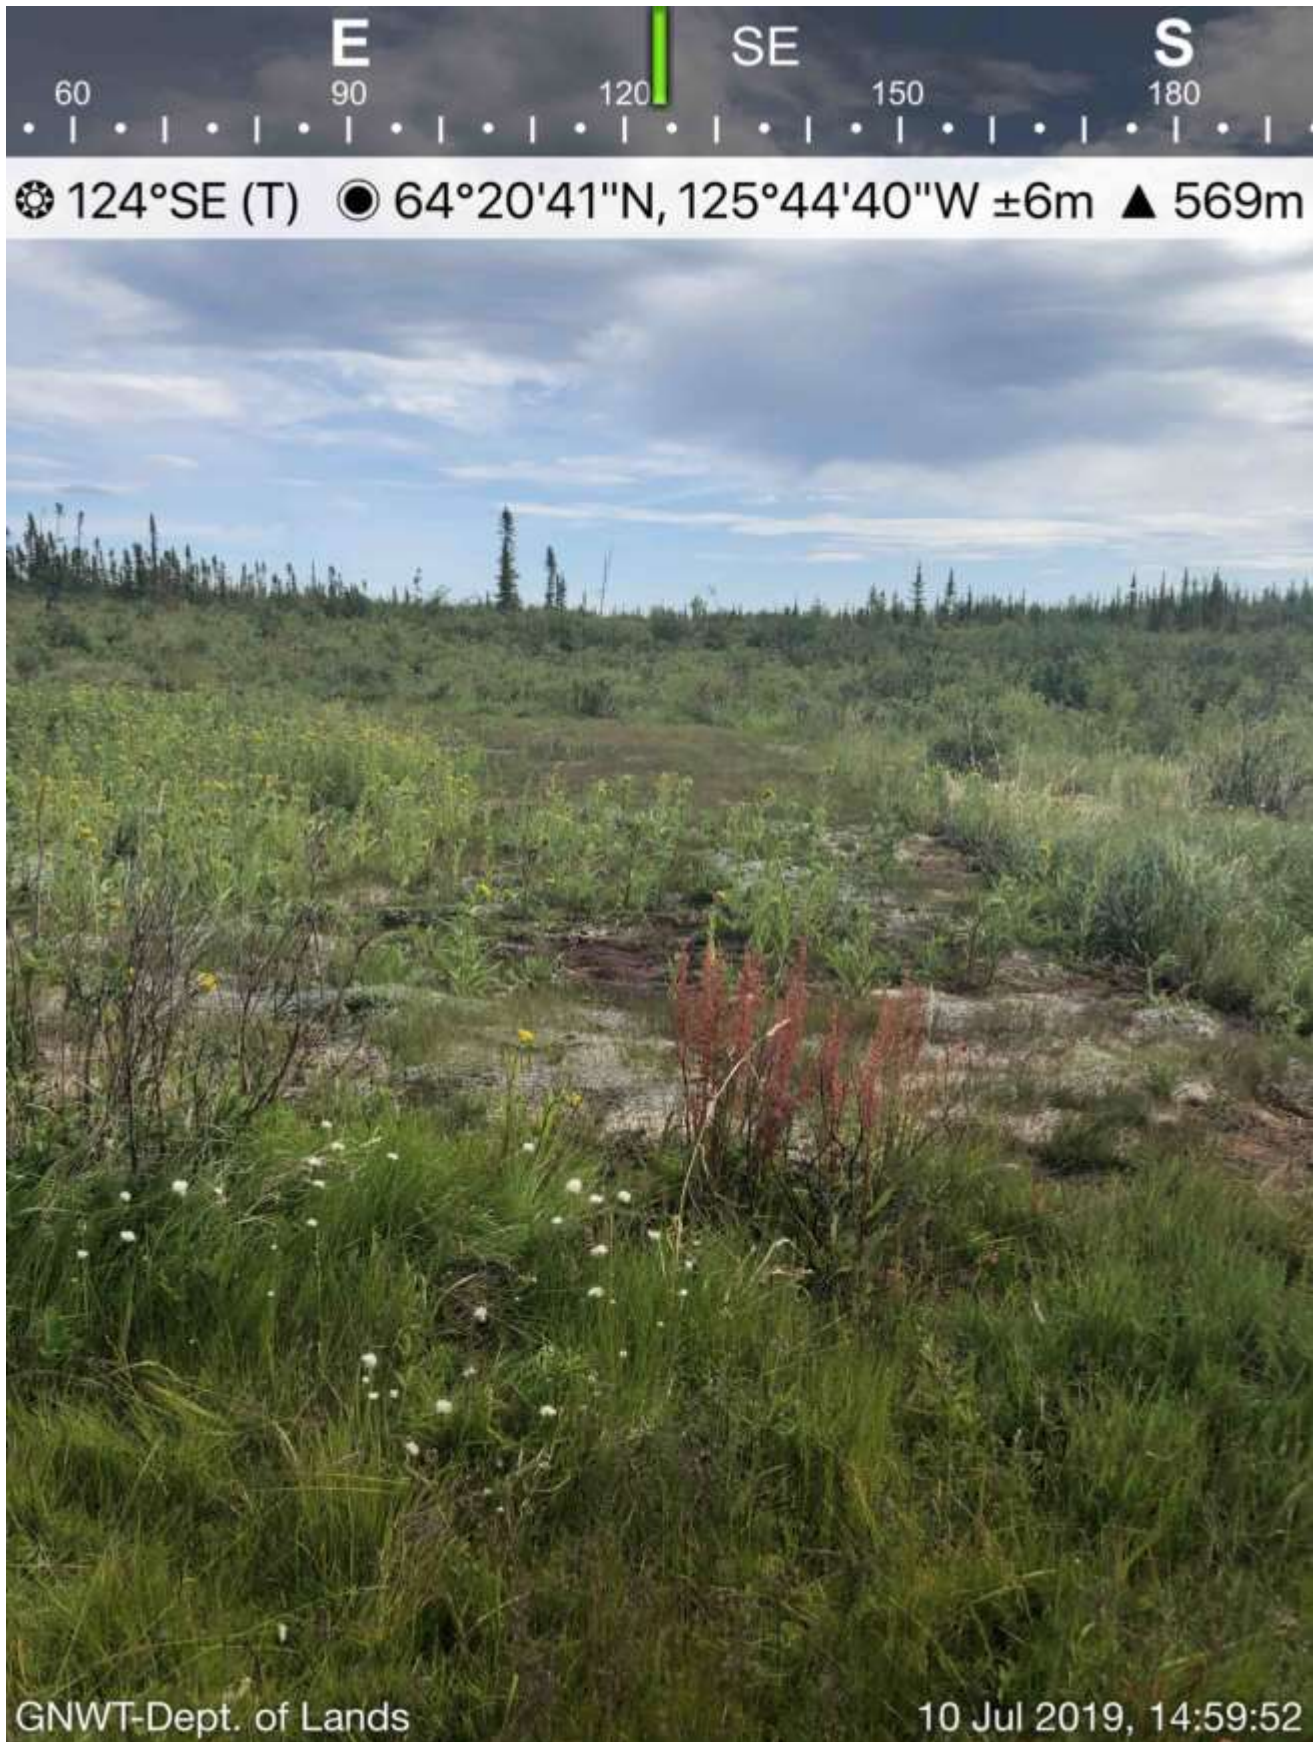
Figure 2

WNW corner of the phytoremediation spill area.

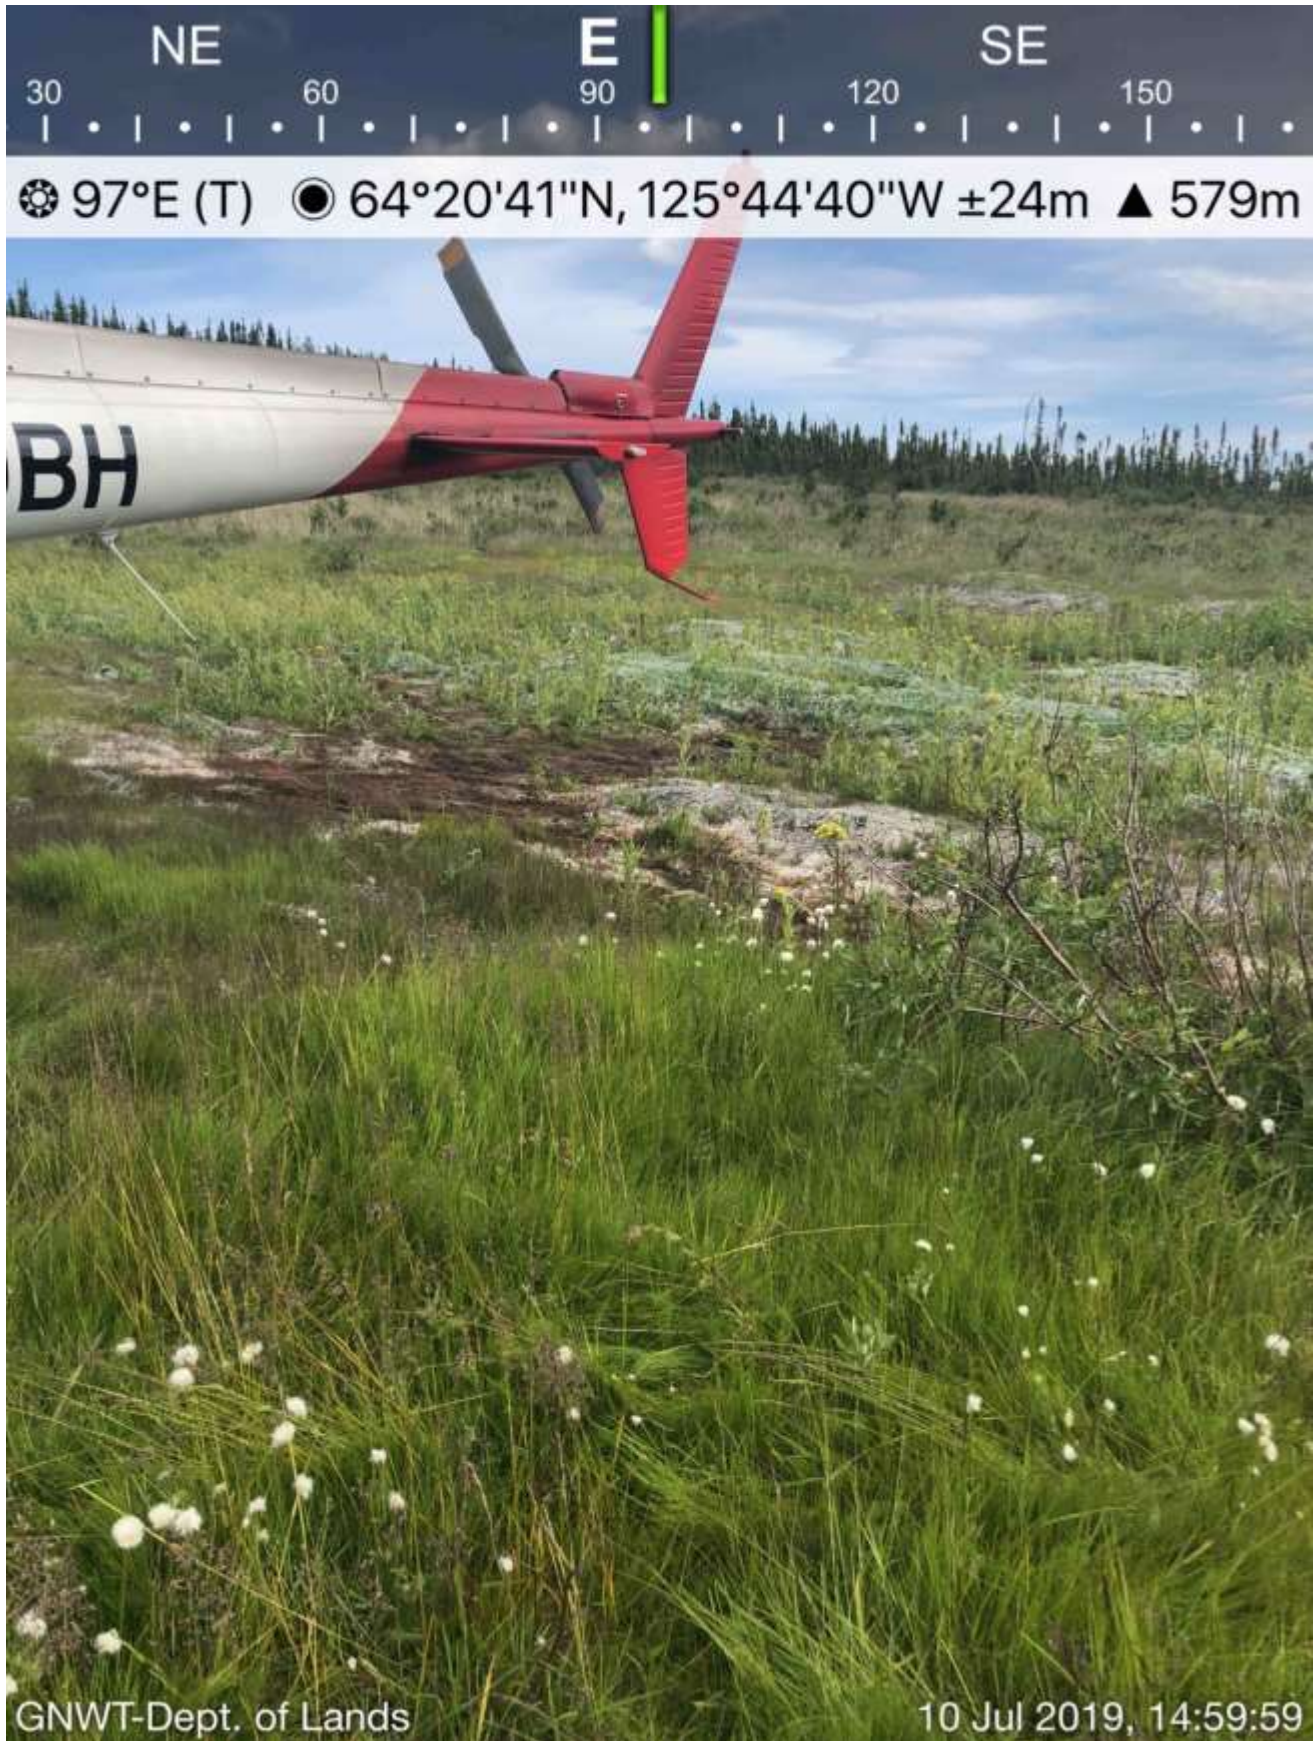
Figure 3
Westside of the Phytoremediated spill area.
