File Number	S04A-006
Type of Operation	OIL AND GAS DRILLING - WELLSITE
Location	Wellsite L-71

ENVIRONMENTAL INSPECTION REPORT

Permittee:	Husky Oil Operations Limited	Permit Expiry Date:	September 11, 2009
Land Use Permit No.	S04A-006	Previous Inspection:	August 06, 2013
Quarrying Permit No.	NA	Inspection Date:	July 05, 2016
Contractor:	NA	Subcontractor:	NA
Location(s) Inspected:	Wellsite L-71		
Current Stage of Operation:	Remediation		
Program Modifications Approved:	None

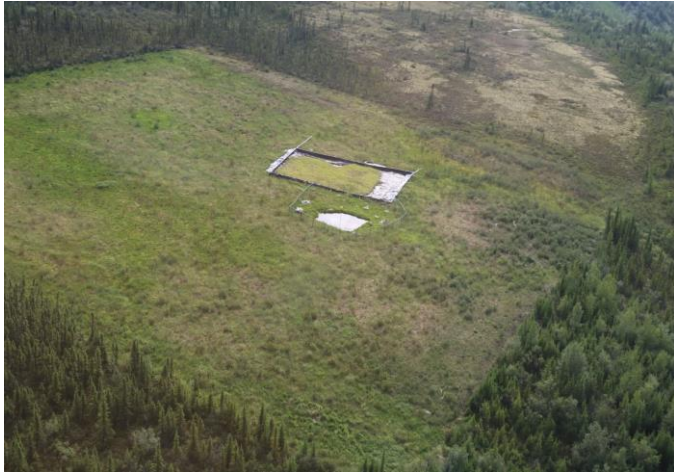
Figure 1
Aerial photo of wellsite showing berm and well center.

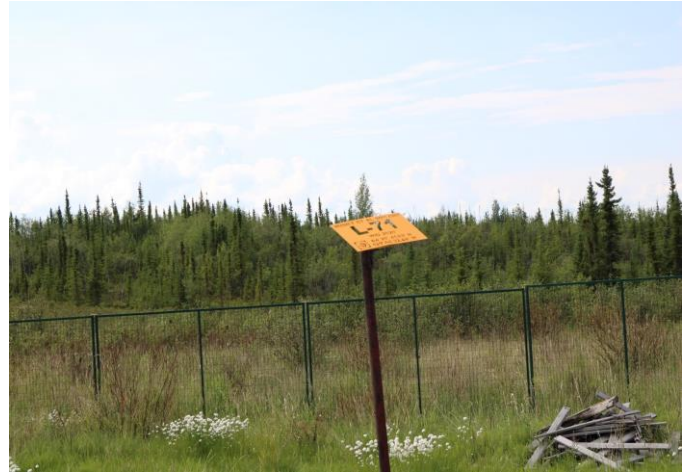
Figure 2
Photo showing wellsite signage.

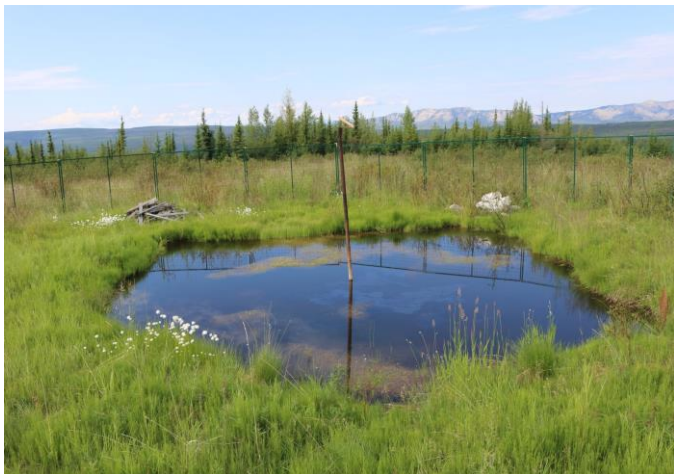
Figure 3
Photo showing water pooling at well center due to contaminated material being removed and placed in berm.

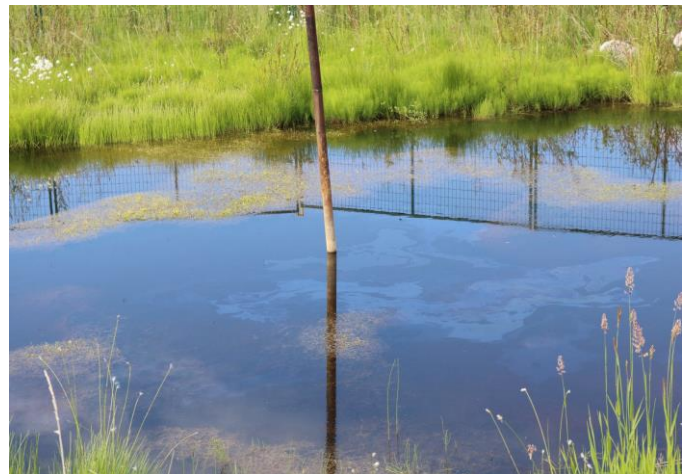
Figure 4
Well center has a lot of water pooling due to material removal, sheen was visible at well center.

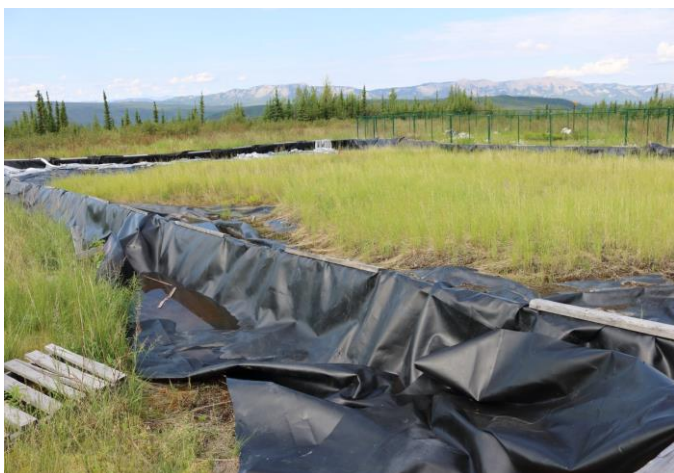
Wellsite L-71 is still undergoing Phytoremediation. A large berm is holding the contaminated soil, the soil will remain in the berm until test results are within standards. Once standards are met all material must be removed (fencing, pallets, berm, etc.) This site will be monitored until Phytoremediation is successful. Husky must present testing results to the Department of Lands once available. There is a small sheen present at well center which will require investigating, and "rain drain" filters will need to be reinstalled. Besides the items needing removal on closure, there are no other concerns to report. No other sign of contamination (spills etc) or erosion.

Figure 5
Photo of berm where contaminated soil is stored and being remediated. This berm will be removed on file closure.

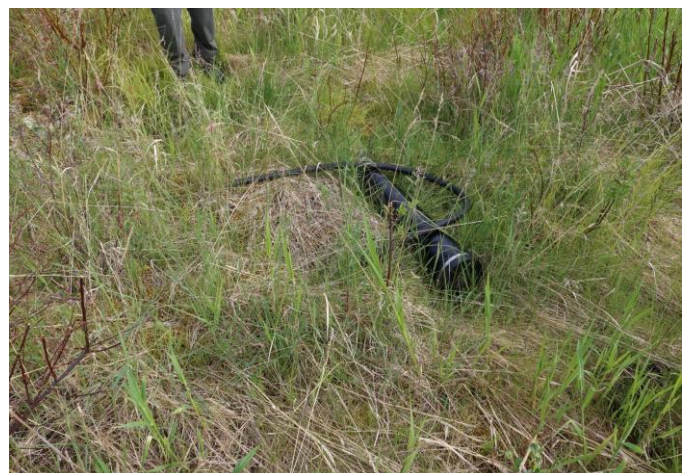
Figure 6
Photo showing the "Rain Drain" no longer connected properly.
