An inspection of The Charter Community of Délı̨nę's Water Licence #S12L3-006 was conducted on September 20<sup>th</sup>, 2017. Specifically, the Water Licence was inspected to ensure that the terms and conditions of the licence were met. Enclosed is a copy of the Inspection Report for your review and records.

## WATER LICENCE INSPECTION REPORT

<b>LICENCE #:</b>	<b>S12L3-006</b>	<b>EXPIRY DATE:</b>	<b>December 04, 2017</b>
<b>LICENCEE:</b>	<b>Charter Community of Délı̨nę</b>	<b>PREVIOUS INSPECTION:</b>	<b>July 27, 2015</b>
<b>COMPANY REP:</b>	<b>David Little</b>	<b>INSPECTION DATE:</b>	<b>September 20, 2017</b>

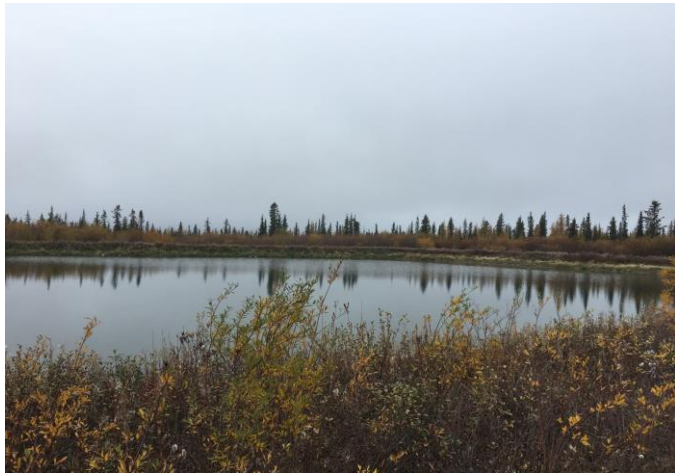
The old sewage lagoon was inspected and is no longer being used by the community (Figure #1). The old lagoon is in the process of being decommissioned, but remains in good condition with no slumping or erosion of the lagoon containment walls (Figure #1). There are two Surveillance Network Program (SNP) sampling locations at the old sewage lagoon that will need to be moved to the new sewage lagoon to reflect the requirement for SNP station #0555-2. The new SNP location should be located at the discharge point of the secondary sewage lagoon, as required by the water licence #S12L3-006, under the Surveillance Network Program, Station Number #0555-2. The exact location will be determined during a follow-up inspection (October 2017) by the GNWT Water Resource Officer in collaboration with Deline Got'ine Government. There are no concerns with the new sewage lagoon as it is structurally sound and well maintained (Figure #2).

**Figure 1 – Old Sewage Lagoon**

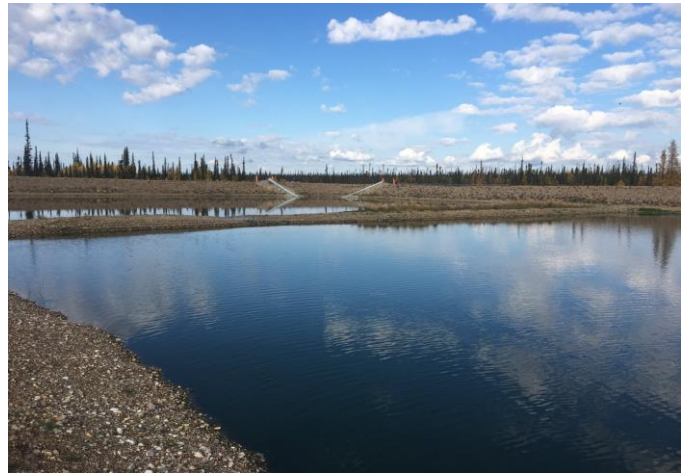
**Figure 2 – New Sewage Lagoon**

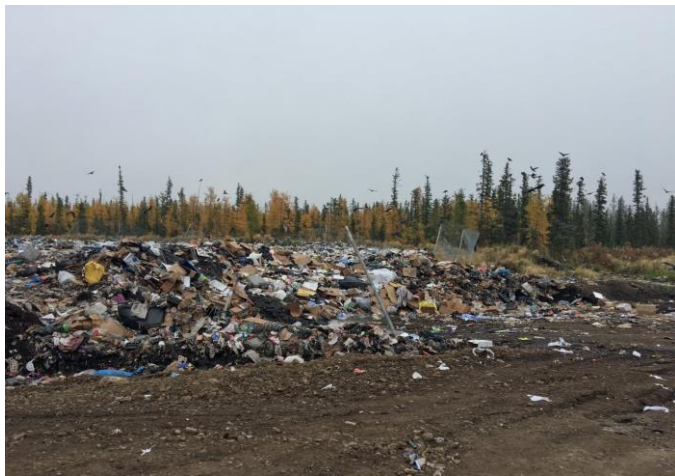
The current landfill being used is well passed capacity and it's anticipated that the community will start to use their new landfill in spring/summer 2018. The new and old landfill should have designated locations to allow for the proper segregation of wastes (wood, household, metal, hazardous wastes, etc.). Hazardous wastes should also be stored in secondary containment and prepped on a regular basis to be shipped to a proper disposal facility (Figure #5). Furthermore, waste oil should be separated and stored in proper containers and staged to be disposed of properly. Household wastes should be buried and covered on a regular basis to reduce the amount of windblown waste leaving the site. The old landfill has a large amount of windswept waste at the household waste site and should be collected at least twice per year (Figure #4).

**Figure 3 – Old Landfill Household Debris**

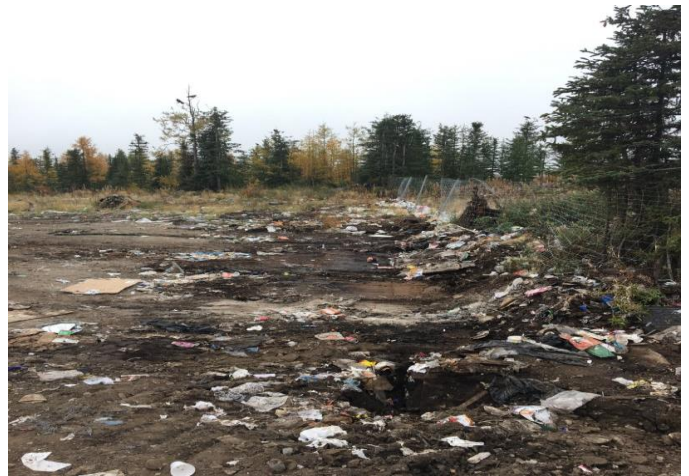
**Figure 4 – Windswept Debris at Old Landfill**

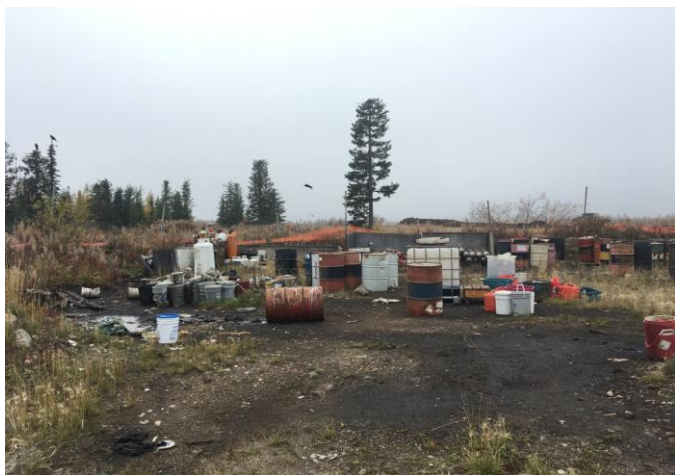
**Figure 5 – Old Landfill Hazardous Wastes**

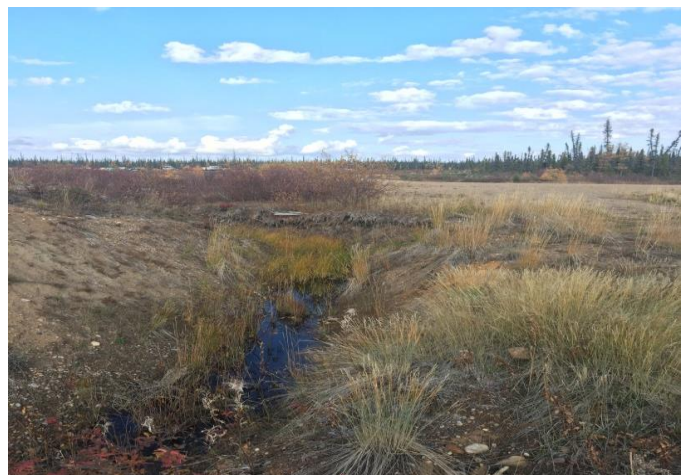
**Figure 6 – Proposed location SNP 0555-4**

Samples Collected Licencee	
Samples Collected ENR	<p>Department of Environment and Natural Resources (Water Resource Officer) will be returning to conduct SNP sampling training with the community's Water Treatment Operator (Clarence Tutcho) in October 2017. New/revised SNP locations (with GPS coordinates) will be determined at this time. The following amendments are recommended to the Surveillance Network Program:</p> <p>0555-2: A new SNP location will be established at the new sewage lagoon to reflect requirement of the Licence;</p> <p>0555-3: SNP location will be moved as the current location is difficult to access;</p> <p>0555-4: A new SNP location will be established at the new landfill to capture surface runoff from the site.</p>

Signage will be required to identify new SNP locations at the new landfill (SNP #0555-4) and new sewage lagoon (SNP #0555-2).

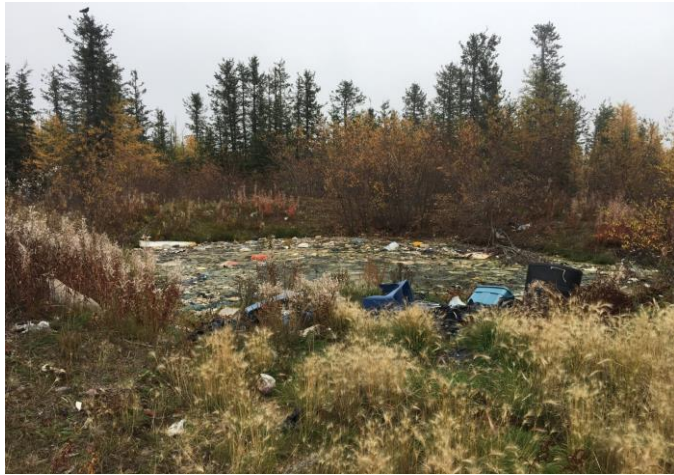
Figure 7 – Old Landfill Pooling Water
