<b>File Number</b>	<b>S14L-005</b>
<b>Type of Operation</b>	<b>MISC.</b>
<b>Location</b>	Tower Site

## ENVIRONMENTAL INSPECTION REPORT

<b>Permittee:</b>	NorthwesTel Inc.	<b>Permit Expiry Date:</b>	August 01, 2019
<b>Land Use Permit No.</b>	S14L-005	<b>Previous Inspection:</b>	June 07, 2017
<b>Quarrying Permit No.</b>	N/A	<b>Inspection Date:</b>	July 09, 2019
<b>Contractor:</b>	N/A	<b>Subcontractor:</b>	N/A
<b>Location(s) Inspected:</b>	Tower Site		
<b>Current Stage of Operation:</b>	Project build completed		
<b>Program Modifications Approved:</b>	None

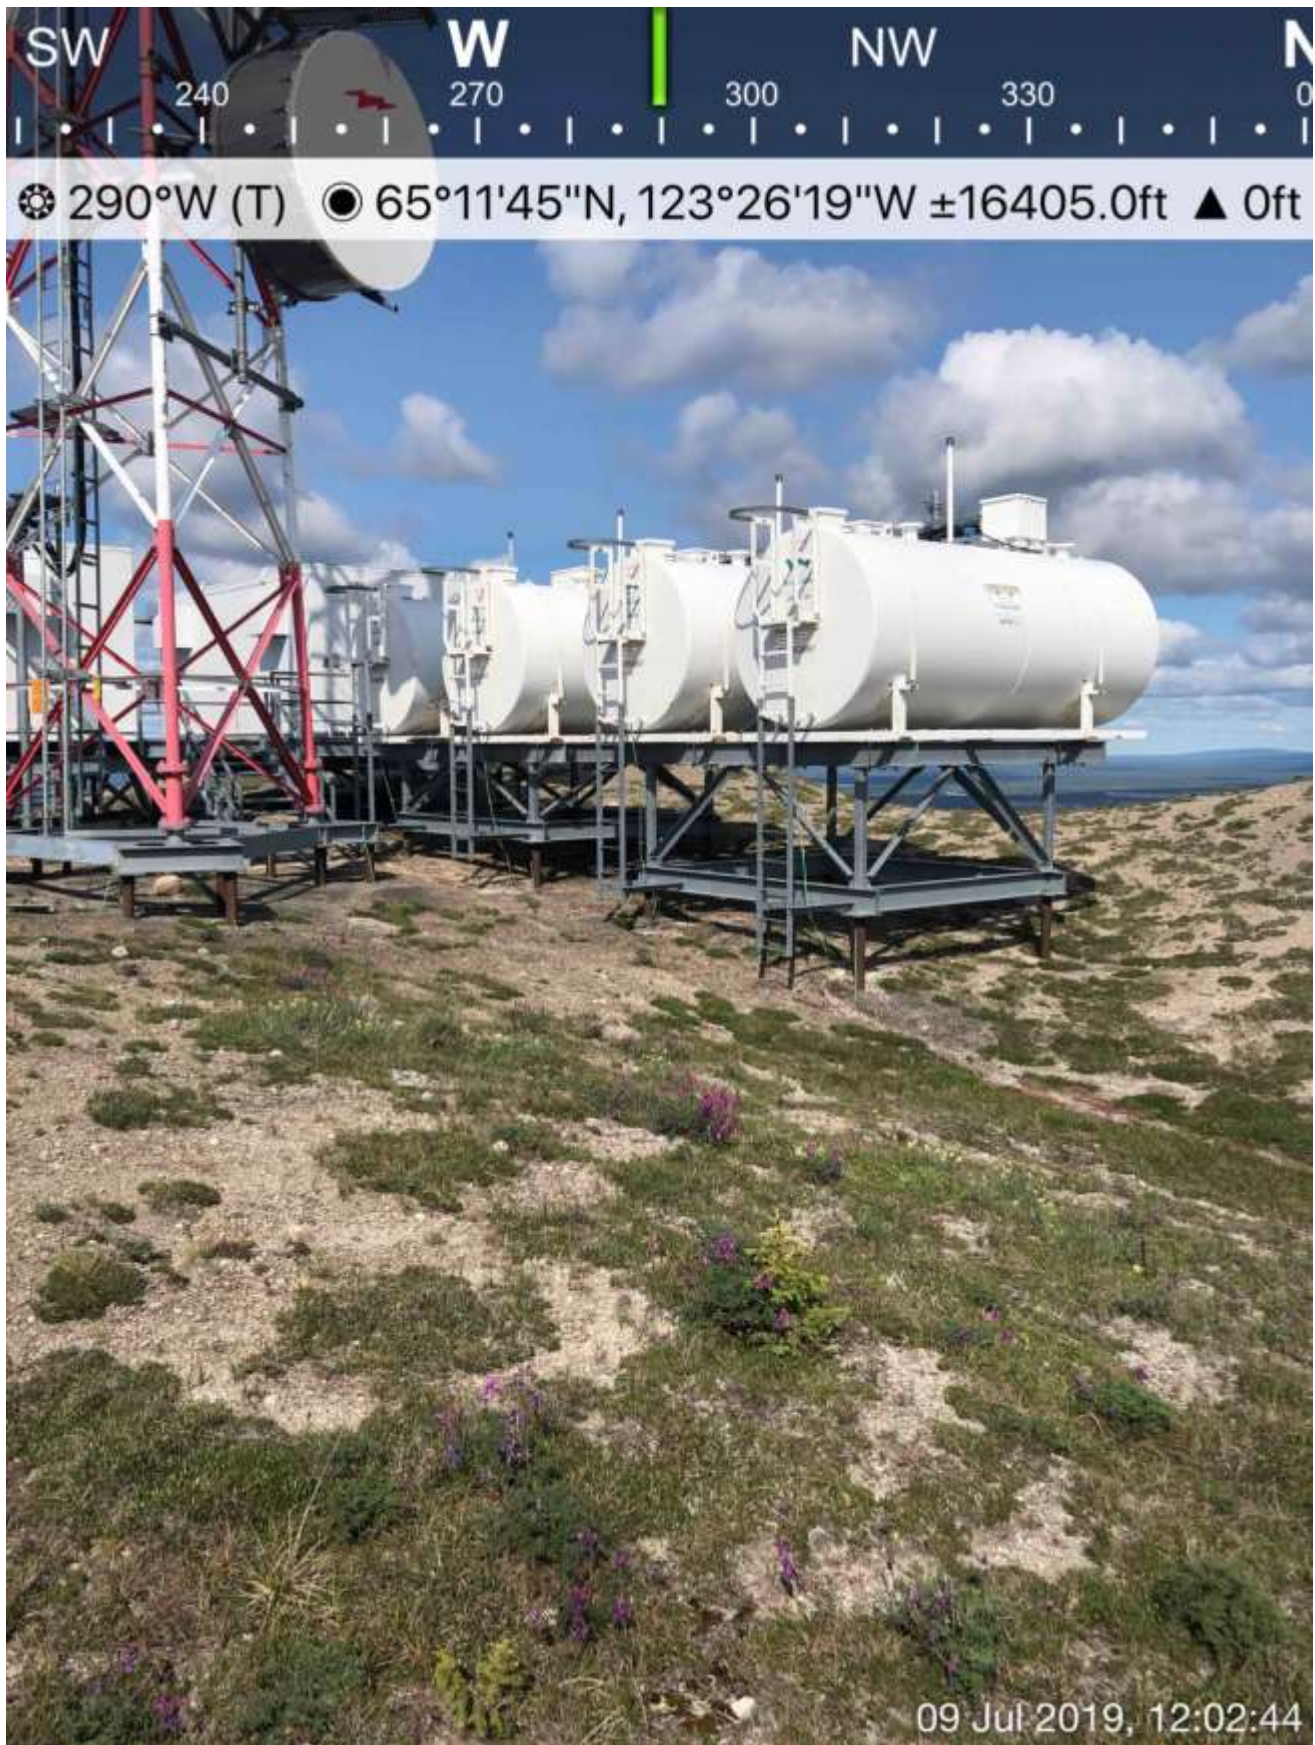
**Figure 1**

The tower site is very tidy, there is no debris or signs of any contamination or spills on site. Four double walled fuel tanks remain on site. There are no signs of damage on these tanks. All structures on this site are well maintained and show no concerns at this time. Helipad on site is well maintained. This site shows no signs of any concerns.

**Fuel Tanks and tower**

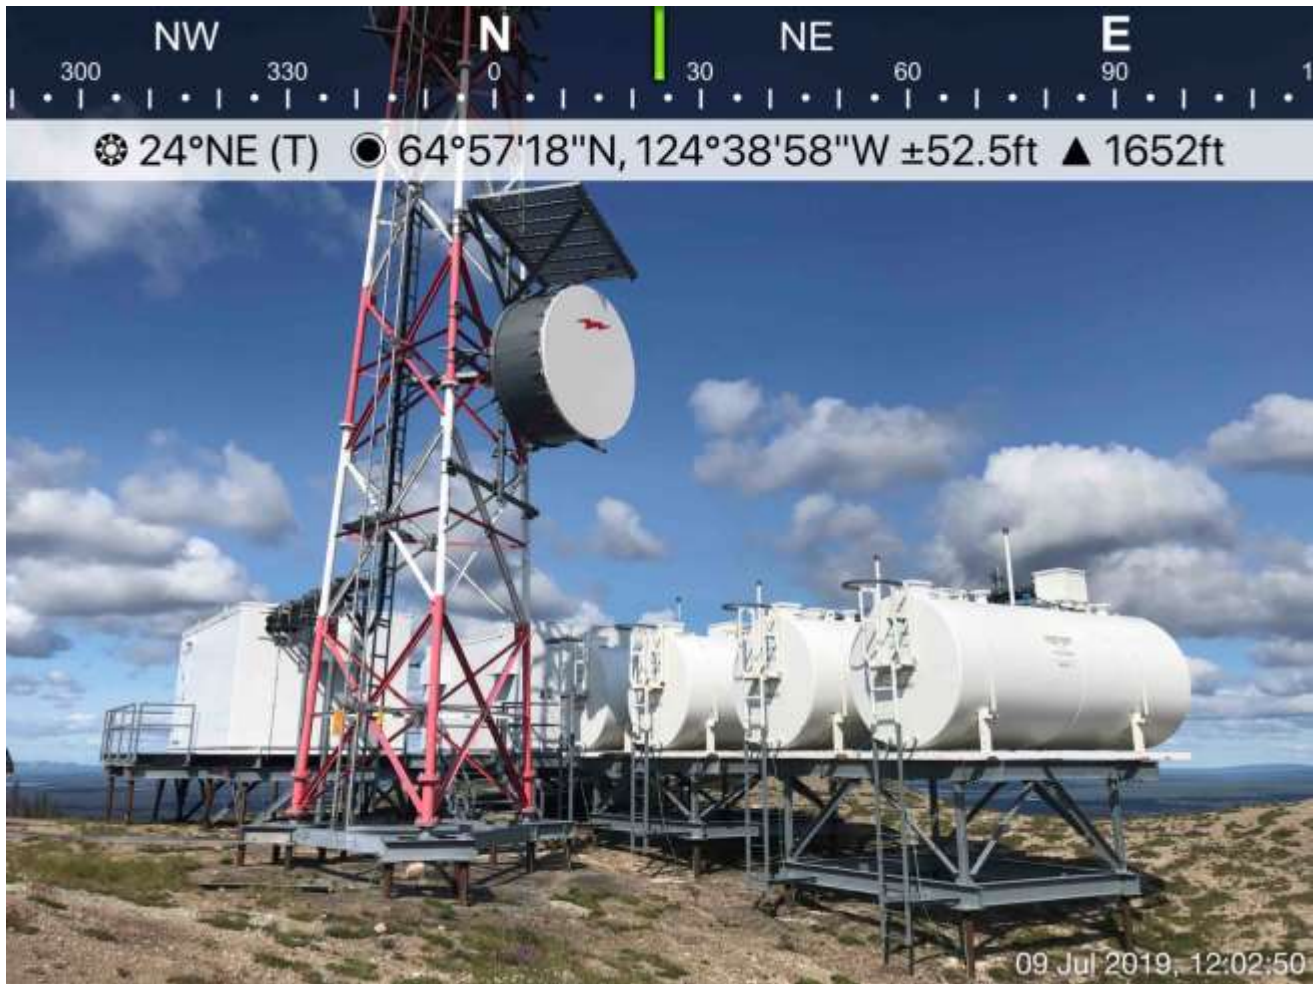
Figure 2

Fuel tanks, tower, facilities

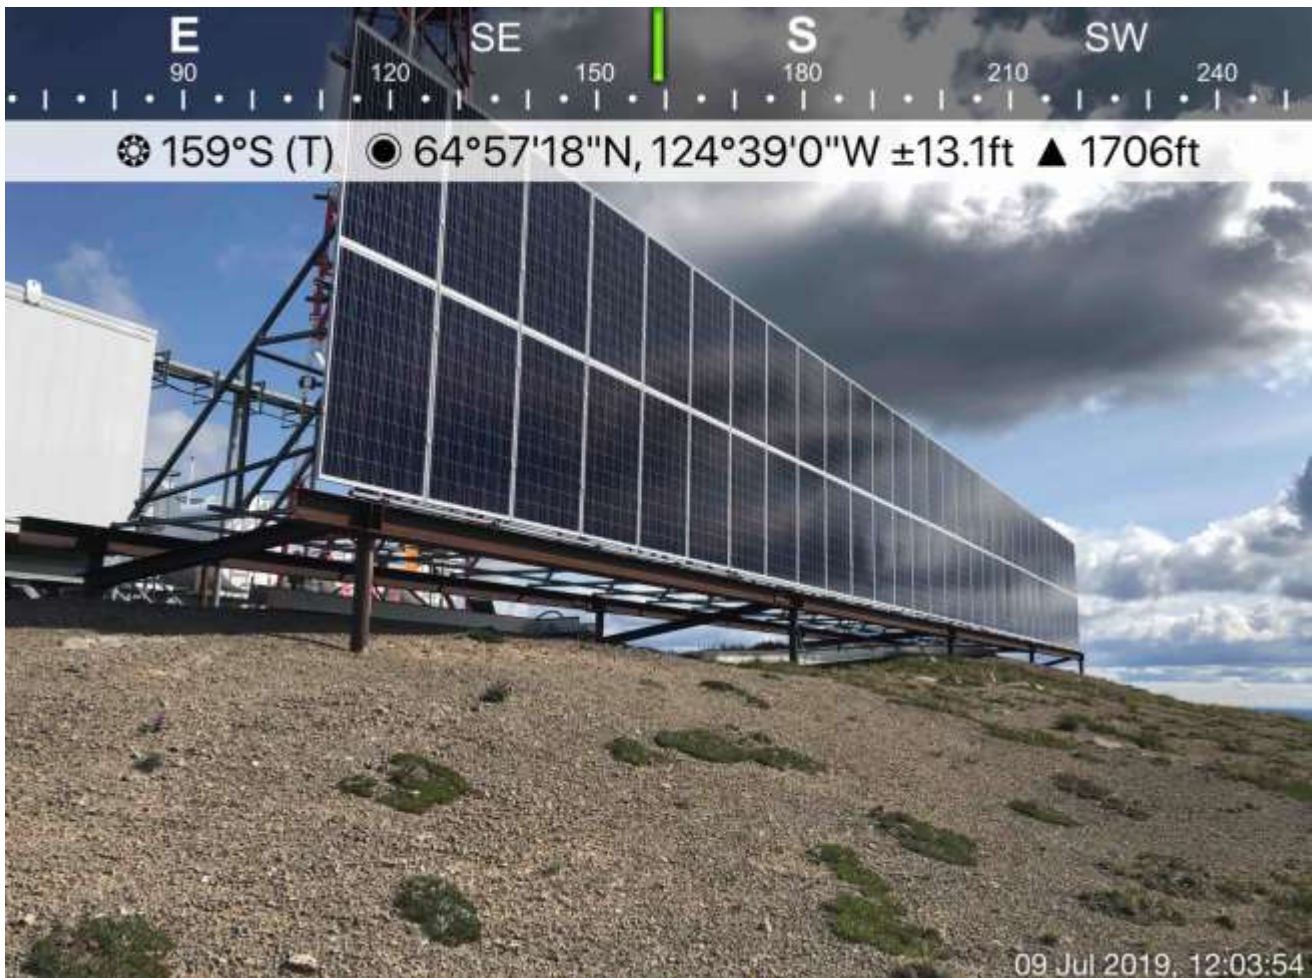
Figure 3

Larger solar panels
