File Number	S20E-005
Type of Operation	ROADS, all season (during const)
Location	Edie Lake Quarry

ENVIRONMENTAL INSPECTION REPORT

Permittee:	GNWT-INF	Permit Expiry Date:	November 18, 2025
Land Use Permit No.	S20E-005	Previous Inspection:	February 08, 2023
Quarrying Permit No.	2020QP0001	Inspection Date:	February 13, 2023
Contractor:	HRN	Subcontractor:	N/A
Location(s) Inspected:	Edie Lake Quarry		
Current Stage of Operation:	Construction		
Program Modifications Approved:	None

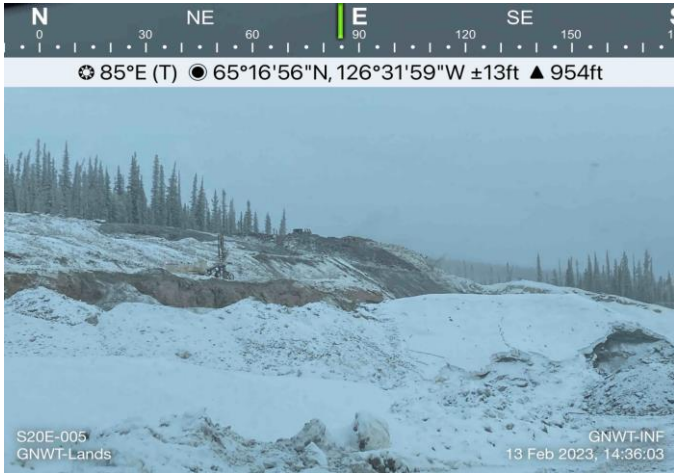
Figure 1

Quarry conditions post-blasting were observed while on site as well as the the continued

efforts to remove overburden material (Figure 1-2). All equipment on site during the inspection conformed to Table 6-5 “Construction Equipment List” outlined on page 31 of the *Prohibition Creek Access Road Construction Project Project Description Report* (Figure 3-5).

Quarry conditions as of February 13, 2023

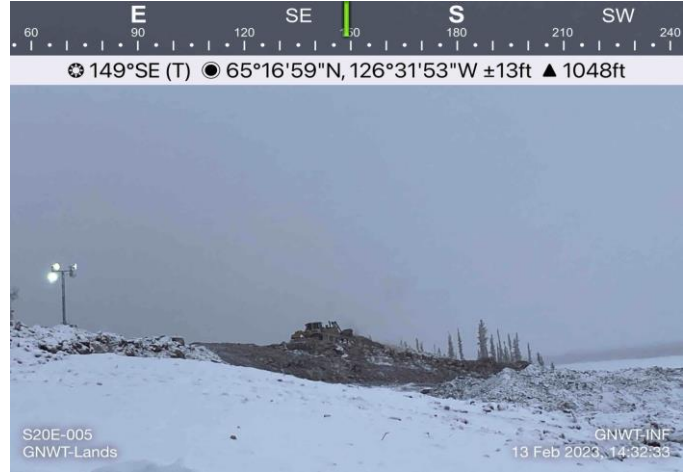
Figure 2

Bulldozer removing overburden soil material

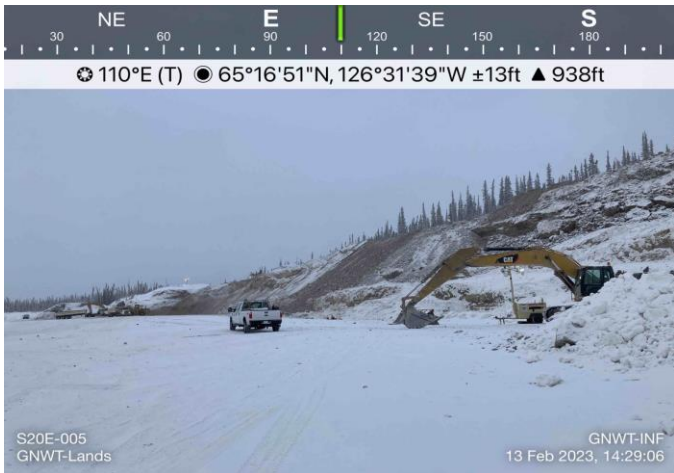
Figure 3

A portion of the fleet observed on site

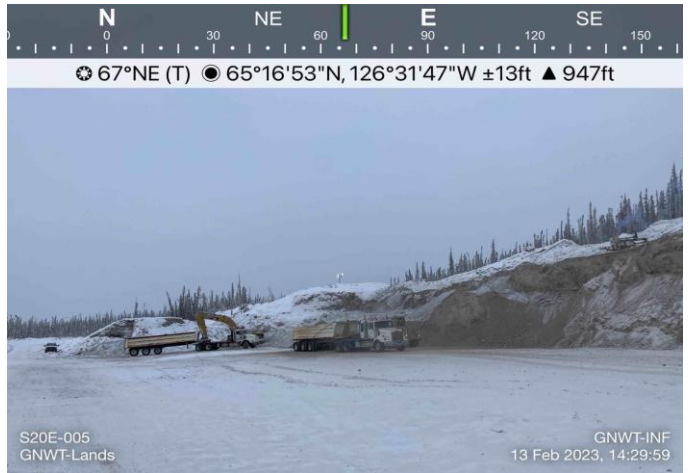
Figure 4

Additional approved fleet within the quarry

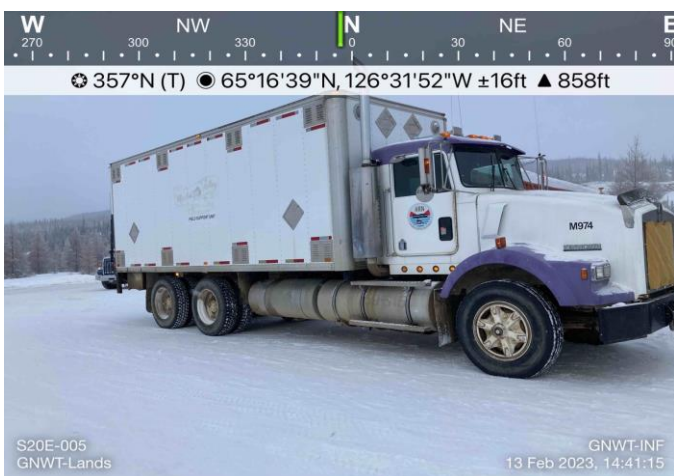
Figure 5

Tandem axle truck used for operational support

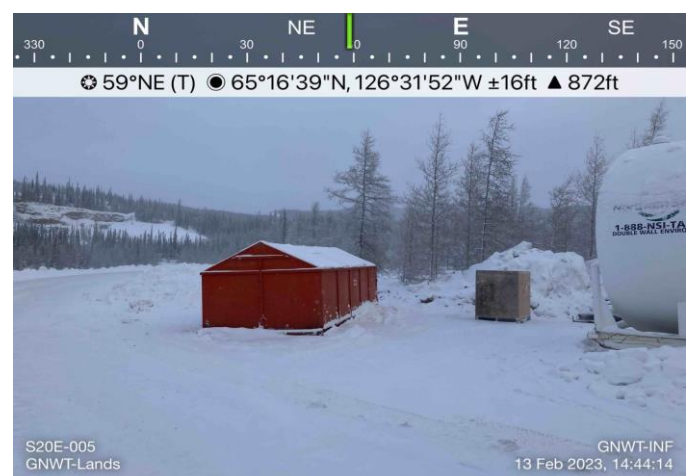
Figure 6

The inspection confirmed that the land use area continues to be kept clean at all times, as is evident from all images included in this report. Waste disposal is occurring in accordance with the *Prohibition Creek Access Road Construction Project Waste Management Plan* and all garbage and waste on site is being stored in secure containers. Hazardous and non-hazardous waste is being stored separately (Figure 6-7).

Non-hazardous waste disposal bin

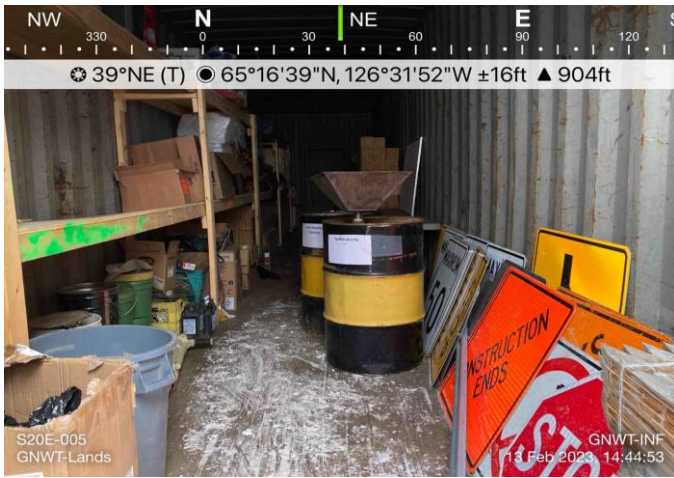
Figure 7

Secure storage of hazardous waste

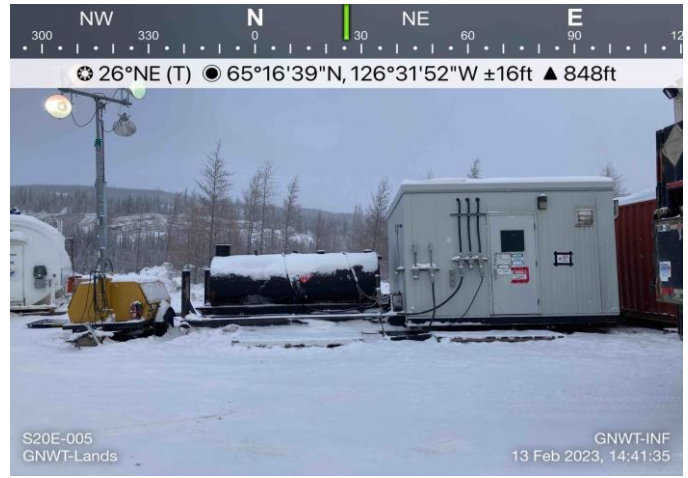
Figure 8

Fuel storage as well as the refueling station have secondary containment (Figures 8-9) and desktop analysis confirmed no operational activities or support facilities are within 100 metres of the Ordinary High Water Mark of any watercourses. Vehicles involved with operations are equipped with spill response kits and equipment stationary for over two hours have drip trays placed under them to capture any potential leaks. Since the time of the last inspection an additional spill response drum was added to the refuelling station and both drums are easily accessible in the even of an emergency, as illustrated in Figure 9.

Generator fuel supply

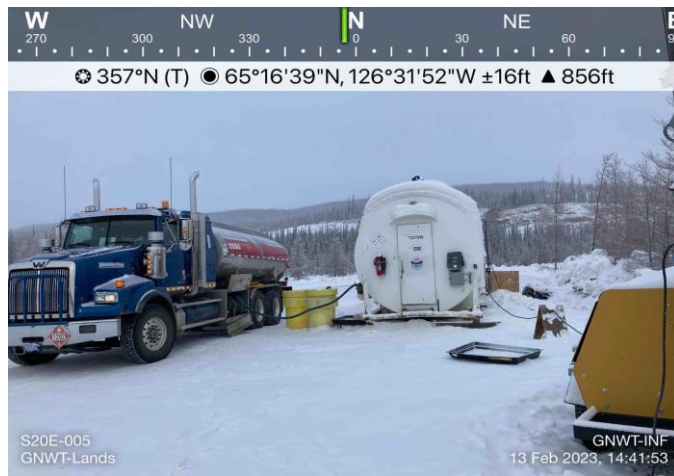
Figure 9

Vehicle refuel station

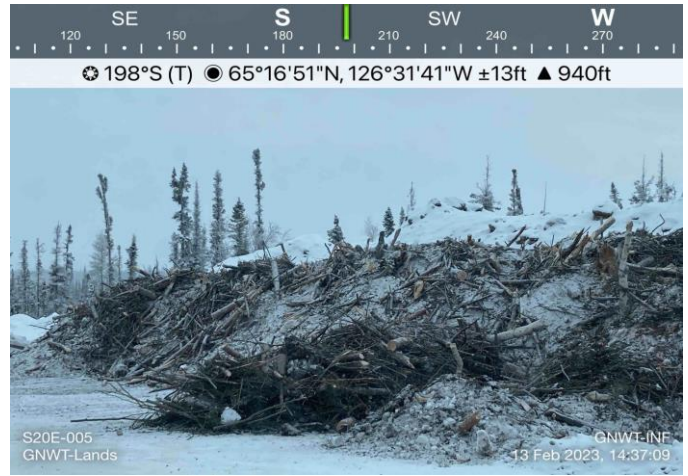
Figure 10

Brush and trees that do not meet the criteria for salvage timber are being stored on site within an area designated for stockpiling (Figure 10).

Brush pile on site

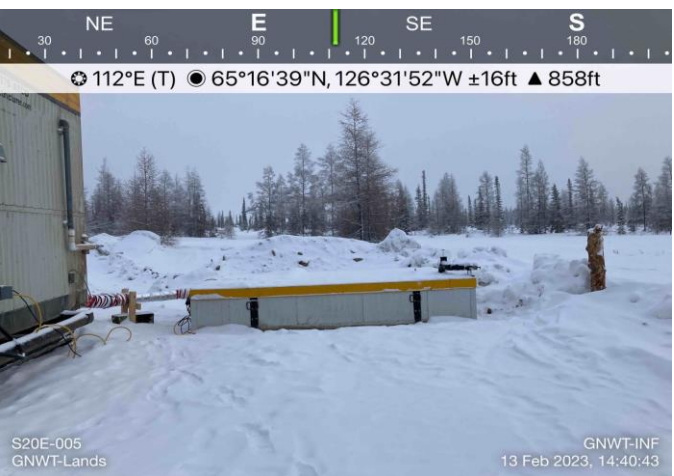
Figure 11

Sewage and greywater are being stored and handled in accordance with *Prohibition Creek Access Road Construction Project Waste Management Plan* (Figure 11-12).

Greywater containment area

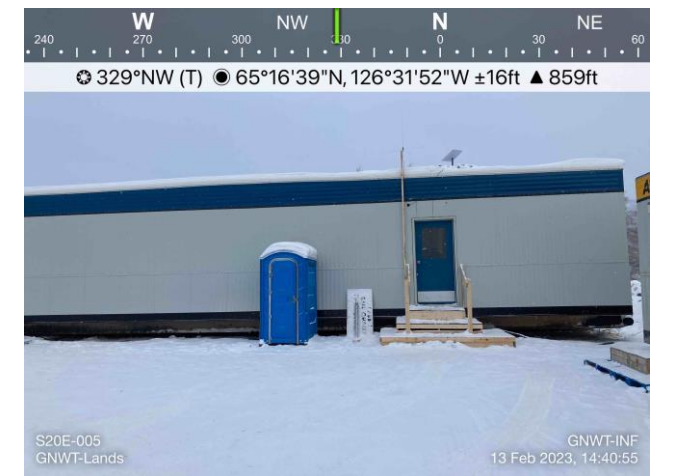
Figure 12

Portable washroom facility outside warming area/office trailer
