<b>File Number</b>	<b>S99A-015</b>
<b>Type of Operation</b>	<b>OIL AND GAS DRILLING - WELLSITE</b>
<b>Location</b>	Remote Sump for wellsite G-18

## ENVIRONMENTAL INSPECTION REPORT

<b>Permittee:</b>	EnCana Corporation	<b>Permit Expiry Date:</b>	December 15, 2004
<b>Land Use Permit No.</b>	S99A-015	<b>Previous Inspection:</b>	August 29, 2016
<b>Quarrying Permit No.</b>	N/A	<b>Inspection Date:</b>	July 09, 2019
<b>Contractor:</b>	N/A	<b>Subcontractor:</b>	N/A
<b>Location(s) Inspected:</b>	Remote Sump for wellsite G-18		
<b>Current Stage of Operation:</b>	Remediation		
<b>Program Modifications Approved:</b>	None

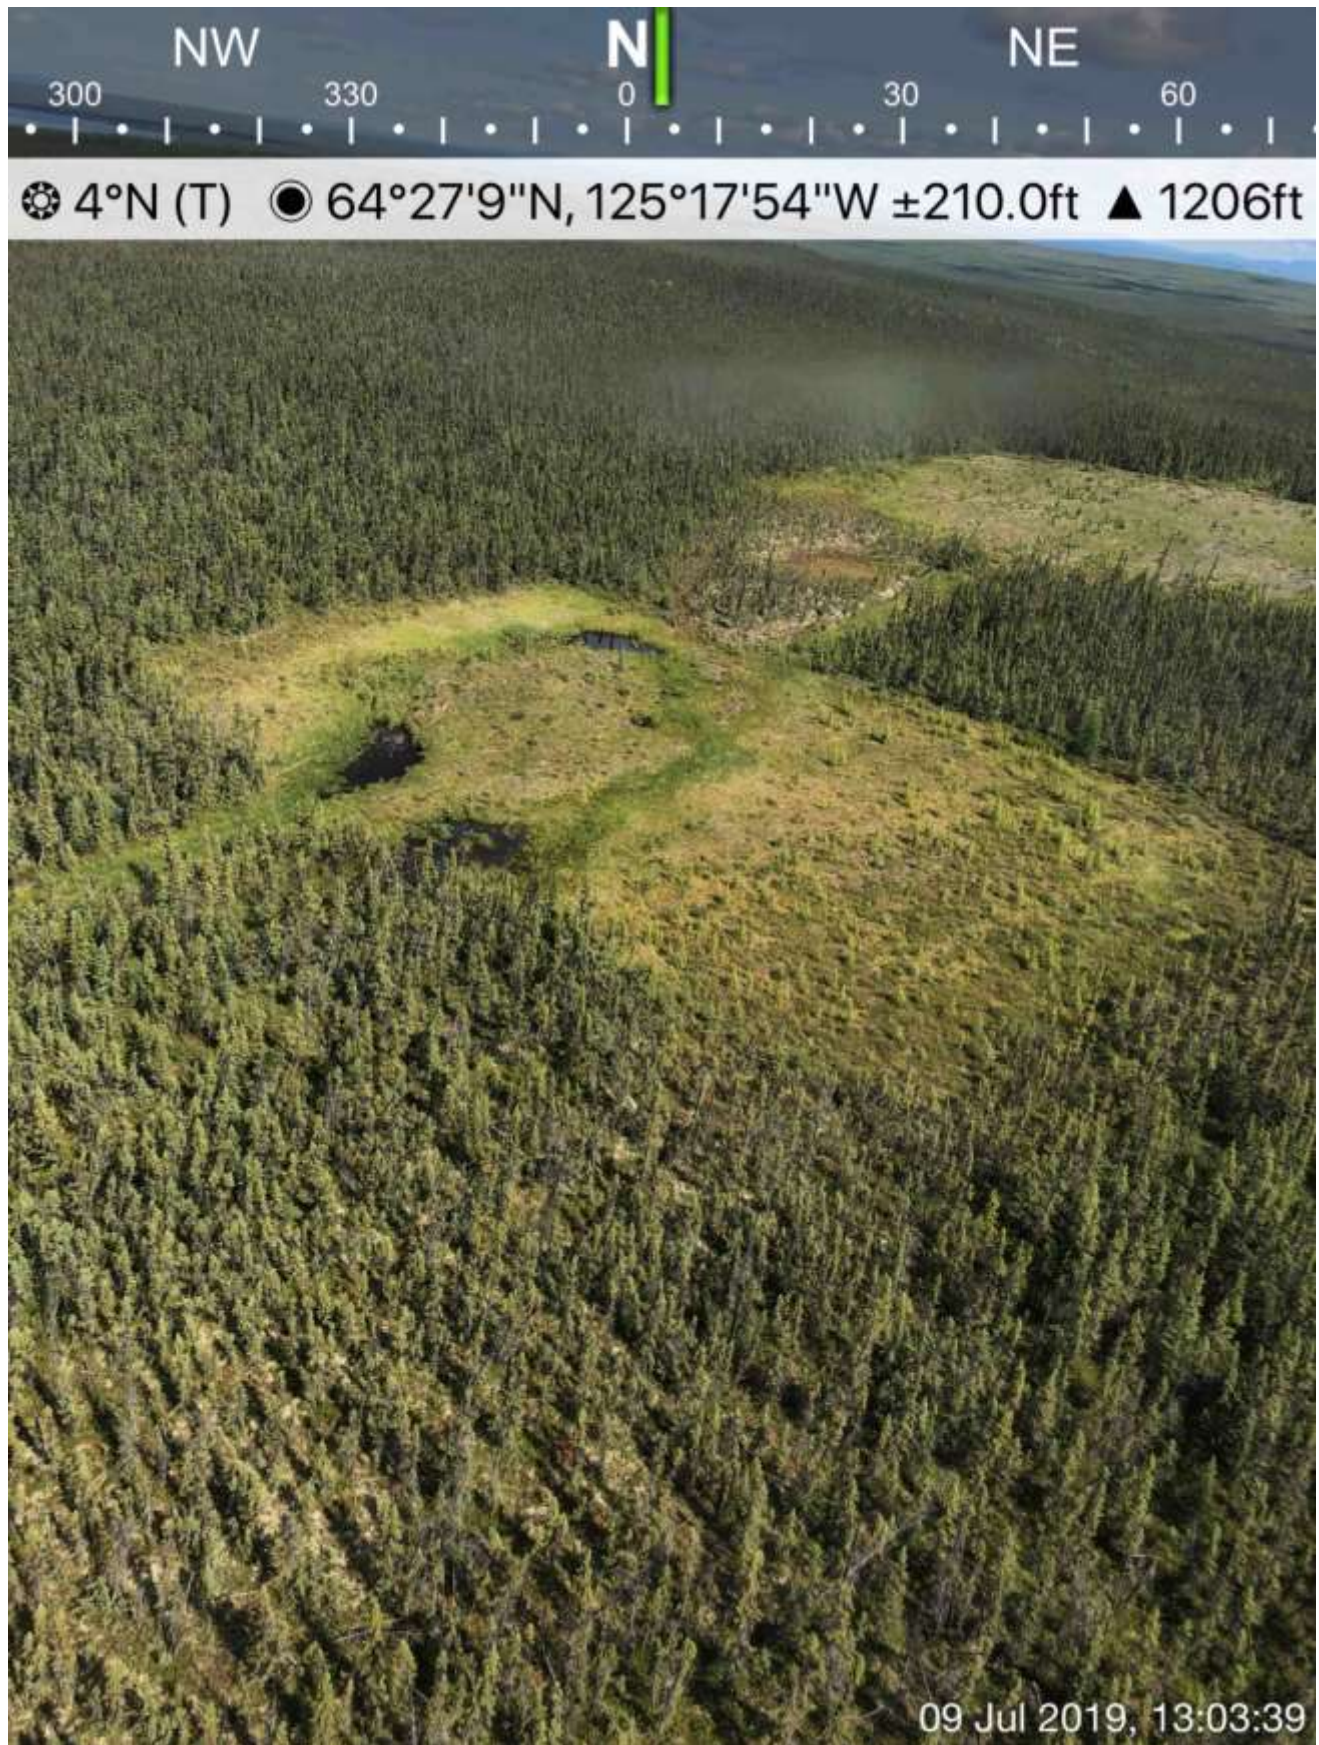
Figure 1

The sump onsite has a large area where ungulates have used for wallowing in the past and present. This sump has a history where drilling muds containing sodium chloride (NaCl) were deposited and encapsulated within. Over time these salts inside the sump have leached out in the surrounding area attracting the ungulates to wallow year after year. This interferes with **Condition 7.6** of the Land Use Permit.

The vegetation on this site has not had any significant change since the last report. Mostly long grasses, small shrubs, and young trees. All this vegetation is relatively sparse throughout the site. On top of the sump, there are portions of unvegetated areas. It is also noted there are two areas adjacent to the sump where water has pooled continuously.

Aerial view of the sump. One muddy wallowing pit with two areas of pooling water.

It is recommended that the Permittee submit an action plan to remediate these adverse effects caused by the sump. This was requested by the last Inspector (August 29<sup>th</sup>, 2016). A remediation plan should diminish rutting and allow for the affected areas to revegetate as per **Conditions 6.17** and **15.3** within the Land Use Permit.

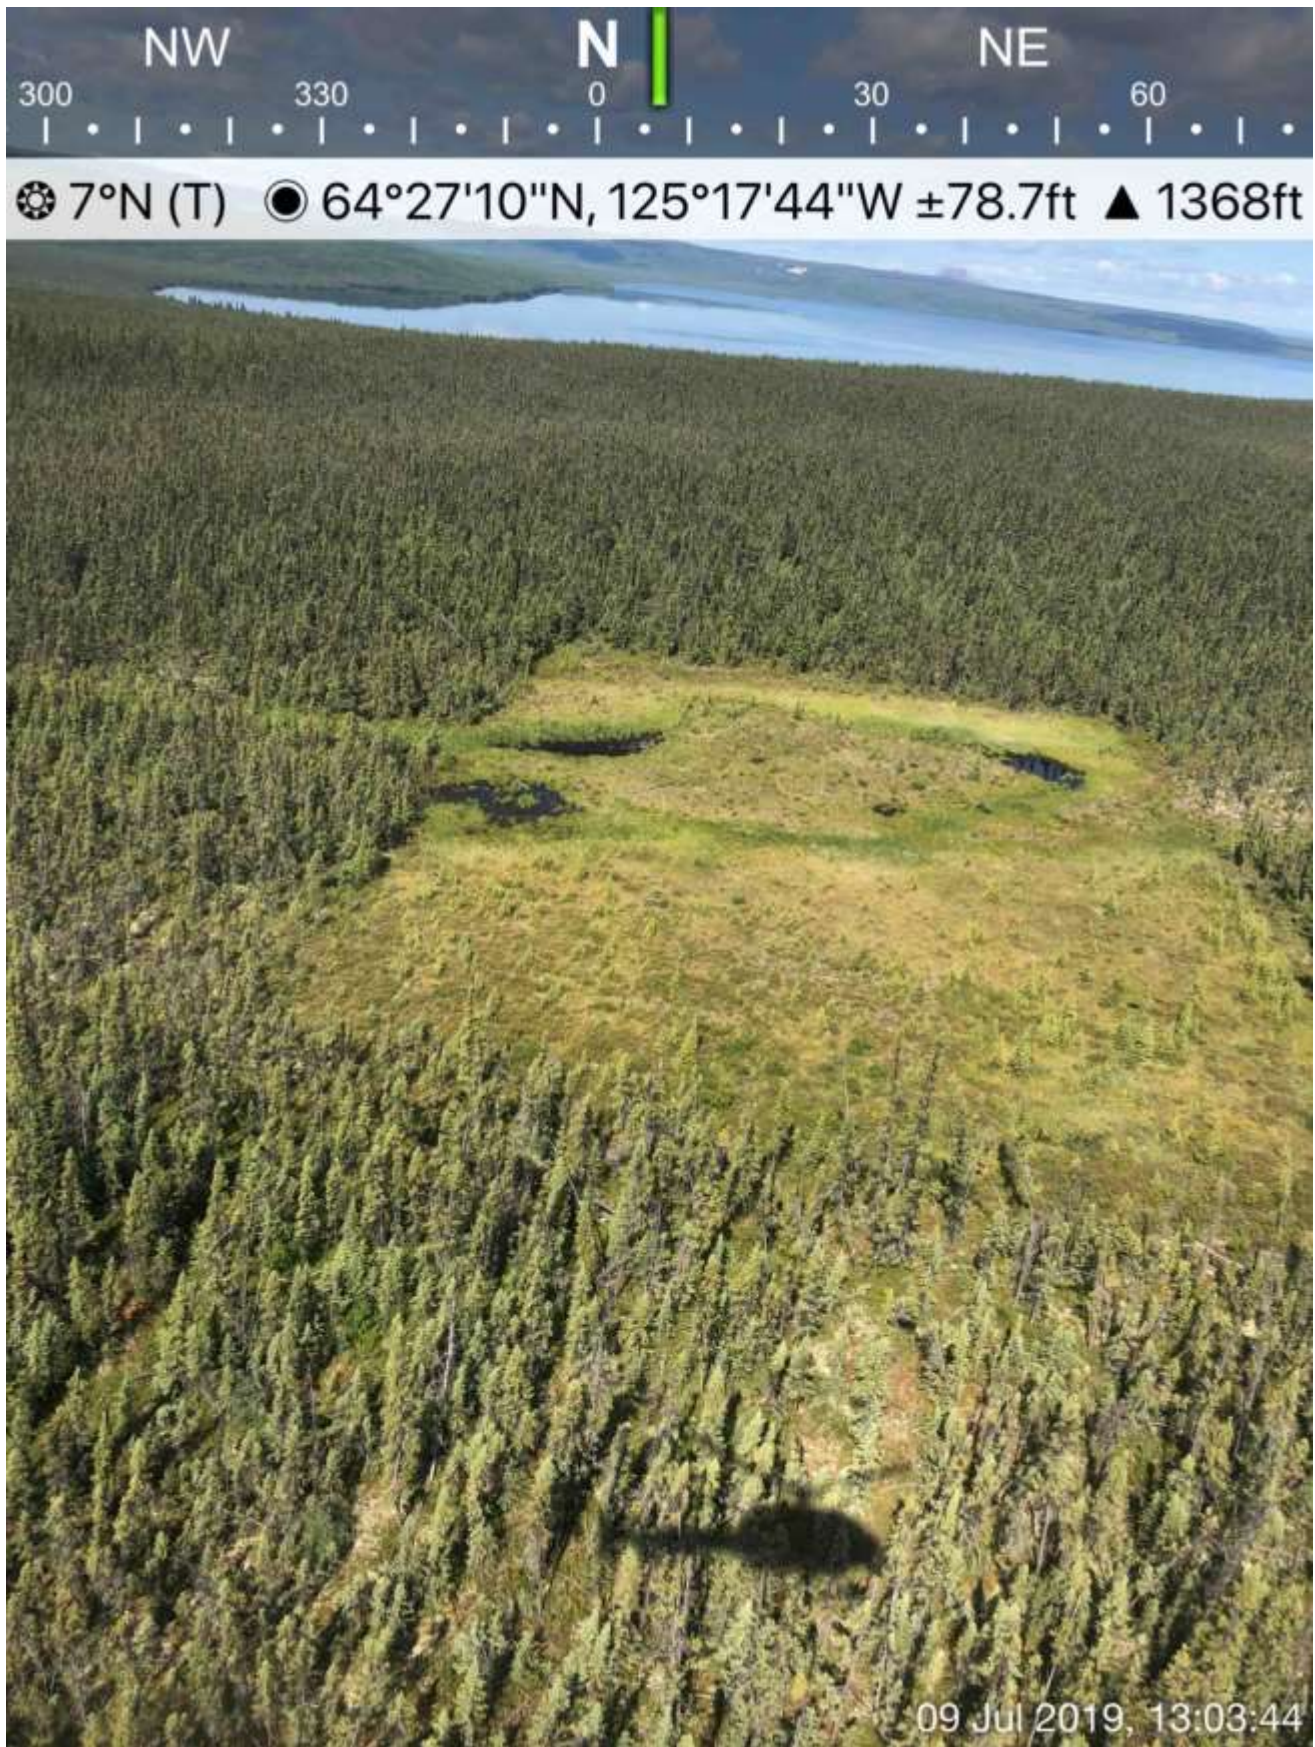
Figure 2

Another aerial view of the sump.
