**RE: Land Use Permit S99A-015
G-18 Remote Sump**

ENVIRONMENTAL INSPECTION REPORT

Permittee:	EnCana Corporation	Permit Expiry Date:	December 15, 2004
Land Use Permit No.	S99A-015	Previous Inspection:	July 06, 2006
Quarrying Permit No.		Inspection Date:	August 06, 2013
Contractor:		Subcontractor:	
Location(s) Inspected:	G-18 Remote Sump		
Current Stage of Operation:	Abandoned Wellsite		
Program Modifications Approved:	None

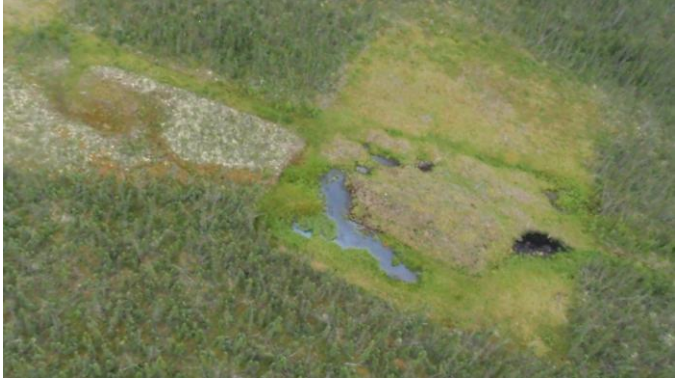
Figure 1

Aerial view of the remote sump looking south. Two areas of disturbance on the west and south sides of the sump. Some ponded water at the toe on the NE corner.

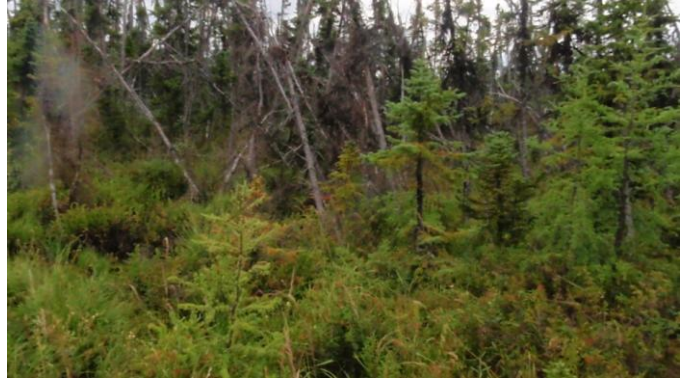
Figure 2

It appears that the sump may be failing as indicated by stressed and dying vegetation and wallowing by ungulates. As this remote sump contains sodium chloride it is not unreasonable to believe that this is the underlying factor of present conditions. According to our records, a total of 60 cubic meters of salt saturated mud was deposited in the sump.

At the west toe the vegetation exhibits signs of stress.

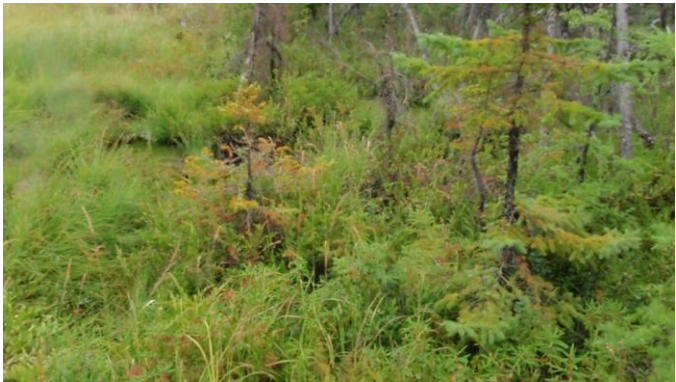
Figure 3

As with the previous photo, stressed and dying vegetation.

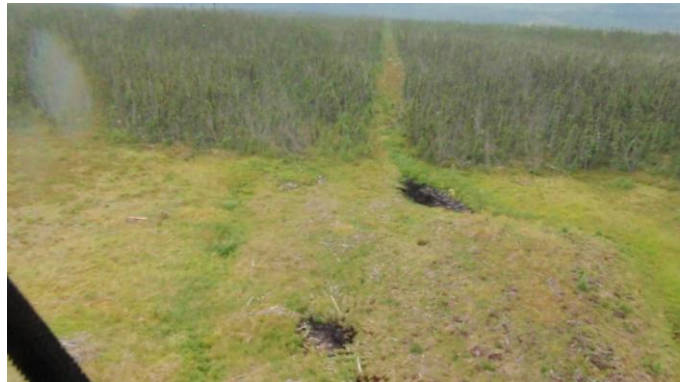
Figure 4

Depicting the two areas of disturbance (wallowing) by ungulates. You may note that the area is otherwise well vegetated.

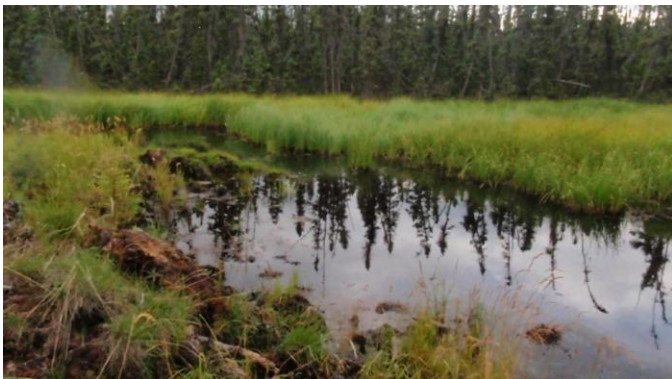
Figure 5

Ponded area on the NE toe of the sump. The sheen is natural. Well established vegetation in this area.

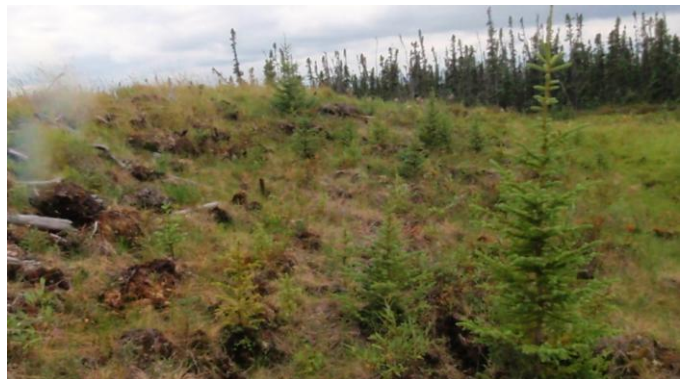
Figure 6

Also well established vegetation on the sump cap as exhibited by white spruce.

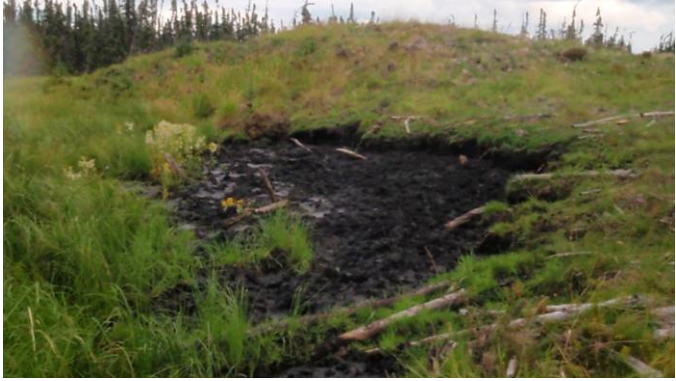
Figure 7

Looking east at affected area. It appears the wallowing area has an active face.

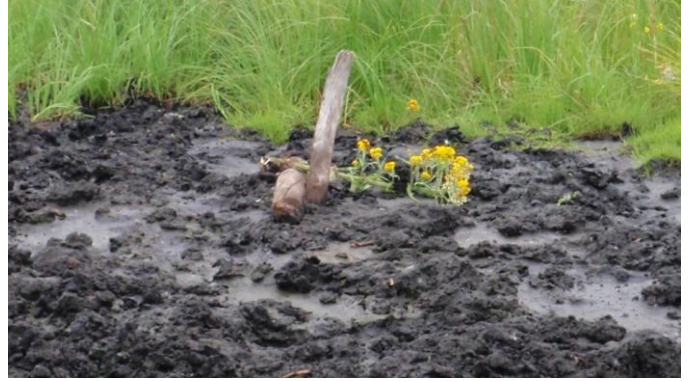
Figure 8

This area has been disturbed by wildlife but the vegetation in the immediate vicinity seems healthy otherwise.

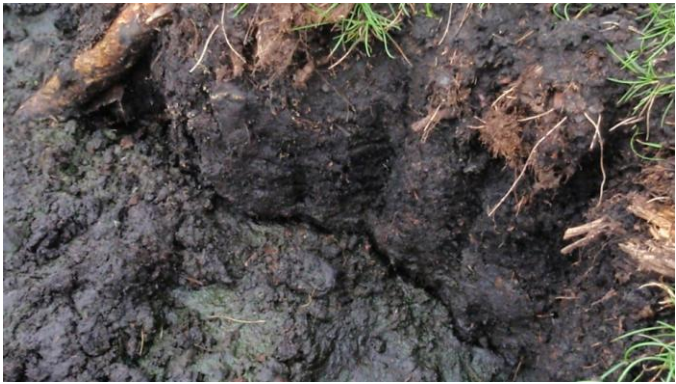
Figure 9

Hoof marks in the active face.

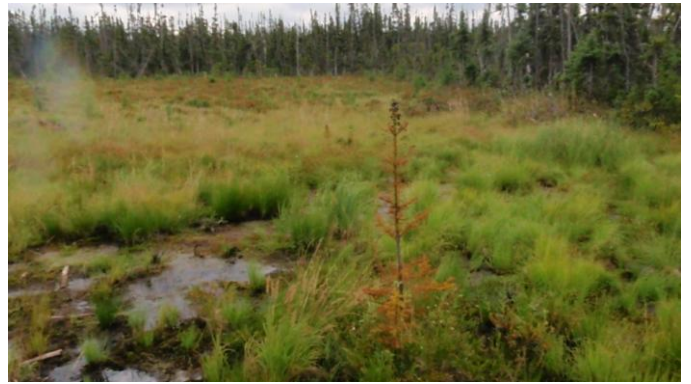
Figure 10

Dead white spruce south of sump.

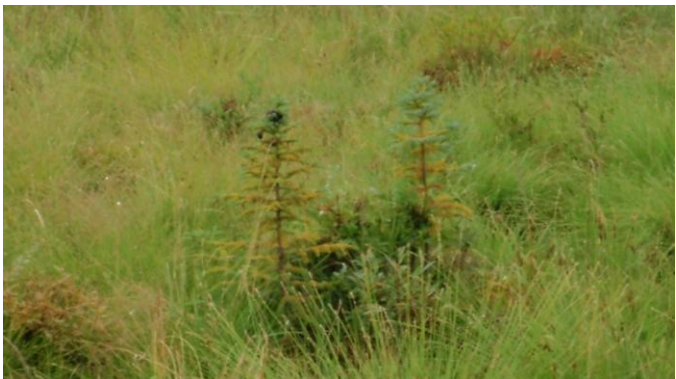
Figure 11

Located approx. 10 meters from the area in question we can start to see stressed and dying vegetation as depicted with these dying white spruce.
