August 15, 2023

File Number	W2014L3-0002
Type of Operation	CLASS A - MUNICIPAL
Location	Behchoko, NT

MUNICIAPL WATER USE INSPECTION REPORT

LICENCE #:	W2014L3-0002	EXPIRY DATE:	November 25, 2029
LICENCEE:	Community Government of Behchoko	PREVIOUS INSPECTION:	June 08, 2022
COMPANY REP:	Senior Administrative Officer	INSPECTION DATE:	May 10, 2023

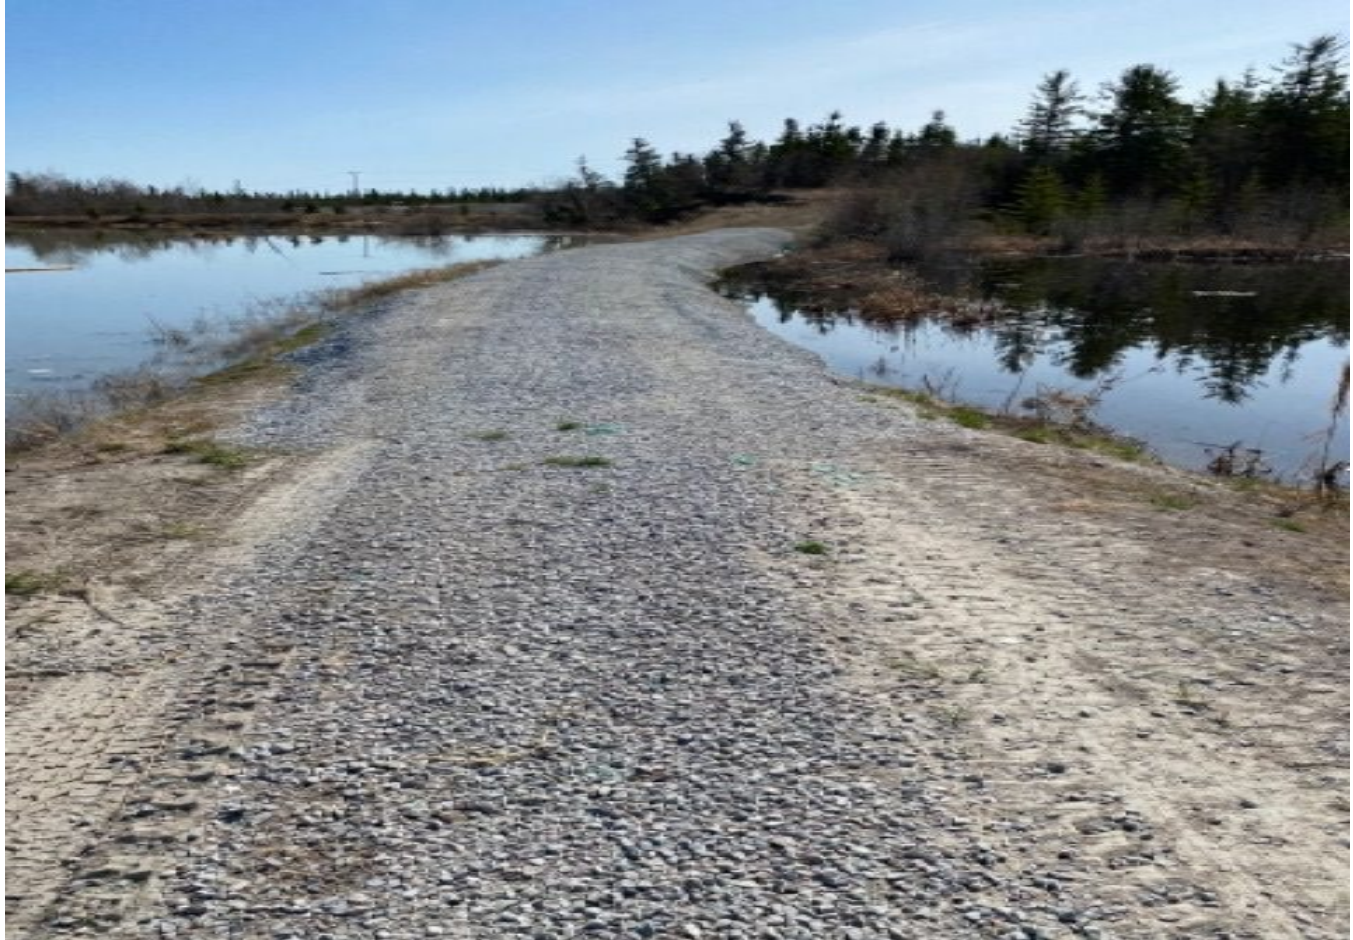
Figure 1

Every year, the berms at the sewage lagoon naturally settle, decreasing the freeboard. As a result of this natural settling, the CGB reported that on April 7, 2023, one of the berms was overtopped (GNWT Spill 2023145). The CGB immediately brought in their engineering consultant and raised the berm to ensure that the contents of the lagoon were contained (Photo 1). There have been on-going discussions between the consultant and the CGB to rectify the situation and prevent further spills from the sewage lagoon.

Photo 1 - Raised berm at Rae Sewage Lagoon

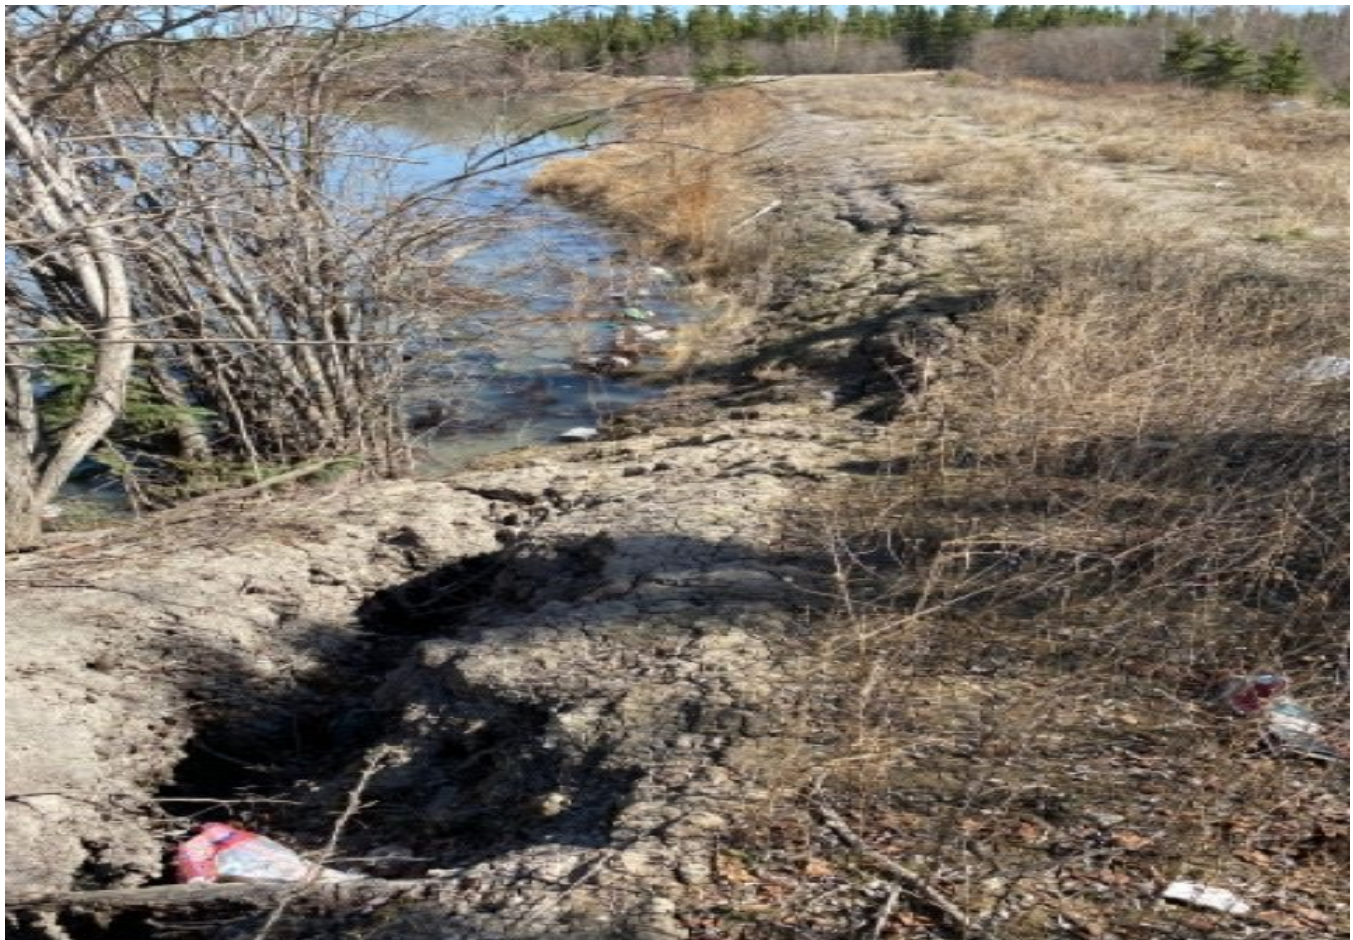
Figure 2

At the time of inspection, the Rae sewage lagoon was found to be operational, but out of compliance. Freeboard levels do not meet the Licence requirement of 1 metre. This is an on-going issue for this site; sludge removal is required to increase capacity for Cell 1. Erosion as a result of high water in both ponds is negatively impacting the integrity of the containment area (Photo 2). The Inspector also noted there was refuse, including oil and grease, in the sewage lagoon and three megabags full of an unknown material (Photo 3 and Photo 4). These materials should be removed and disposed of properly.

Photo 2 - Crack in berm of Cell 1 at Rae Sewage Lagoon

Explanatory Remarks: The freeboard level in the Rae Sewage Lagoon is less than the required 1 metre. There are several locations in the Rae Sewage Lagoon where there has been erosion and settling reducing the freeboard. The Inspector recommends working with the a consultant to conduct geotechnical inspection of the berms, raise berms, and conduct necessary maintenance to ensure it provides proper containment of sewage effluent.

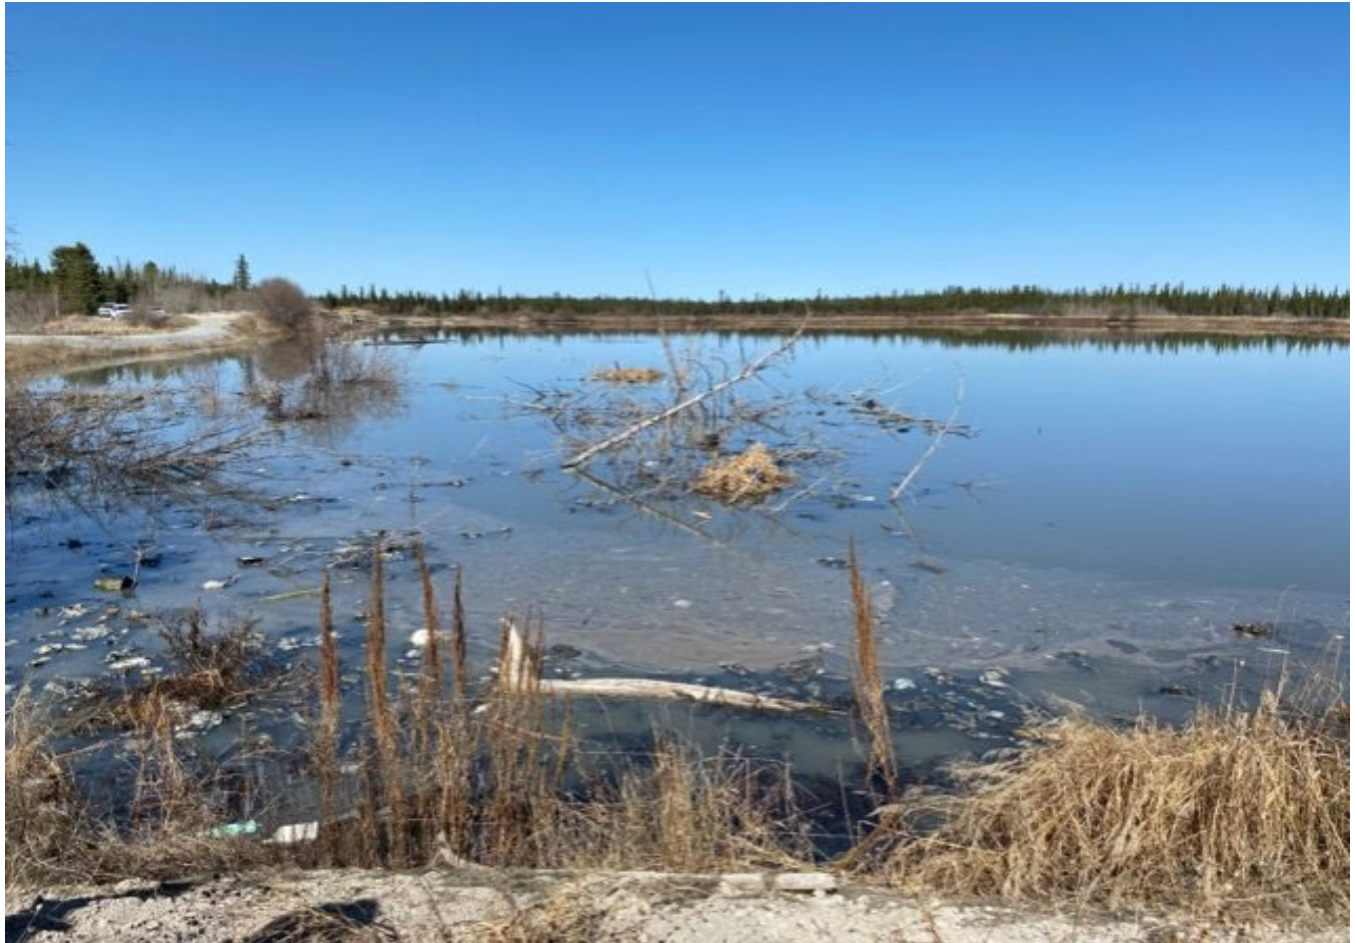
Figure 3

Photo 3 - Oil and Plastics in Rae Sewage Lagoon

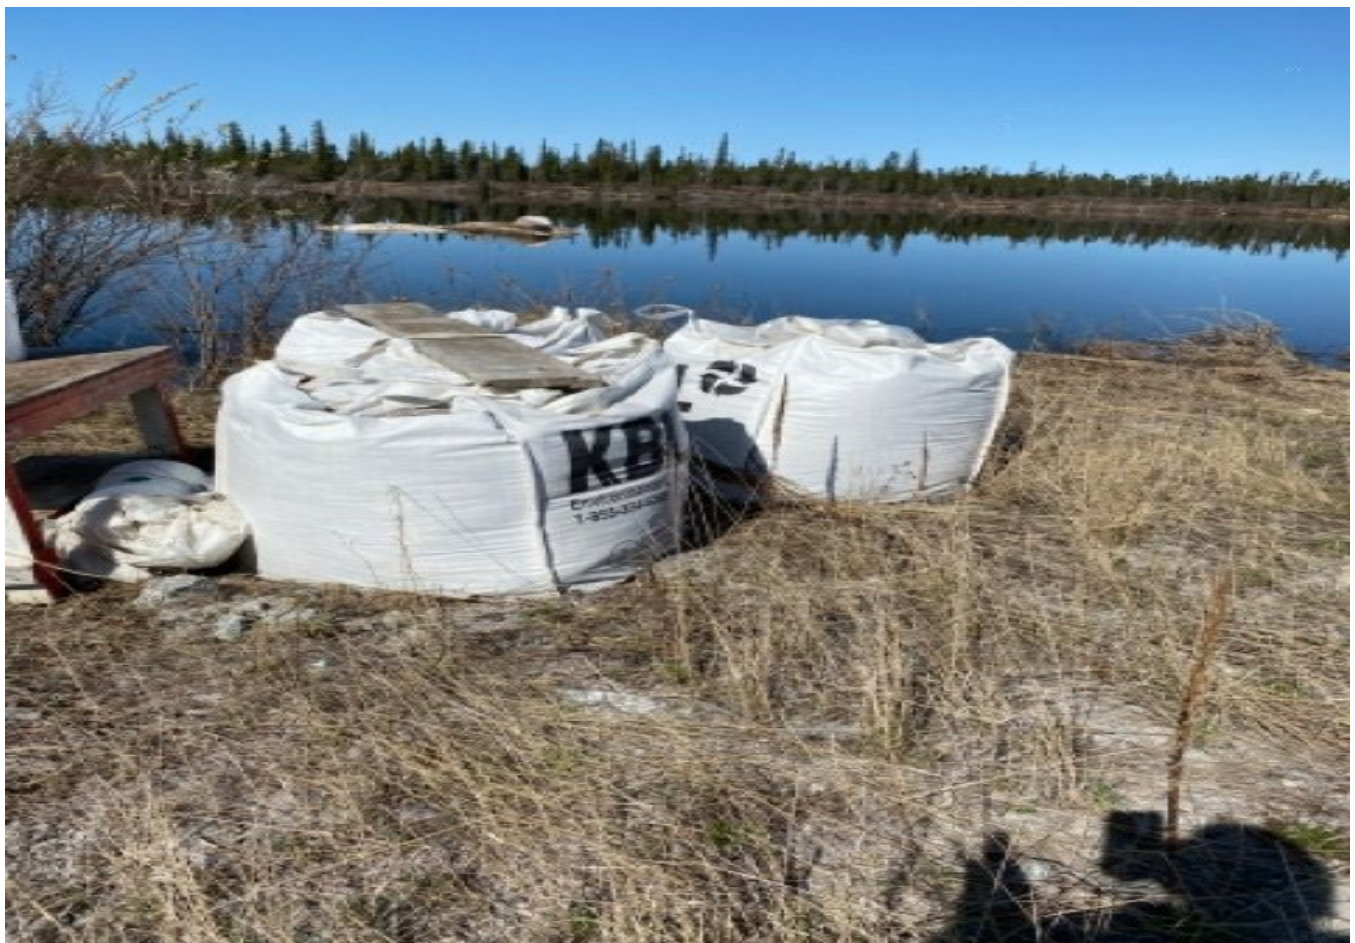
Figure 4

Photo 4 - Megabags with unknown material at Rae Sewage Lagoon

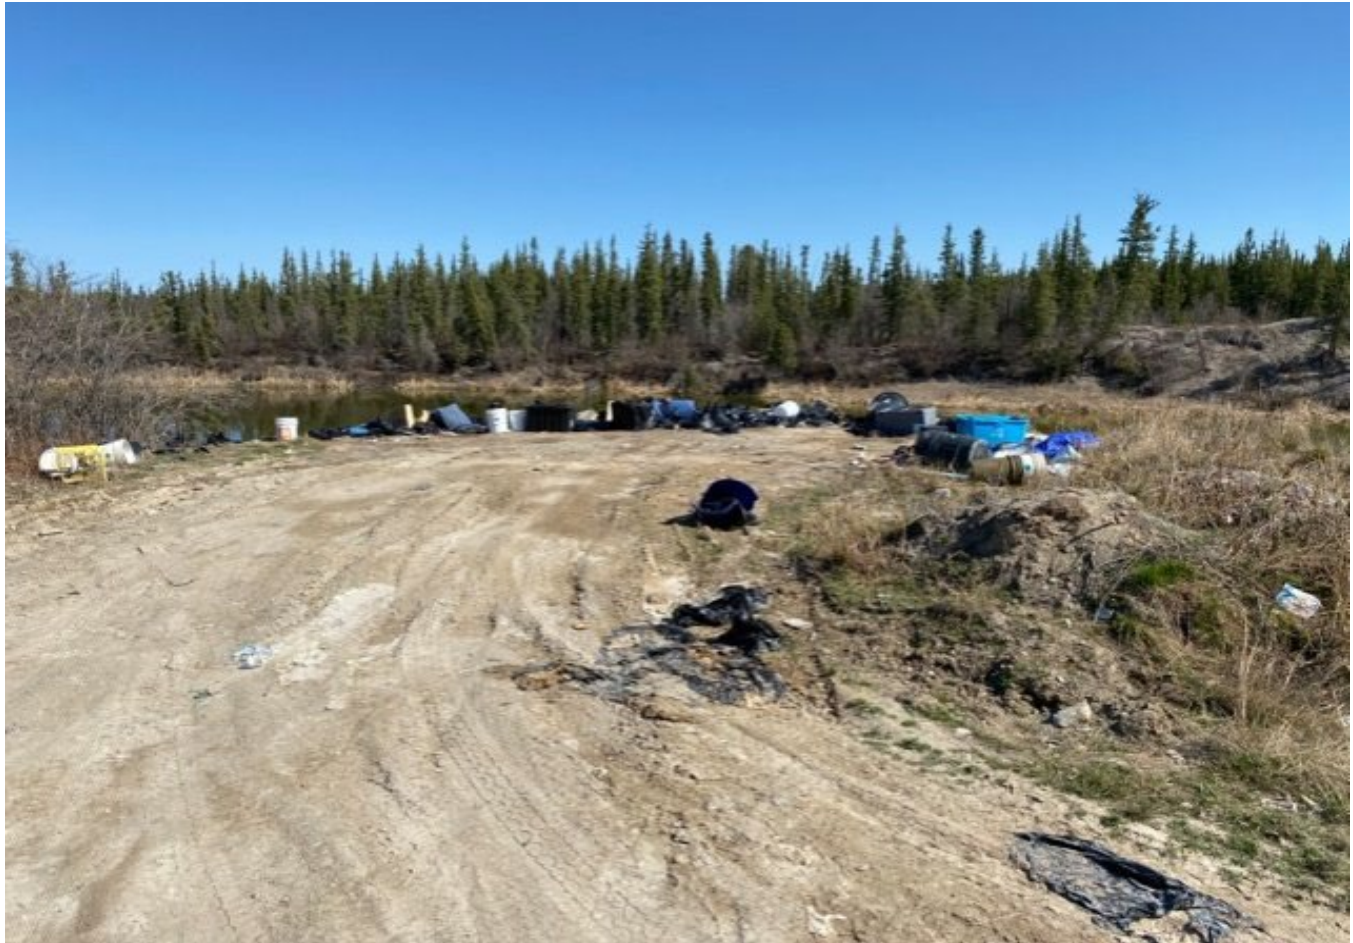
Figure 5

The honey bag disposal area is out of compliance, unsafe, and unsightly. Plastic containers and other garbage has been dumped on the bank of the pond that honey bags drain into. At the time of the inspection there were numerous plastic containers on the bank and floating in the receiving environment (Photo 5). This area requires extensive clean-up and is a health and safety concern. The Inspector recommends signage to outline how to appropriately dispose of honey bags.

Photo 5 - Honey bucket disposal area

Explanatory Remarks: This site has become a dumping area for waste other than bagged toilet waste. This area should be cleaned up to remove hard plastics and signage should be installed to ensure the public is aware of what acceptable to dispose of at that location. It is noted that this clean-up poses a significant health risk and should be done in coordination with a Health Inspector and trained personnel.

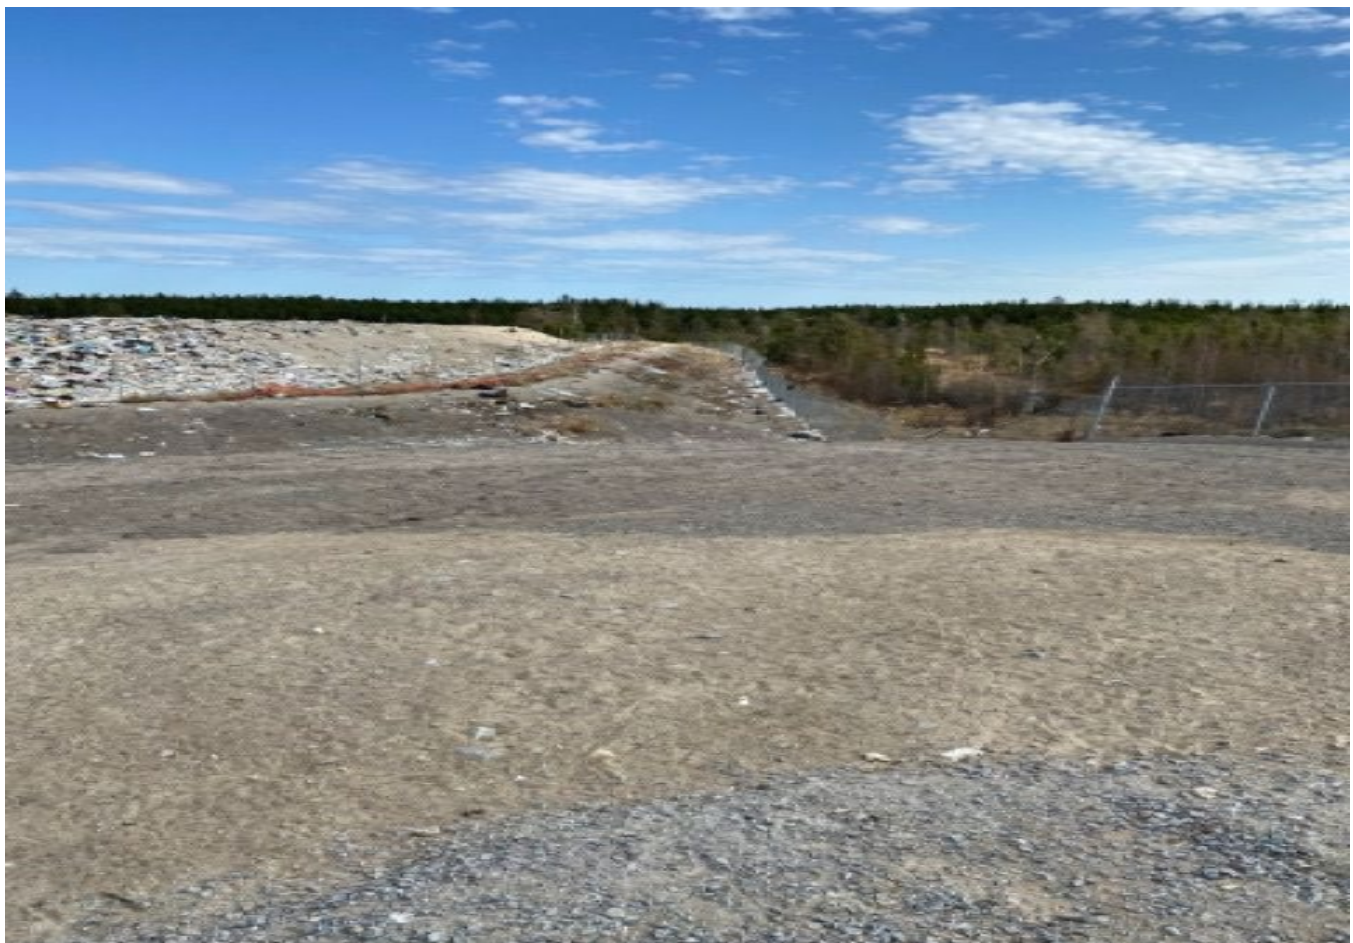
Figure 6

Segregation of waste streams appears to be acceptable. Waste appliances, hot water tanks, tires, and electronic devices appeared to be segregated from other household waste. Fencing needs to be repaired, or replaced to prevent wildlife encounters/scavenging and contain windblown garbage from spreading to areas adjacent to the dump site (Photo 6). Hazardous waste appears to be segregated appropriately, but there is a significant volume stockpiled that requires shipment to a proper disposal facility.

Photo 6 - Solid waste facility fencing requiring repair

Explanatory Remarks: Repair or reinstall the fence that is missing or damaged to comply with this condition.
