Diavik Diamond Mines (2012) Inc.  
P.O. Box 2498  
Suite 300, 5201-50th Avenue  
Yellowknife, NT X1A 2P8  
Canada  
T (867) 669 6500  
F 1-866-313-2754

Our reference: DDMI Incident numbers 1000614923  
Your reference: GNWT Spill 2022427

**Subject: Follow-up to GNWT Spill Report 2022427**

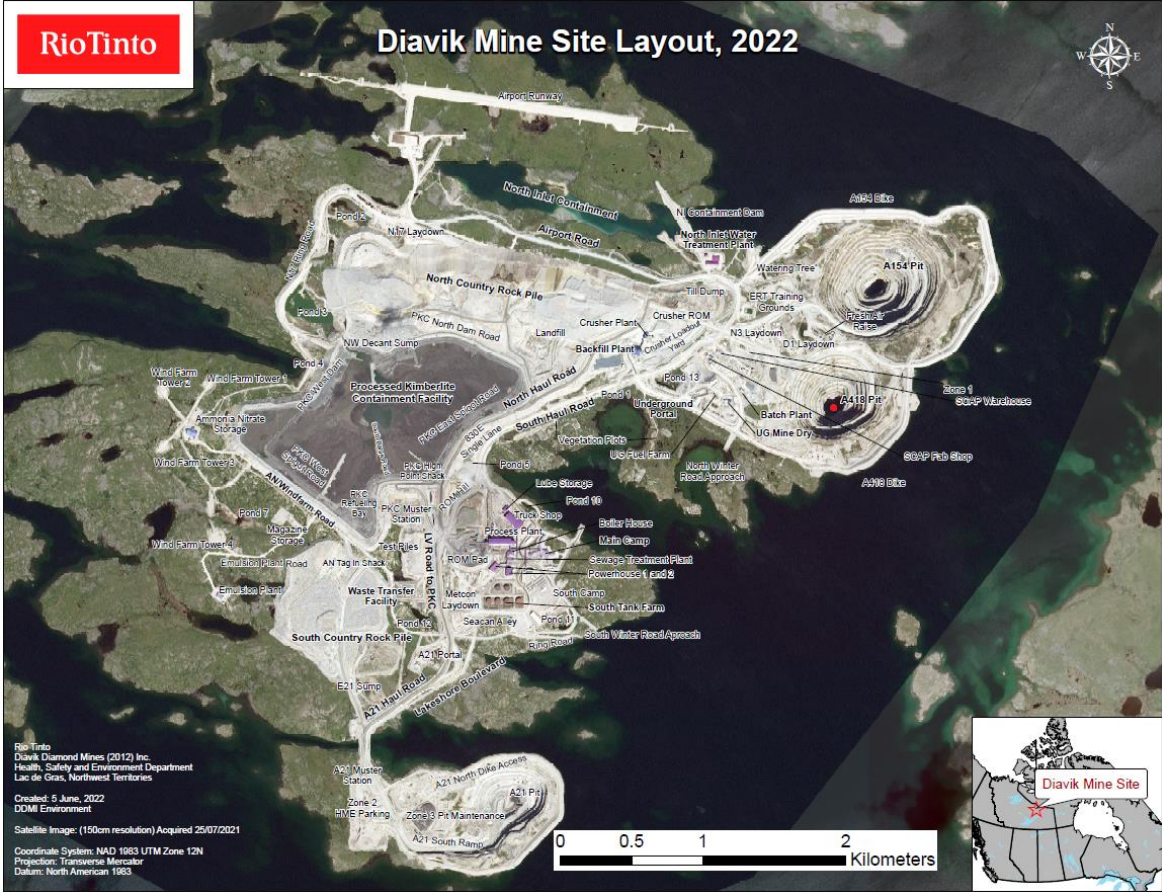
On August 20<sup>th</sup>, at approximately 11:00 am, approximately 30 m<sup>3</sup> of North Inlet mine contact water used for hydrostatic testing of a Processed Kimberlite to Mine Workings (PKMW) commissioning pipeline spilled in the A418 pit. The mine contact water was intercepted by the existing A418 sump pump infrastructure and was returned to the North Inlet Containment Facility. There was no release to the external receiving environment.

During the incident investigation, it was determined that a part of the pipeline was temporarily disconnected the day prior to hydrostatic testing due to haul traffic in the A418 pit. Pipeline connections were not re-verified before testing, which resulted in the uncontrolled release of water into the A418 pit.

Figure 1 Spill 2022427 release location.

miscommunication, as haul truck traffic was in the area the day before the testing was conducted resulting in a temporary disconnection of part of the pipeline. Updates to the commissioning checklist to include verification of pipeline connections have been made.
