April 14, 2023

Our reference: DDMI Incident Number 1000633364
Your reference: GNWT Spill 2023102

Subject: Follow-up Report to GNWT Spill 2023102

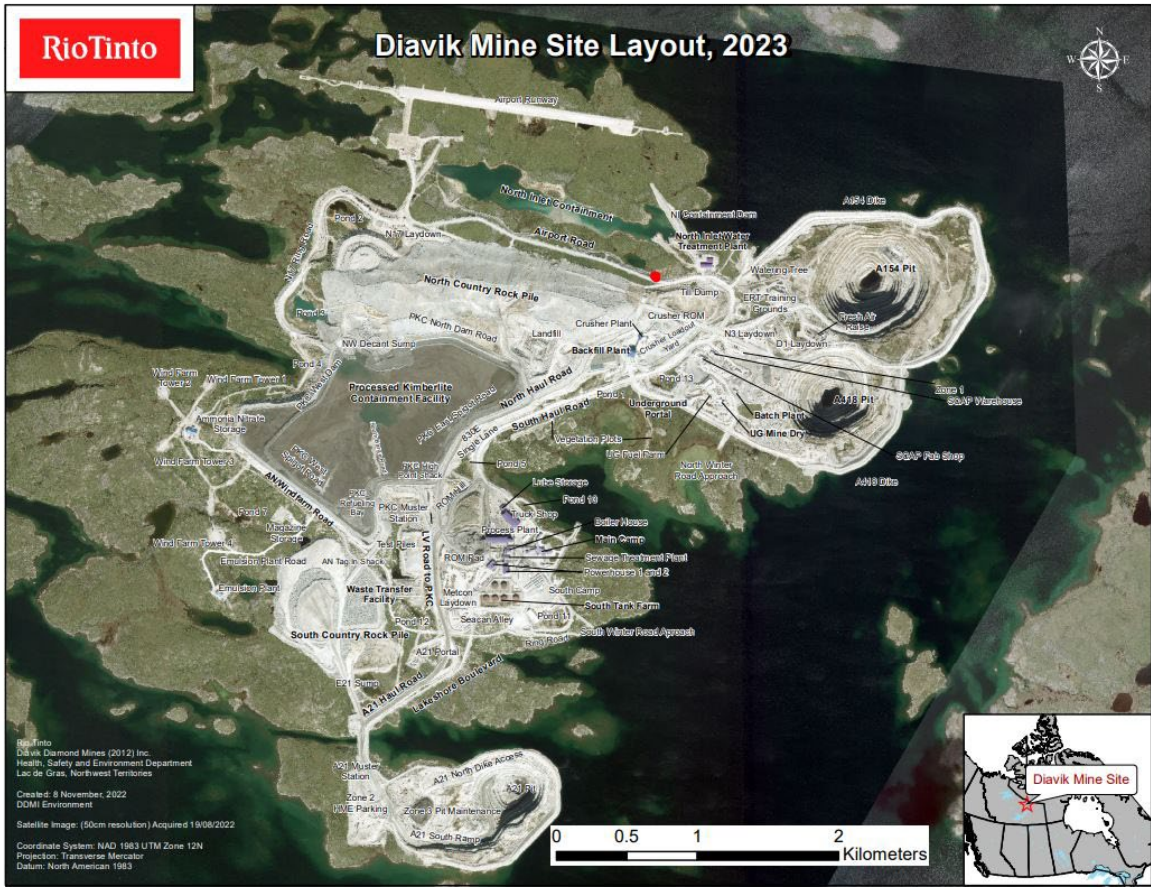
On February 7th, 2023, at approximately 11:00am, underground dewatering water was released from a broken section of the 9105 underground dewatering pipeline within the North Inlet Containment Facility (Figure 1). It was determined that extreme cold weather conditions had forced the pipeline to come apart at a joint (Figure 2). Notice of the release was not communicated to the Environment Department, as the department responsible for the maintenance of the pipeline mistakenly understood that because the water was reporting to the North Inlet Containment Facility and fully within containment, that it was not considered a spill and could be repaired in the spring. Environmental staff became aware of the situation on March 13th, with initial reporting provided to the Inspector March 14th. In total, approximately 450,000 m³ of underground dewatering water released from the broken pipeline section and flowed into the North Inlet Containment Facility during this time.

Figure 1. Spill 2023102– Broken pipeline location in the North Inlet Containment Facility (red circle).

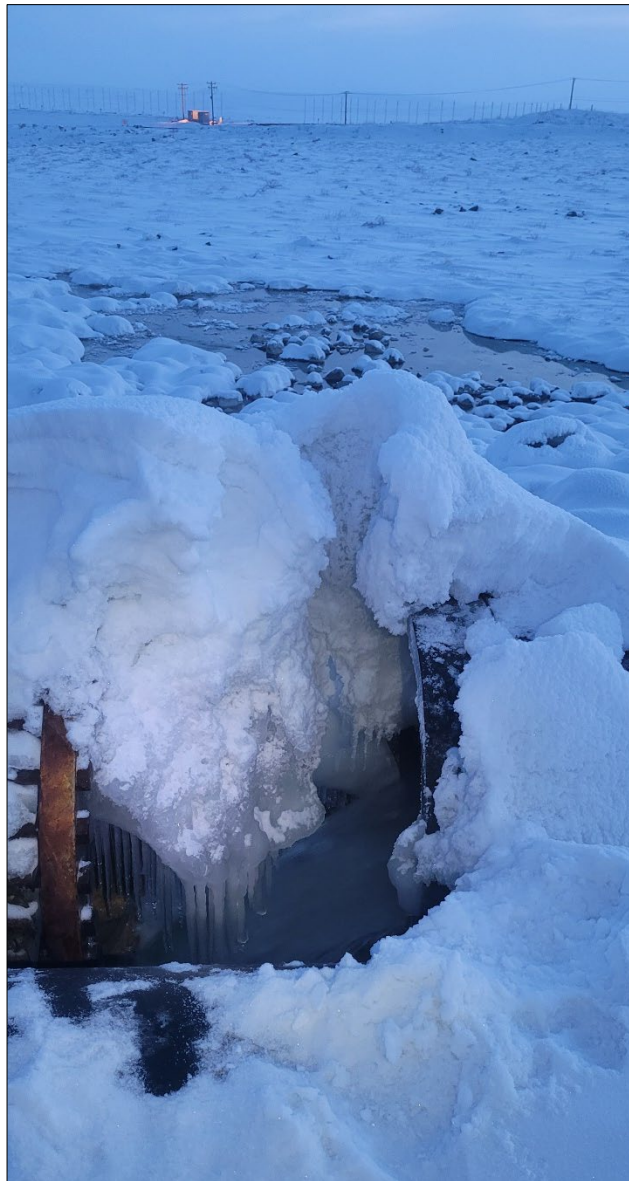
Figure 2. Spill 2023102 – Water flow at damaged dewatering pipeline in the North Inlet Containment Facility area.

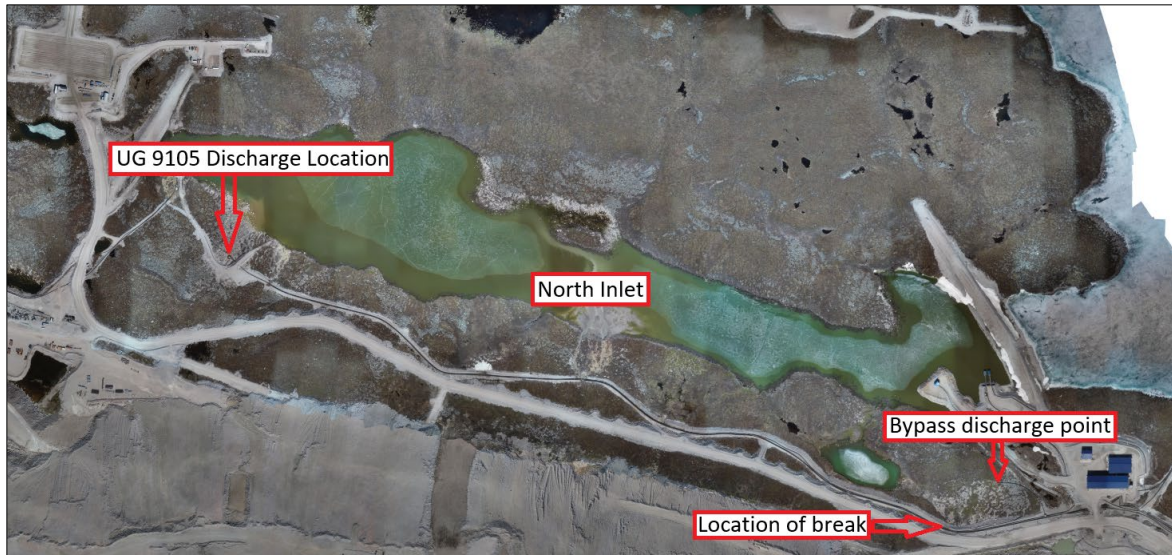
Figure 3. Bypass discharge point, as well as original UG 9105 discharge location and location of break

When the Environment Department was made aware of the leak, the area owner was contacted, and an investigation took place. It was determined that the pipeline could not be immediately repaired at the joint due to significant ice build-up and there being no safe access for heavy equipment, and so water was diverted to a bypass pipeline that also flows

directly into the North Inlet Containment Facility on March 16th (Figure 3). Dewatering of the underground continued during this period.

Repairs on the pipeline break were completed by April 3rd. It was then discovered that the pipeline section downstream of the original break location was frozen due to the partial flow through it between Feb 7th and March 16th. On April 8th, an attempt was made to divert flow back into the original pipeline to clear the ice blockage, but this was unsuccessful. DDMI will continue utilize the bypass pipeline until consistent warmer temperatures thaw the original pipeline and water can be diverted back to the 9105 discharge line. DDMI notes that this temporary updated pipeline configuration does not change the North Inlet water balance and is only a change in the exact location of where the water enters the facility. At no point does water discharge to the receiving environment, and all water continues to be treated at the North Inlet Water Treatment Plant prior to entering Lac de Gras.
