Our reference: DDMI Incident number 1000648218

Your reference: GNWT Spill 2023530

Subject: Follow-up to GNWT Spill report 2023530

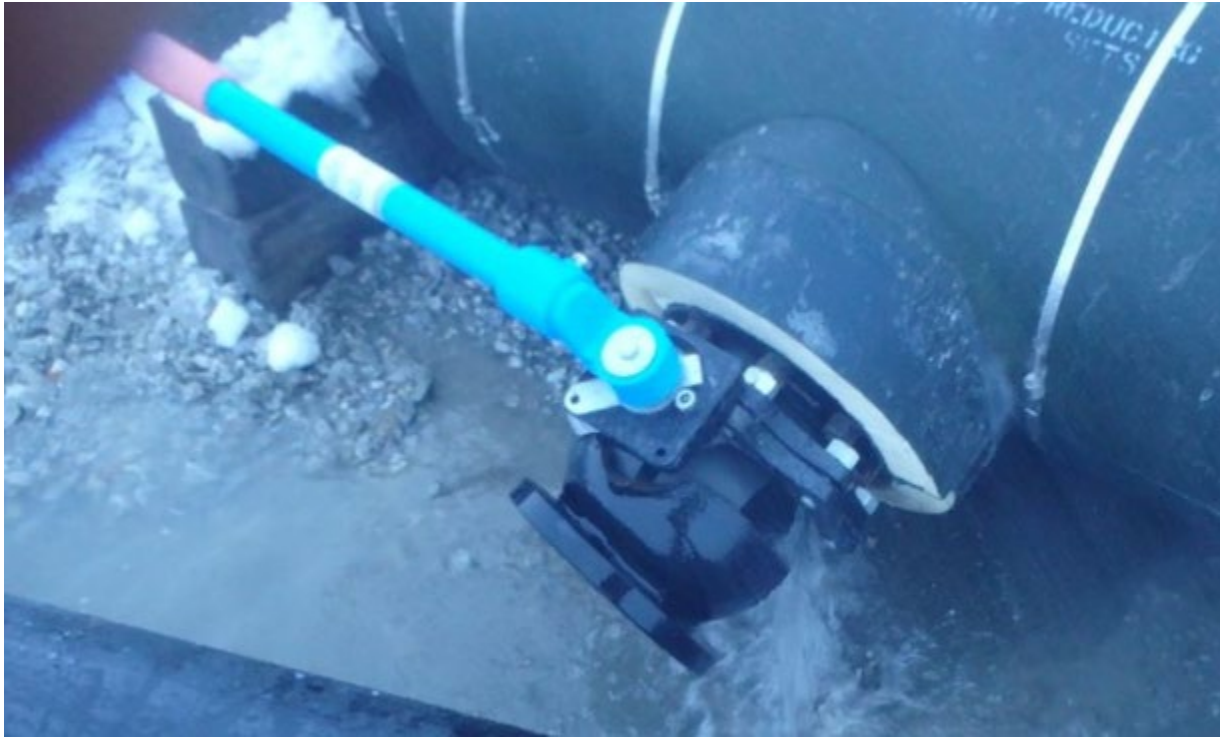
Figure 2 Broken valve during release

An investigation of all drain valves on the 311 and 312 PKMW lines has been completed. Results of investigation indicate that the reason for failure at those valves was that they were actuated during commissioning of the line, so the ball valve had water in it, which expanded in the low temperatures resulting in the failure. The rest of the drain valves were not actuated so the risk of similar failure mechanism is minimal. Out of an abundance of caution, DDMI has identified a different, frost-resistant valve, and will begin replacing existing valves with the new variety in the future.

- Flow to the line was immediately shut down so the line could be drained for repairs.
- Line was locked out for repairs.
- Environment department was notified of the spill.
- The valve mount has been capped until replacement can be made.

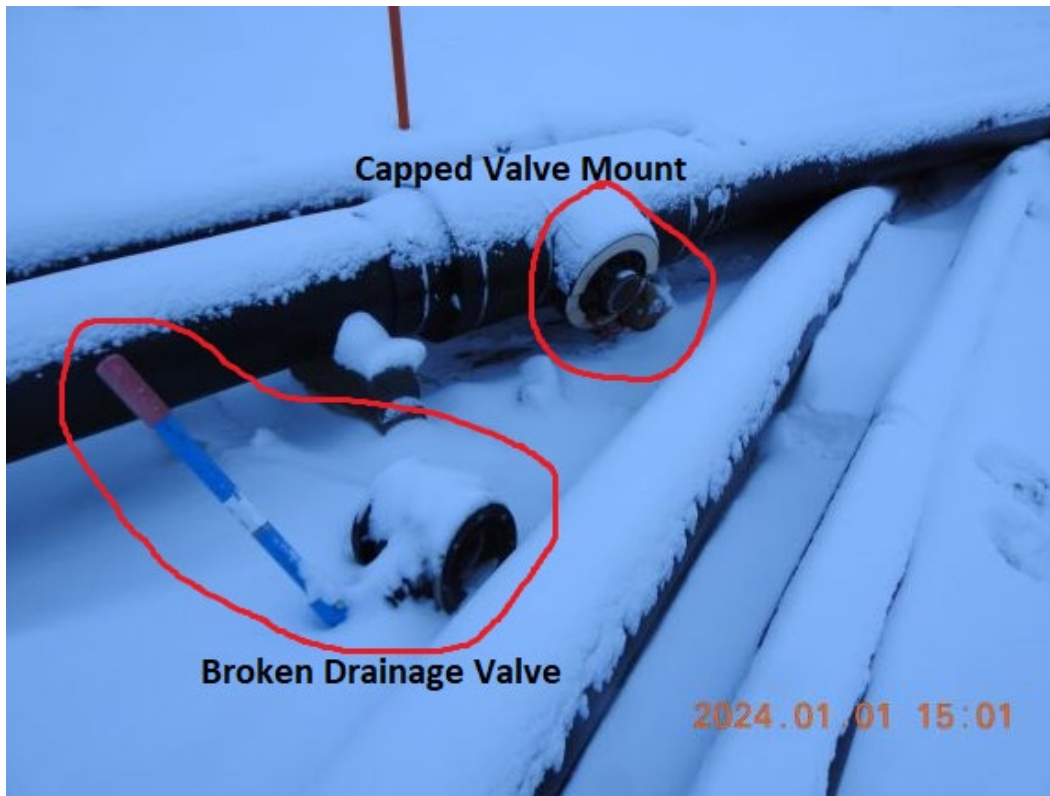
Figure 3 Capped valve mount and broken drainage valve

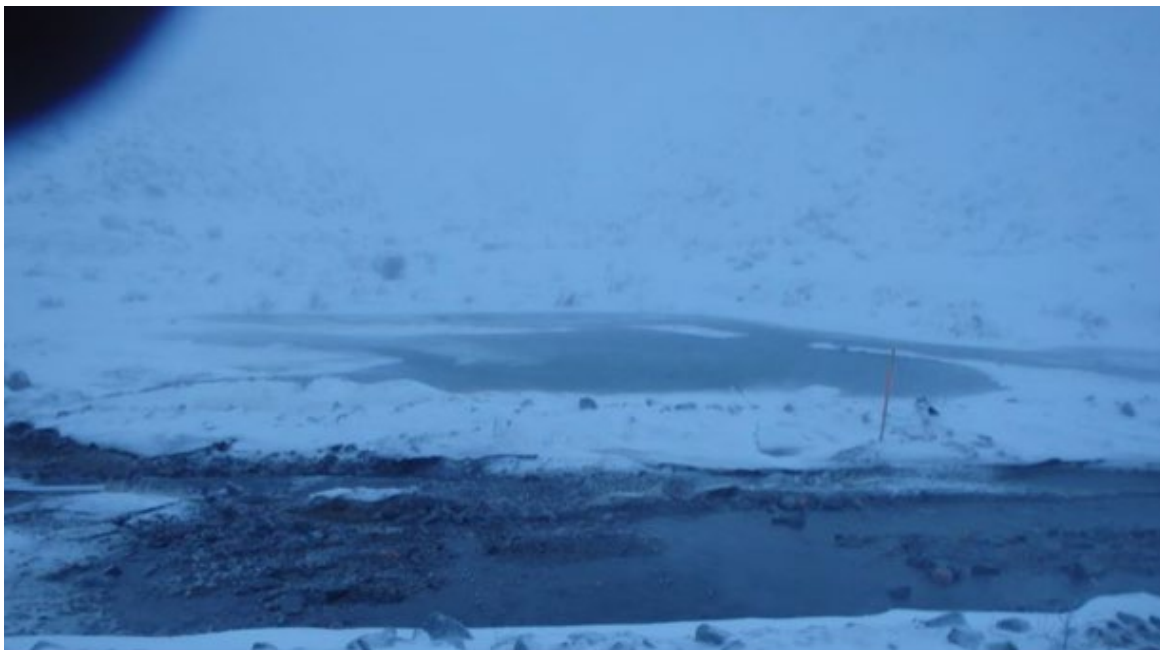
Figure 4 Release into Pond 5
