Diavik Diamond Mines (2012) Inc.
P.O. Box 2498
Suite 300, 5201-50th Avenue
Yellowknife, NT X1A 2P8 Canada
T +1-867-669-6500 F +1-866-313-2754

Our reference: DDMI Incident number 1000650613
Your reference: GNWT Spill 2024071

Subject: Follow-up to GNWT Spill report 2024071

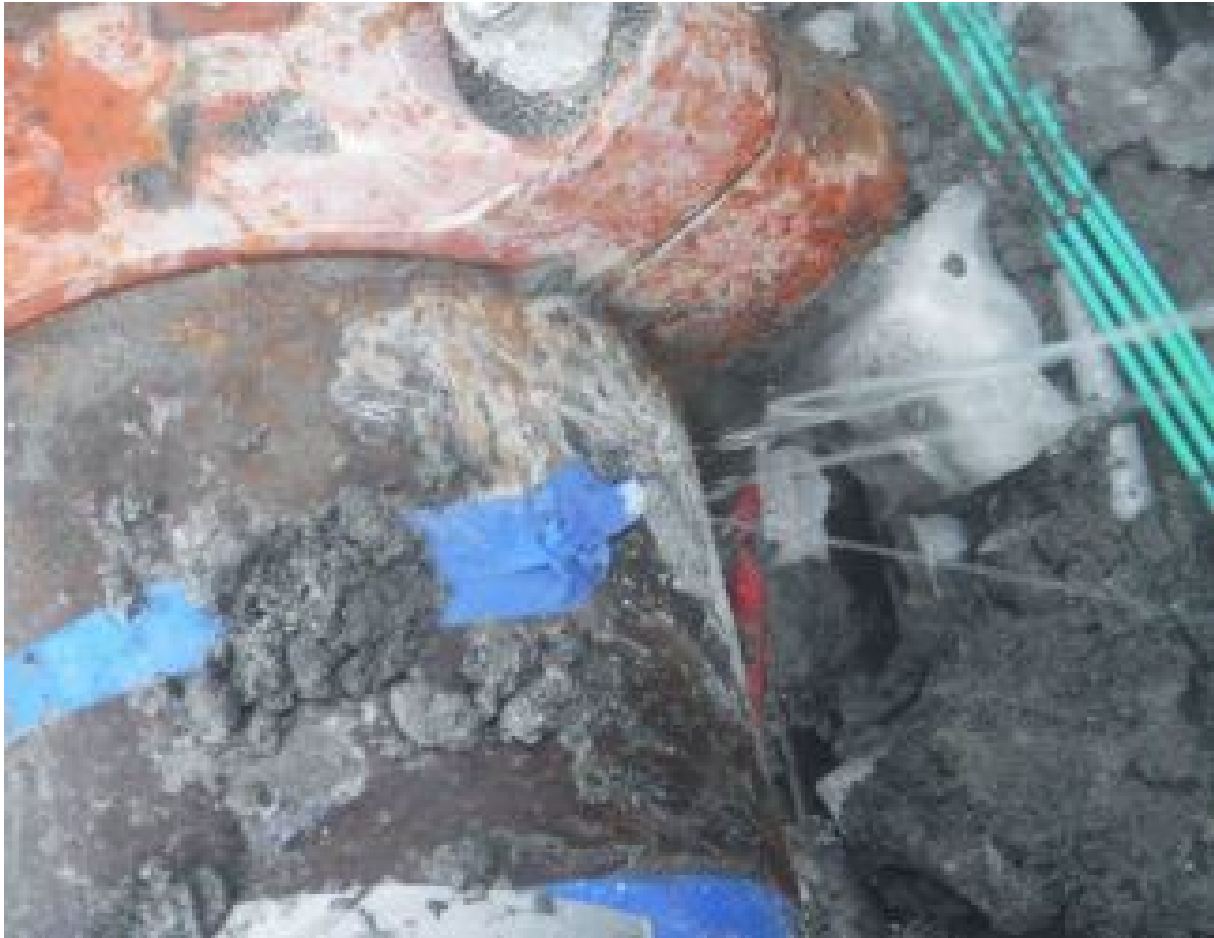
On March 17th, at approximately 06:00, water was discovered running into the Process Plant building beneath a personnel door. Upon investigation, it was found that a leak had developed on the bottom of a flange (Figure 2) for the Processed Kimberlite to Mine Workings (PKMW) line #311, leading to an ice buildup outside the Process Plant in the vicinity of the impacted section of pipe. At the time of discovery, the Process Plant was down for maintenance and the line was being flushed with process water. Inspection of the ice buildup showed it to be comprised of water rather than FPK slurry, indicating that the leak started after the shutdown of the Process Plant for maintenance on March 15th. It is estimated that 12 m³ of process water was released from the line. All spilled material is currently frozen in place in the immediate vicinity of the Process Plant (Figure 3) and not safely accessible to heavy equipment due to the risk of icefall; however, all spilled material will report to the Drainage Control and Collection (DCC) System at freshet. No material will be released to the receiving environment.

Figure 2 Leaking valve on PKMW line #311

Flow was immediately shut off to line #311 in preparation for repair

All PKMW line drain valves were temporarily removed and capped to pre-empt additional valve failures. New valves are being sourced and replacement is scheduled in summer 2024. Additionally, a comprehensive assessment of the entire PKMW line is underway, identifying areas where the pipeline can be realigned to eliminate joints, bends, and elbows to reduce failure risk. Identified realignment work will be completed summer 2024.

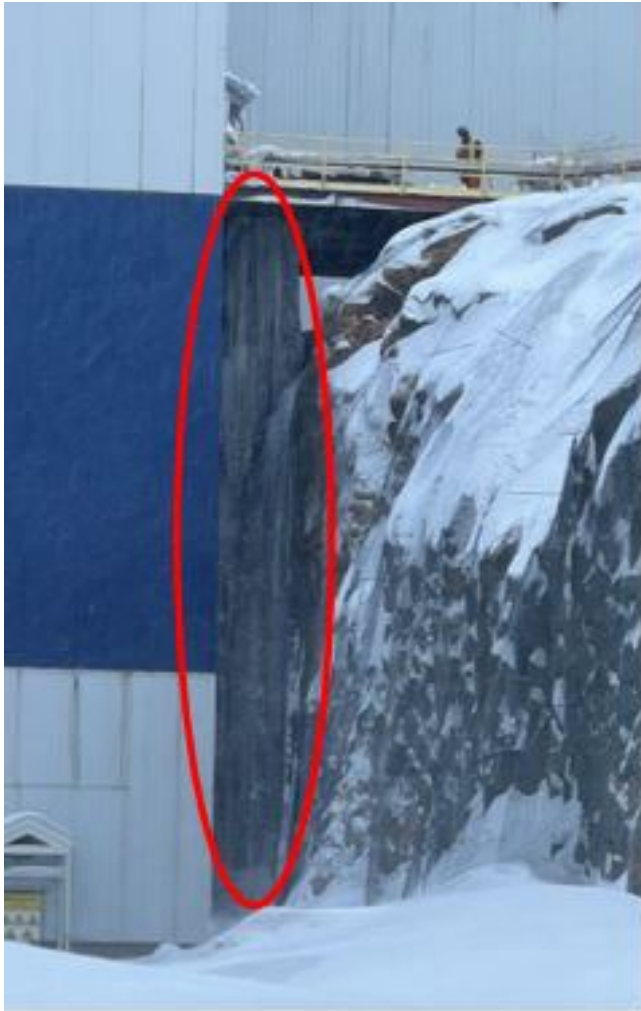
Figure 3 Ice buildup outside Process Plant.
