Diavik Diamond Mines (2012) Inc.  
P.O. Box 2498  
Suite 300, 5201-50th Avenue  
Yellowknife, NT X1A 2P8 Canada  
T +1-867-669-6500 F +1-866-313-2754

Our reference: DDMI Incident number 2980687160\_40194  
Your reference: GNWT Spill 2024260

**Subject: Follow-up to GNWT Spill report 2024260**

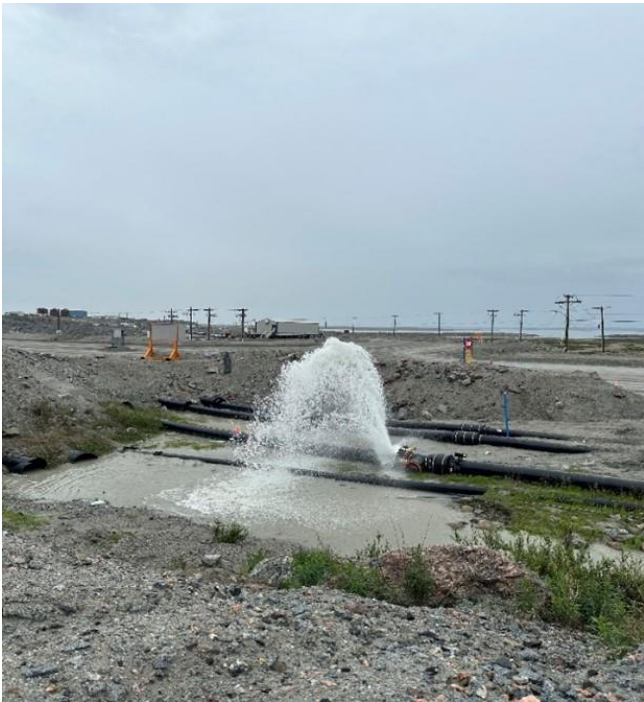
- Approximately 100 m<sup>3</sup> of mine contact water was released in front of the Backfill Plant (Figure 2).
- Initial investigation determined that the spill was the result of a crack in the pipeline at a flange (Figure 3).

- All spilled material was contained within the Drainage Control and Collection System (DCCS) with drainage into Collection Pond 1.
- No material was released to the receiving environment.

Figure 2: Extent of spill in front of Backfill Plant

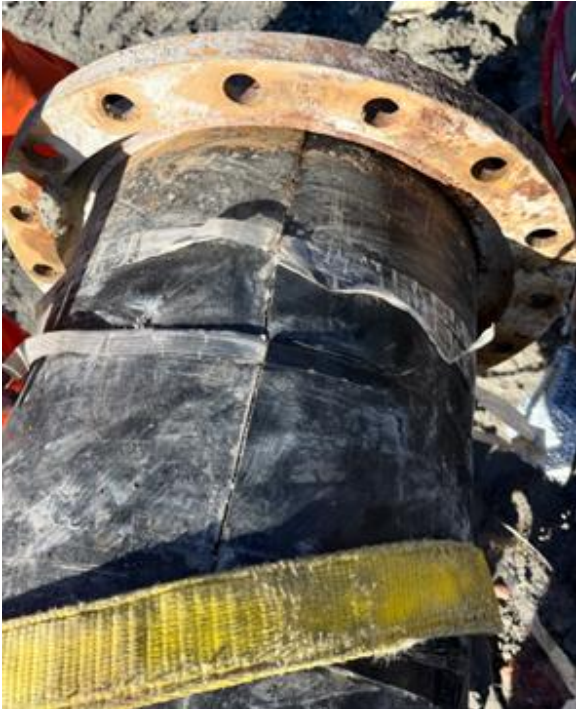
- Follow-up investigation determined that the crack was likely due to over-pressurization due to multiple pump inputs being added into the pipeline without a clearly defined control strategy.

Figure 3: Crack in Process Plant Wet Well pipeline at flange

- Diavik reported the spill to the online spill reporting line and notified the GNWT-ECC Inspector;
- Cracked section of pipeline was repaired (Figure 4);
- Control strategy and clear go / no-go criteria being developed to manage use of dewatering pump tie-ins around core process plant water supply usage to prevent risk of over-pressurization.

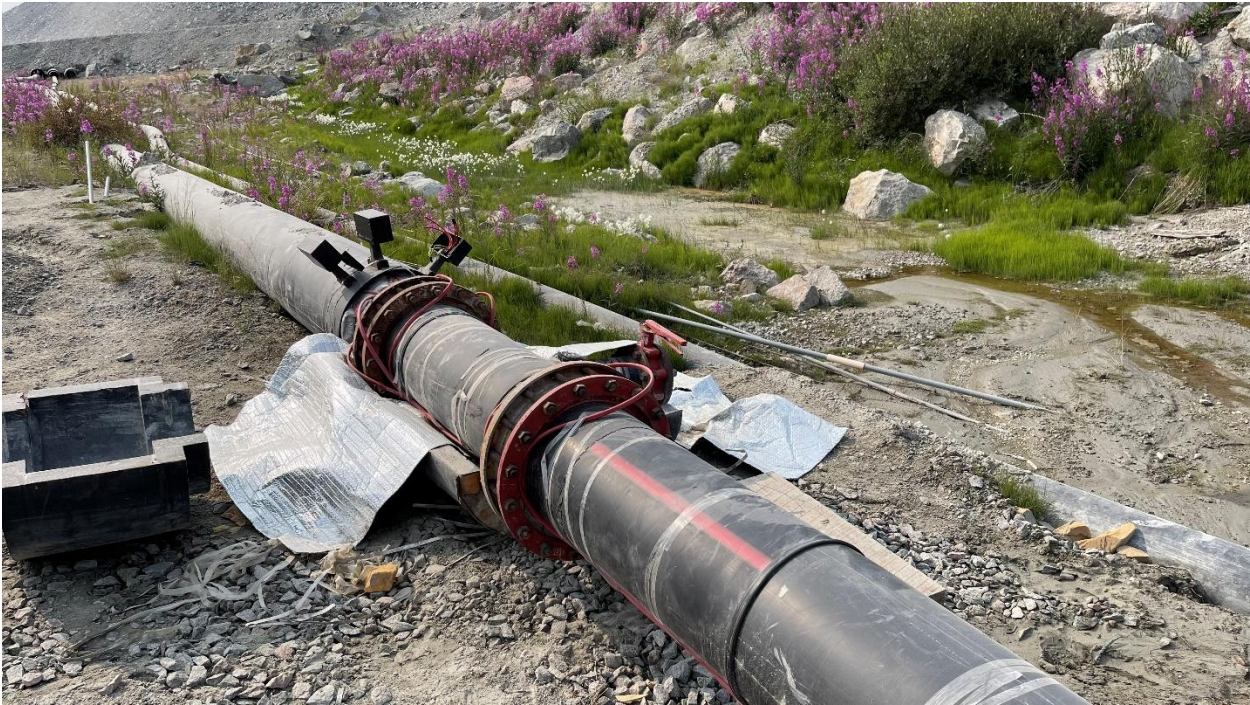
Figure 4: Repaired section of pipeline
