Diavik Diamond Mines (2012) Inc.
P.O. Box 2498
Suite 300, 5201-50th Avenue
Yellowknife, NT X1A 2P8 Canada
T +1-867-669-6500 F +1-866-313-2754

Our reference: DDMI Incident number 2982617045_40203
Your reference: GNWT Spill 2024261

Subject: Follow-up to GNWT Spill report 2024261

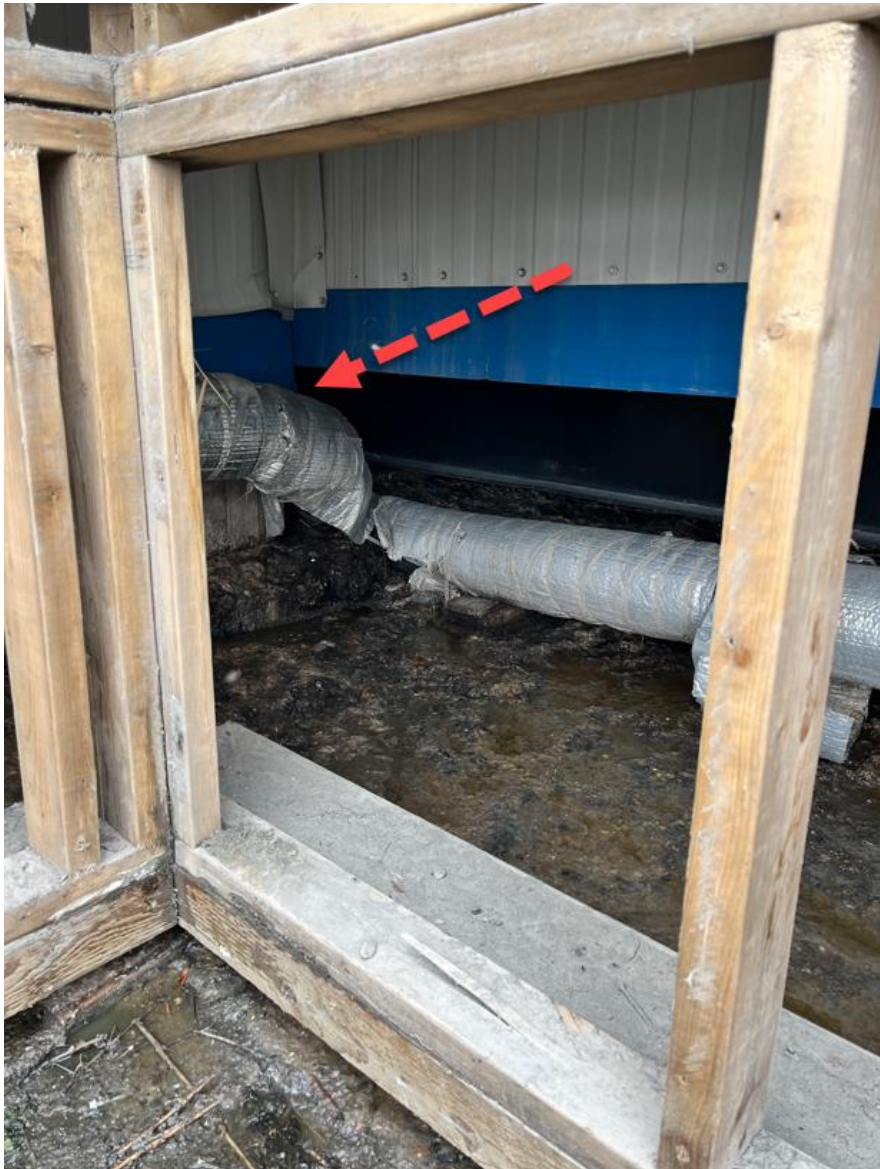
- On July 8th, 2024, at approximately 18:30, a smell of sewage was reported in the E-Wing Dormitory of the Main Accommodations Complex (Figure 1).
- Approximately 200L of sewage and grey water was found to have leaked under the dormitory (Figure 2).
- Upon investigation it was determined that the sewage/grey water effluent pipe had fractured due to a failed pipe hanger support (Figure 3).
- All spilled material was contained within the Drainage Control and Collection System (DCCS) and no material was released to the receiving environment.

Figure 2: Location (red arrow) and extent of spill beneath E-Wing dormitory

- Washroom water supply isolated and tenants relocated from dormitory;
- Dormitory skirting removed and investigation of cause of leak conducted by maintenance crews;
- Lime applied to impacted area;
- Spill reported to Environment Department.

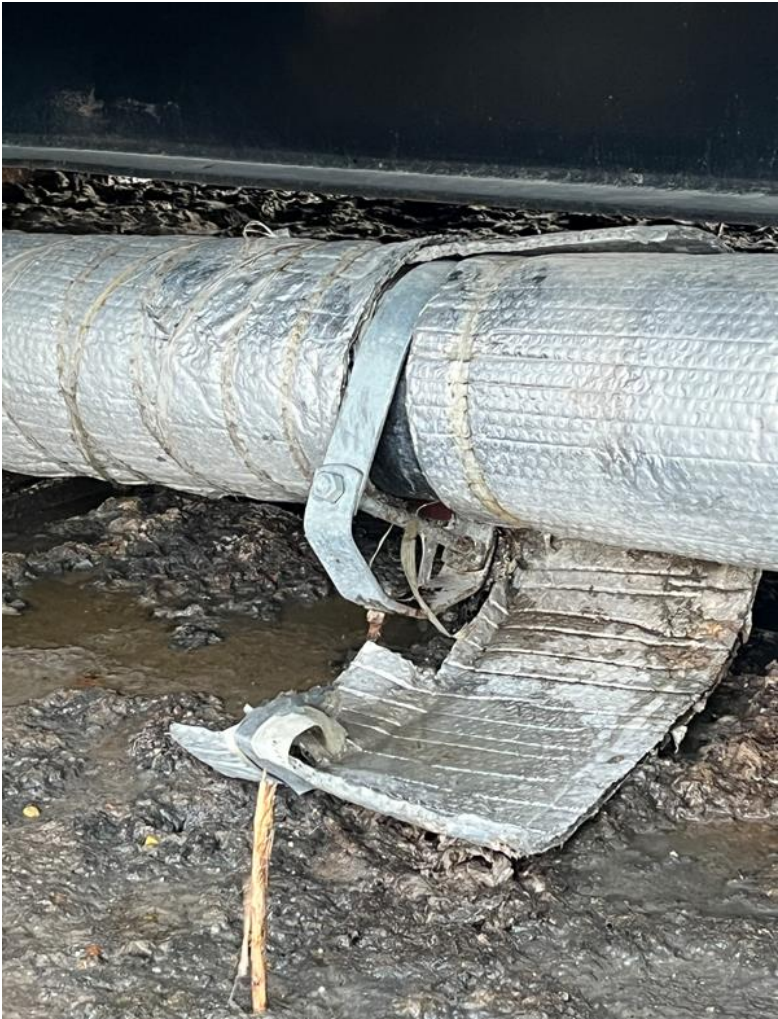
Figure 3: Failed pipe hangar

- A number of other locations with failed supports that could have led to future spills were identified, and all were reinforced with either blocking or additional pipe hangars.

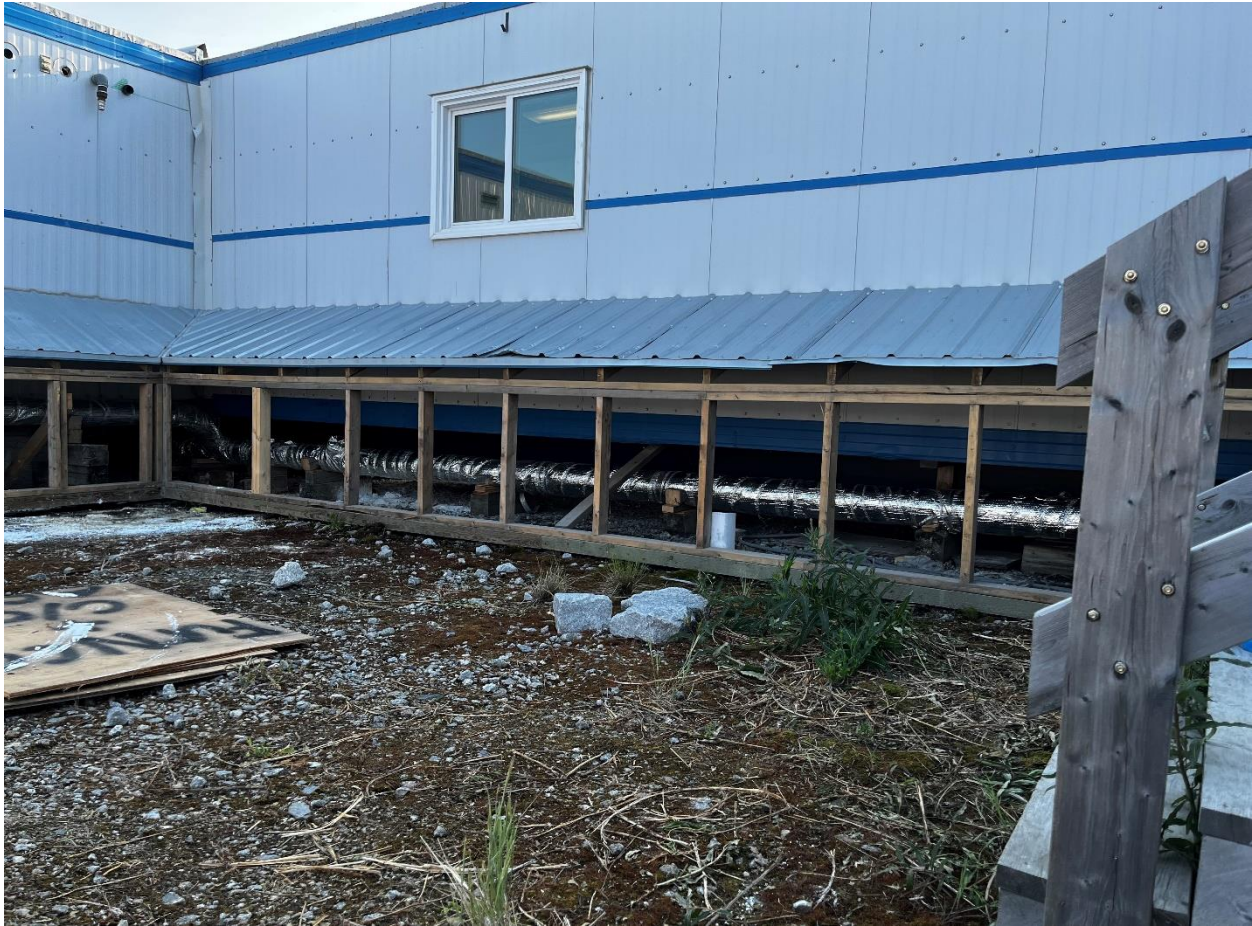
Figure 4: Inspected and repaired pipe section

- Diavik reported the spill to the online spill reporting line and notified the GNWT-ECC Inspector;
- Cracked section of pipeline was repaired (Figure 4);
- All sewage/grey water piping and drains beneath the dormitory were fully inspected (for seals, supports, heat tracing and insulation) to preclude future potential fail points;
