Diavik Diamond Mines (2012) Inc.
P.O. Box 2498
Suite 300, 5201-50th Avenue
Yellowknife, NT X1A 2P8 Canada
T +1-867-669-6500 F +1-866-313-2754

Our reference: DDMI Incident number 2982617045_40203
Your reference: GNWT Spill 2024262

Subject: Follow-up to GNWT Spill report 2024262

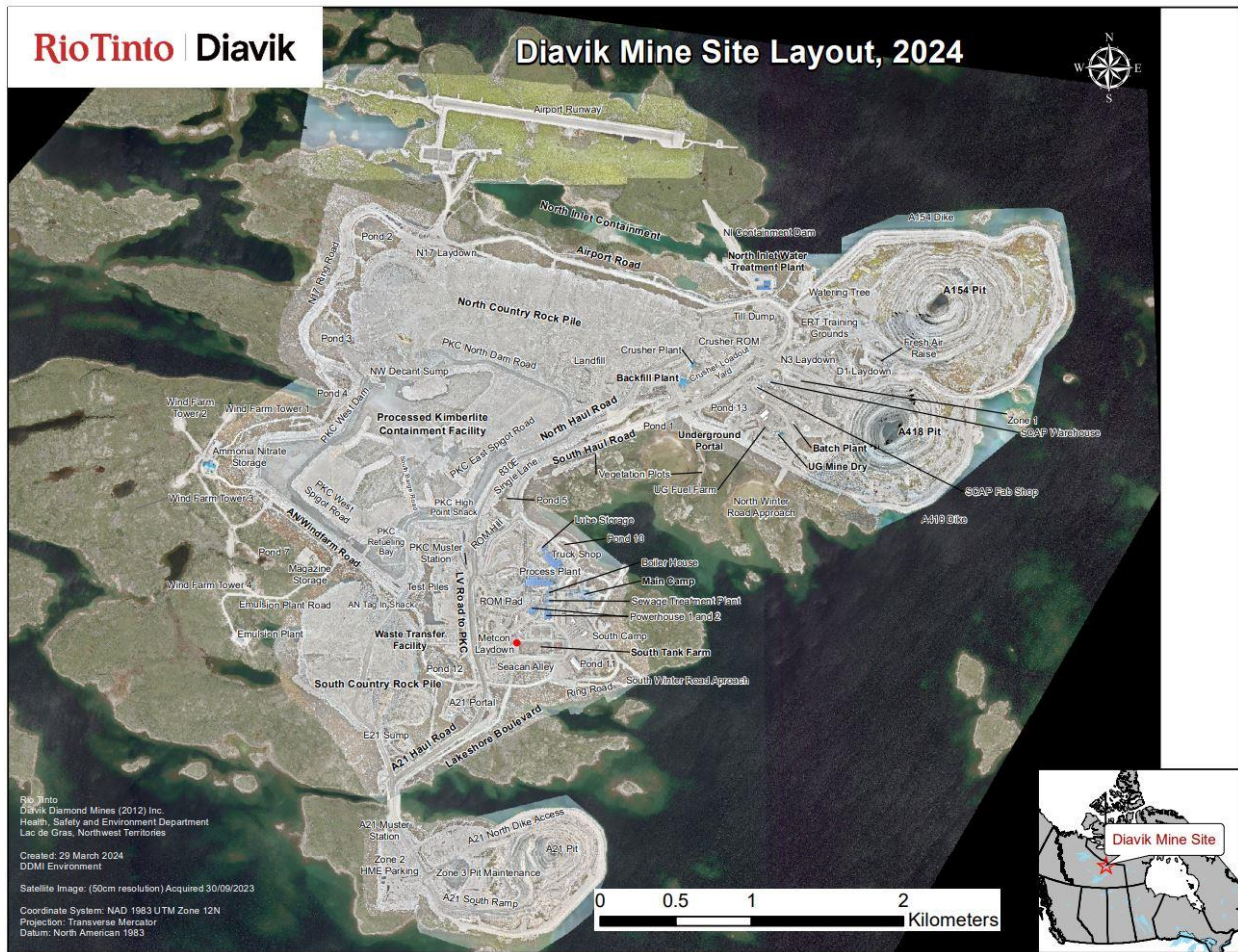
- On July 9th, 2024, at approximately 15:00, a spill was identified from a tank trailer containing a load of 0W40 motor oil as it was driven up a hill out of the Metcon Yard tanker storage (Figure 1).

Figure 1: Spill 2024262 Location indicated by the red dot.

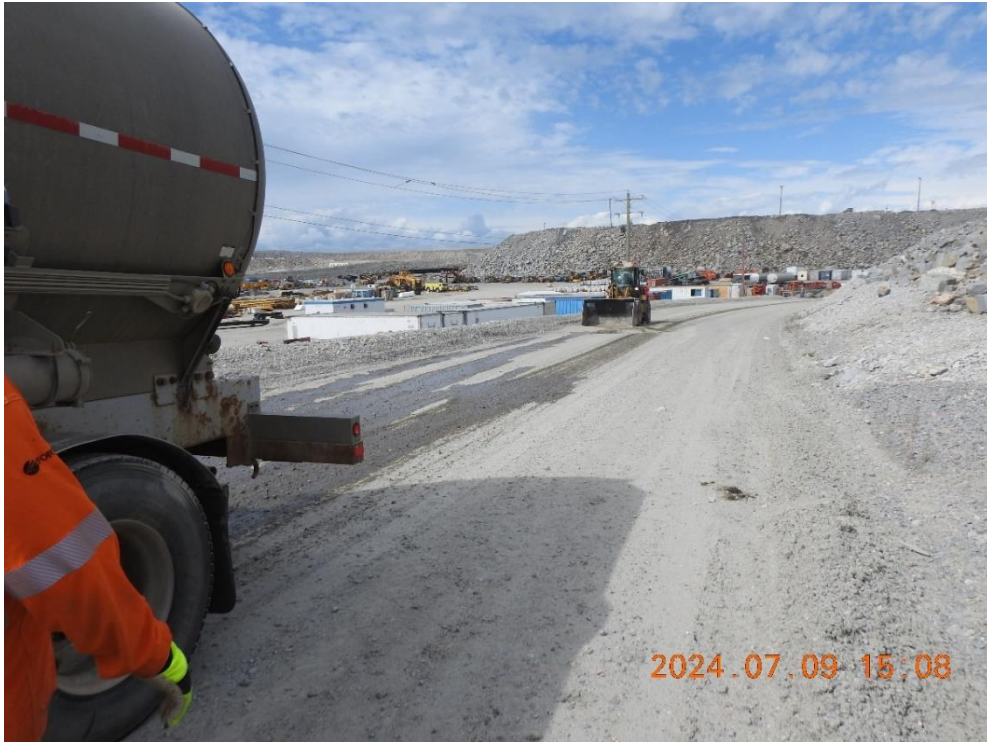
- Approximately 200L of motor oil was released (Figure 2).
- The tank trailer operator noticed the spill, checked the trailer and determined that the leak was coming from a partially open fill valve at the back of the trailer (Figure 3).

Figure 2: Location of spill on hill leading out of the Metcon Yard

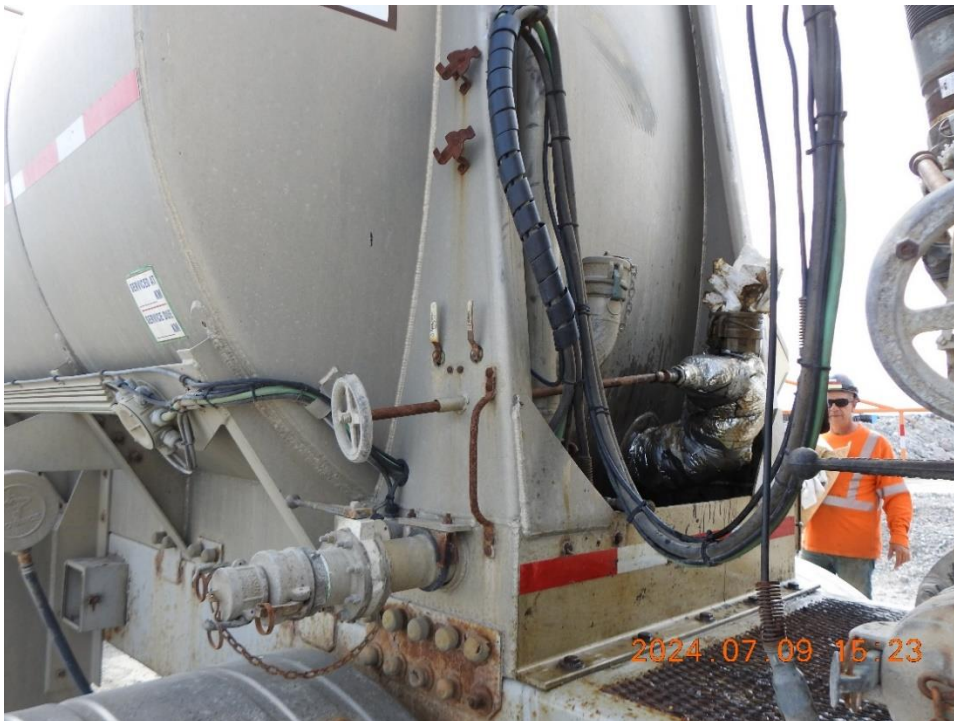
- The driver immediately closed the valve, stopping the flow (Figure 4).
- Although the tanker cannot be offloaded via the fill valve, inspection showed that the fill pipe inside the tank was above fluid level when the tanker was on level ground in the Metcon yard, but became submerged, leading to fluid loss as the tanker drove up the hill.

Figure 3: Tank trailer fill valve on discovery of spill

- Diavik reported the spill to the online spill reporting line and notified the GNWT-ECC Inspector
- A monthly inspection template of all Metcon storage tankers including checking of all valves and caps is in development.

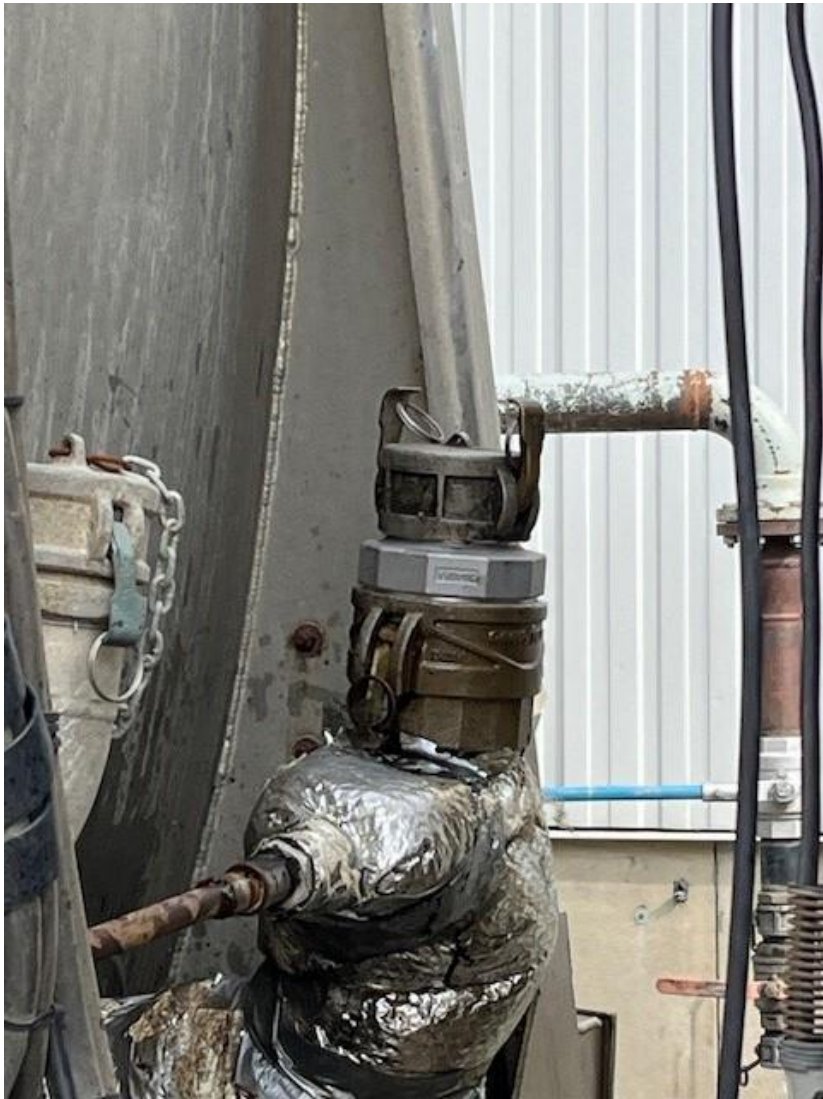
Figure 4: Tank trailer fill valve closed

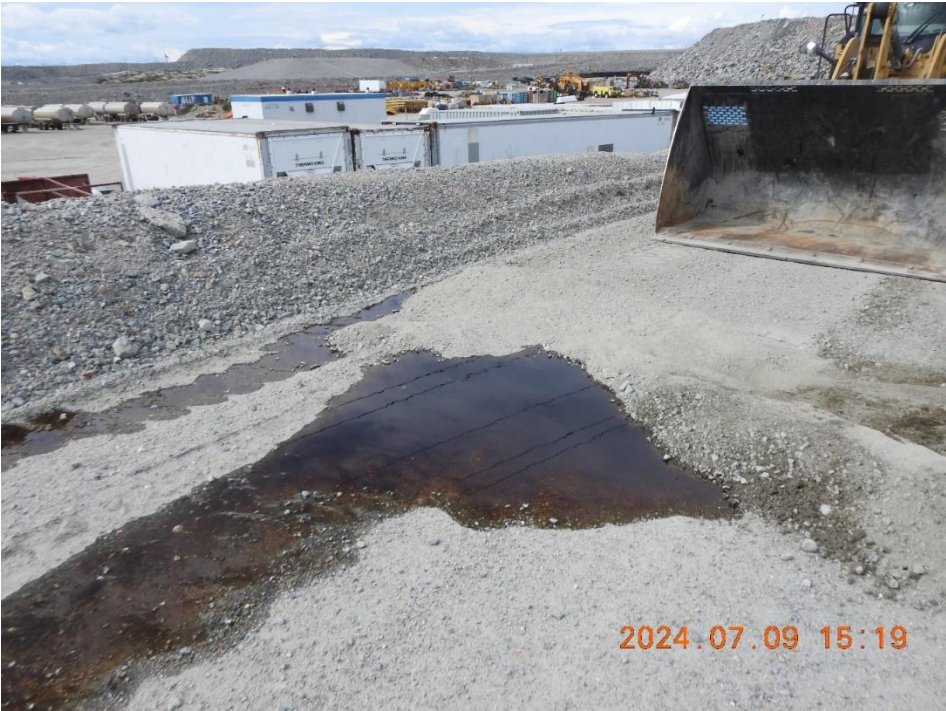
Figure 5: Rapid construction of gravel berm to limit downhill flow of spill

- Source of spill identified and stopped in field by operator
- Gravel berm immediately constructed to stop downhill flow of spilled material (figure 5)
- Spilled material was cleaned up (figure 6) and disposed of in the landfarm
- Spill reported to Environment Department

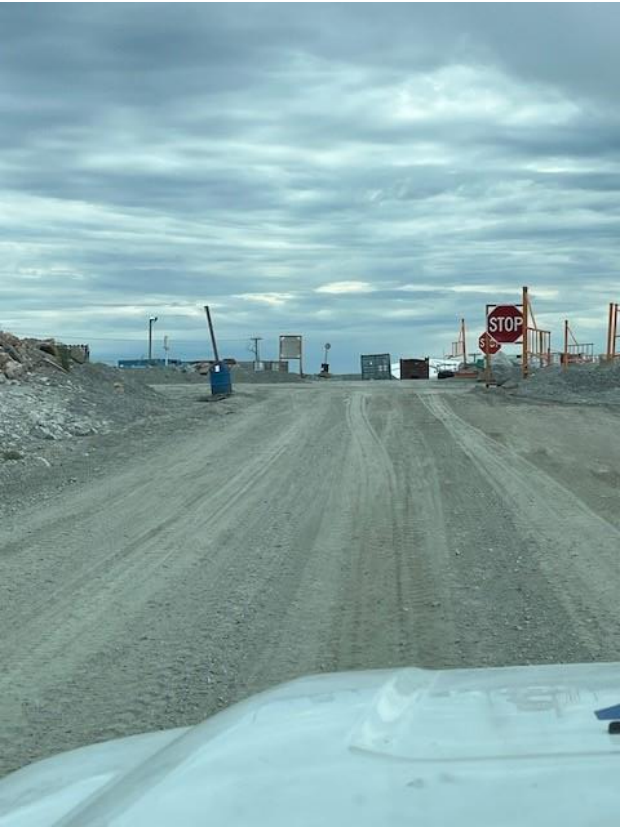
Figure 6: Spill area post-clean up
