20 August 2024

Our reference: DDMI Incident number 4088576141_41971
Your reference: GNWT Spill 2024285

Subject: Follow-up to GNWT Spill report 2024285

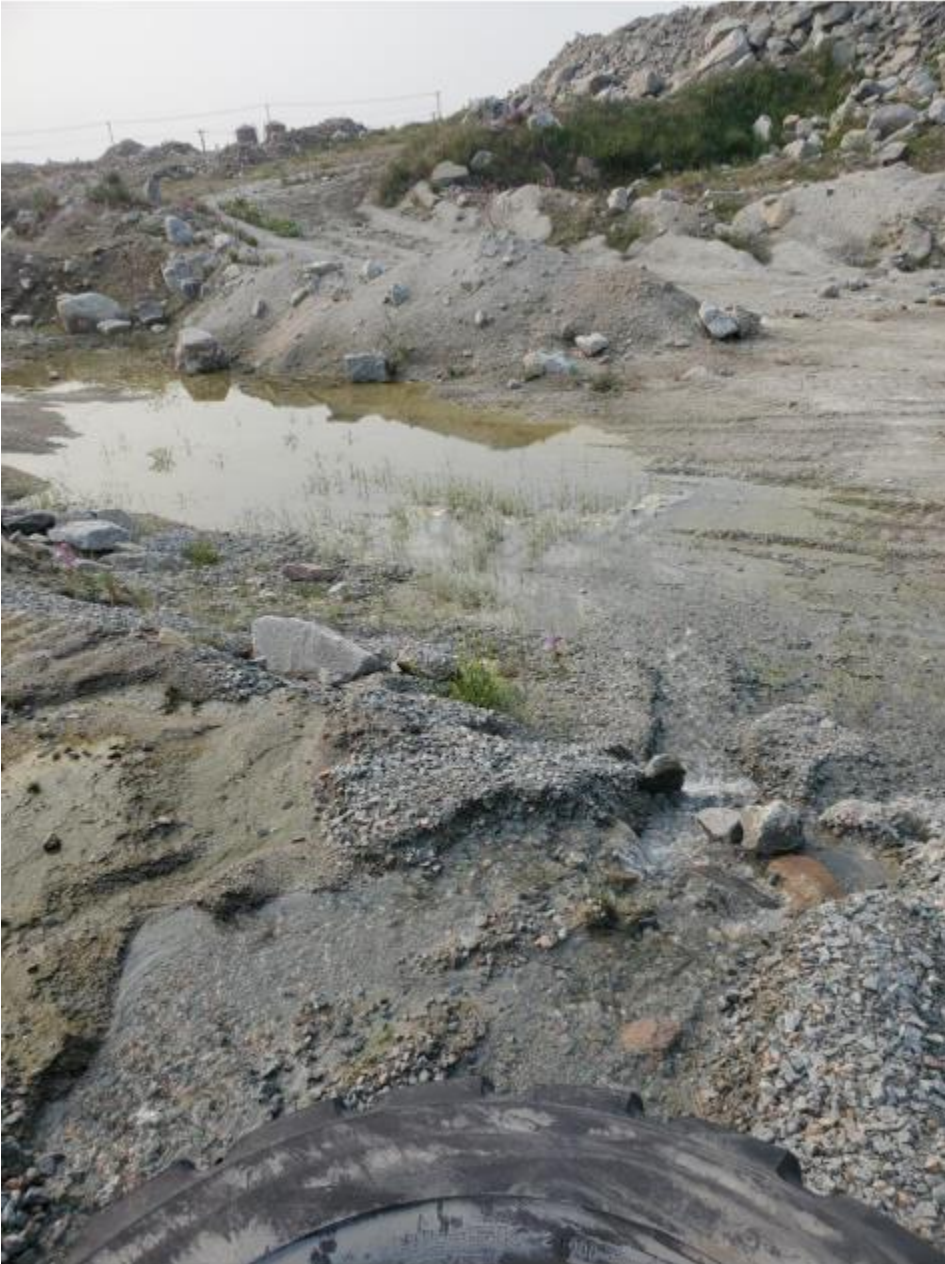
- On 23 July 2024, at approximately 3:30 pm, a Surface Geotechnical employee working in the area near the North Inlet Water Treatment Plant reported a leak in the Process Plant Wet Well pipeline (Figure 1).
- Upon further investigation, it is estimated the leak began at approximately 9:30 am on 21 July 2024.
- Approximately 2,800 m³ of mine contact water was released and pooled approximately 10 m away from pipeline failure (Figure 2). Leak occurred at a portion of pipeline that was enclosed in a berm, causing the spill to not be visible from regular operating areas.
- Initial investigation determined that the spill was a result of a blown gasket inside flange insulation (Figure 3) caused by an over-pressure in the line.
- All spilled material was contained within the Drainage Control and Collection System (DCCS) and no material was released to the receiving environment.

Figure 2: Spilled material exiting berm and pooling.

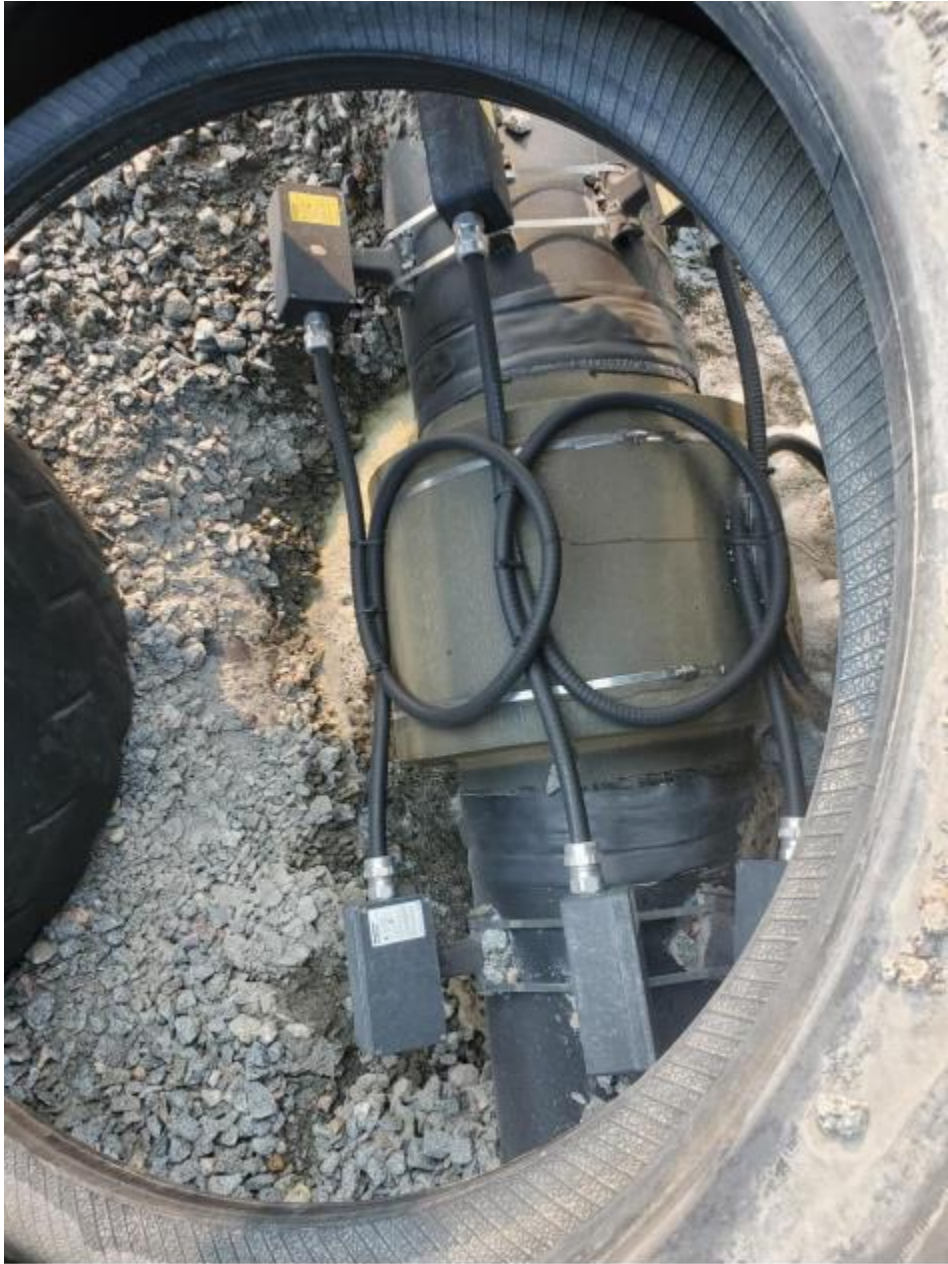
Figure 3: Location of spill after pipeline flow was turned off.

- Upon discovery of leak, Process Plant Control Room was notified and pumps on the line were shut off.
- Spill reported to Environment Department.
- System isolated and drained.
- Investigation into cause of leak conducted by maintenance crew.

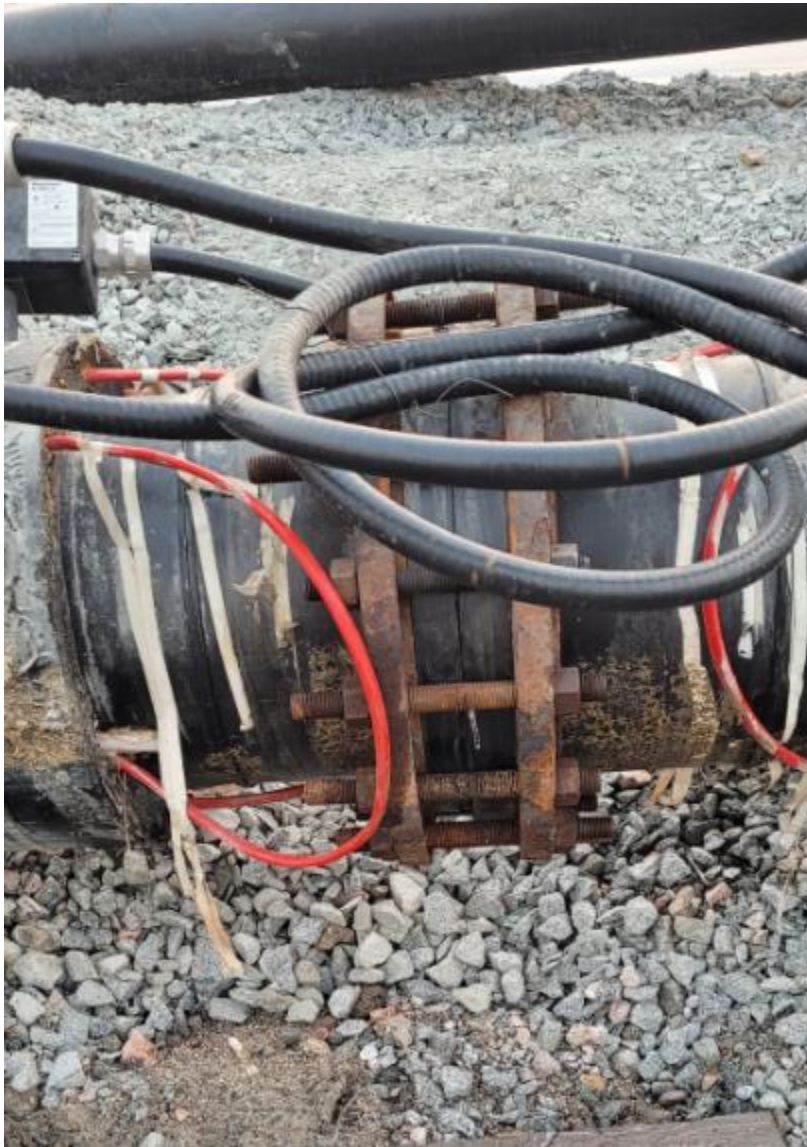
Figure 4: Failed gasket removed and joint bolted.

- Diavik reported spill to online spill reporting line and notified the GNWT-ECCC Inspector.
- Pipeline failure repaired. Gasket component removed entirely and pipeline joint bolted together to prevent future leaks at location of failure (Figure 4).
- Signage posted on Collection Pond pump shacks requiring operators to call Process Plant Control Room before starting pumps.
- Prioritized inspection of HDPE pipe gaskets where the pipes are in close proximity to Lac de Gras.
