**Land Use Permit
W2016D0003
Sable Development**

Re: June 12th 2017 Land Use Permit Inspection W2016D0003

ENVIRONMENTAL INSPECTION REPORT

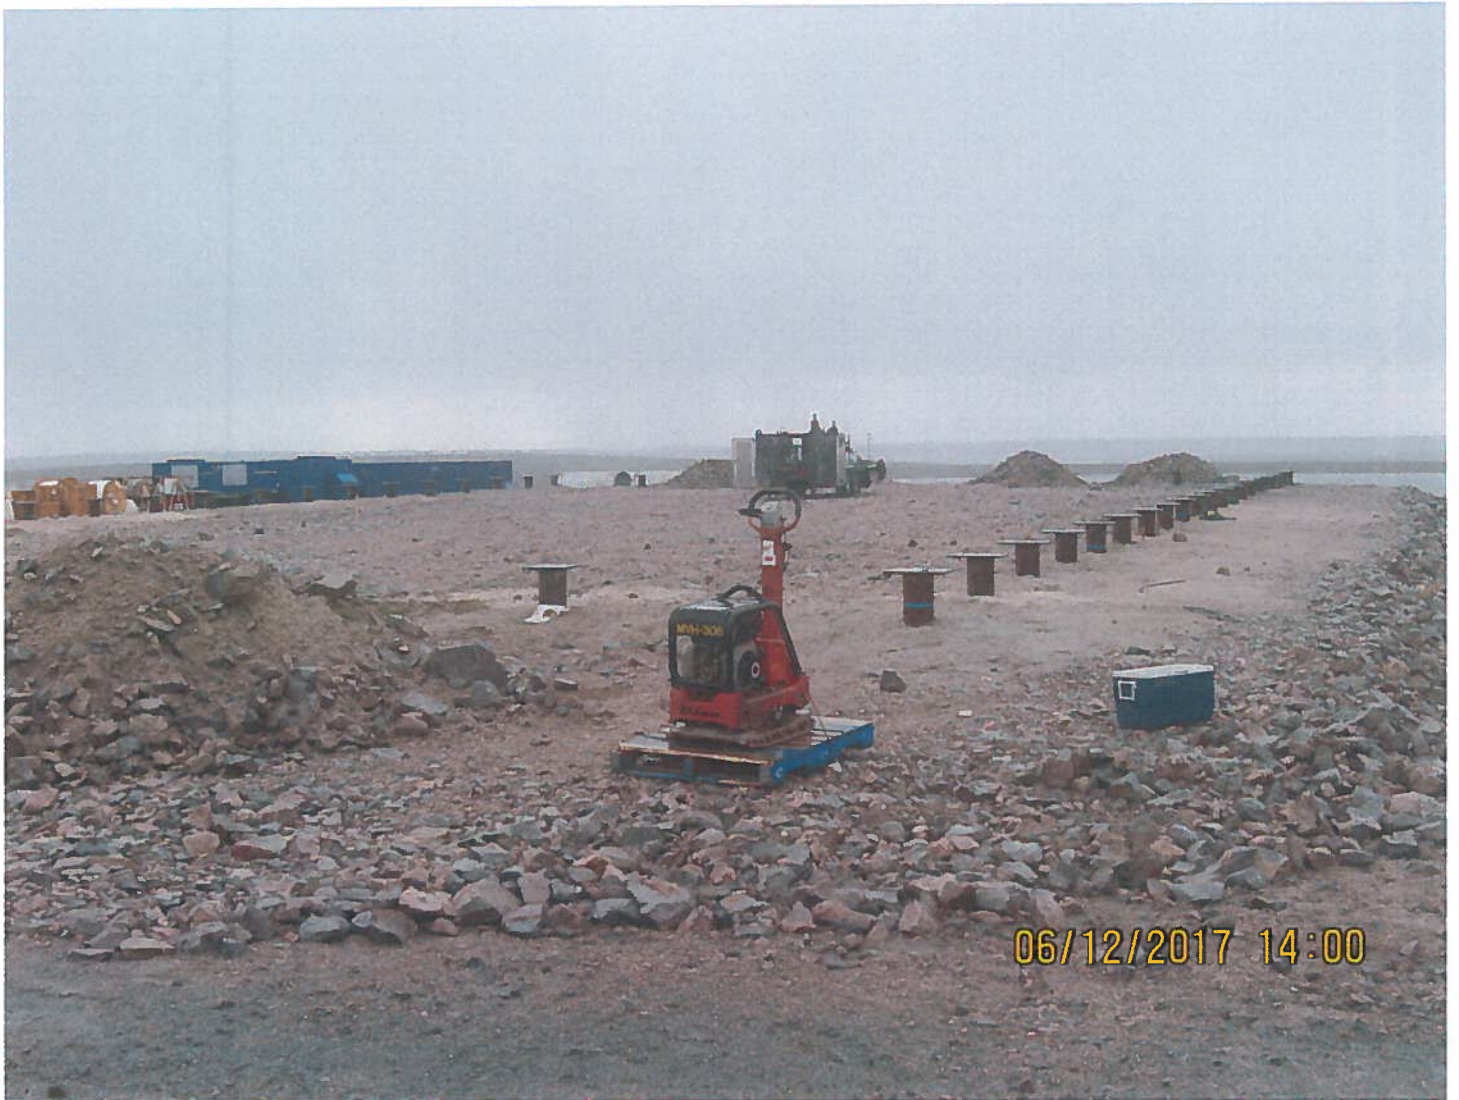
The Sable Office Complex is being used as a lunchroom, washroom, first aid station and emergency accommodations. Breakaway drilling installed foundation pilings for the Maintenance shelter. The piling work was started in mid-May and took approximately 3 weeks to complete (Photo 1). Rig mats will be installed in mid-July for the flooring of the building. Construction of a Chamco building (maintenance shelter) will start once the flooring is done and the building will be completed by the end of September. The footprint of this shelter will be 30 x 70 meters.

Photo 1: Sable Office Complex - Pilings have been installed for the new Chamco Building that will be installed this summer. The building will be used as a Maintenance building for equipment.

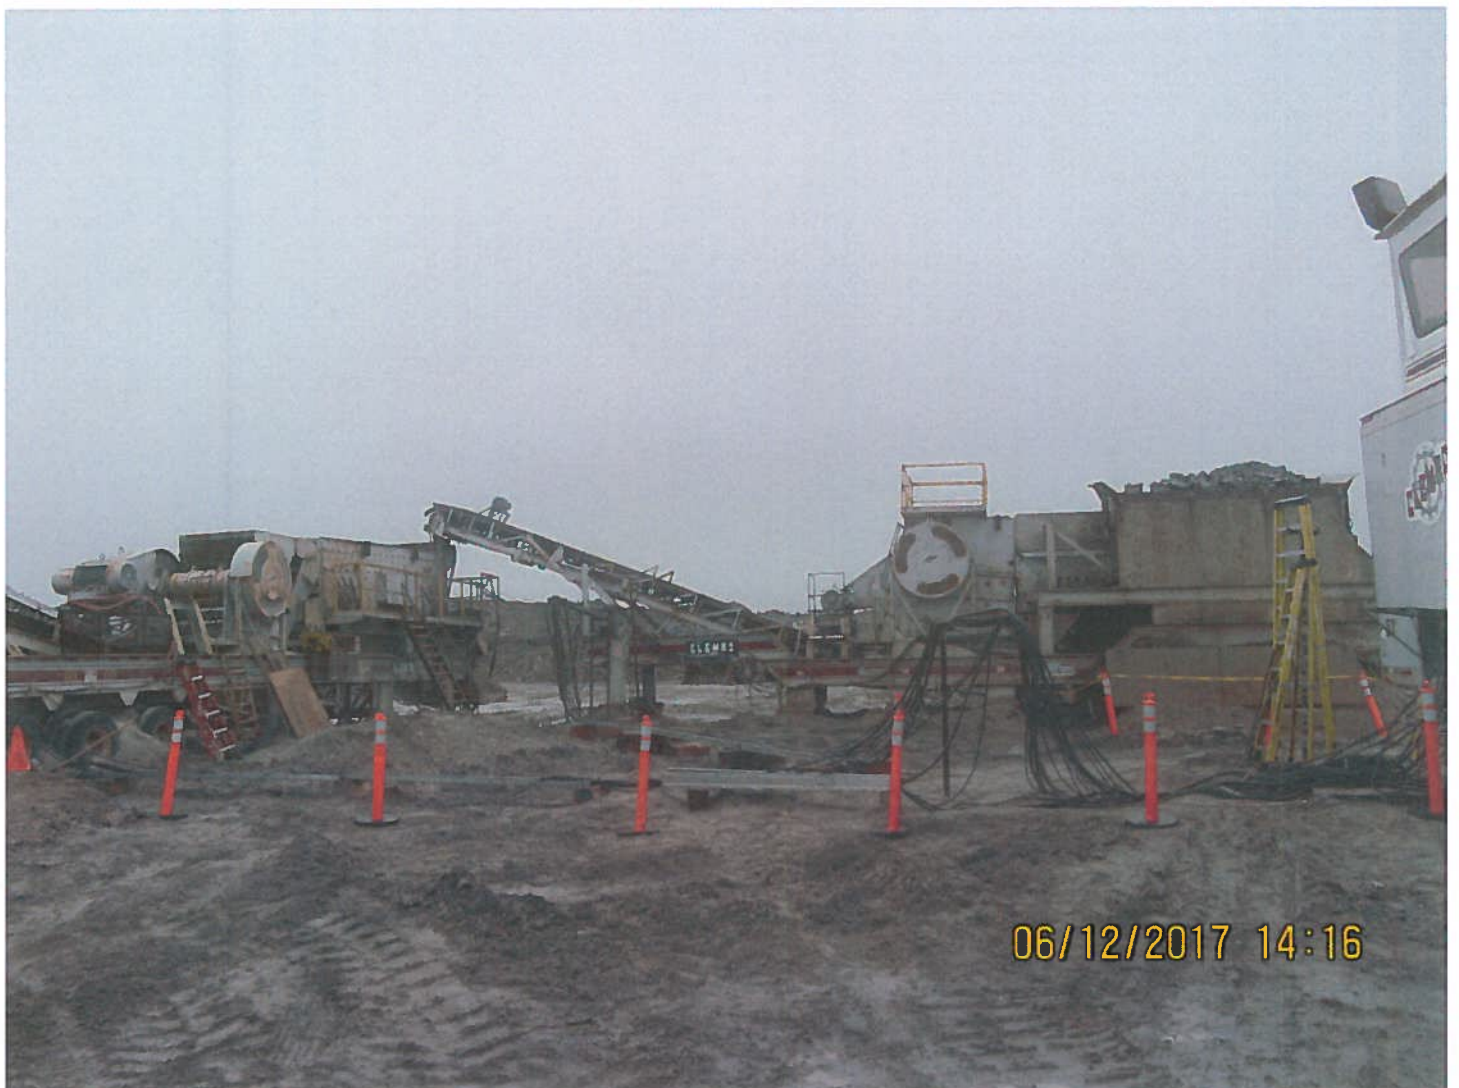
The Sable Crusher was in operation during this inspection (Photo 2). The crusher started up in the first week of June and will be crushing material for the various projects on site. The Frozen Core Plant will be decommissioned and taken down in the first week of July 2017.

Photo 2: Sable Development - The Crusher at Sable started in the first week of June. Crushed rock of various sizes will be used for several projects at the Sable Development.

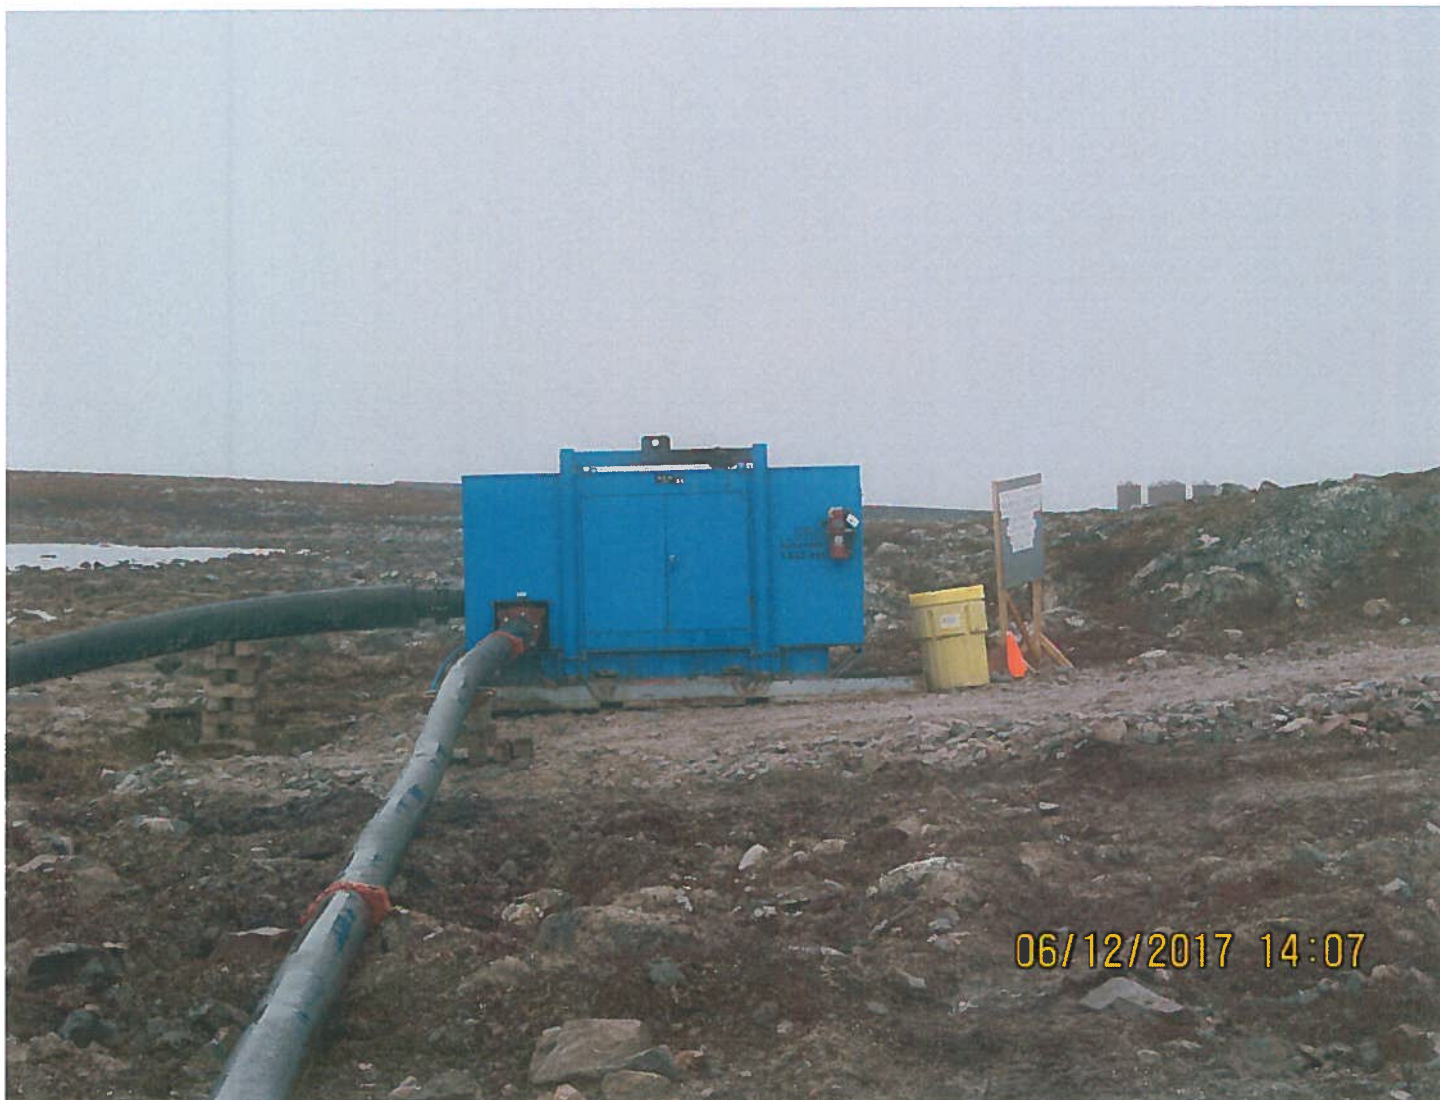
Dewatering of Sable Lake started on June 8th 2017. The Inspector noted a HL250 Pump in secondary containment on the shoreline of Sable Lake (Photo 3). The pump is refueled daily by mobile refueling equipment. The Pump also had a fully stocked spill kit in close proximity. A 10" HDPE pipe was joined together and runs from Sable to Ulu lake. The pipeline and pump are inspected daily by DDEC environmental staff (Photo 4). No concerns were noted. Pumping, Effluent Quality Criteria (EQC) and drawdown rates are inspected/monitored under Water Licence WL2012L2-0001.

Photo 3: Sable Lake - A dewatering Pump was set up at Sable Lake to remove water from Sable to Ulu Lake. The pump is in secondary containment and a Spill kit was in close proximity.

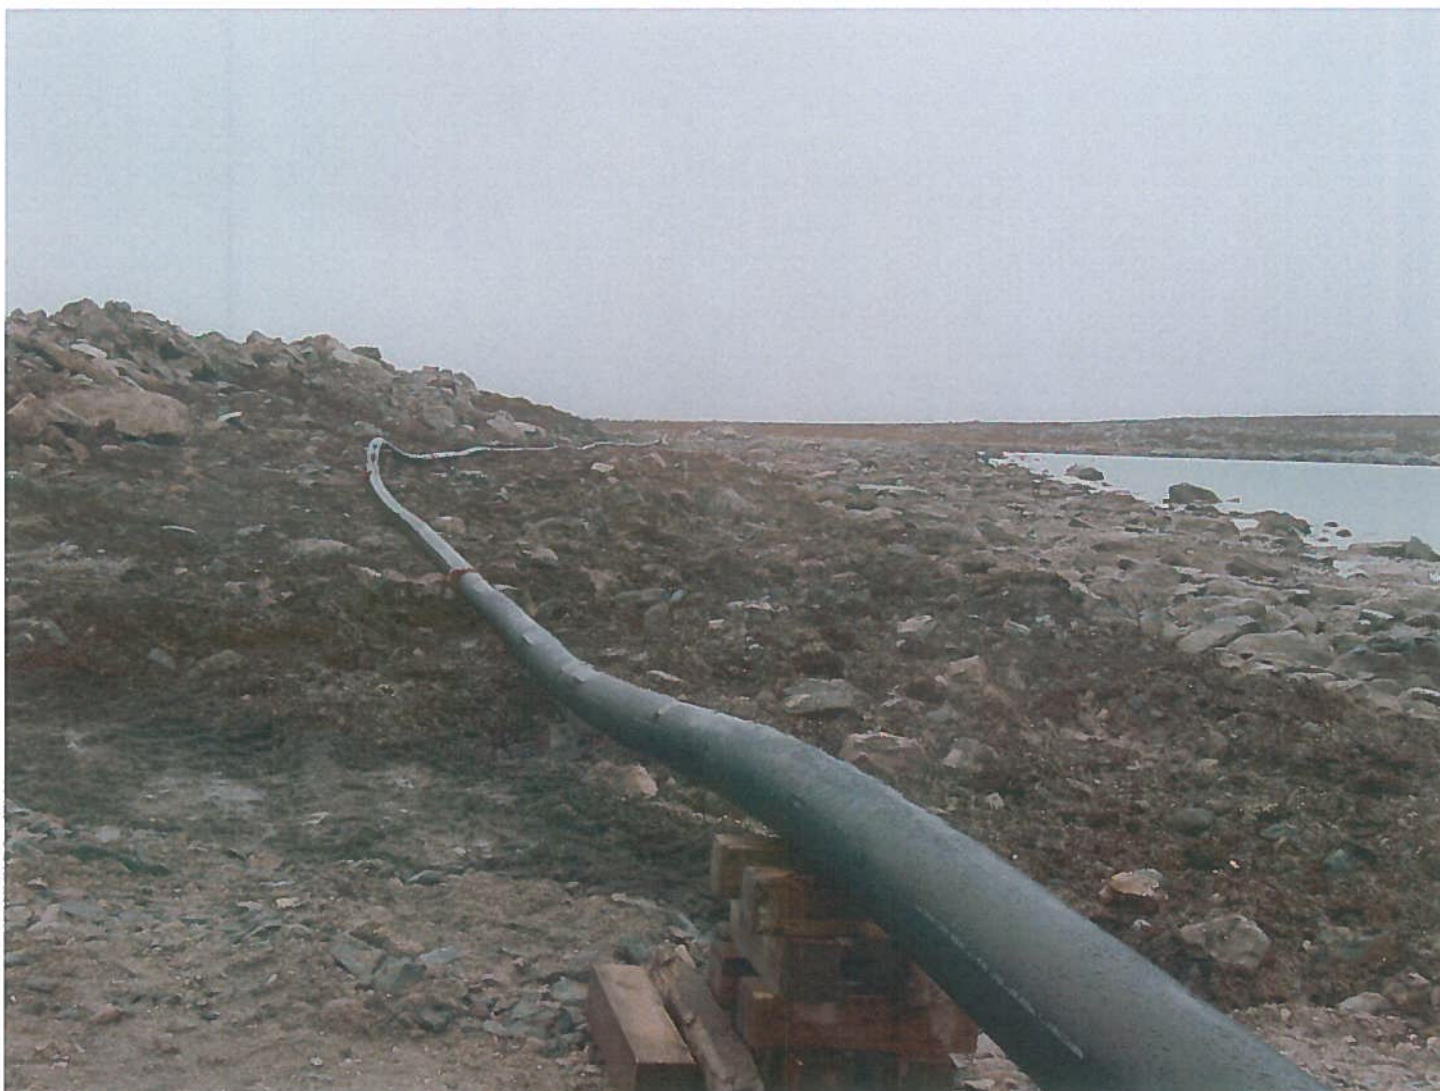
Photo 4: Sable Lake Dewatering Line- A 10" HDPE line was joined together in sections from Sable to Ulu Lake. The dewatering line is inspected daily for leaks by DDEC environment staff.
