**Dominion Diamond Ekati Corporation**

**Land Use Permit  
W2016D0003  
Sable Development**

**Re: March 6<sup>th</sup> 2017 Land Use Permit Inspection W2016D0003**

## ENVIRONMENTAL INSPECTION REPORT

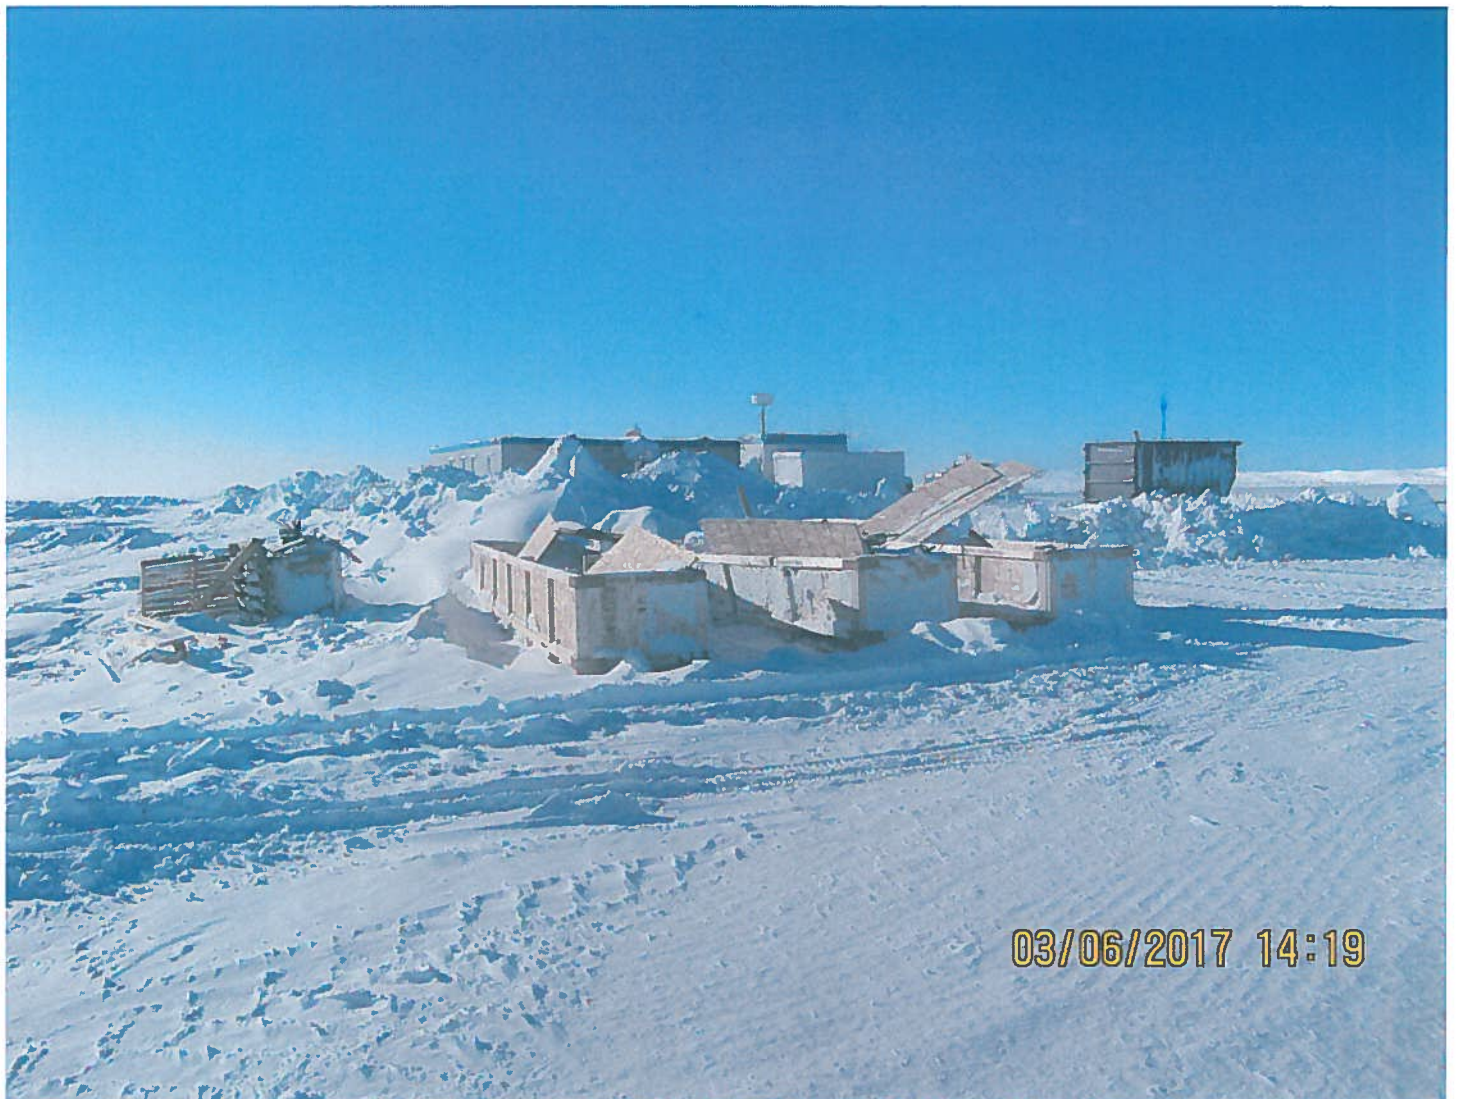
The Sable Office Complex is being used as a lunchroom, washroom, first aid station and emergency accommodations. All vehicles located on the Truck Parking Facility were inspected and no concerns were noted. The parking facility is being maintained. Several crates and pallets were noted at the parking facility. The crates/pallets/scrap steel and wood debris will need to be disposed of to an approved facility (Photo 1).

Photo 1: Sable Office Complex - Several crates and pallets were noted at the parking facility. The crates/pallets/scrap steel and wood debris will need to be disposed of to an approved facility

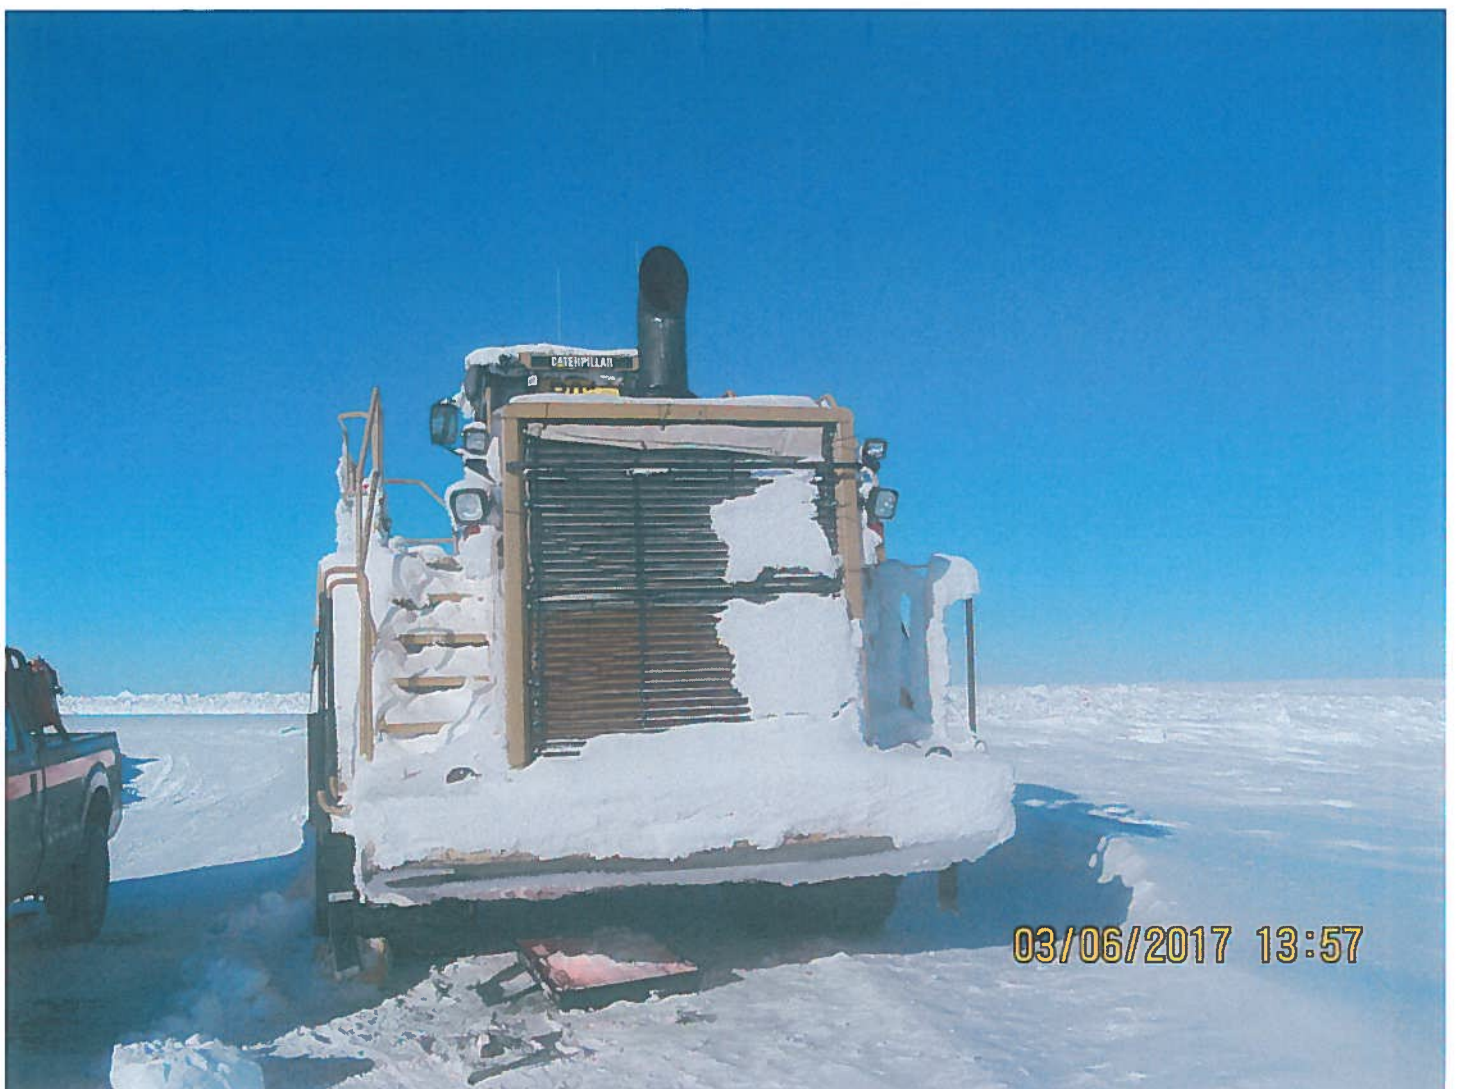
The Falcon Access Road was inspected and the Inspector noted a R015 988 Loader parked at the entrance (Photo 2). The Inspector was informed that the unit requires a new water pump. A drip tray was located under the unit to catch any drips (glycol). The ice around the spill location had been scraped up and contaminated snow was placed in the drip tray. The Inspector was informed that the unit will be repaired on location and the contents of the drip tray will be disposed of to an approved facility in the near future.

Photo 2: Falcon Lake Road - A loader ( R015 988 ) was located on the Falcon Lake access road. Repair work will be conducted shortly. Glycol spill will need to be disposed of to an approved facility.

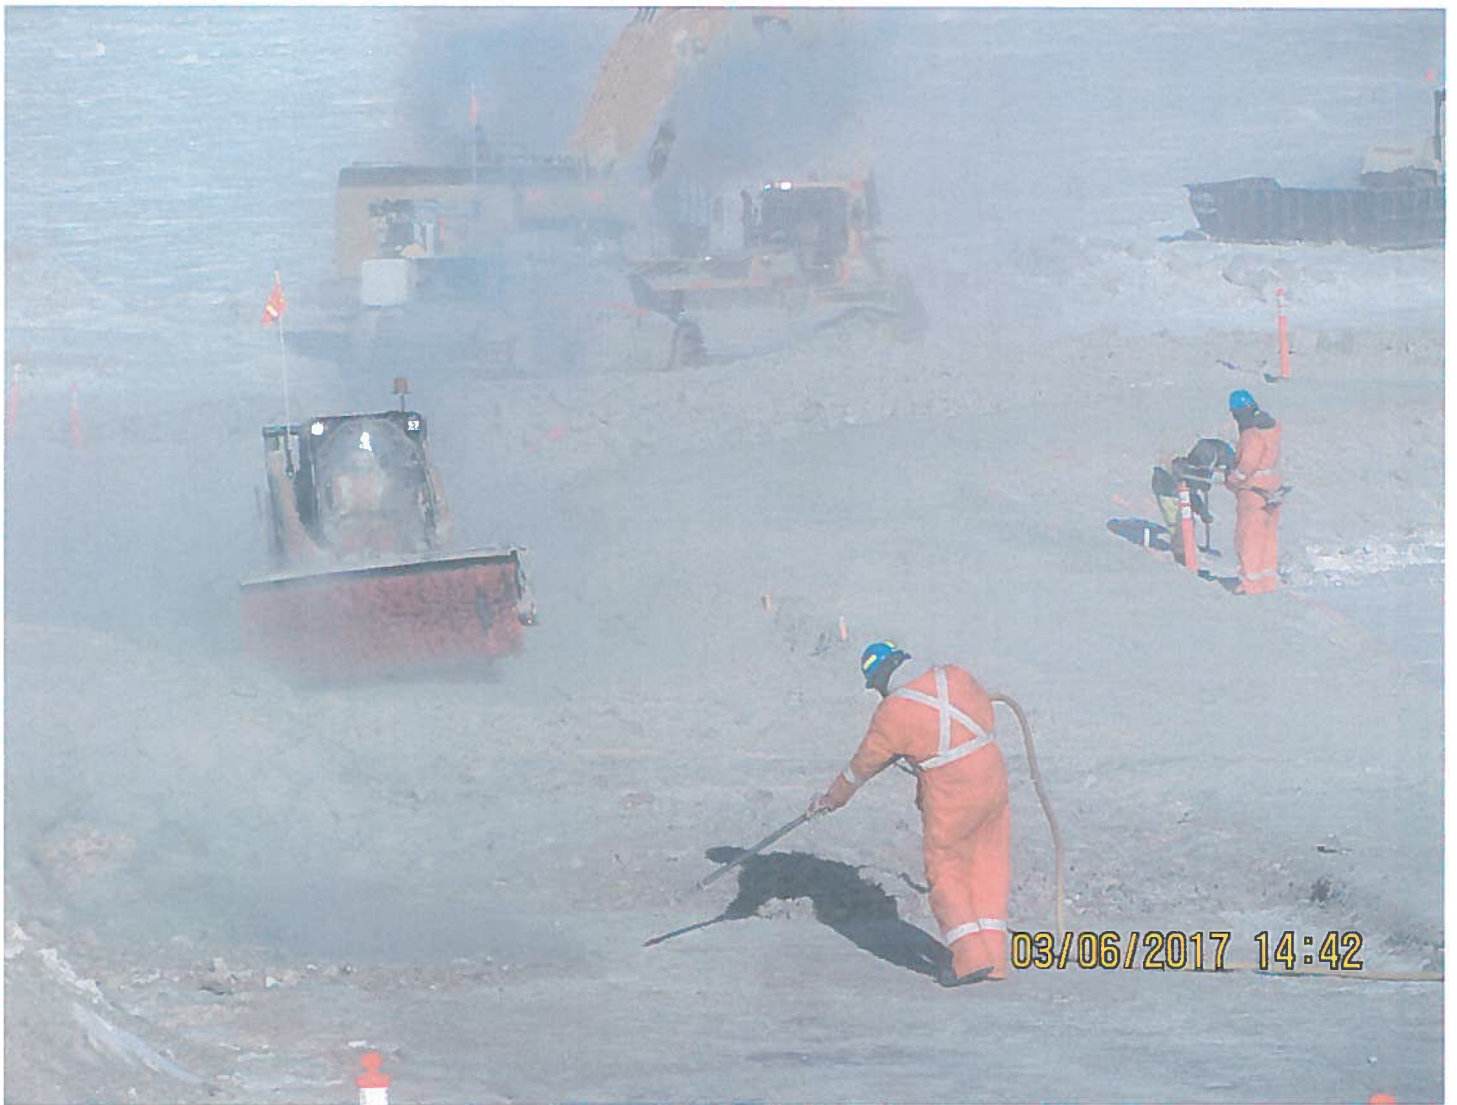
The Inspector was informed that slurry (3/4" granite/fines/water) will continue to be placed in the two rock frozen core dam for approximately one more week (March 12<sup>th</sup>). A 1 meter layer of <200mm crush will be placed over the frozen core and an additional 3 meter layer of Run of Mine (ROM) will cap the project. March 31<sup>st</sup> 2017 is the scheduled completion date for the Two Rock Frozen Core Dam project. Five vertical ground temperature monitors will also be installed in the Frozen core dam to monitor temperature conditions. An addition four vertical ground temperature monitors will be installed in the future. The Inspector observed Nuna staff removing snow from the trench by a brush attachment on a bobcat and by hand with compressed air (Photo 3). A clean surface is required to ensure the layers of slurry bond together.

Photo 3: Two Rock Frozen Core Dam - Nuna staff are preparing the surface of the frozen core dam. The surface is being cleaned by a bobcat with a brush attachment and by compressed air. A clean surface is required to ensure the layers of slurry bond together.

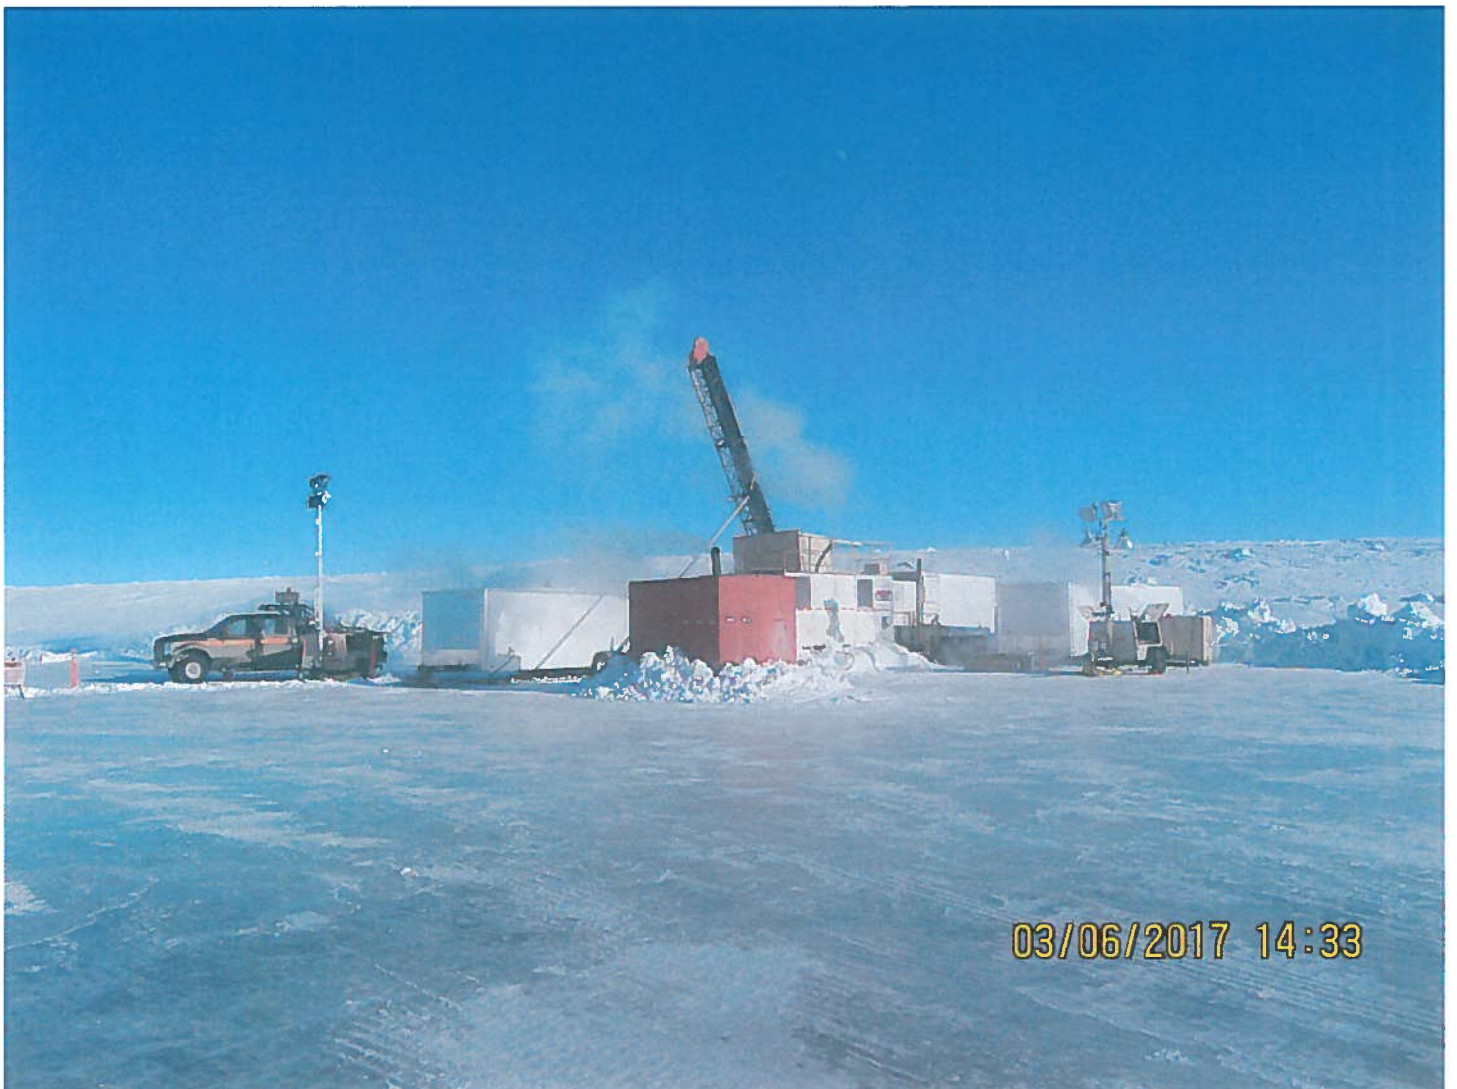
The Inspector has been receiving weekly updates on the progress of the drill program. DDEC is also conducting internal inspections on a weekly basis. An inspection will be conducted once the final clean-up of Sable Lake is conducted. The Drill was positioned over SB17-D during this inspection (Photo 4).

Photo 4: Sable Lake - Geotechnical Drilling was observed during this inspection on Sable Lake over hole SB17-D. Five holes have been completed to date. Final hole to drill will be SB17-C.
