**Land Use Permit
W2016D0003
Sable Development**

Re: October 18th 2017 Land Use Permit Inspection W2016D0003

ENVIRONMENTAL INSPECTION REPORT

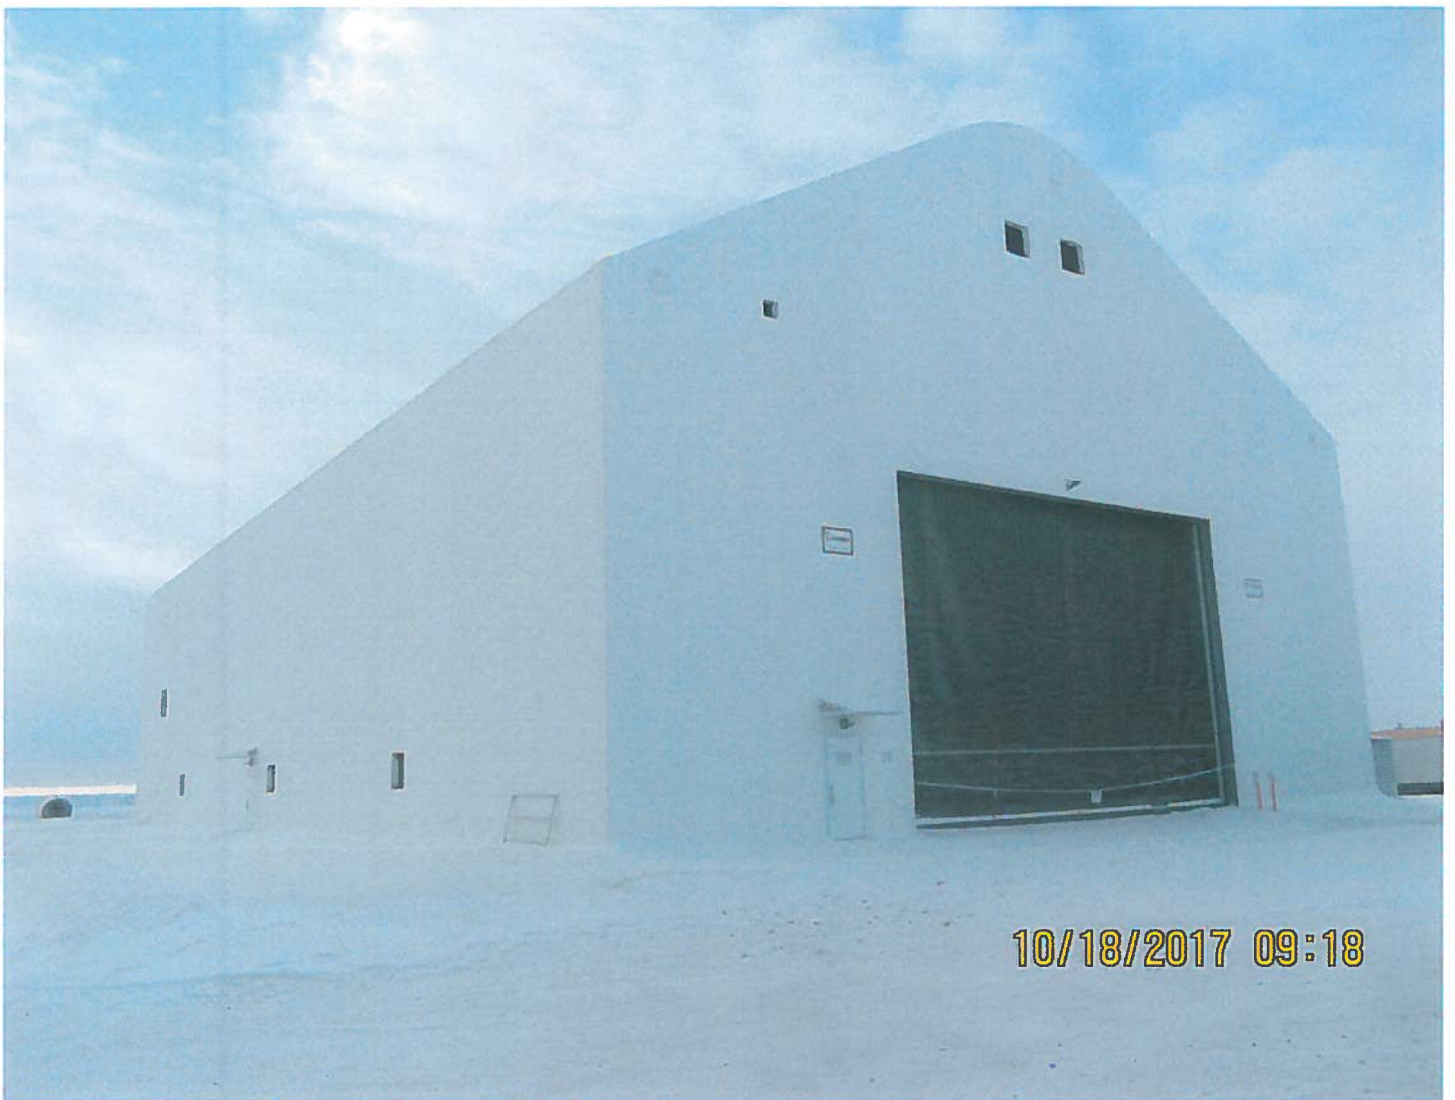
Photo 1: Sable Office Complex - The exterior of the maintenance shelter has now been completed. The electrical and mechanical will be connected in the future.

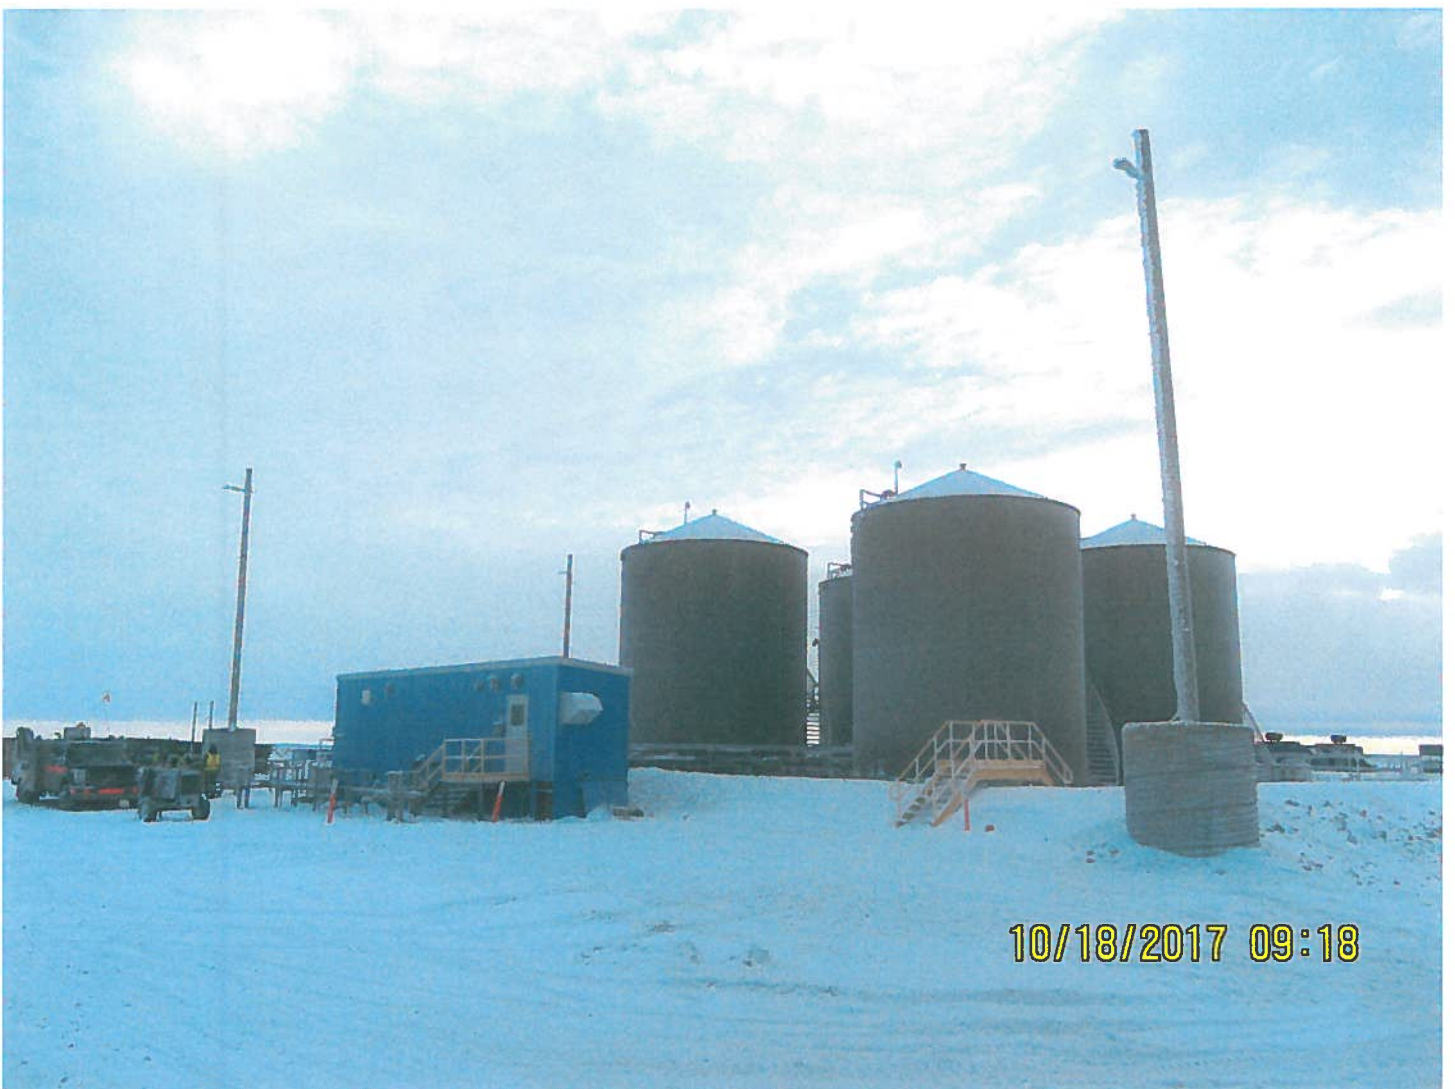
Photo 2: Sable Office Complex - Work with fuel piping and electrical continues within the 4 - 500,000 Litre fuel tank berm. The refuelling facility will be functional in the near future.

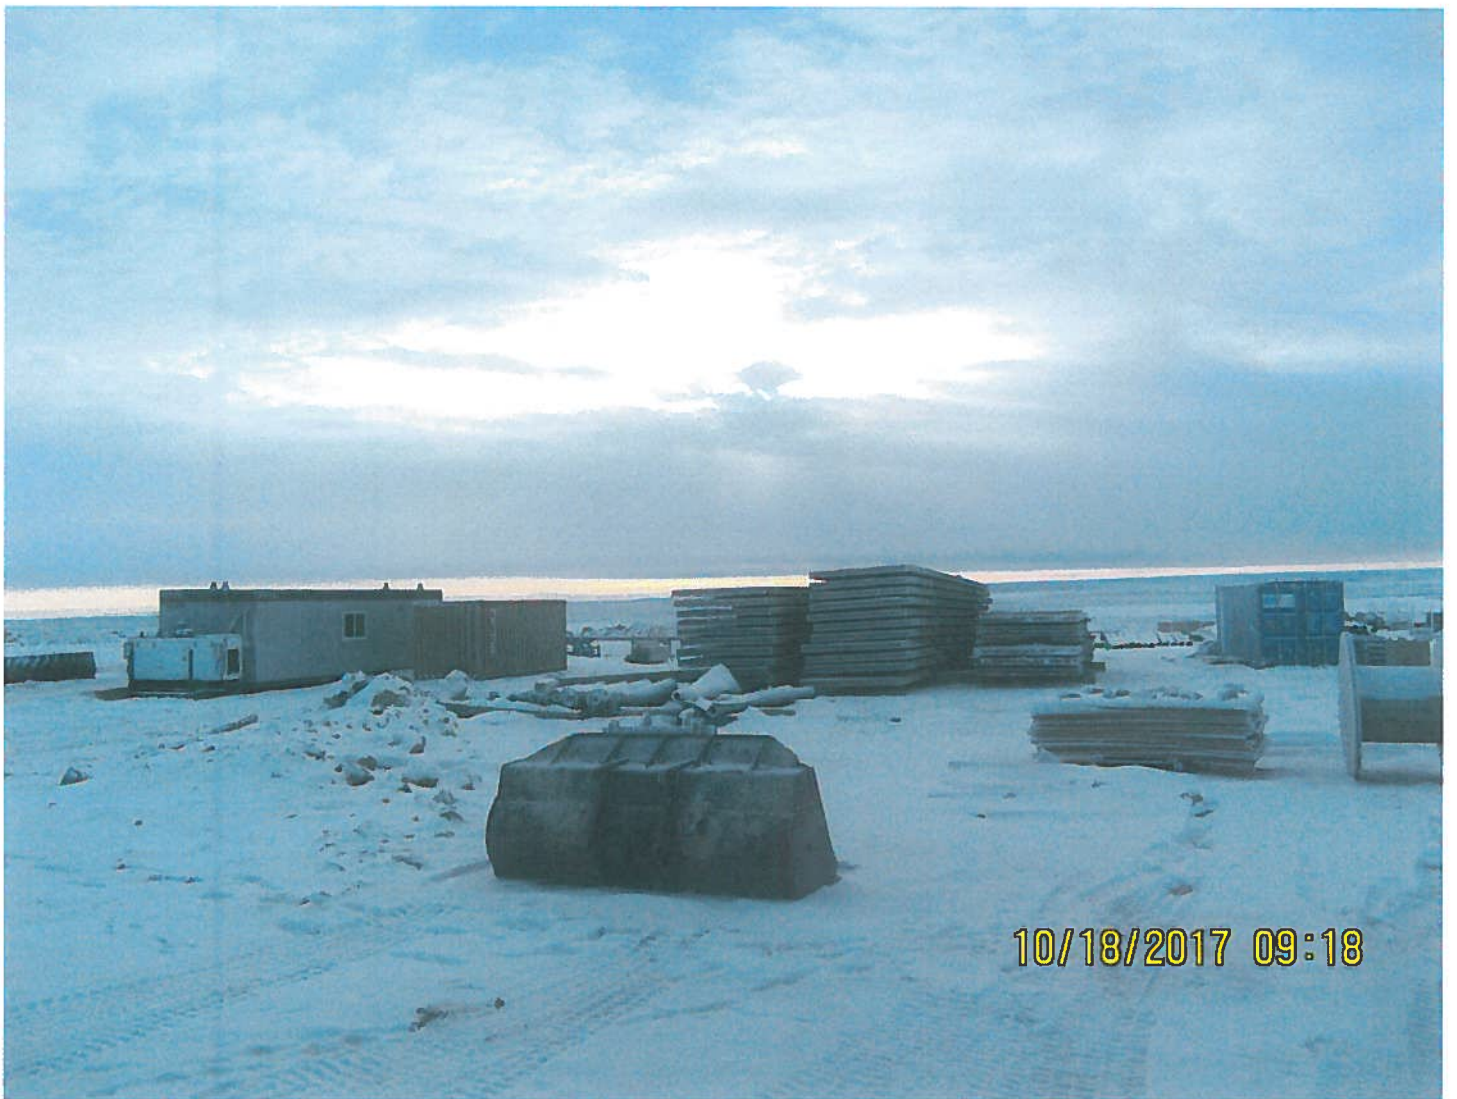
Photo 3: Sable Office Complex Laydown Area - The Sable Office Complex Laydown area was inspected and no concerns were noted.

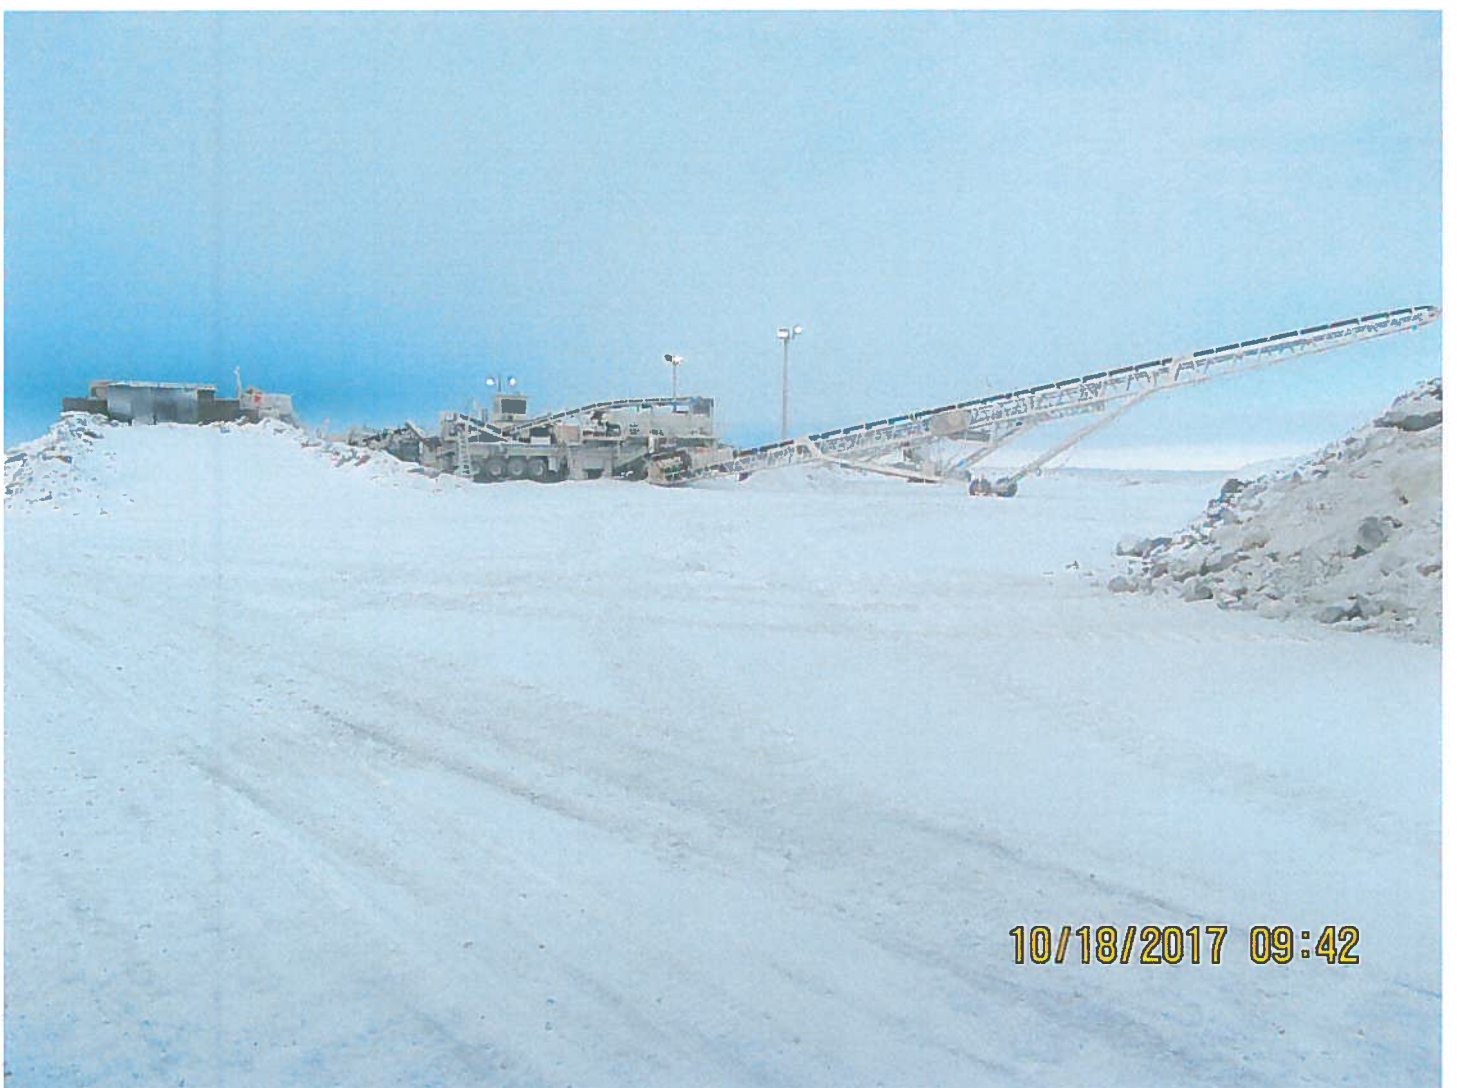
Photo 4: Sable Crusher Laydown Area - A crusher from the Misery facilities was relocated to the Sable Crusher pad. The crusher will be producing clean granite material required for stemming.

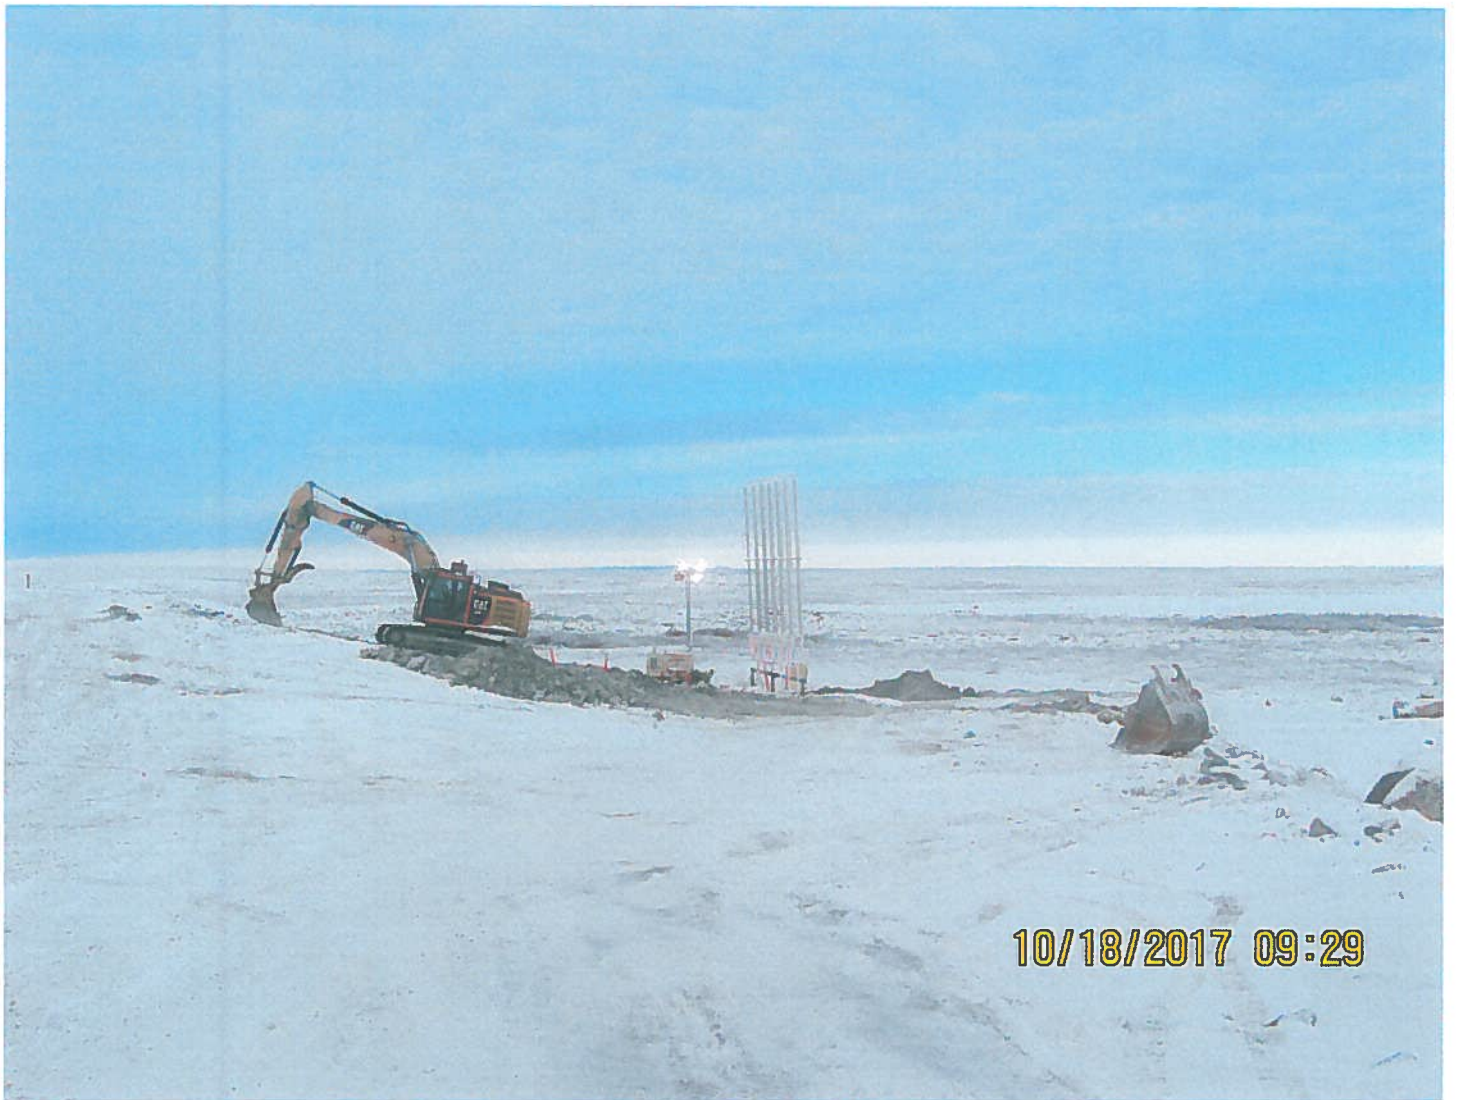
An excavator was observed working on the downstream side of the Frozen Core Dam (Photo 5). Repair work was being conducted on a small section of the dam. Additional material on the eastern section was added and the dam is being contoured as per design specifications. The water pump that was installed in a containment tray on the west side of Two Rock Sedimentation Pond has now been removed (Photo 6).

Photo 5: Frozen Core Dam - An excavator was observed working on the downstream side of the frozen core dam. Repair work was being conducted on a small section of the dam.

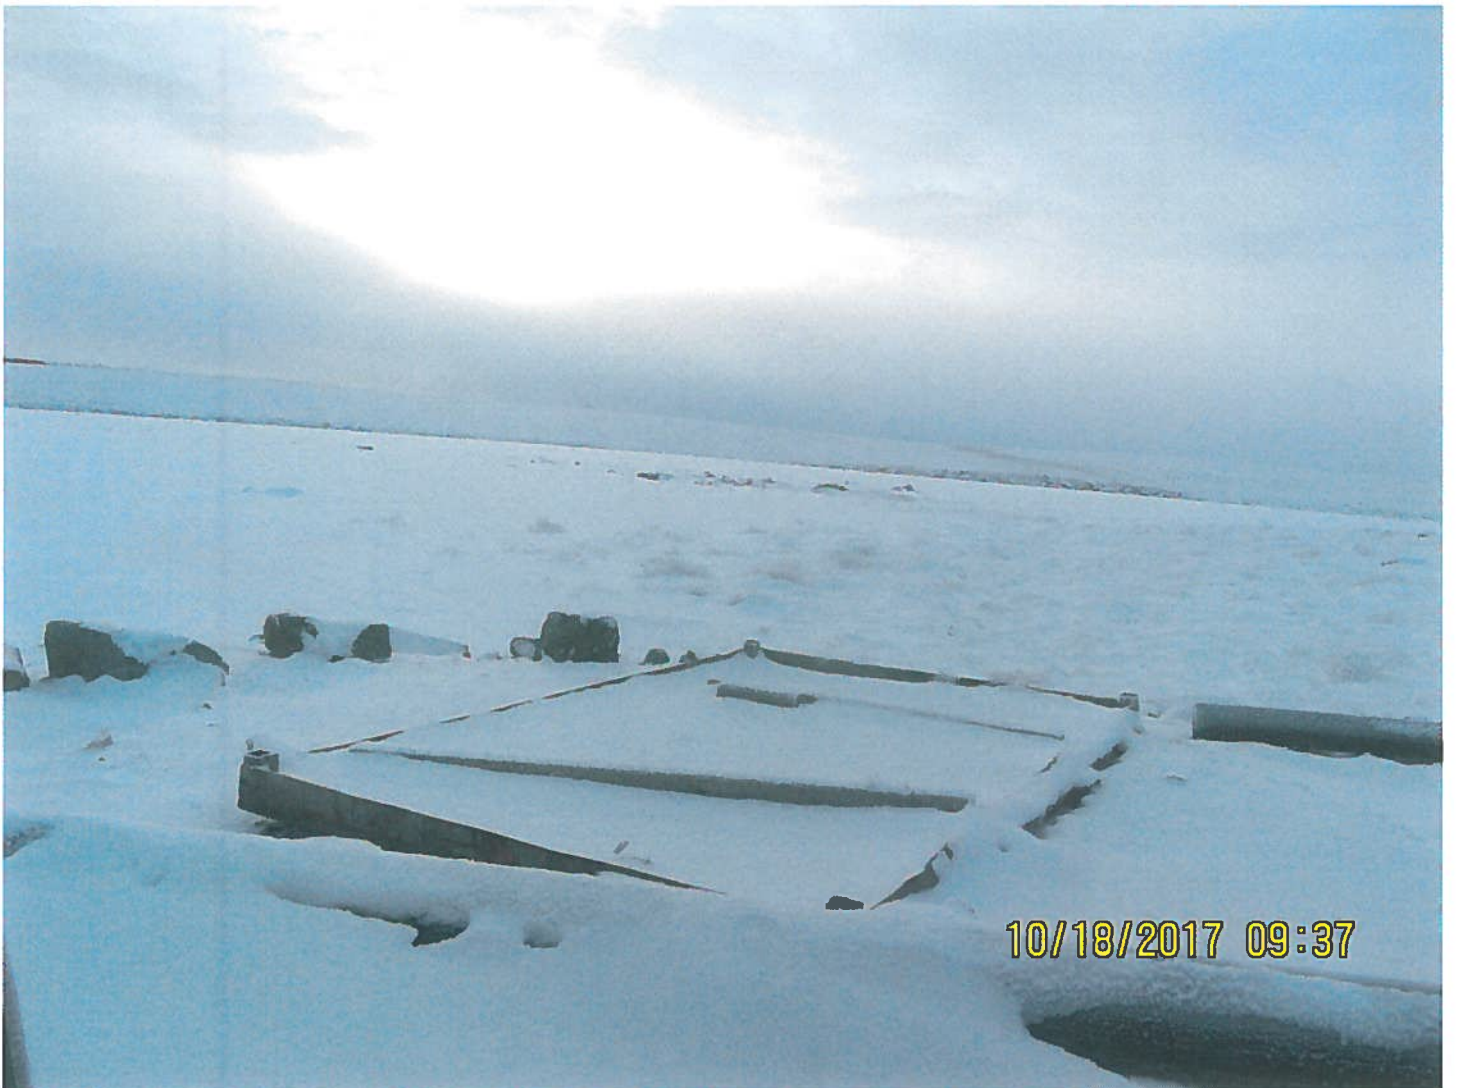
Photo 6: Two Rock Sedimentation Pond - The water pump that was installed in this containment tray on the west side of Two Rock Sedimentation Pond has now been removed.
