**Re: Land Use Permit W2016E0004 and W2021E0007  
Road Construction (TASR) and Whati Access Road  
Tlicho All Season Road (TASR) Alignment from ~Km 196, Highway #3 to Whati, NT**

## ENVIRONMENTAL INSPECTION REPORT

Permittee:	Government of Northwest Territories – DOI	Inspection Date – October 16 <sup>th</sup> , 2024
------------	---	---

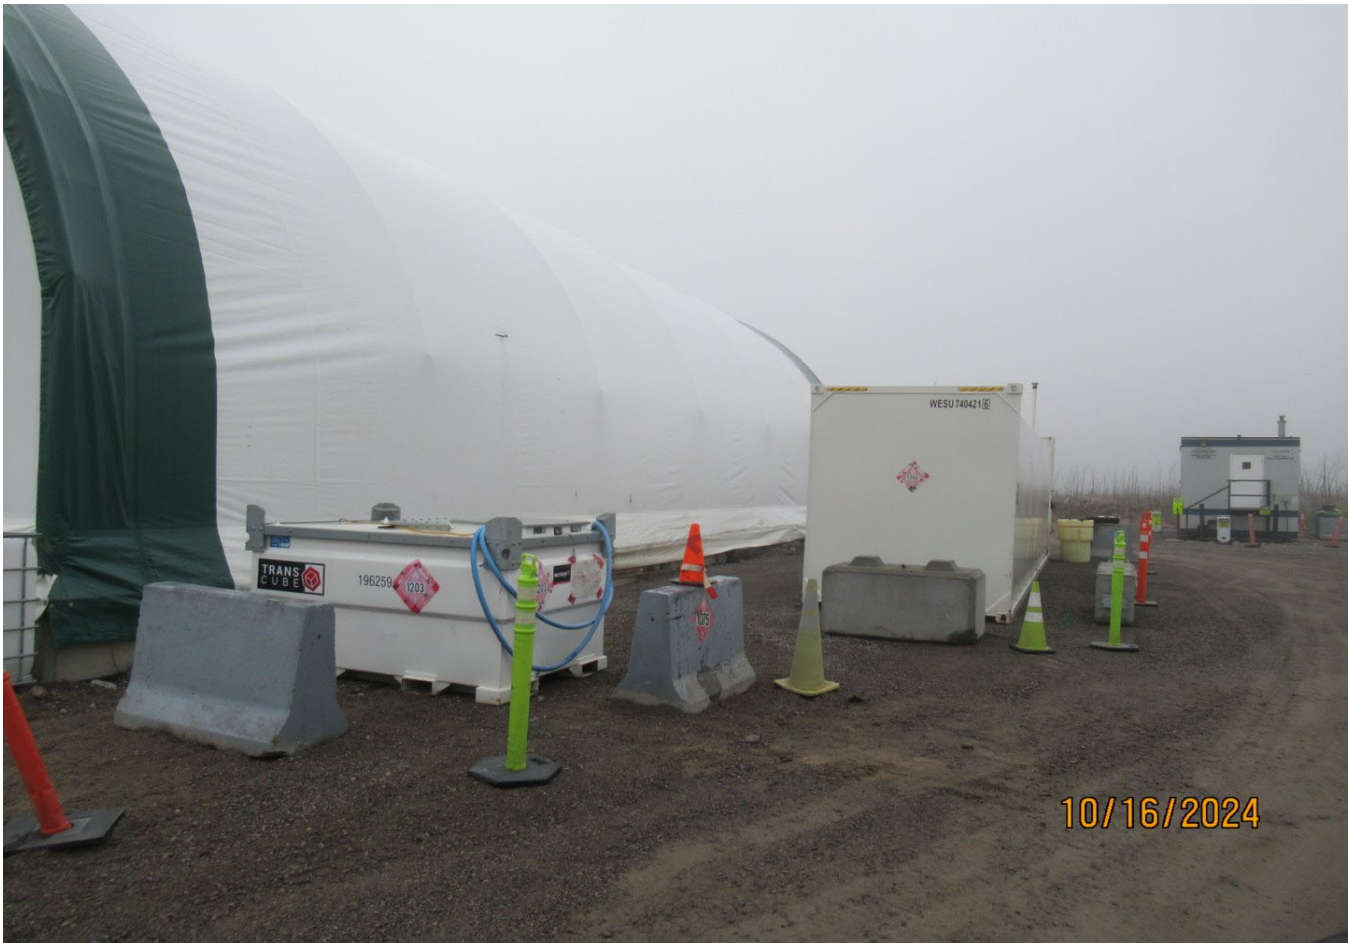
As noted in the Environmental Inspection Report dated August 1<sup>st</sup>, 2024, a minor amount of hydrocarbon impacted soils remained in the excavation below the previous location of the Transtainer (Figure 1). Additional material had to be removed to meet the applicable guidelines and once complete, a report submitted demonstrating no further environmental concerns remained.

On August 23<sup>rd</sup>, 2024 Mr. Dave Green of North Star Infrastructure (Contractor) provided the undersigned Inspector KBL Environmental Ltd.'s August 22<sup>nd</sup>, 2024 report, *Soil Assessment Highway 9 Roads facility*. Through lab analysis of the soil removed during the August 15<sup>th</sup>, 2024 excavation, it was confirmed by the Consultant that Tier 1 levels for petroleum hydrocarbons for coarse-grained surface soils (Residential) were met and no further soil removal was required.

**Figure 1**  
**Transcube and Transtainer on the northwest side of the sprung.**

Backfilling commenced shortly after receiving results from the Consultant and authorization from the Inspector. The cooperation of the Contractor (NSI) to address the concerns at the Transtainer is appreciated and it is anticipated that diligent fuel storage & handling will continue to minimize the potential for a future occurrence.

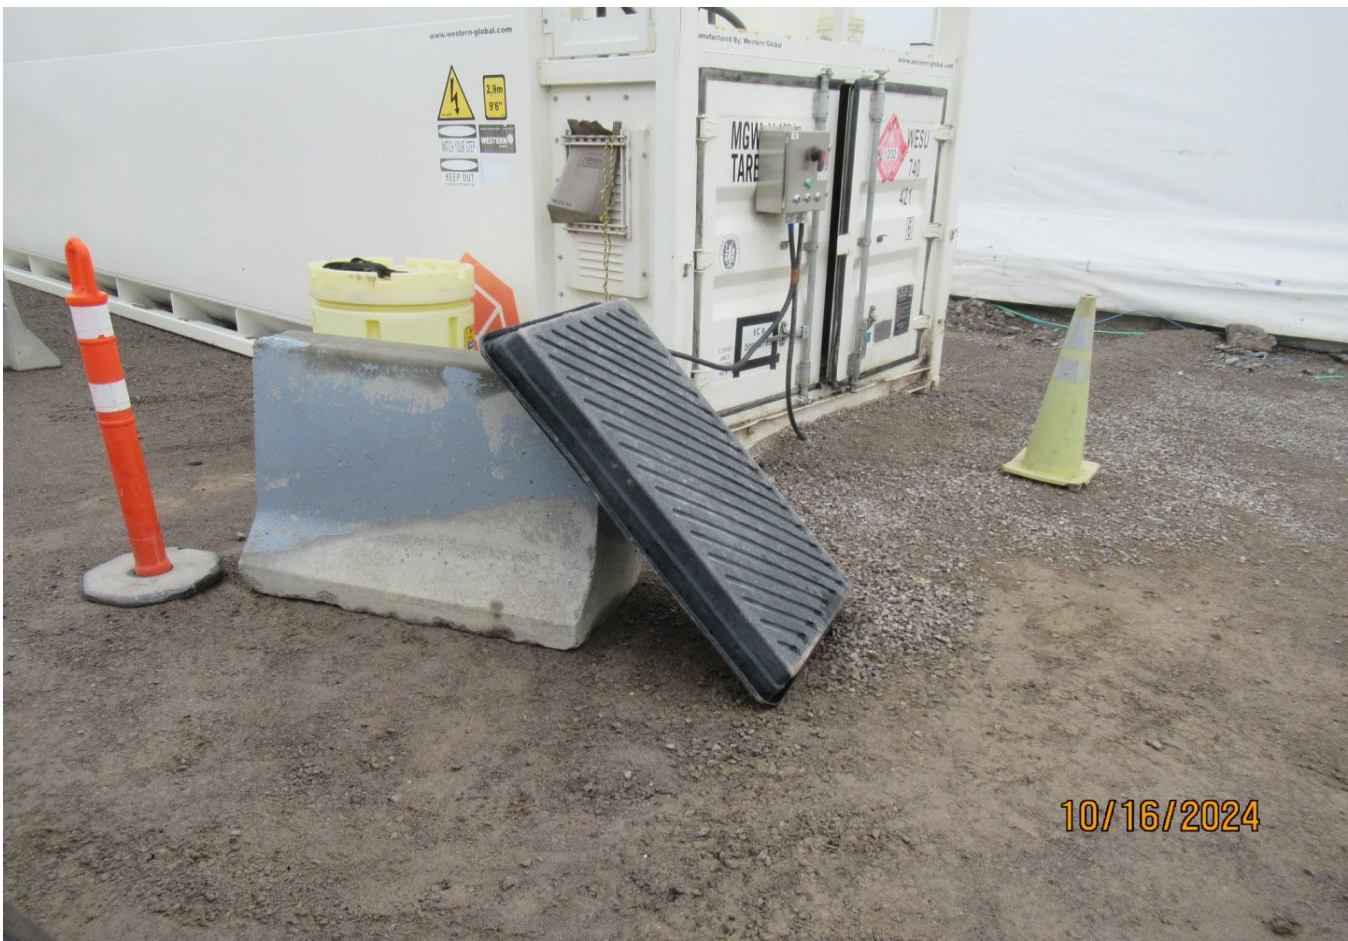
- A drip tray & spill kit were observed on the west side of the Transtainer (Figure 2) and no obvious hydrocarbon spills/stains were observed on the ground surface.
- The laydown east of the shop appeared organized with no obvious waste items present.
- All parked equipment & vehicles had drip trays present (Figure 3).
- The Inspector was informed by Mr. Devon Stephenson (NSI) that the eighteen (18) office connex units will be decommissioned and demobilized from the land use area at the very earliest opportunity (Figure 4).
- Other infrastructure to be demobilized is the generator connex and the wash cart once the two new ATCO trailers viewed in Figure 5 are operational.

**Figure 2**  
**Spill kit and drip tray are present for use on the south side of the Transtainer.**

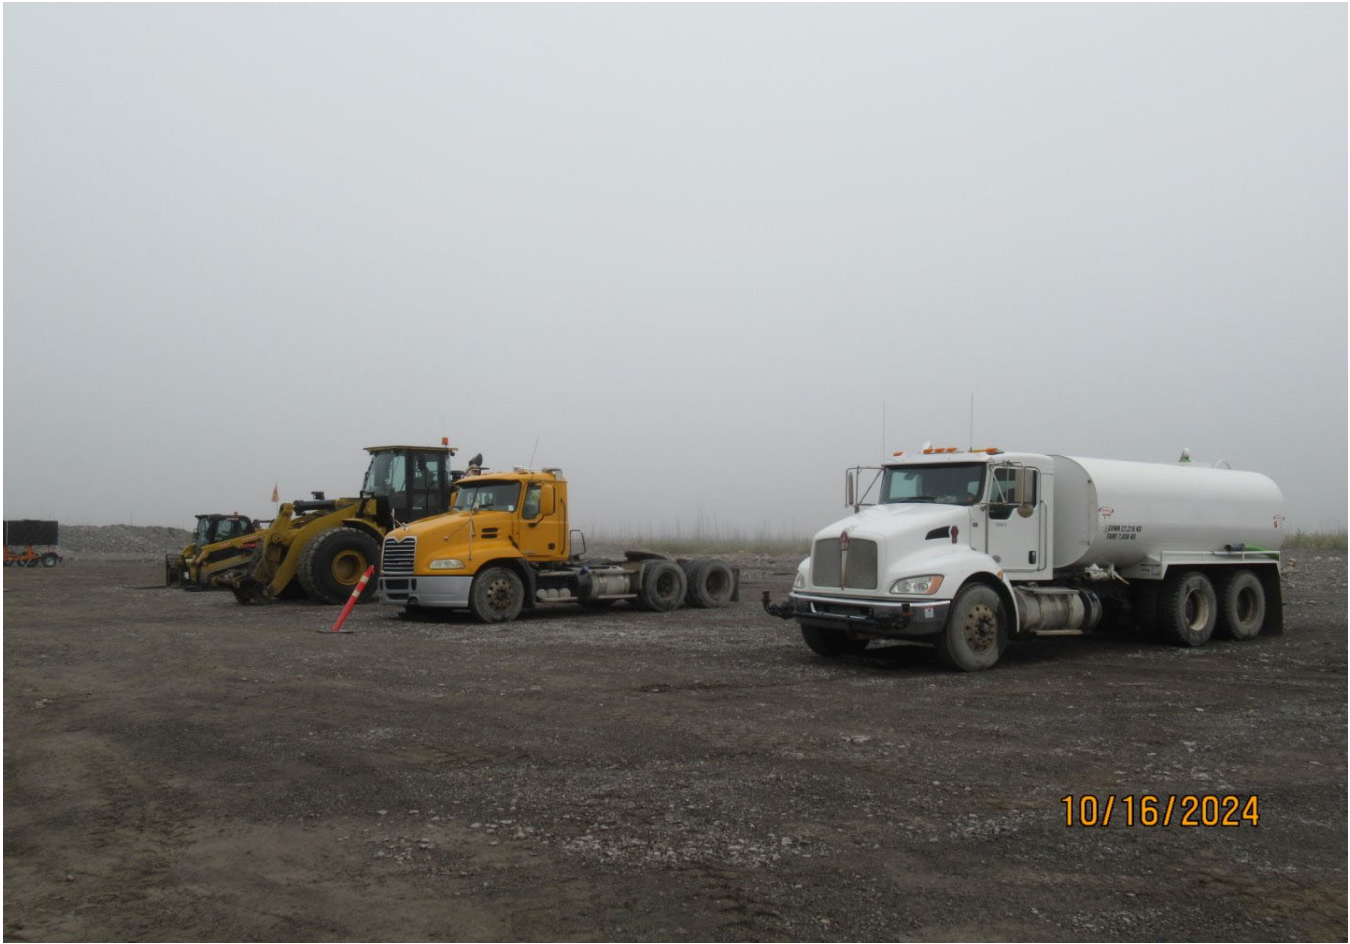
**Figure 3**

**All parked vehicles and equipment had drip trays present.**

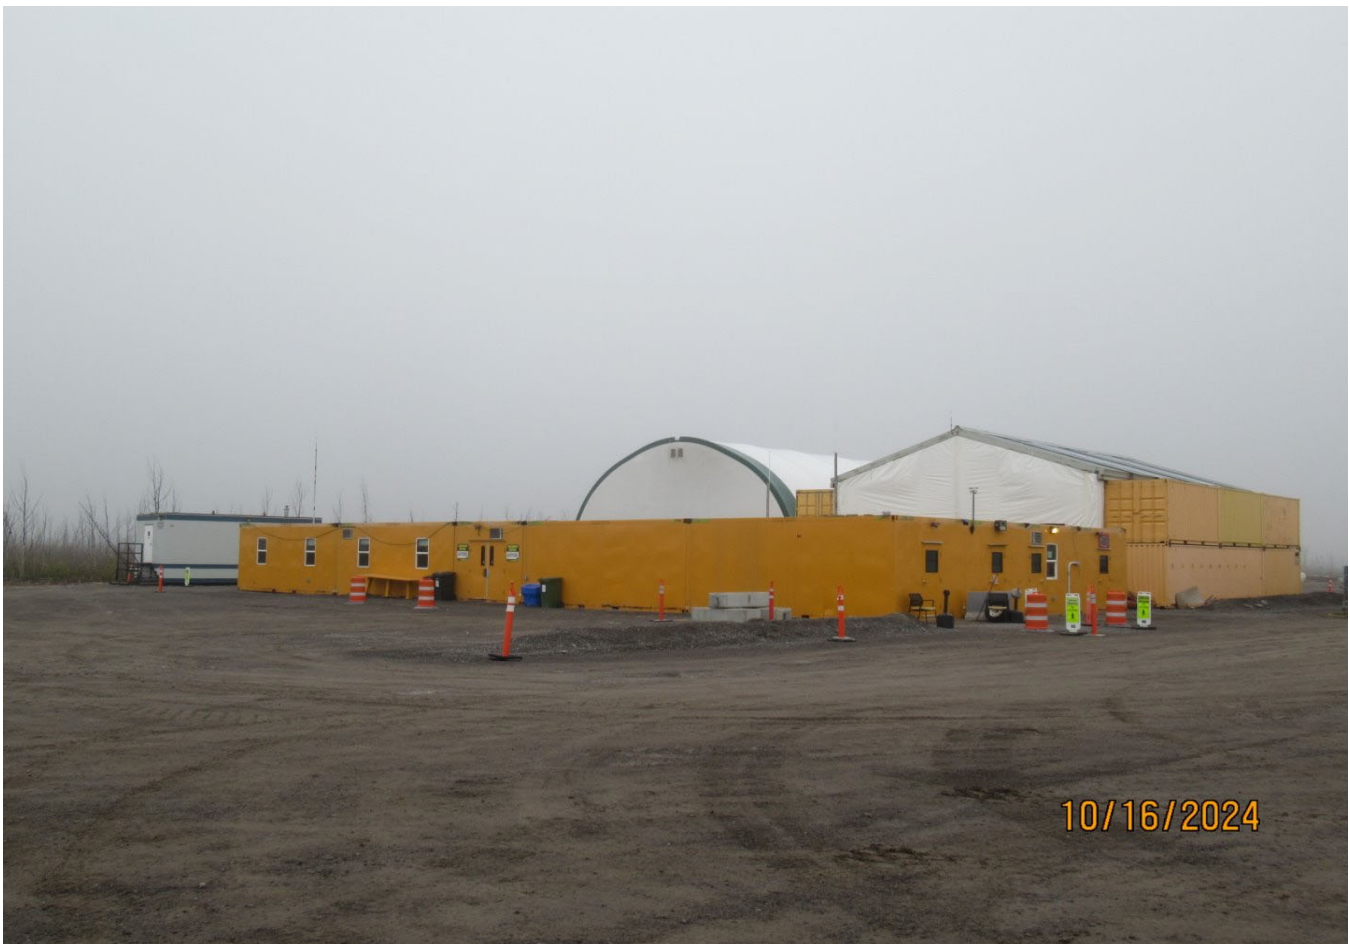
**Figure 4**

**Looking north at the Km 19.5 shop complex. The eighteen (18) office connex units will be decommissioned and demobilized from the land use area at the very earliest opportunity.**

**Please provide the undersigned Inspector notification once the ATCO trailers and new propane generators are operational, and when known, the proposed schedule for the removal of the existing infrastructure discussed above.**

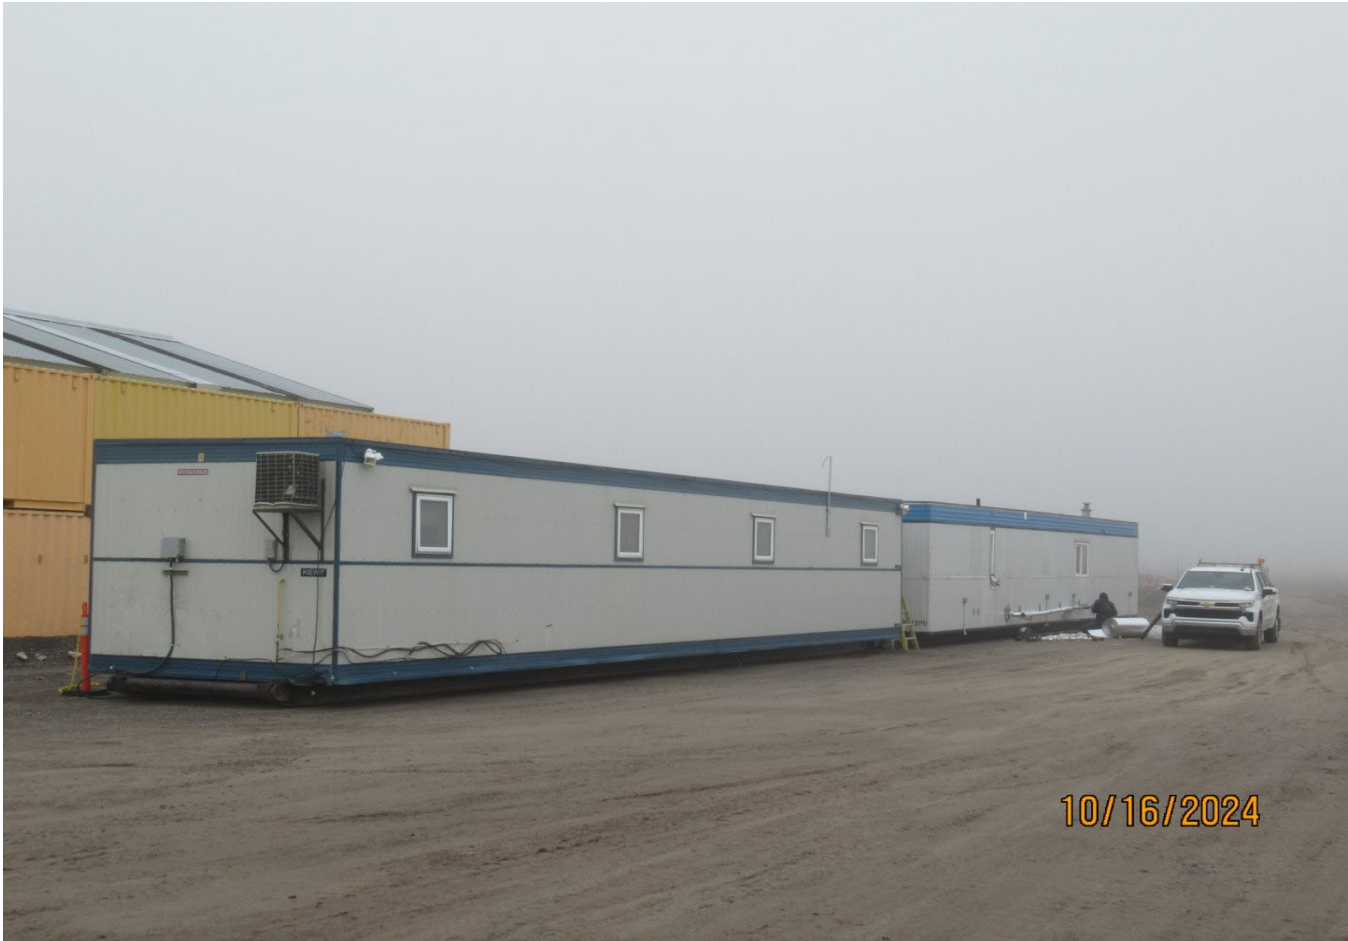
**Figure 5**

**Two ATCO trailers are being installed to replace the eighteen office connex units.**

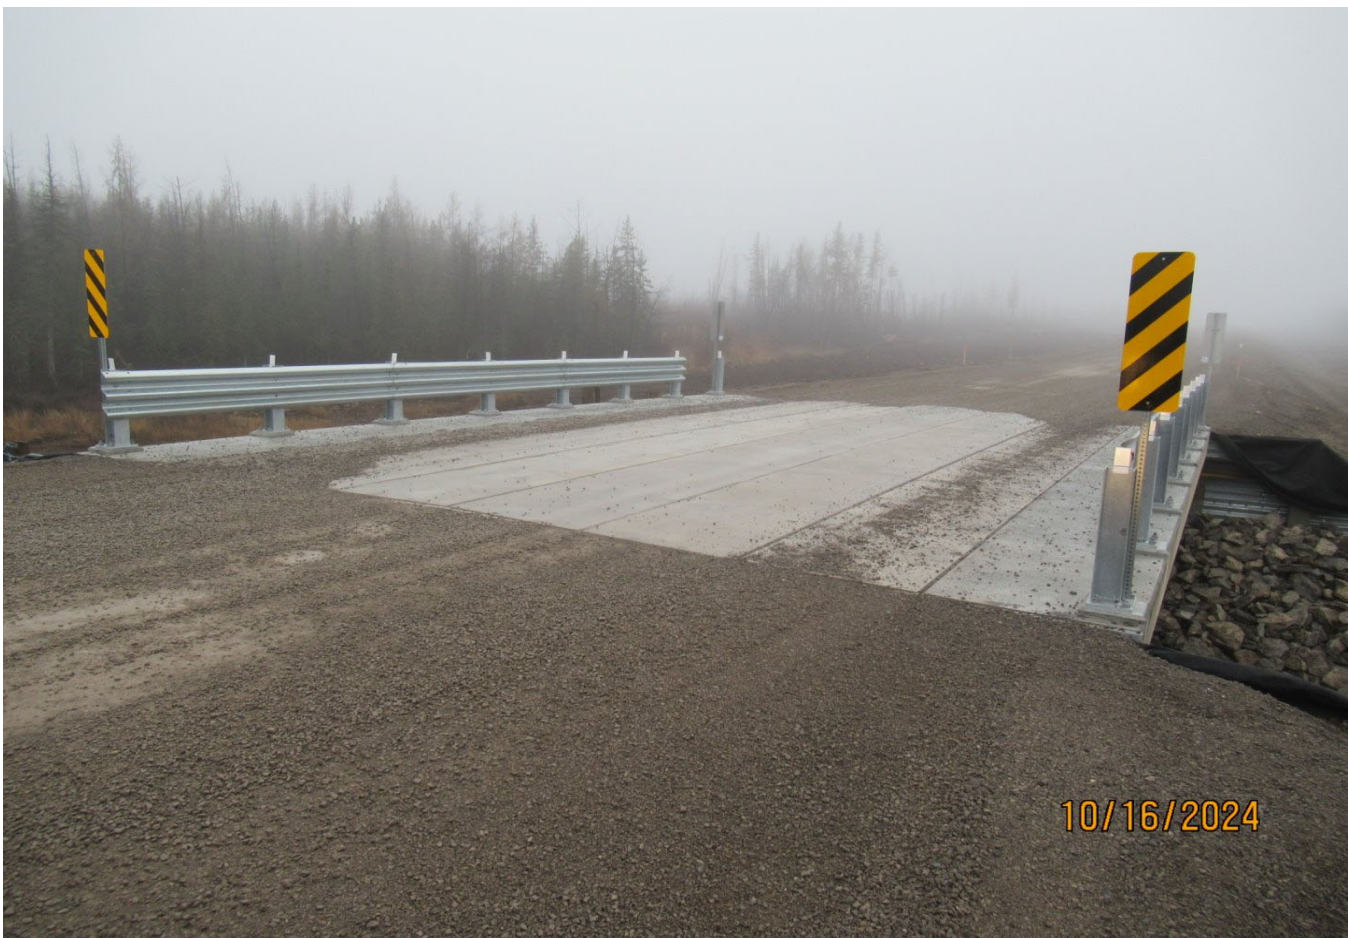
**Figure 6**

At the time of the inspection, all equipment had been demobilized from the land use area and restoration along the access road was complete. As part of this land use operation, a bridge (Figure 6) was installed at Km 0+540 of the Whati Access Road and no immediate concerns were observed. The final task required for environmental protection of a watercourse was the placement of rip rap on the slopes of the bridge abutments (Figure 7 & 8). Sourced rock appeared to have minimal fines with the exception of the one area viewed to the left of Figure 8.

**Newly installed bridge at Km 0+540 of the Whati Access Road. Looking southwest at the bridge.**

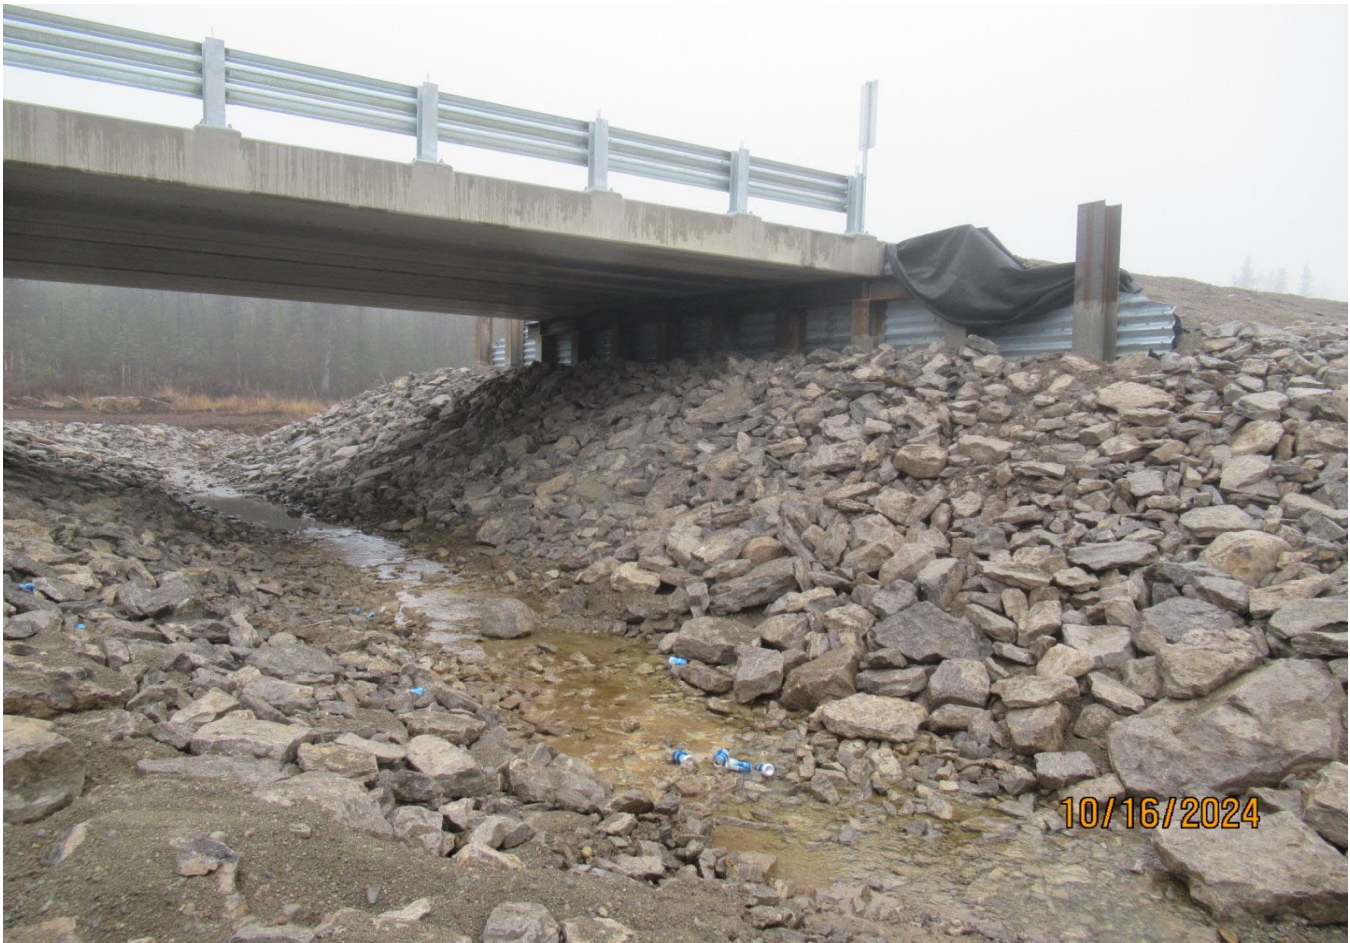
**Figure 7**

**Rip rap on the west abutment. Material appeared to have minimal fines present.**

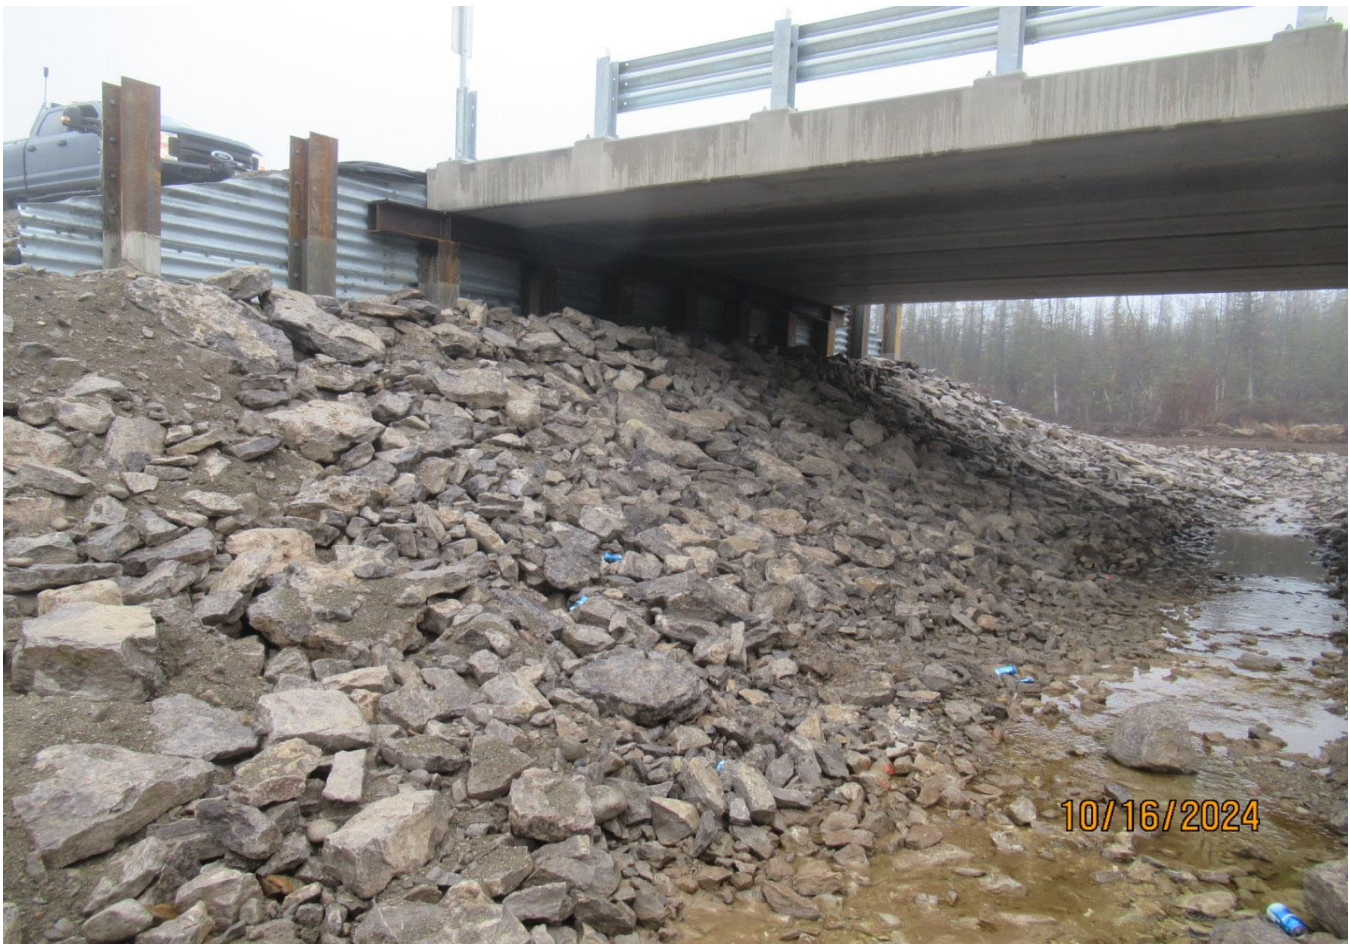
**Figure 8**

**Another view of rip rap below the bridge. Some "fines" were present on the east abutment but they should not pose any immediate environmental concerns.**

The Permittee must ensure this area is diligently monitored during high precipitation events and at spring freshet, and if any erosion or sedimentation concerns are observed, or may occur, the Inspector must be immediately notified with measures to be implemented provided.

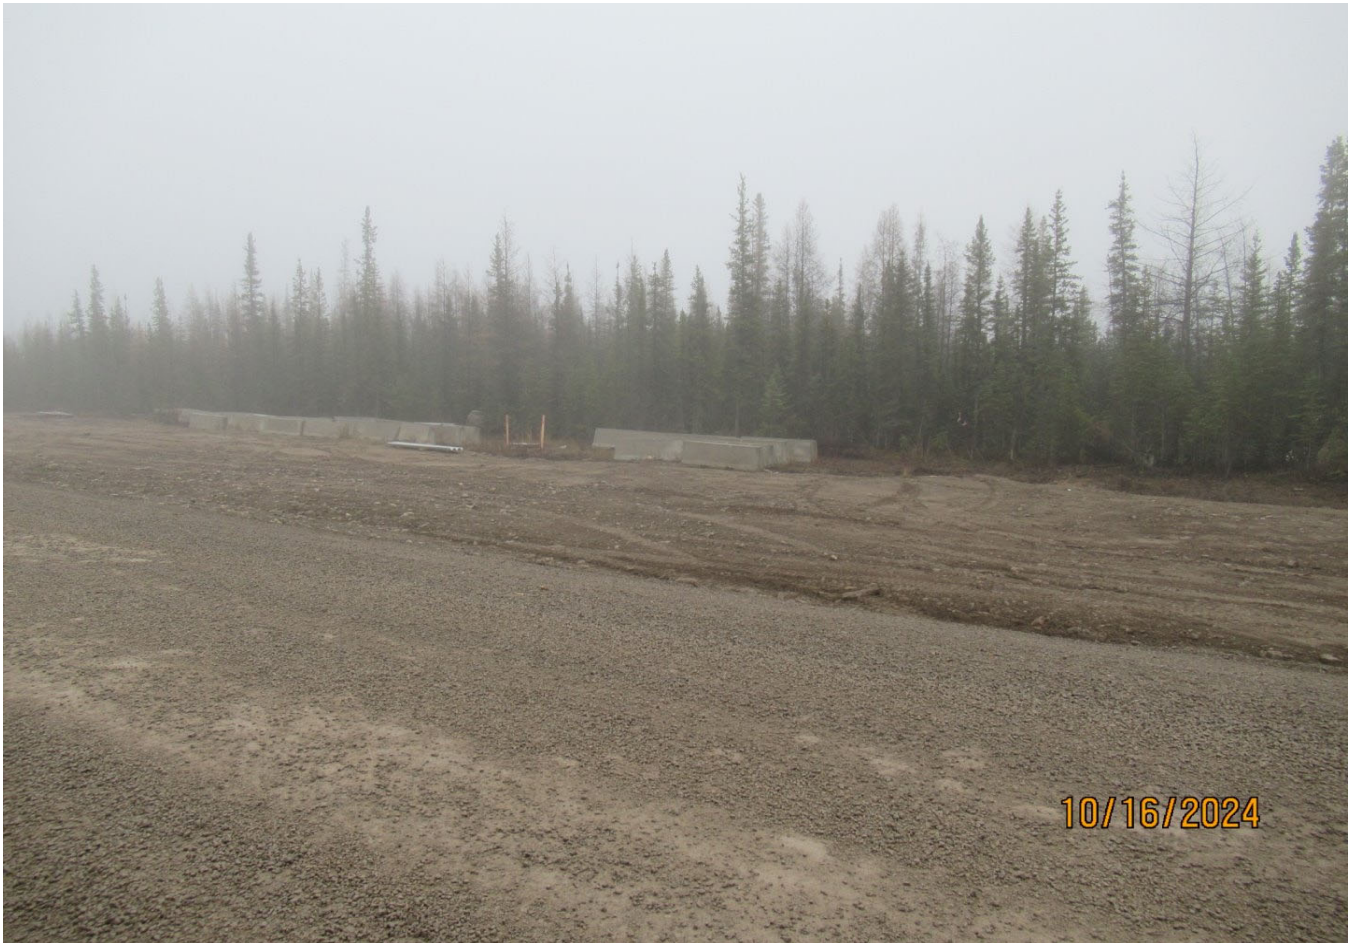
**Figure 9**

During bridge construction activities, the laydown viewed in Figure 9 was in use. The Inspector is pleased to report that all items used in connection with this land use operation have been removed, and the only items remaining are jersey barriers. At the earliest opportunity, these barriers should also be removed from their current location. The large culverts that were replaced by the bridge were also removed from this laydown and taken to the Whati landfill for proper disposal (Figure 10).

**Contractor laydown on the east side of the bridge. Items have been removed with the exception of the concrete jersey barriers.**

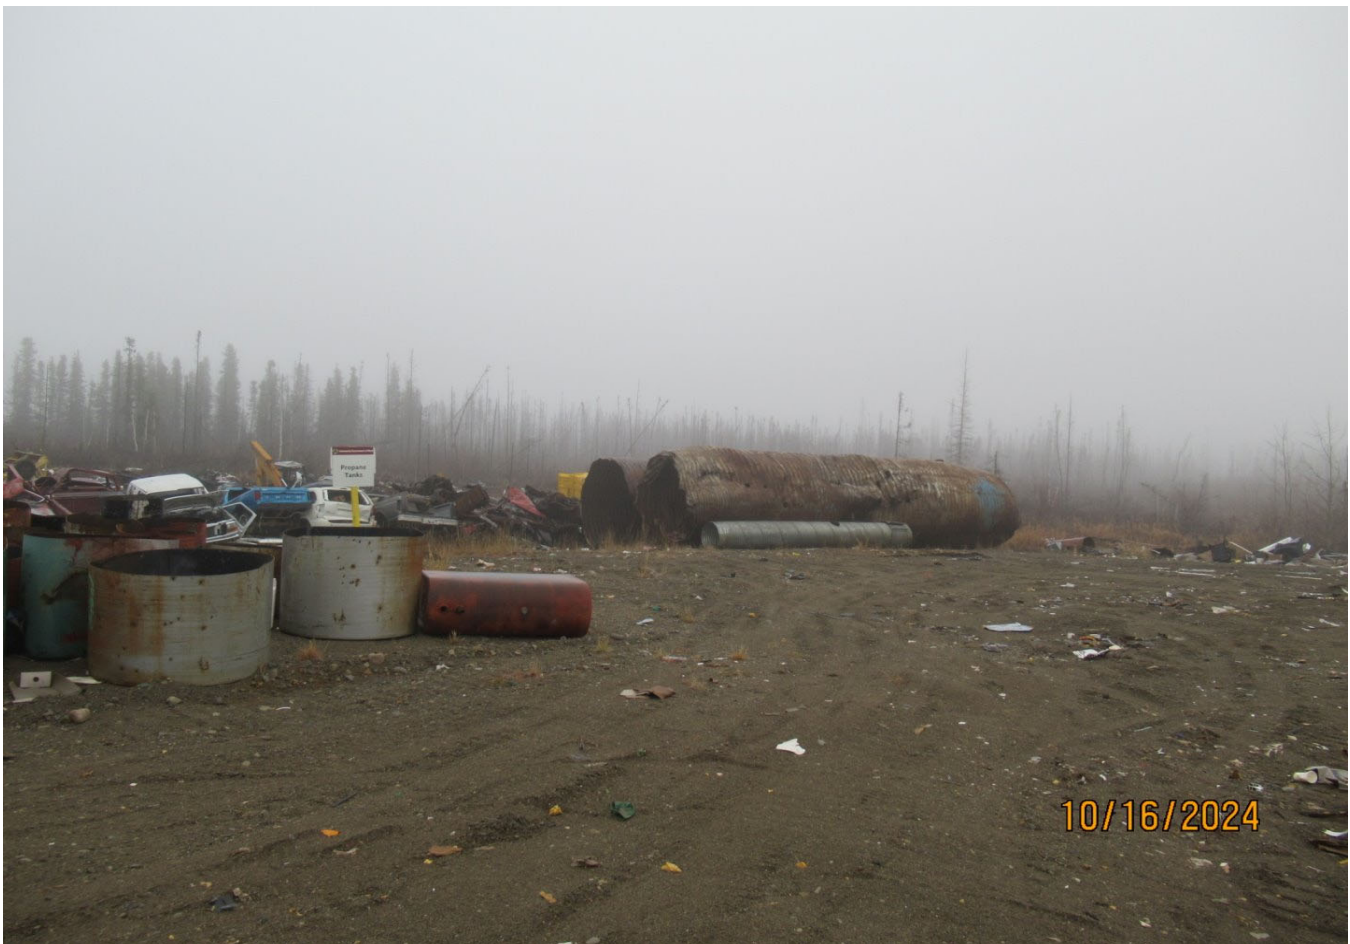
**Figure 10**

**Culverts removed from the Whati Access Road have been taken to the landfill for proper disposal.**

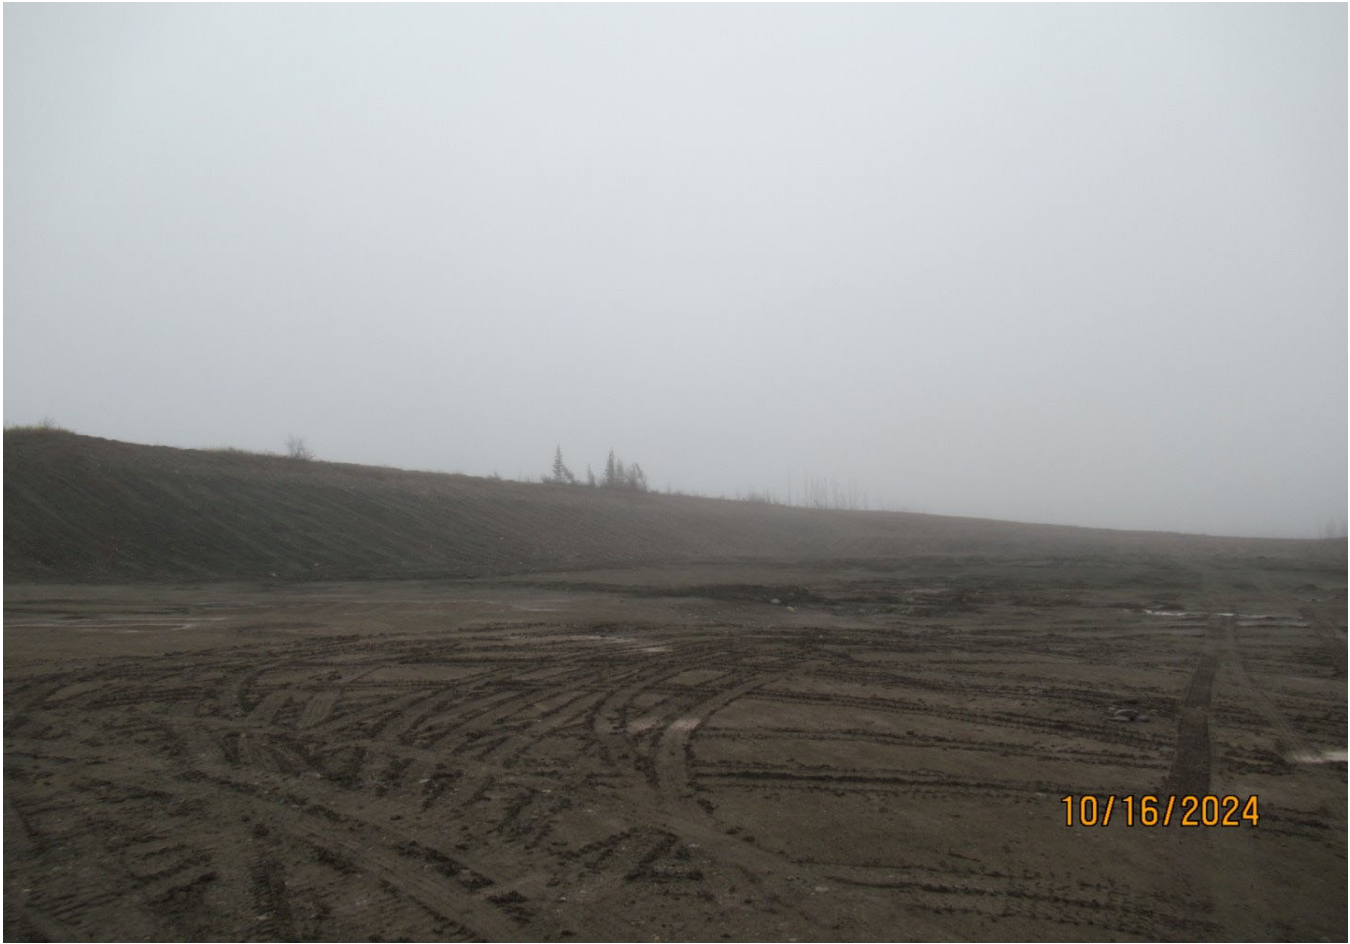
**Figure 11**

Community quarry reclamation was discussed with the Contractor (Rowe's Construction) during this land use operation, and as seen in Figure 11 through 13, reclamation appeared satisfactory. The active working faces were contoured, dozer tracks will create microclimates & seed catches, no windrows of overburden or trees were observed, and the quarry floor appears to have been graded to drain.

**Example of a reclaimed slope in the quarry.**

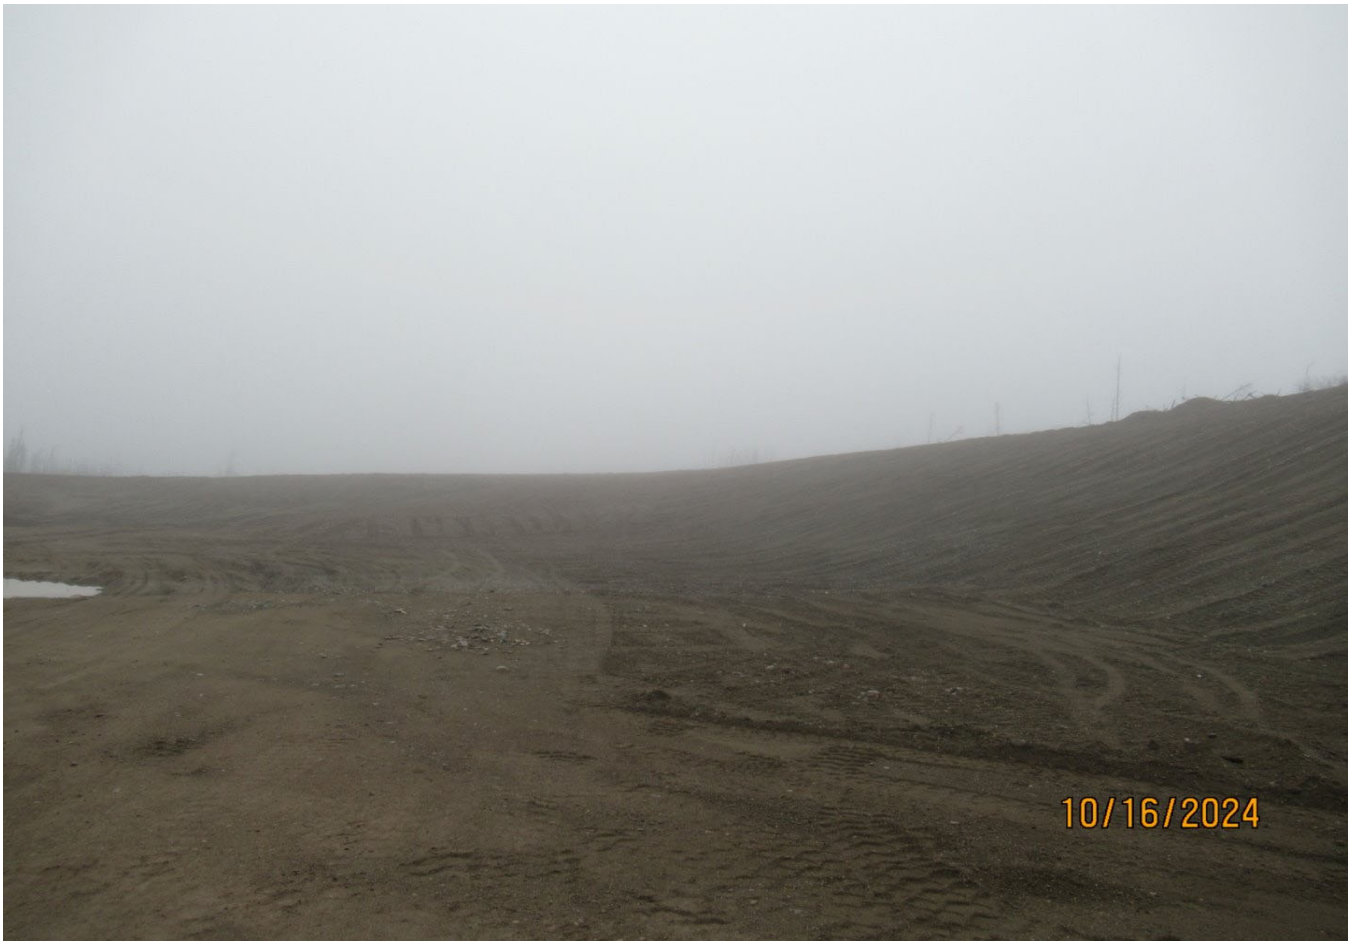
**Figure 12**

**Another example of reclaimed slopes in the quarry.**

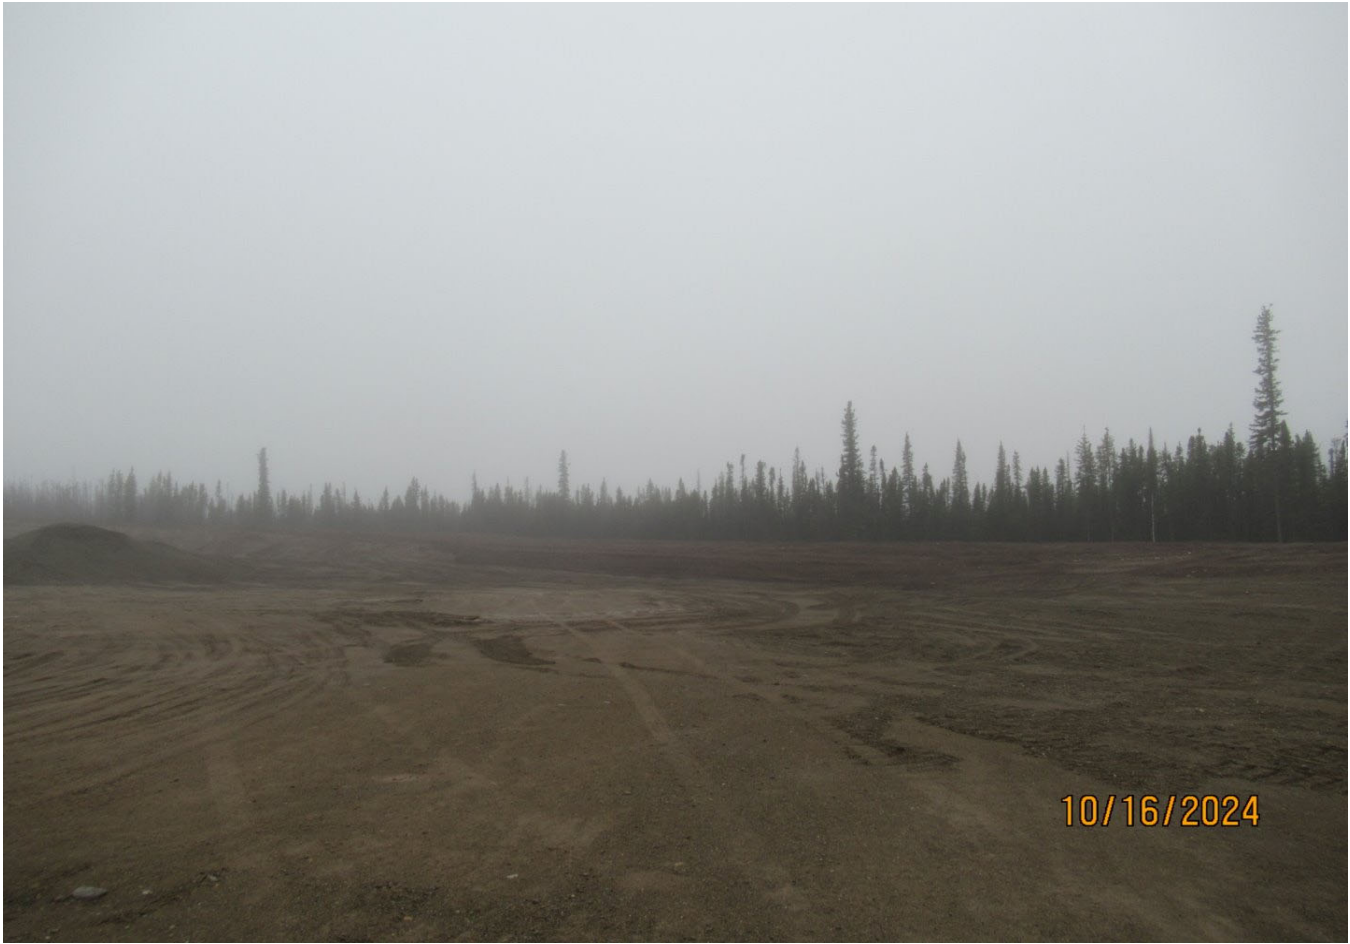
**Figure 13**

**North side of the quarry and no windrows of trees or overburden were observed.**

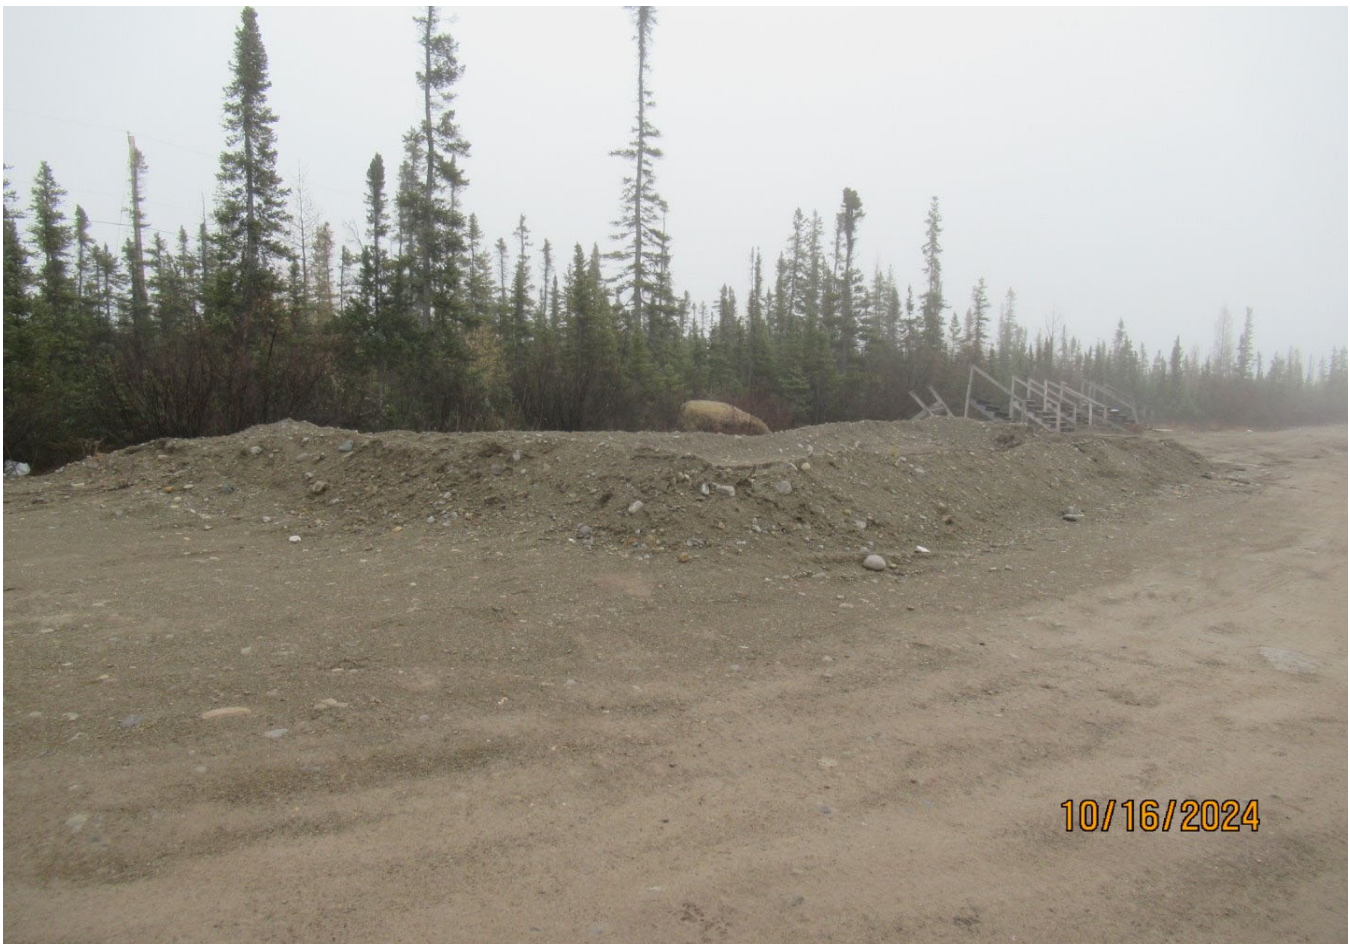
**Figure 14**

The final area inspected was the previous location of the 90,000 Litre enviro tank (Figure 14) in the community of Whati. No obvious hydrocarbon spills were observed and therefore it appears that fuel storage & handling was acceptable throughout this land use operation.

**Previous location of the 90,000 Litre fuel tank in the Community of Whati. No hydrocarbon spills were observed.**
