**Re: Land Use Permit W2017D0004
Mining and Associated Activities
Misery Underground Project, Northwest Territories**

ENVIRONMENTAL INSPECTION REPORT

Location(s) Inspected:	The Misery Underground Project (surface) and Misery Camp.
------------------------	---

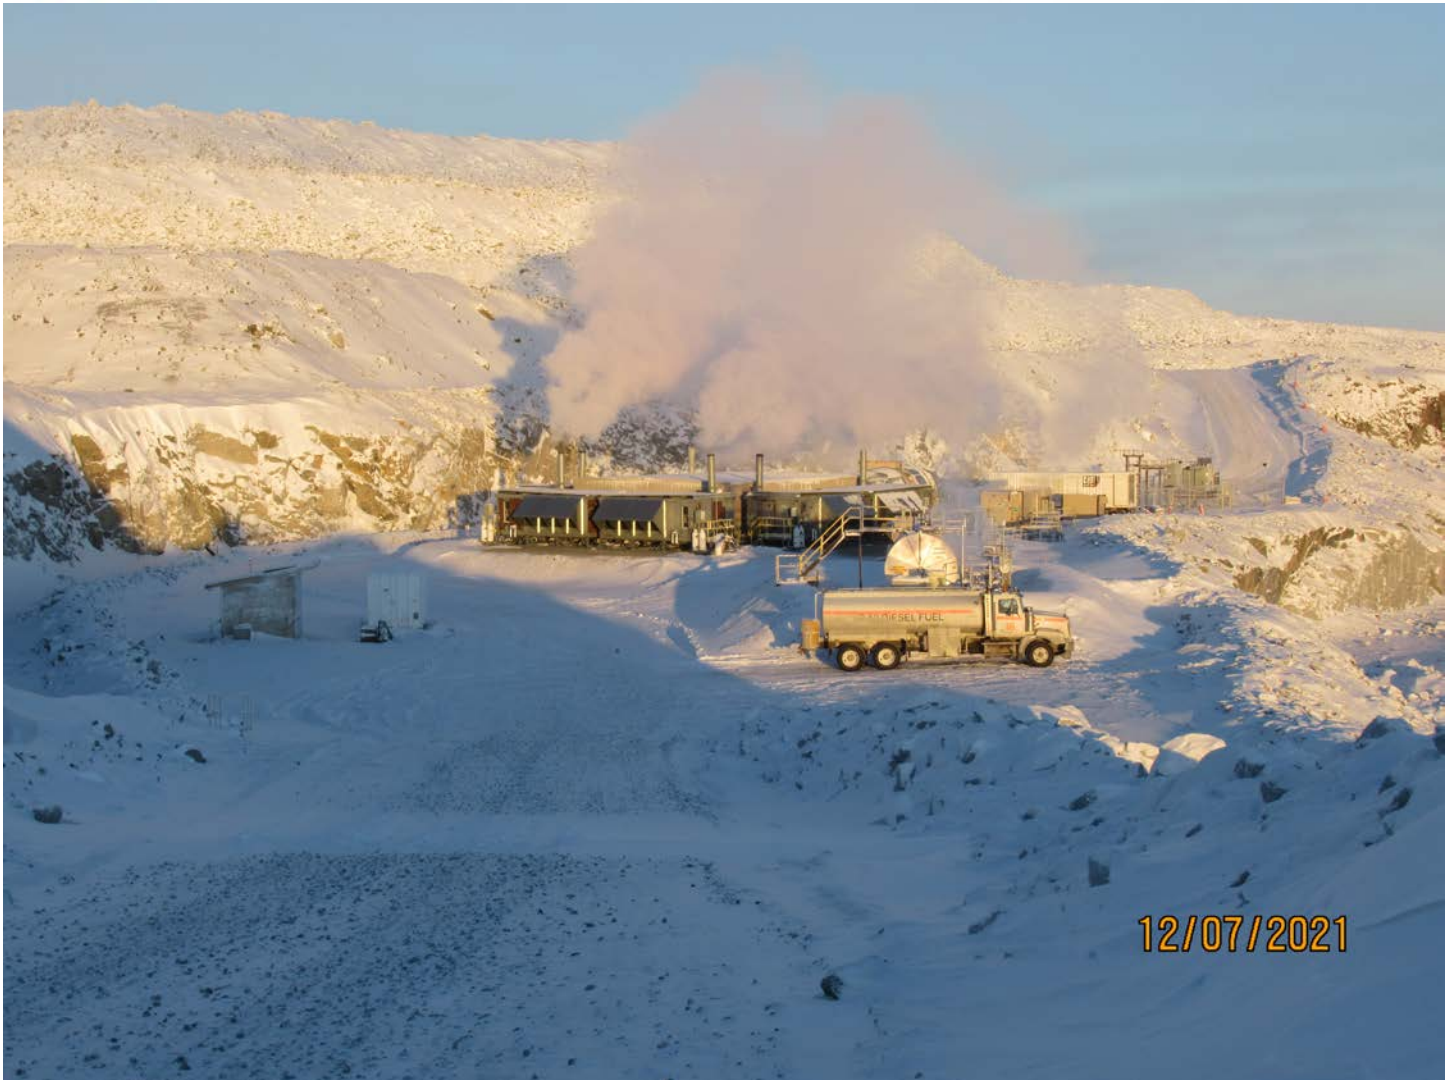
As seen in Photos #1 & #2, there is a Fresh Air Raise (FAR) located on the Misery Pit 440 Bench that provides heated air to the underground operations of the Misery Underground (MUG) Project. There is also an electrical sub-station that is used to supply electrical power to the underground and other related equipment staged on the bench (ie: back-up generator, stench gas station, fuel tank, etc. – Photos #3-#5). There was a fuel truck on the 440 Bench that was refueling the FAR station tank with transfer operations taking place within the containment berm (Photo #6). Though the 440 Bench appeared to be free of major hydrocarbon staining and spills, an inspection of the area will be conducted in snow-free conditions to ensure any hydrocarbon impacted soils are cleaned up, disposed of at an approved facility and properly documented (Conditions #18 & #38).

Photo 1: Looking north at the FAR station and related underground infrastructure staged at the Misery Pit 440 Bench.

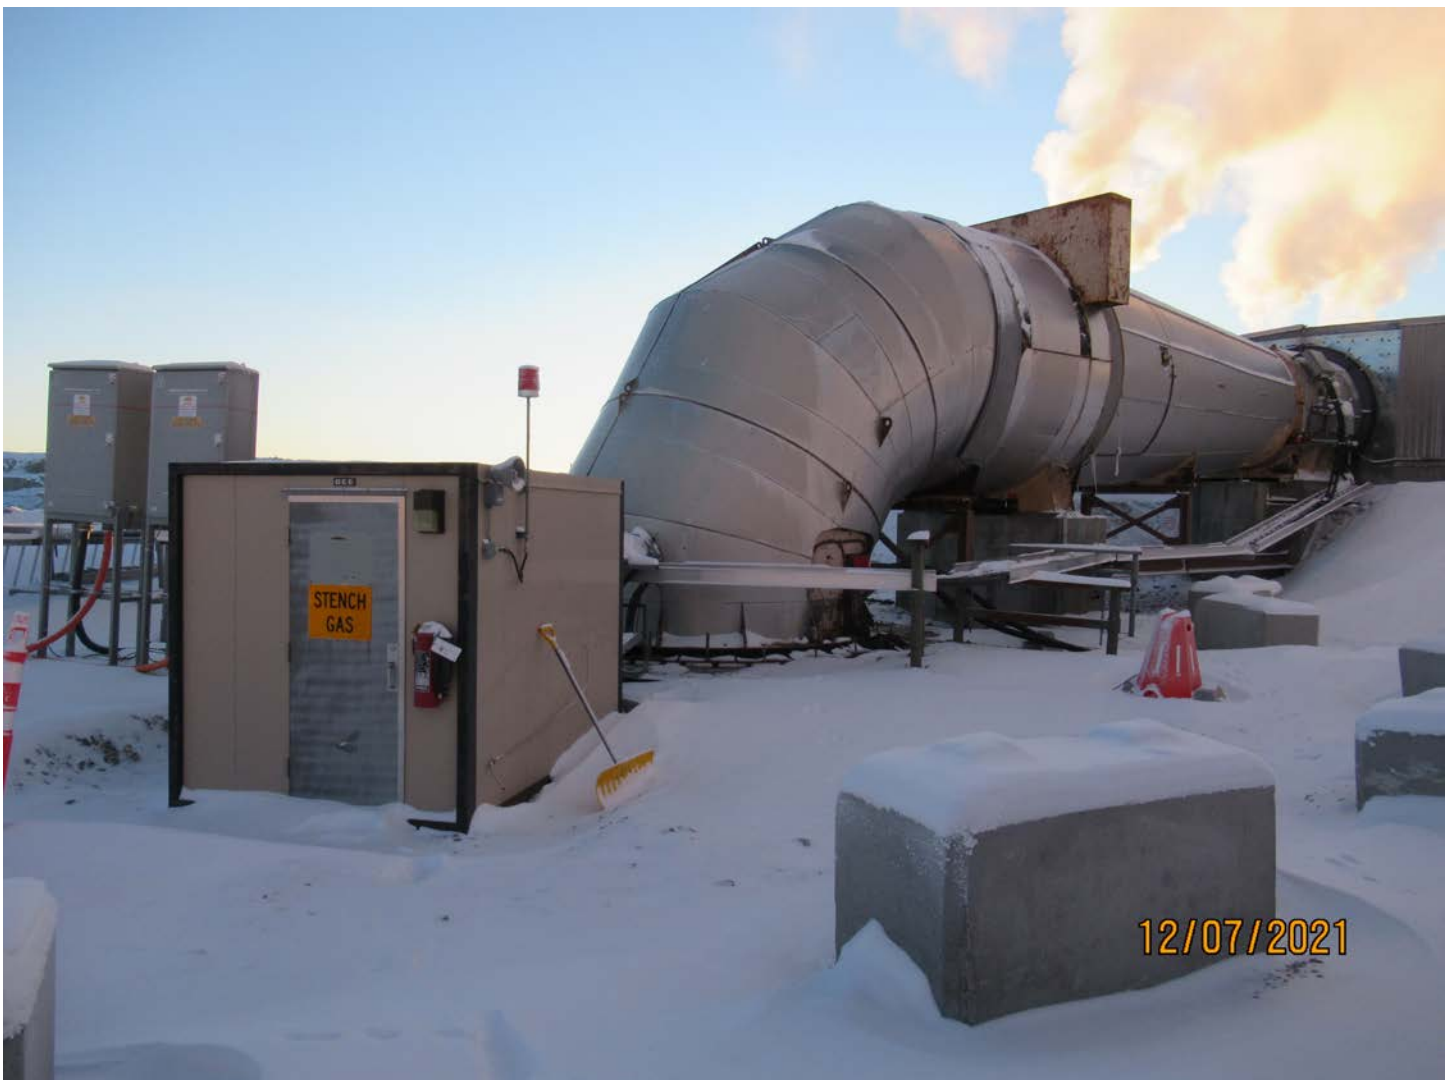
Photo 2: The FAR station pumps heated air into the underground. The electrical also runs through the borehole to the underground operations.

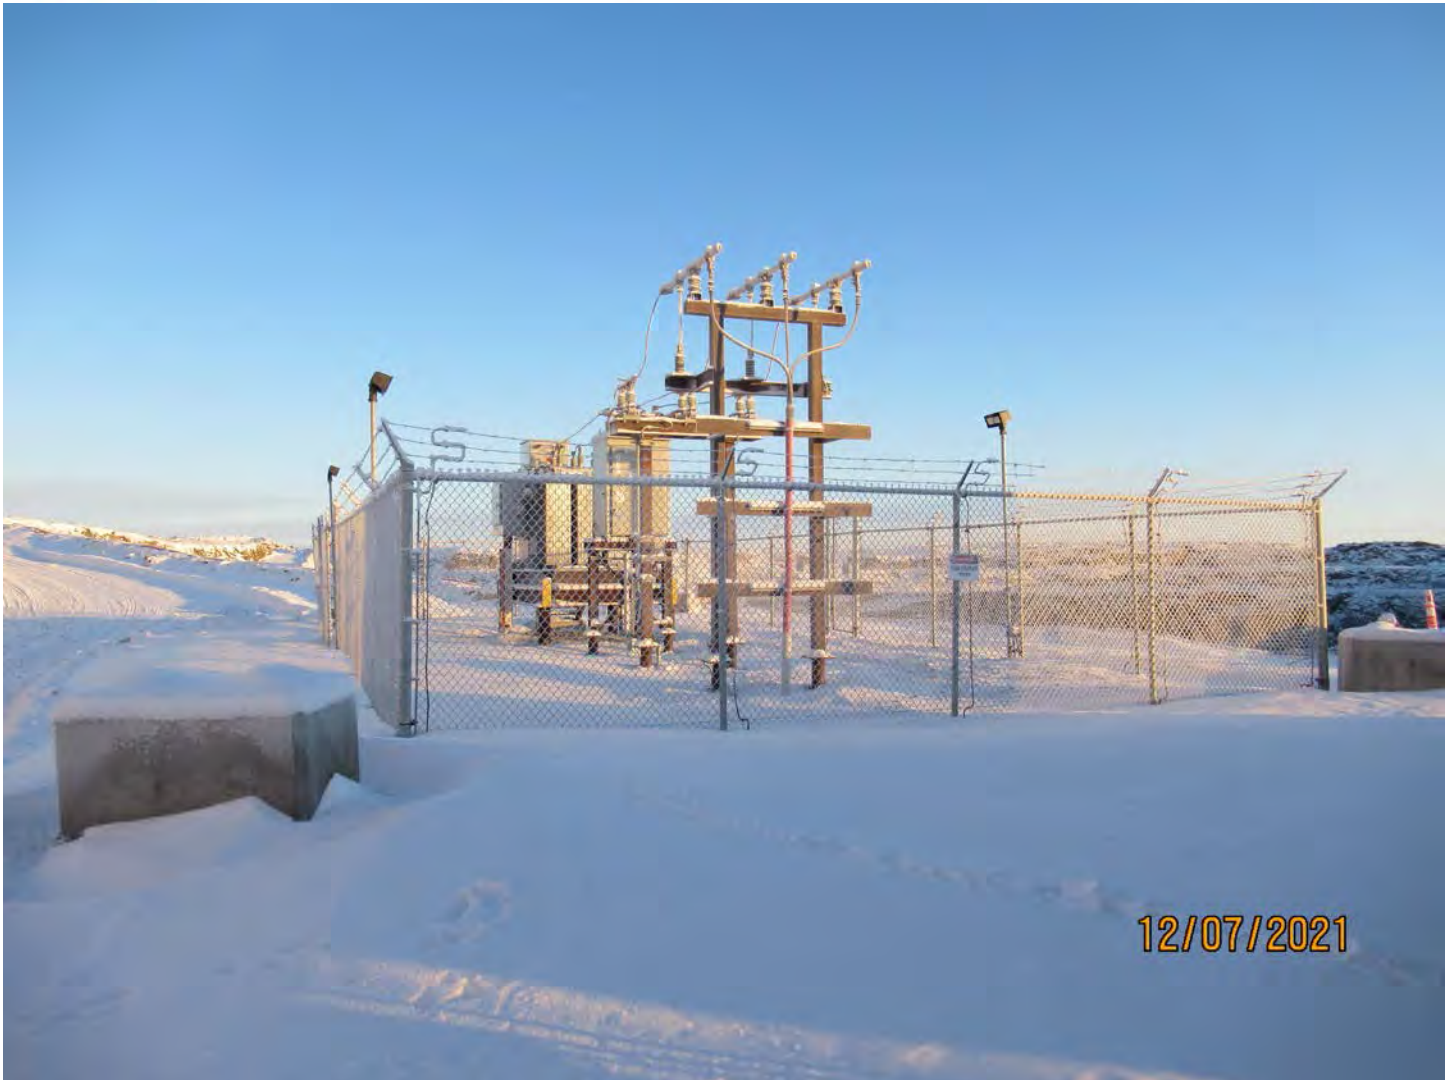
Photo 3: Looking at the electrical sub-station on the Misery Pit 440 Bench.

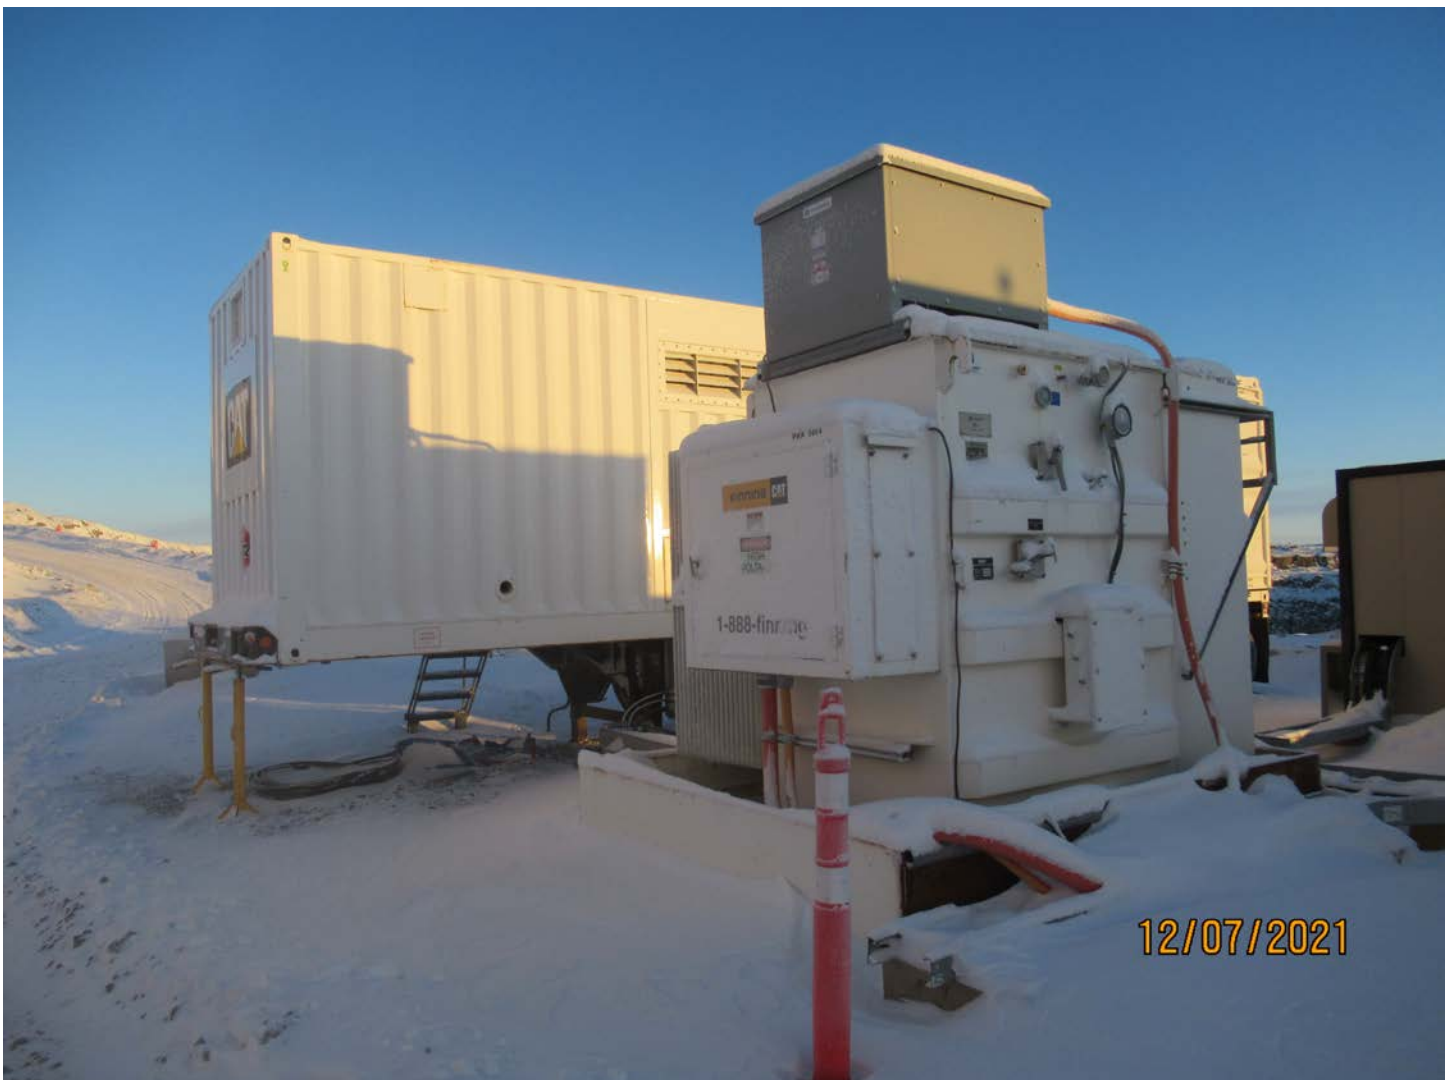
Photo 4: Generators staged on the Misery Pit 440 Bench.

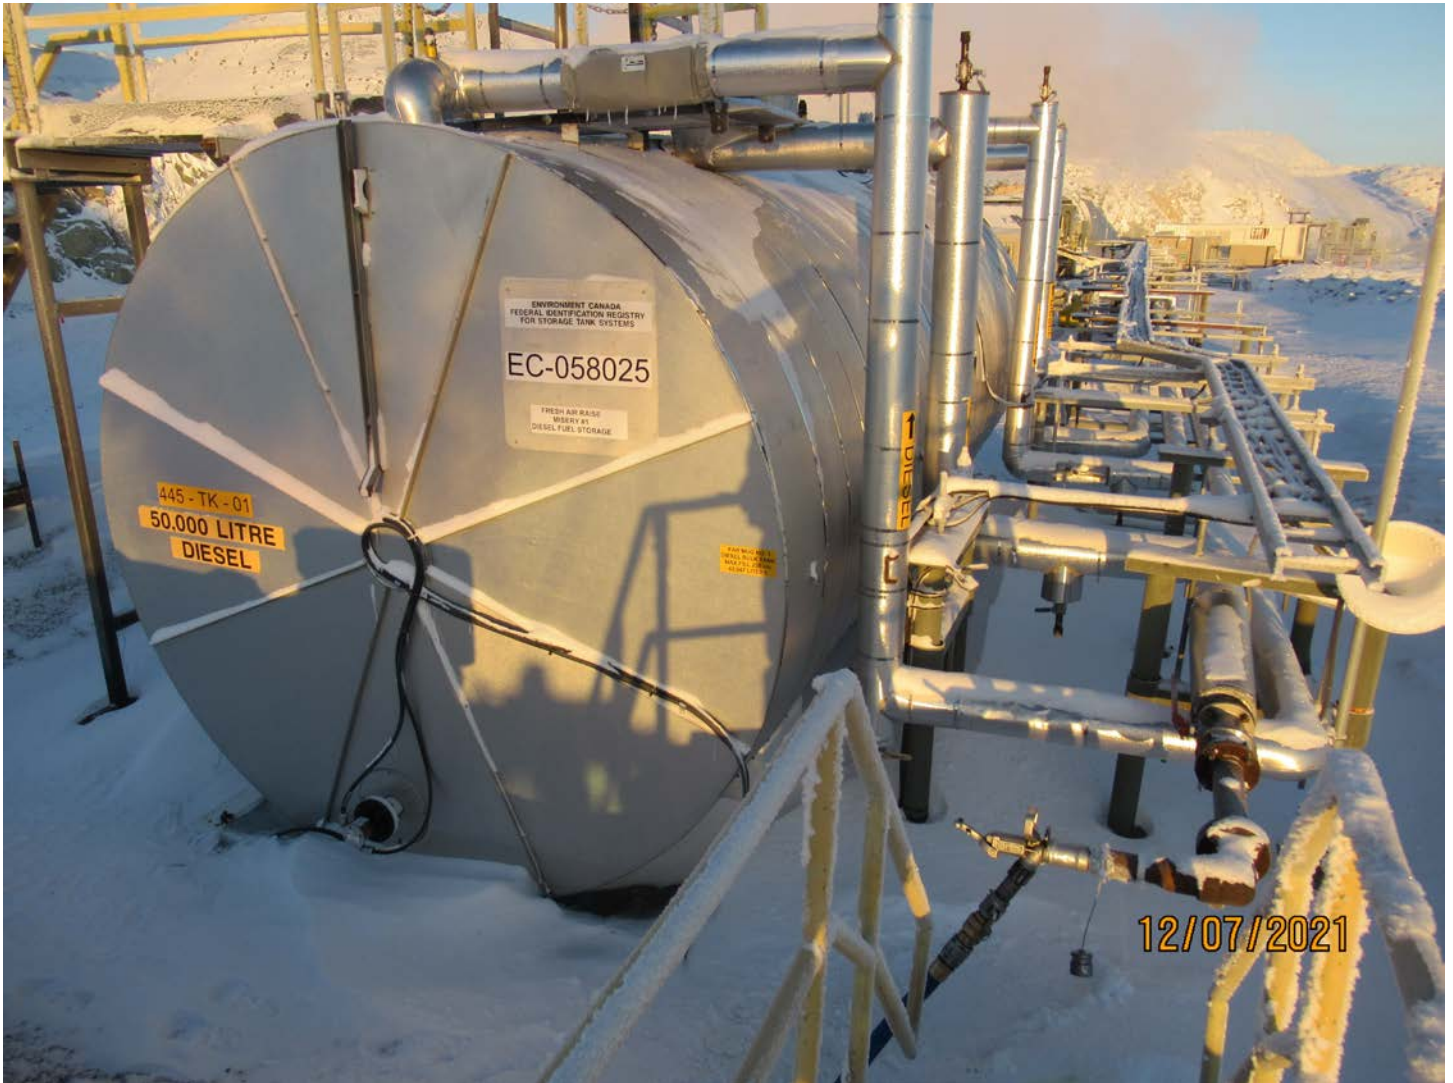
Photo 5: This 50,000 L diesel tank is used to supply the FAR station.

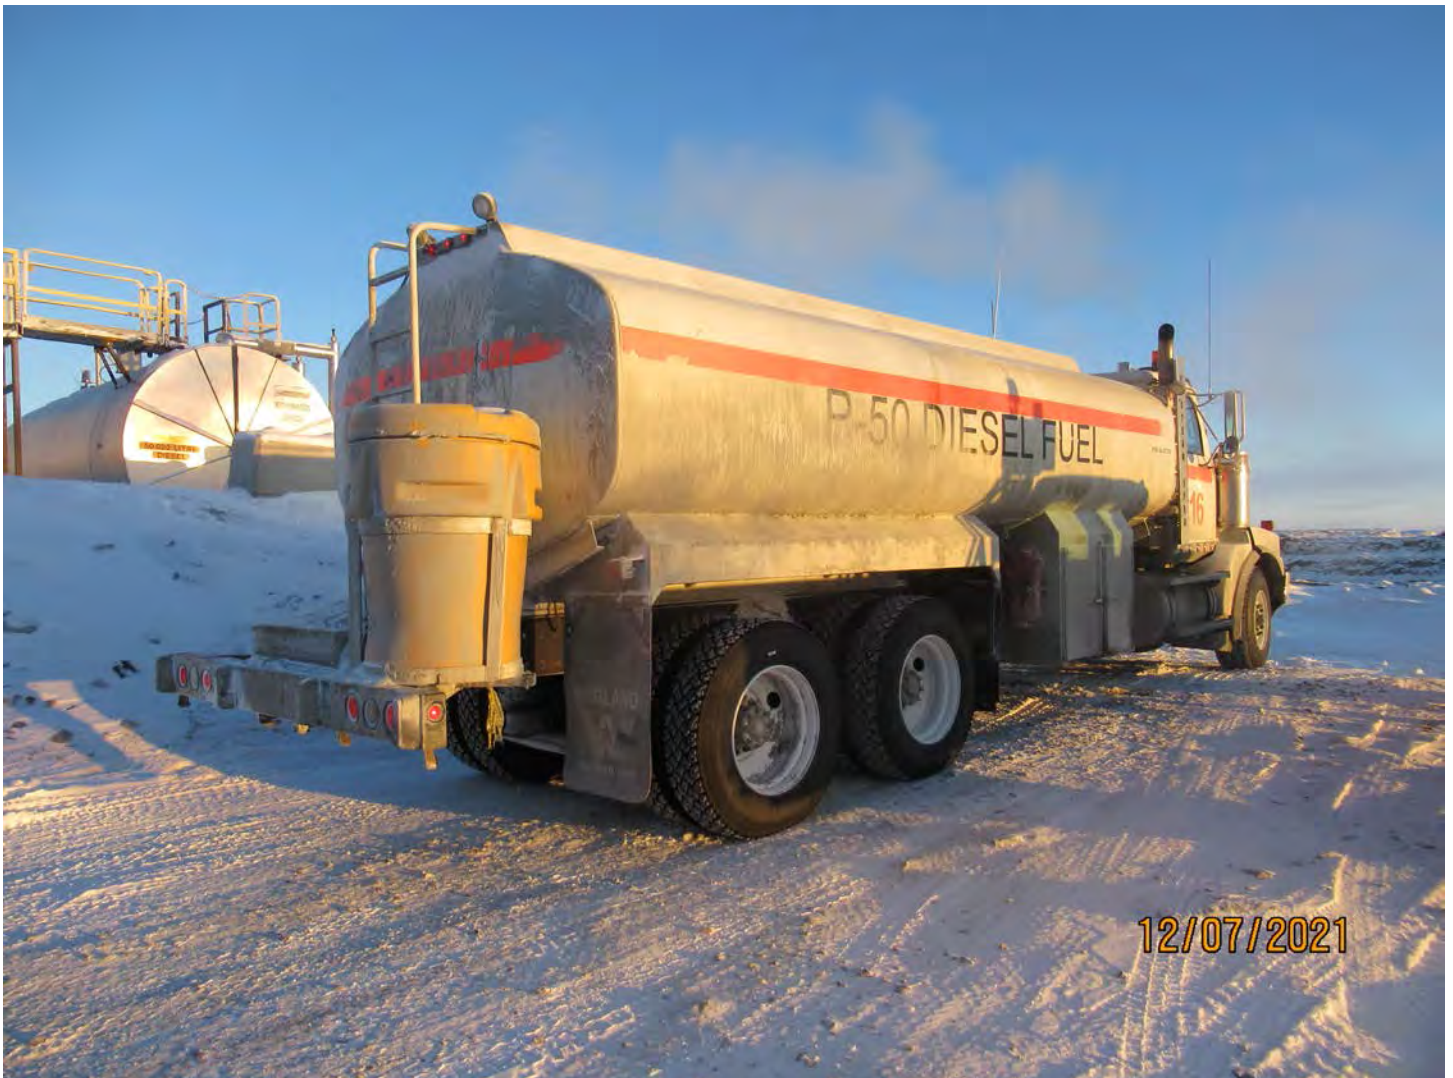
Photo 6: This fuel truck was transferring fuel to the fuel tank in Photo #5. Note the onboard spill kit.

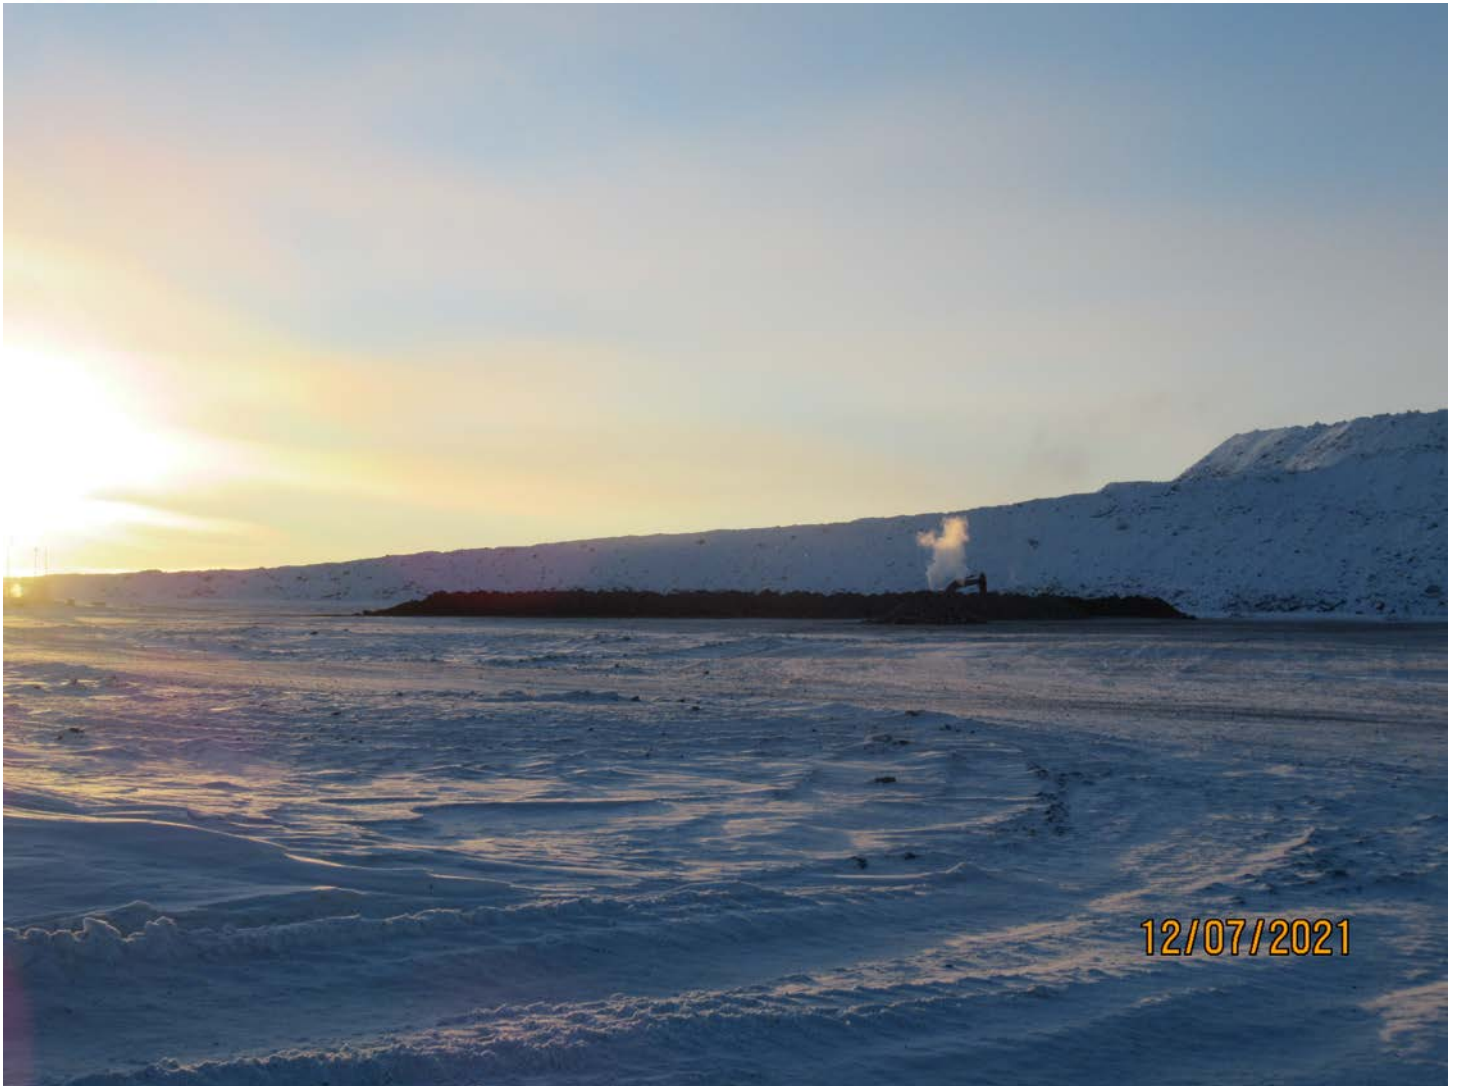
Photo 7: Ore from the Misery Underground is staged east of the Misery WRSA where it is sorted and loaded prior to transport to the Ekati Process Plant.

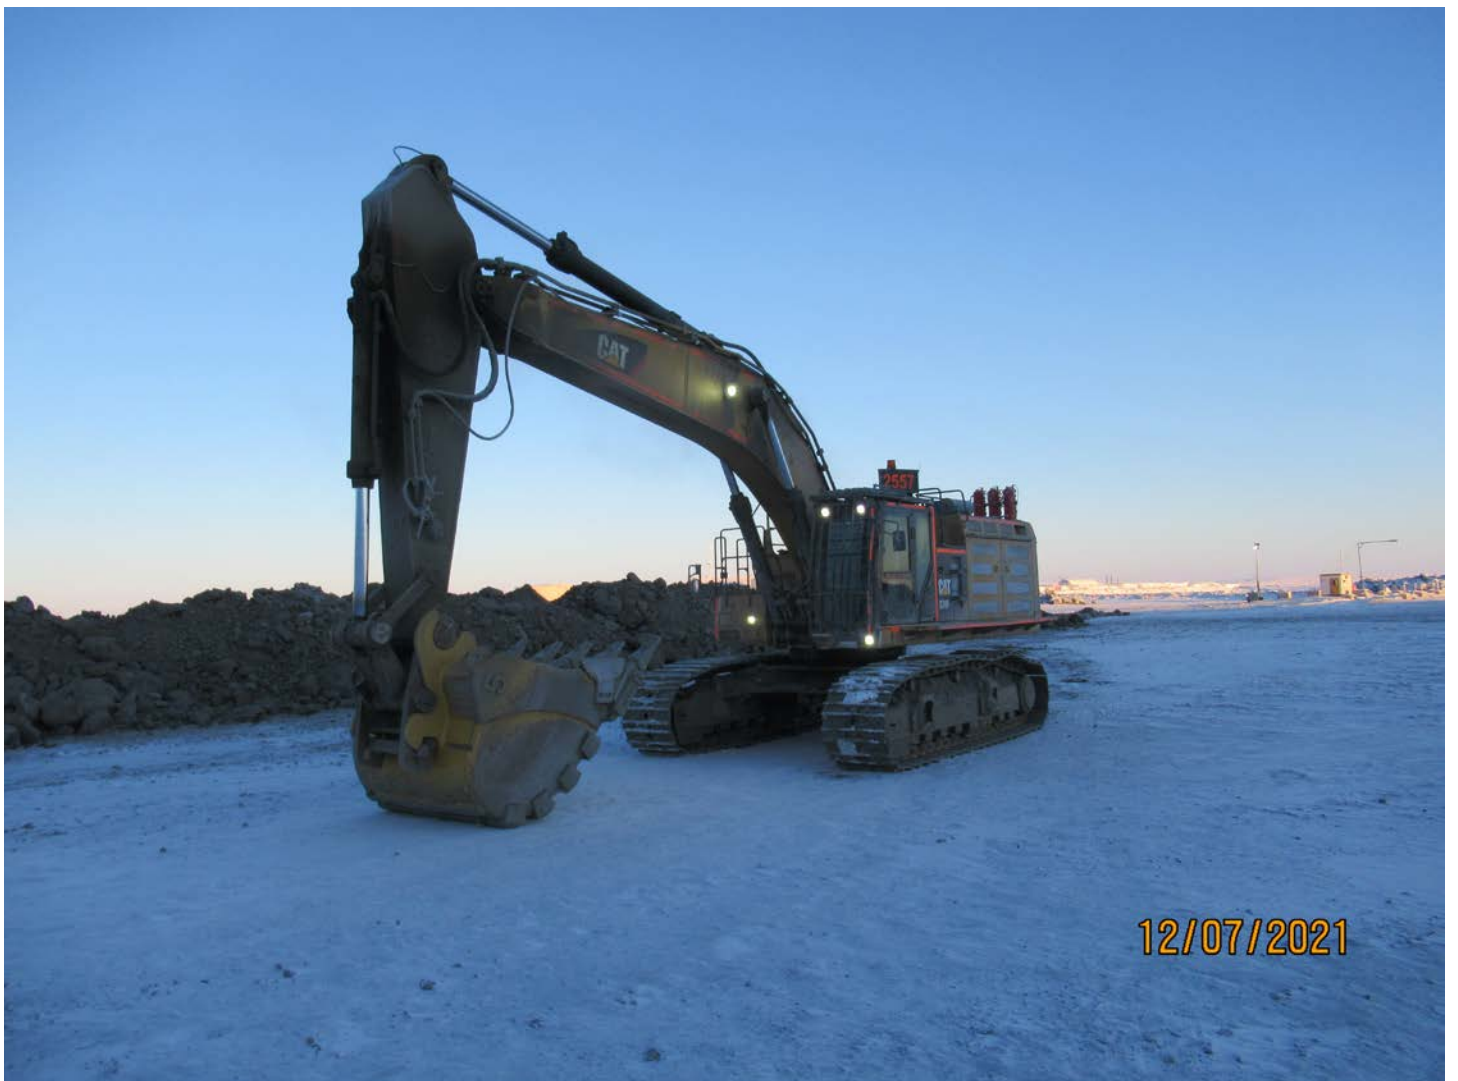
Photo 8: This excavator is used to sort and pile the ore at the laydown in Photo #7.

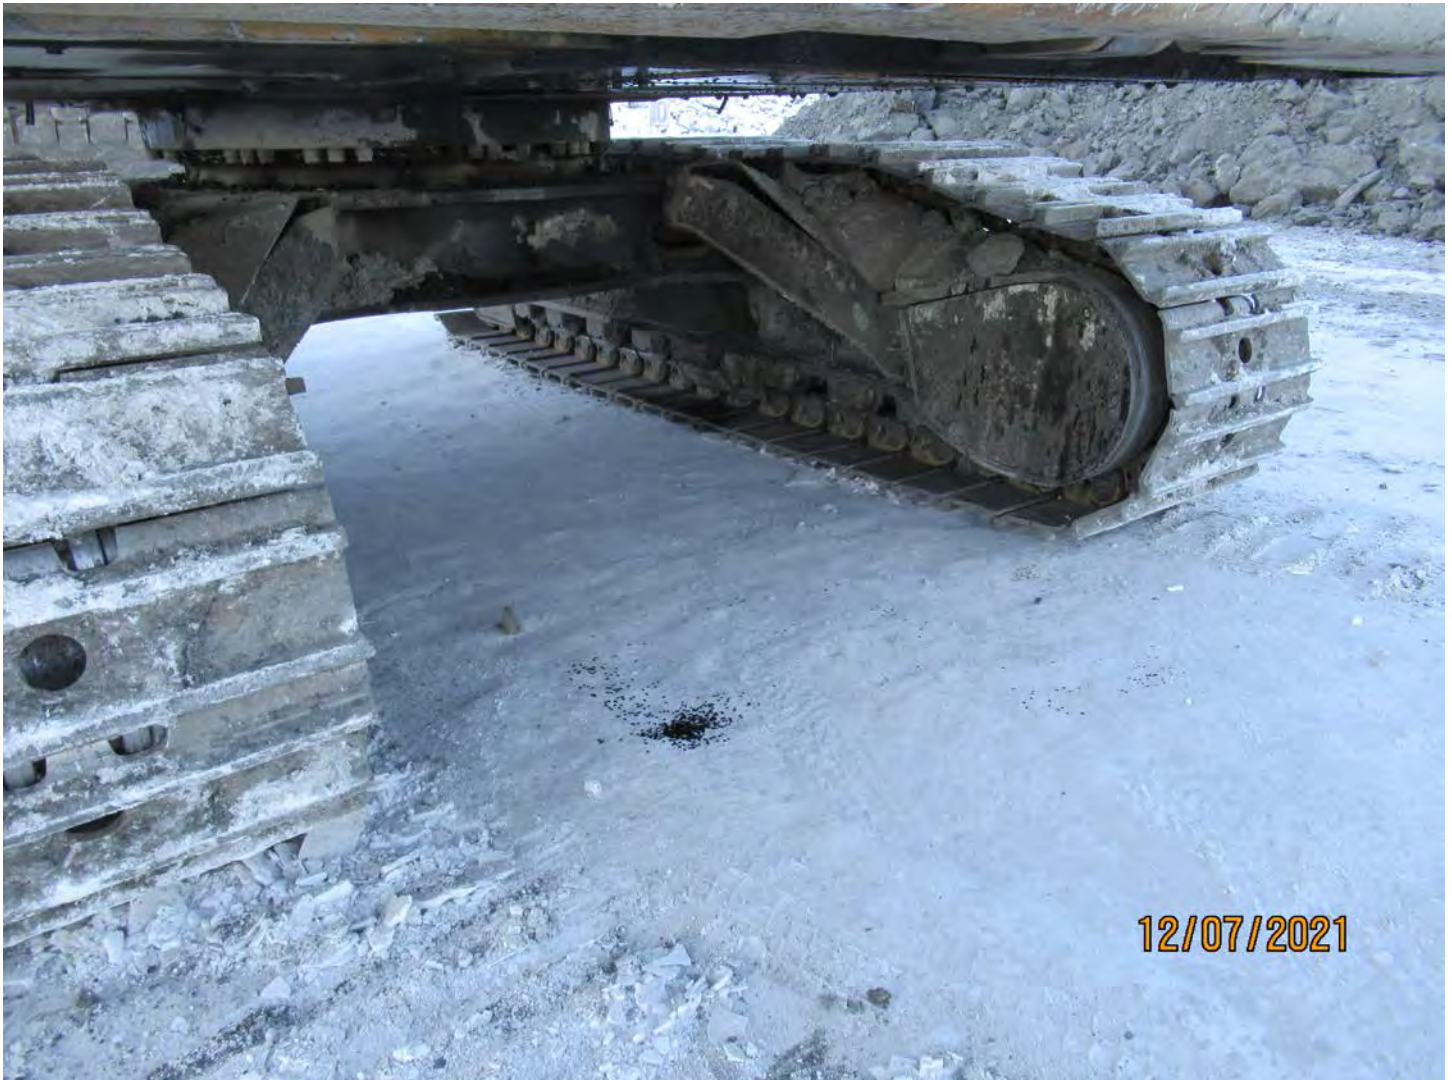
Immediately east of and adjacent to the Misery Waste Rock Storage Area (WRSA), there is a laydown that is used to stage the ore that is mined from the MUG Project. An excavator that is used to sort the ore into windrows prior to loading and transport to the Ekati Process Plant was parked at the ore pile. As seen in Photos #7-#9, there was no secondary containment in place under the parked excavator and there were hydrocarbons dripping onto the ground. As per Condition #37 of LUP W2017D0004, secondary containment must be utilized under all equipment that may be parked for two hours or more.

Photo 9: As seen, there was no secondary containment placed under the parked equipment and hydrocarbons were dripping onto the ground.

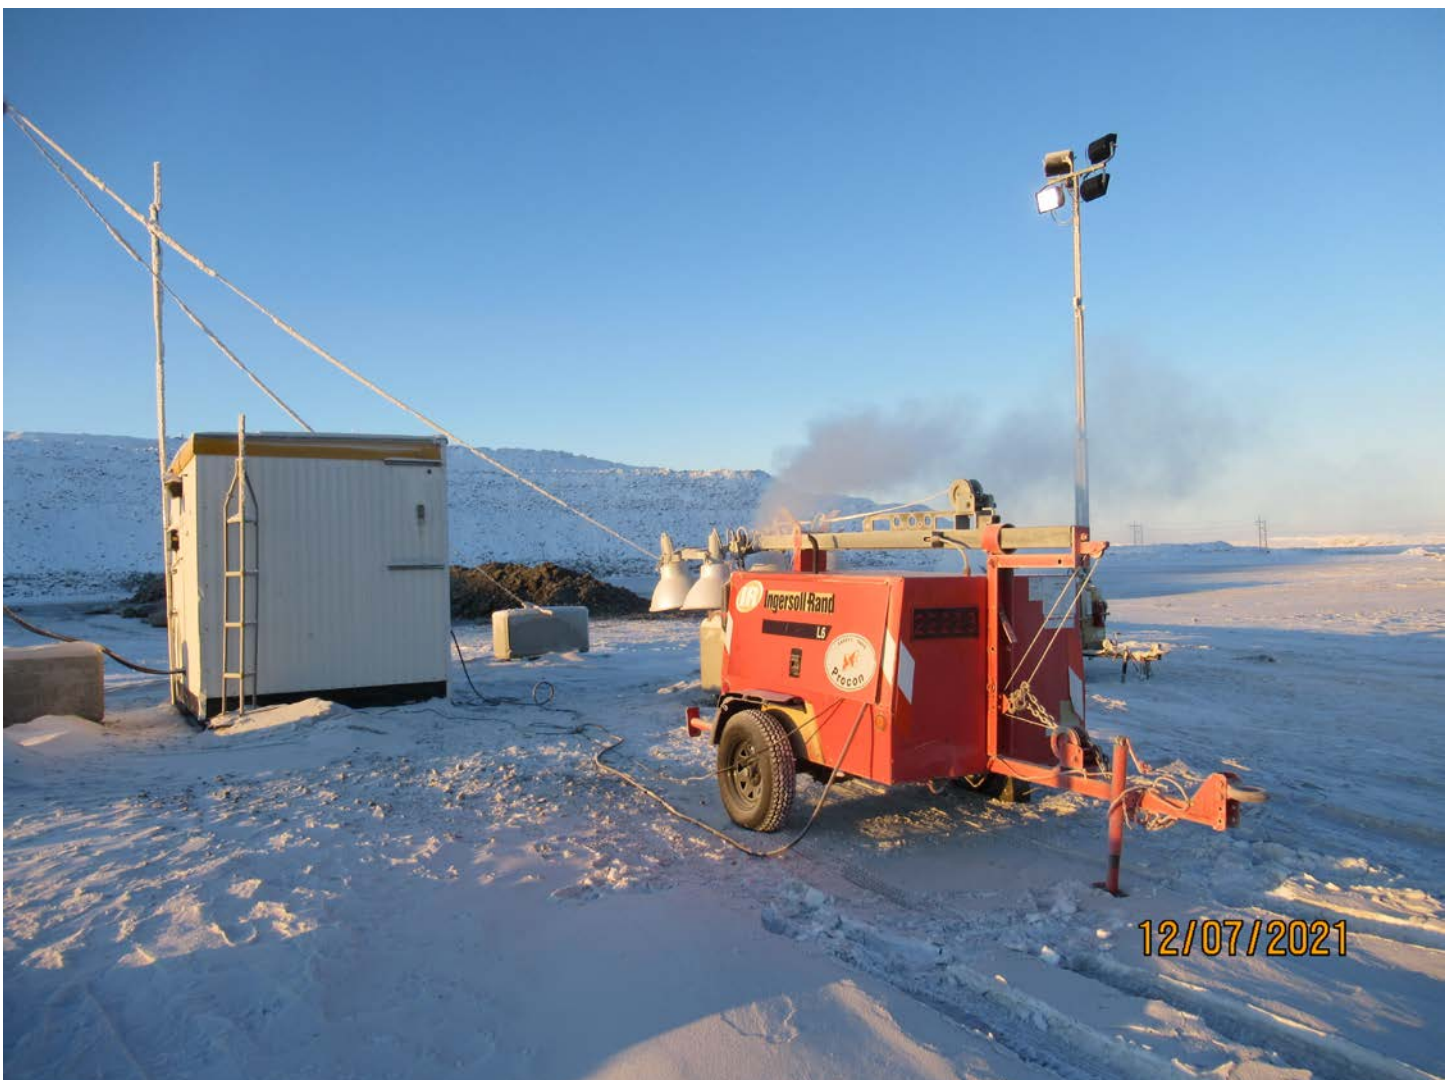
The Inspector also noted there was no secondary containment placed under the light plants in the laydown (two of the three light plants were operating – Photos #10-#12). To help mitigate potential hydrocarbon spills at the light plants, secondary containment must be used during fuel transfers at the plants (Condition #32) and there must be secondary containment trays placed under the light plants to prevent hydrocarbons from impacting the area (Condition #33). The Permittee must ensure all spills are properly documented, cleaned up and disposed of at an approved facility (Conditions #18 & #38). The Permittee must also ensure there are adequate and readily available spill response materials in areas where hydrocarbon spills may occur (Condition #36).

Photo 10: The light plants at the ore laydown also required secondary containment.

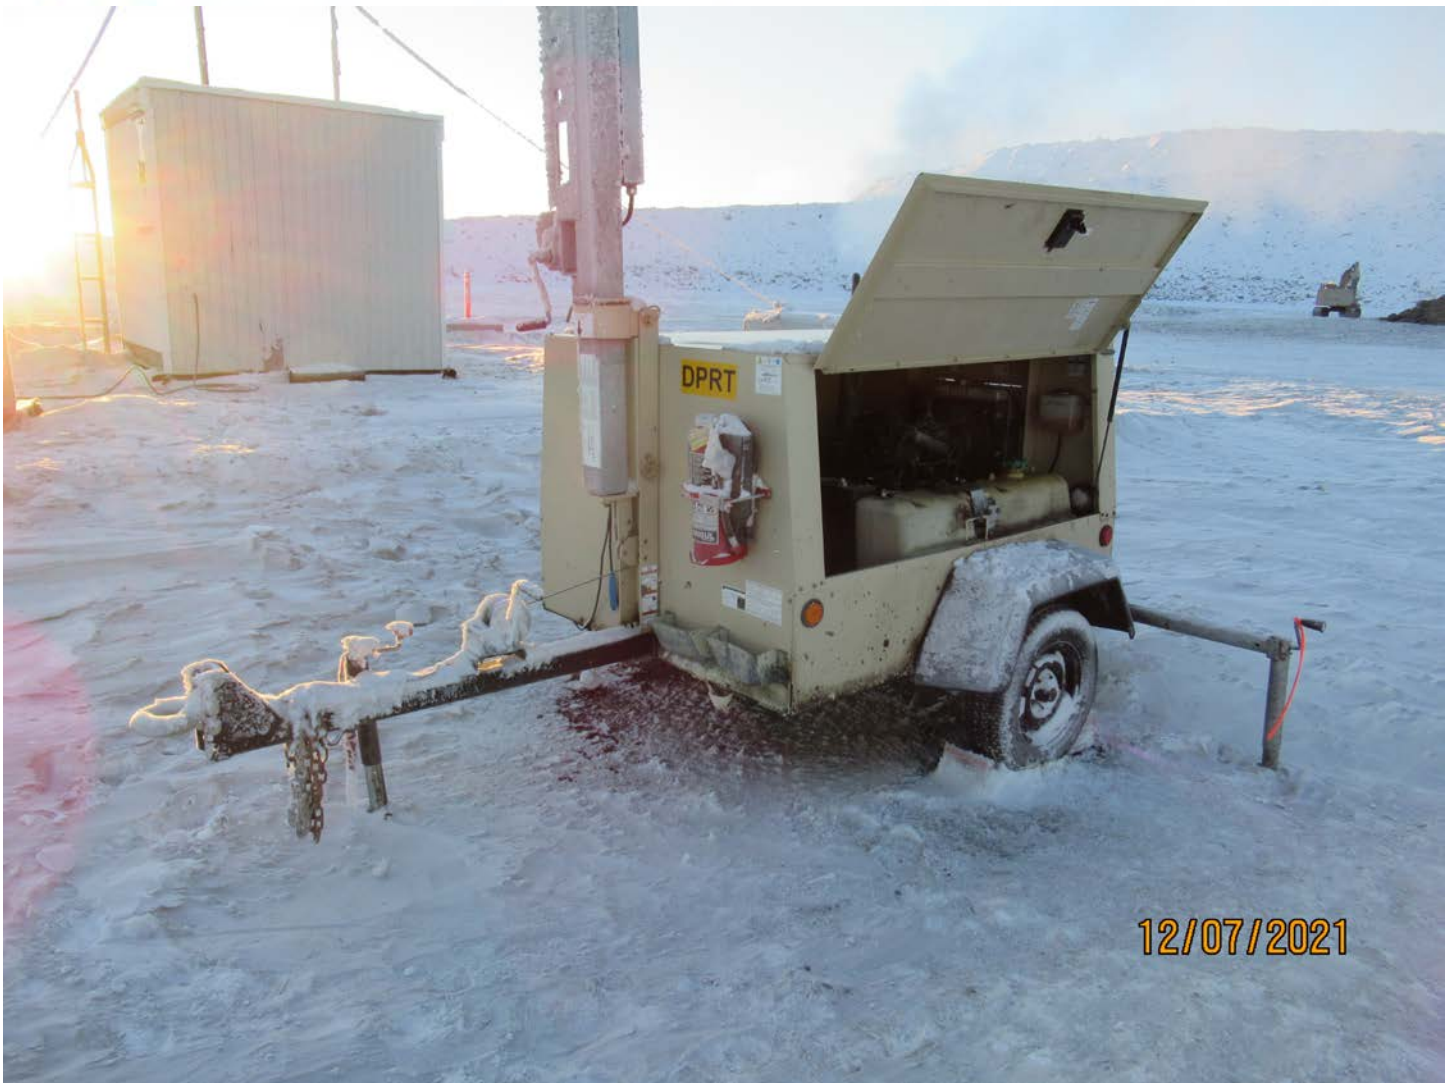
Photo 11: A second operational light plant at the ore laydown that requires secondary containment.

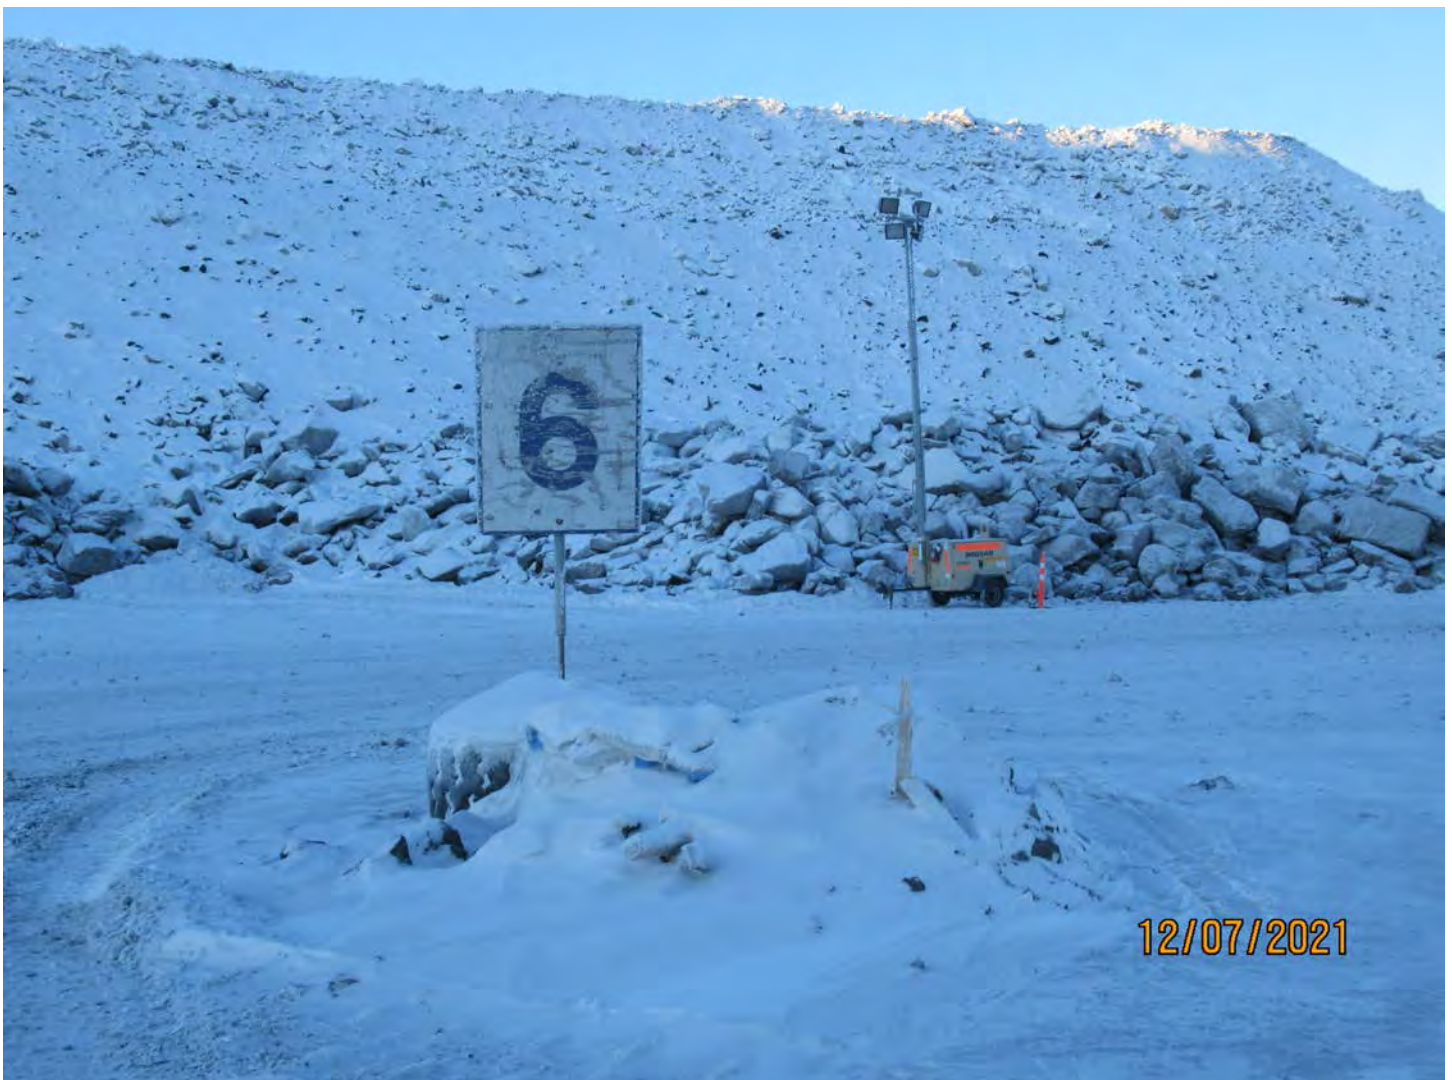
Photo 12: A third light plant at the ore laydown that was not in use during the inspection.

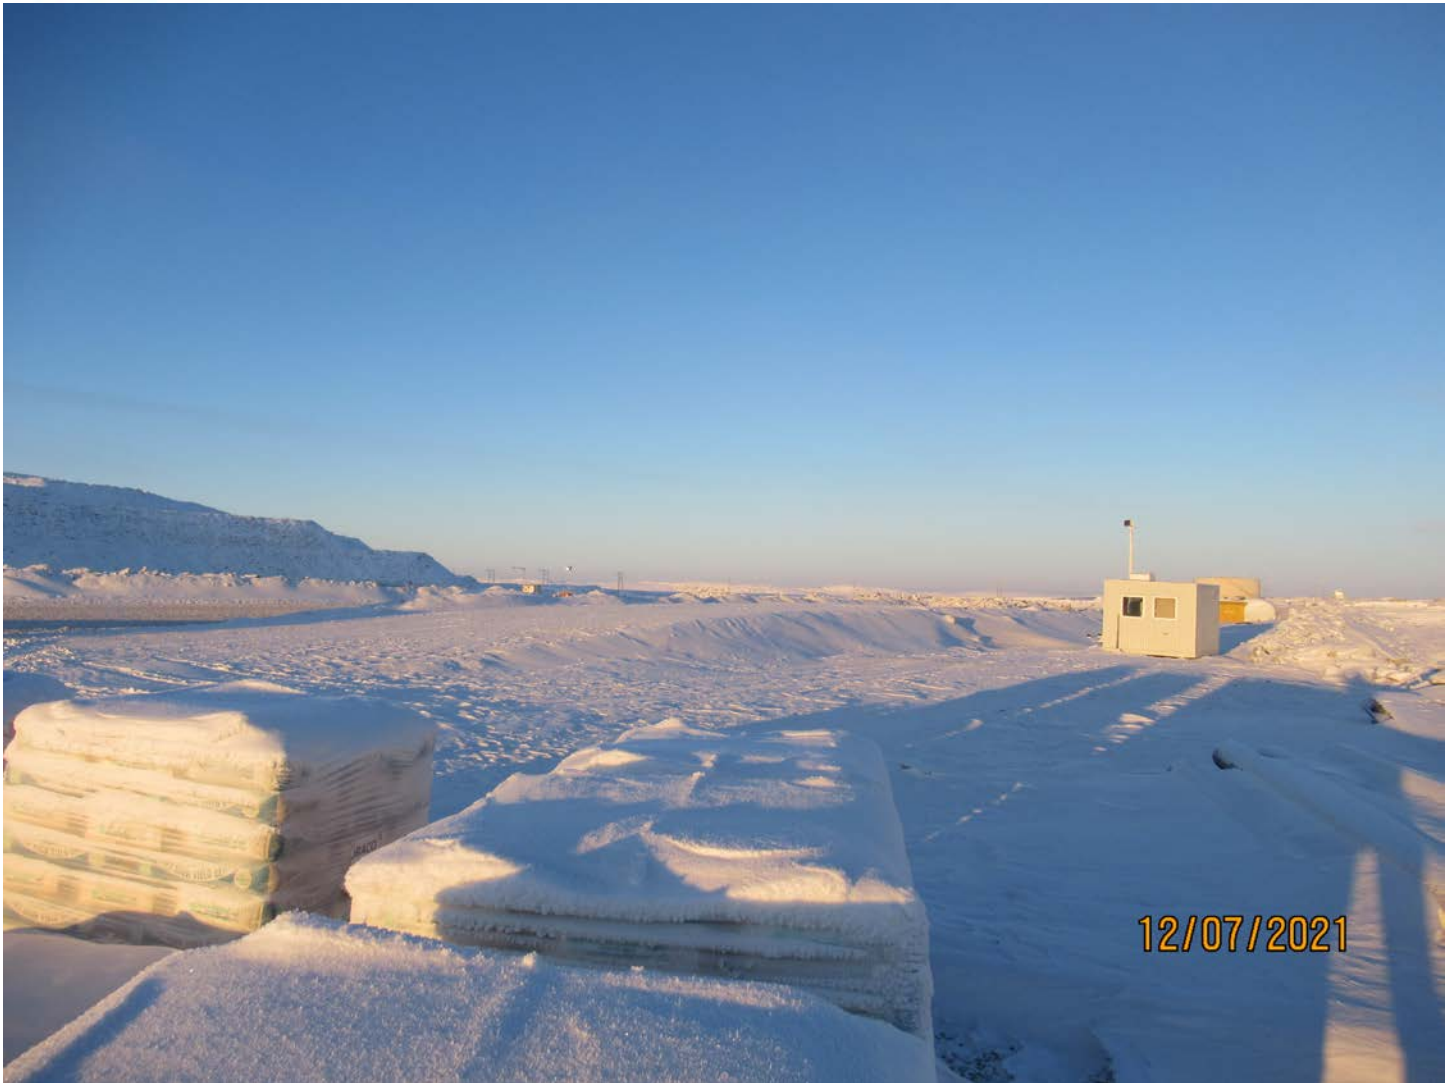
Photo 13: The weigh scale at the Misery Pit laydown.

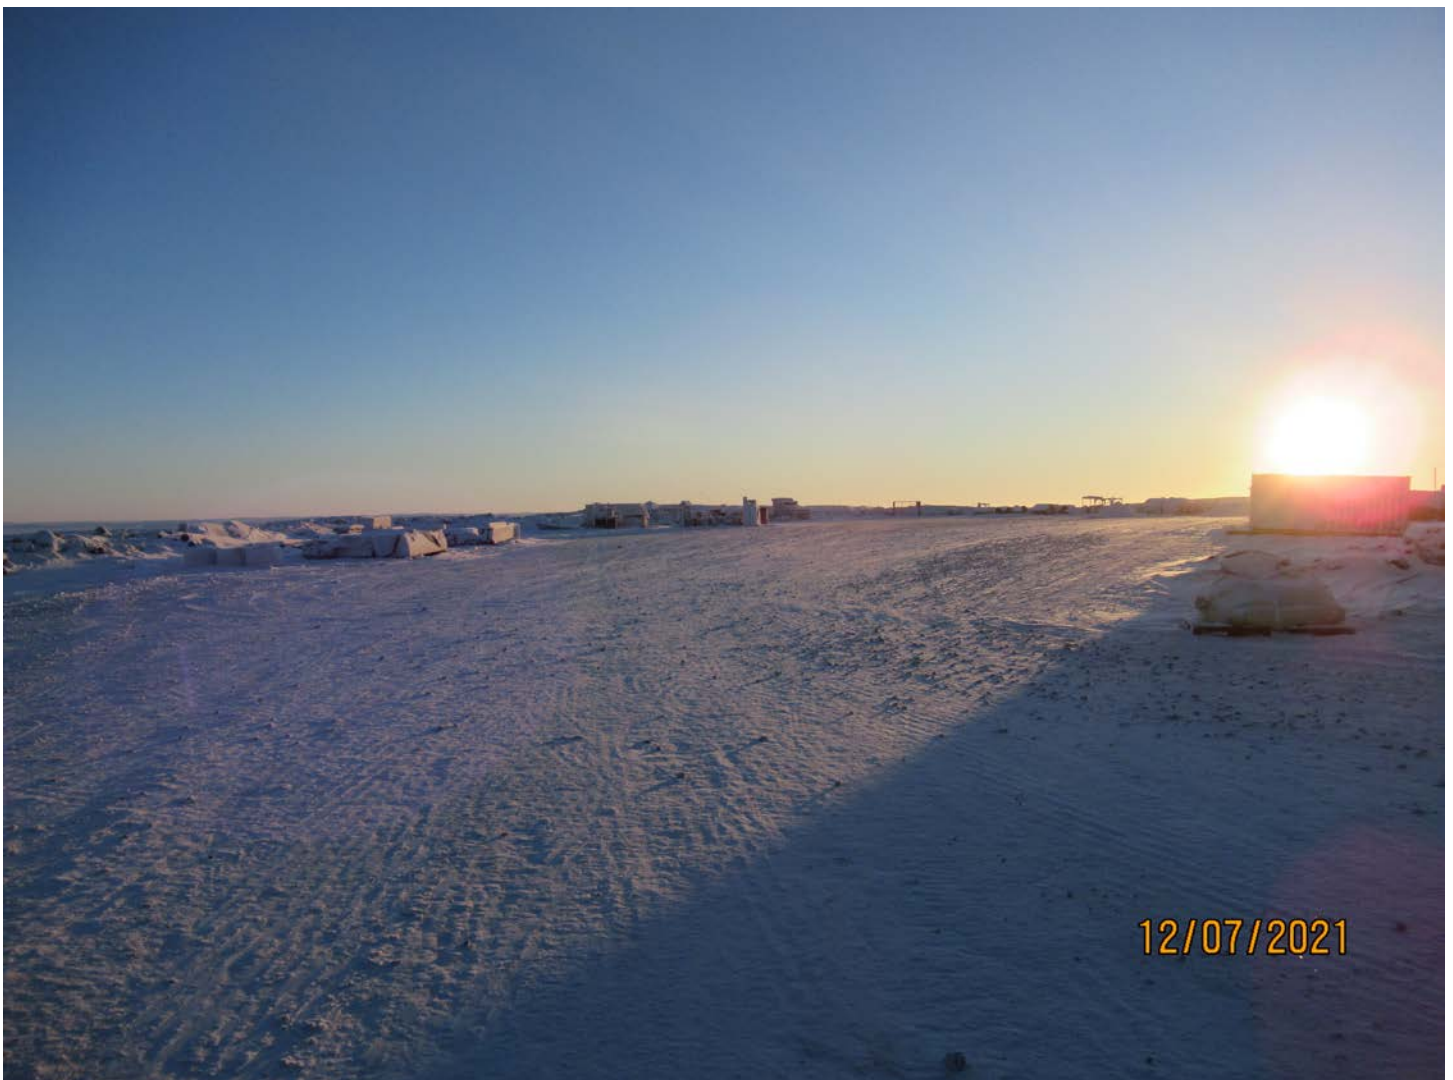
In addition to the Misery Pit 440 Bench and the ore staging area, the inspection also included the MUG Project winter road laydowns. The laydowns are used to stage materials as they arrive during the Winter Road haul season prior to the materials being sorted and sent to various projects located throughout the Ekati minesite. As seen, there was a weigh scale in place at the laydown and the site was ready to receive winter haul freight (Photos #13 & #14). No further concerns were noted by the Inspector regarding the surface operations of the MUG Project.

Photo 14: The Misery Pit laydown appeared ready to receive freight brought to the mine on the winter haul road.
