**Re: Land Use Permit W2017D0004
Mining and Associated Activities
Misery Underground Project, Northwest Territories**

ENVIRONMENTAL INSPECTION REPORT

Location(s) Inspected:	The Misery Underground Project (surface) and Misery Camp.
------------------------	---

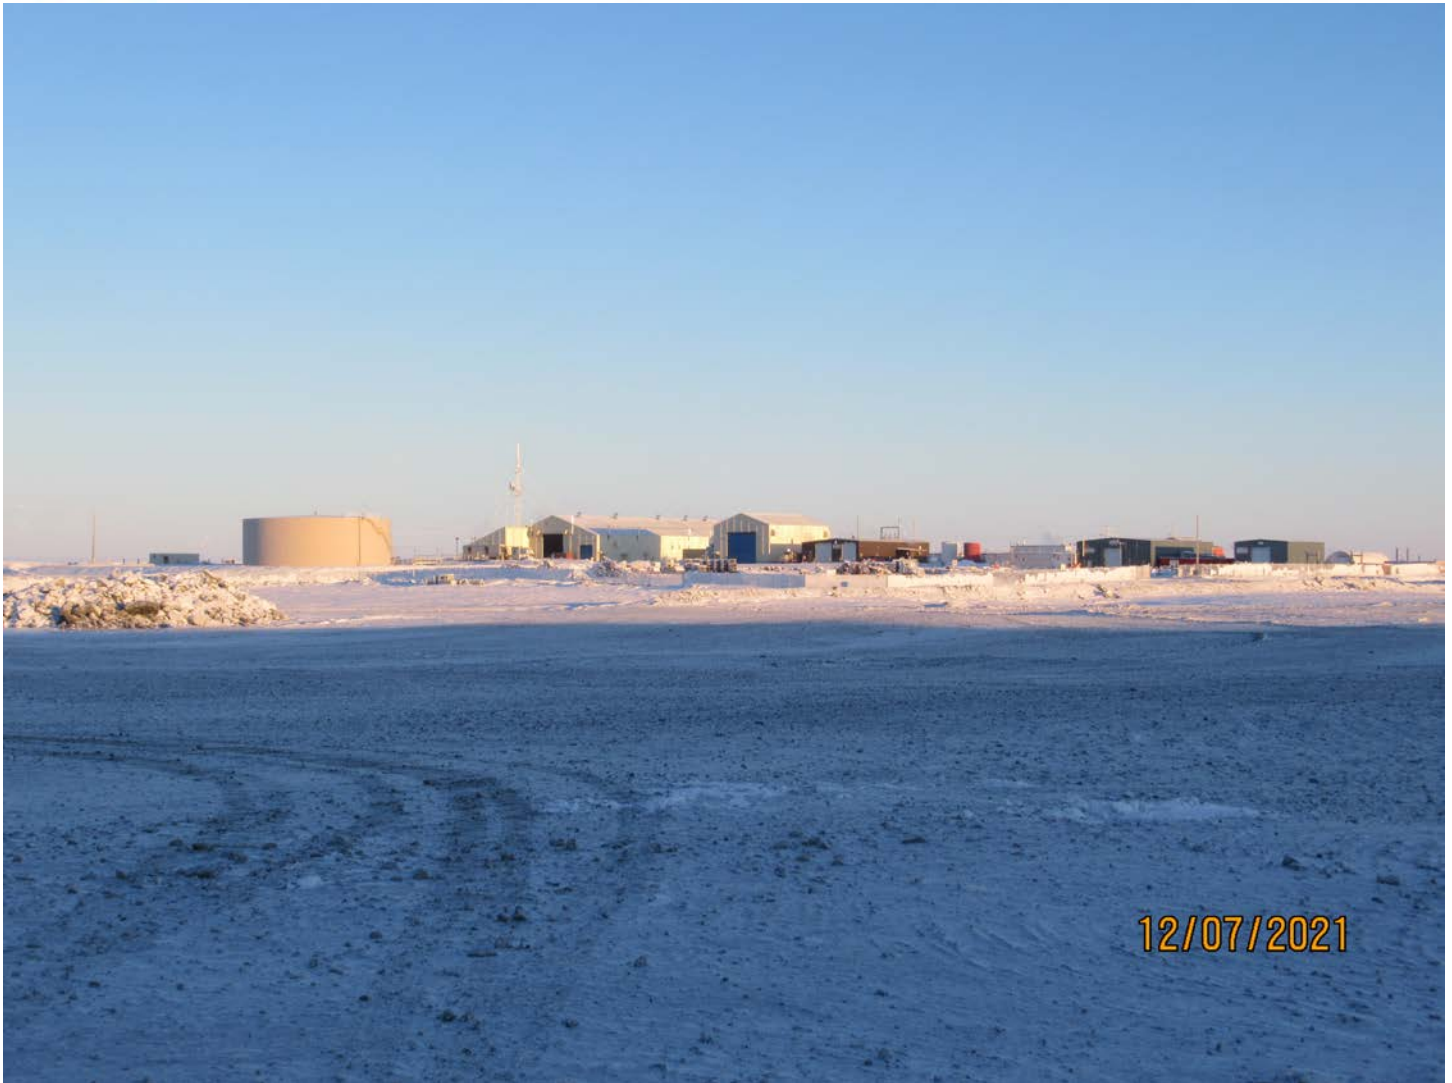
Photo 15: An overview of the Misery Camp in this photo taken from the ore laydown.

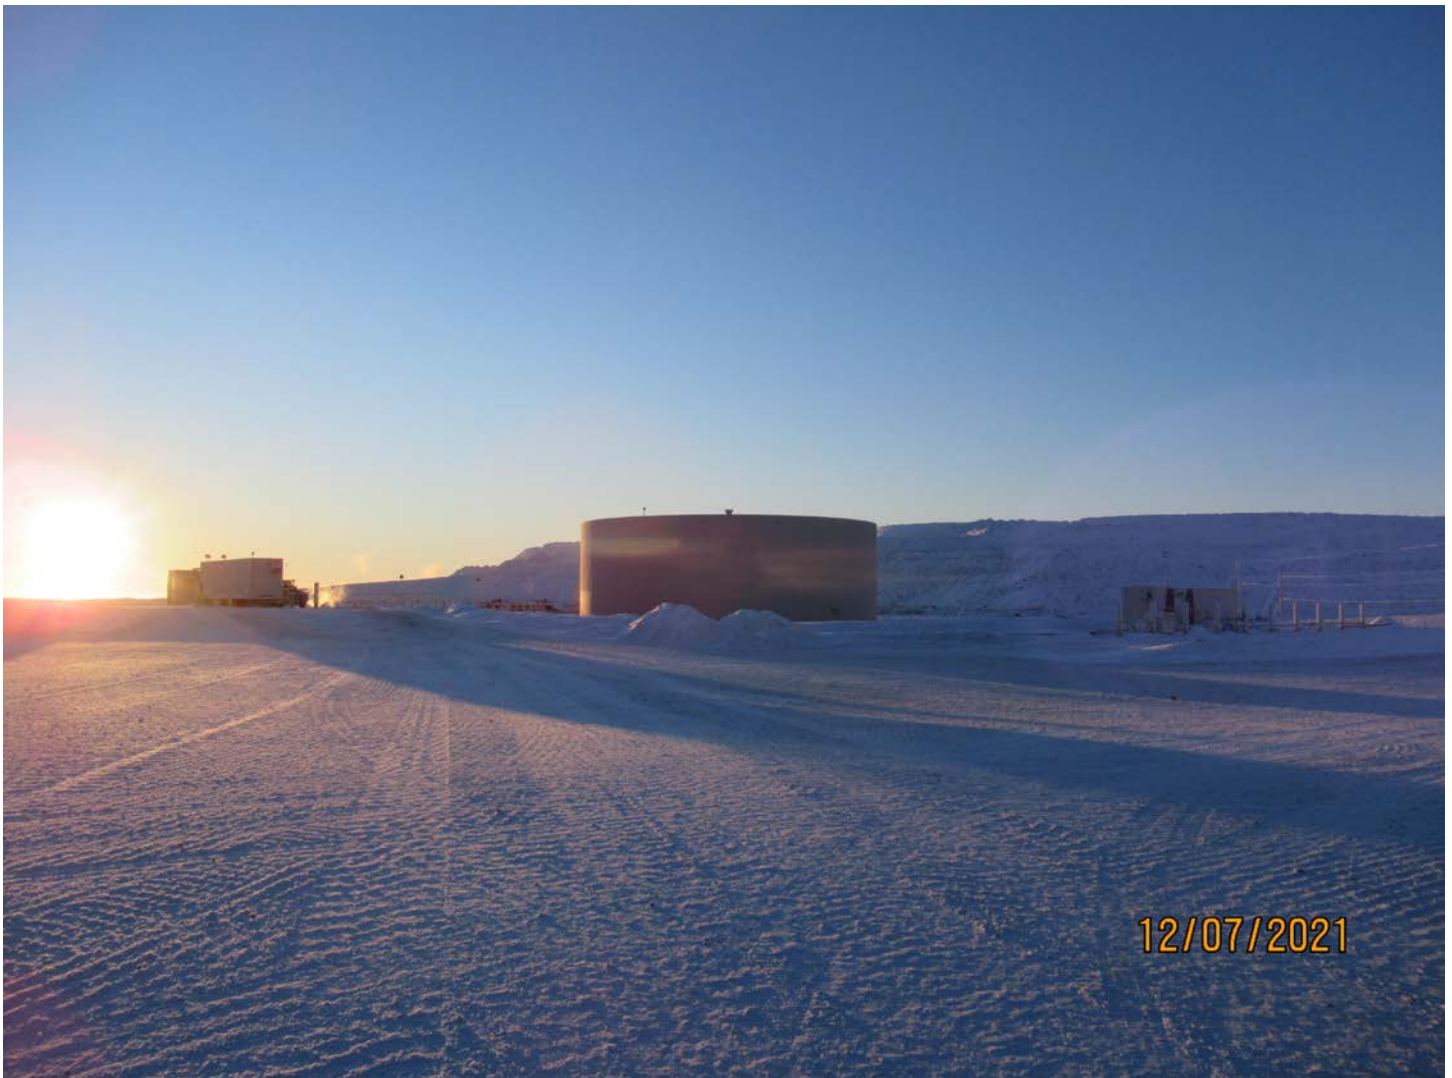
Photo 16: The Misery Pit bulk fuel tank, bulk fuel offload station (right) and the vehicle fueling area (left).

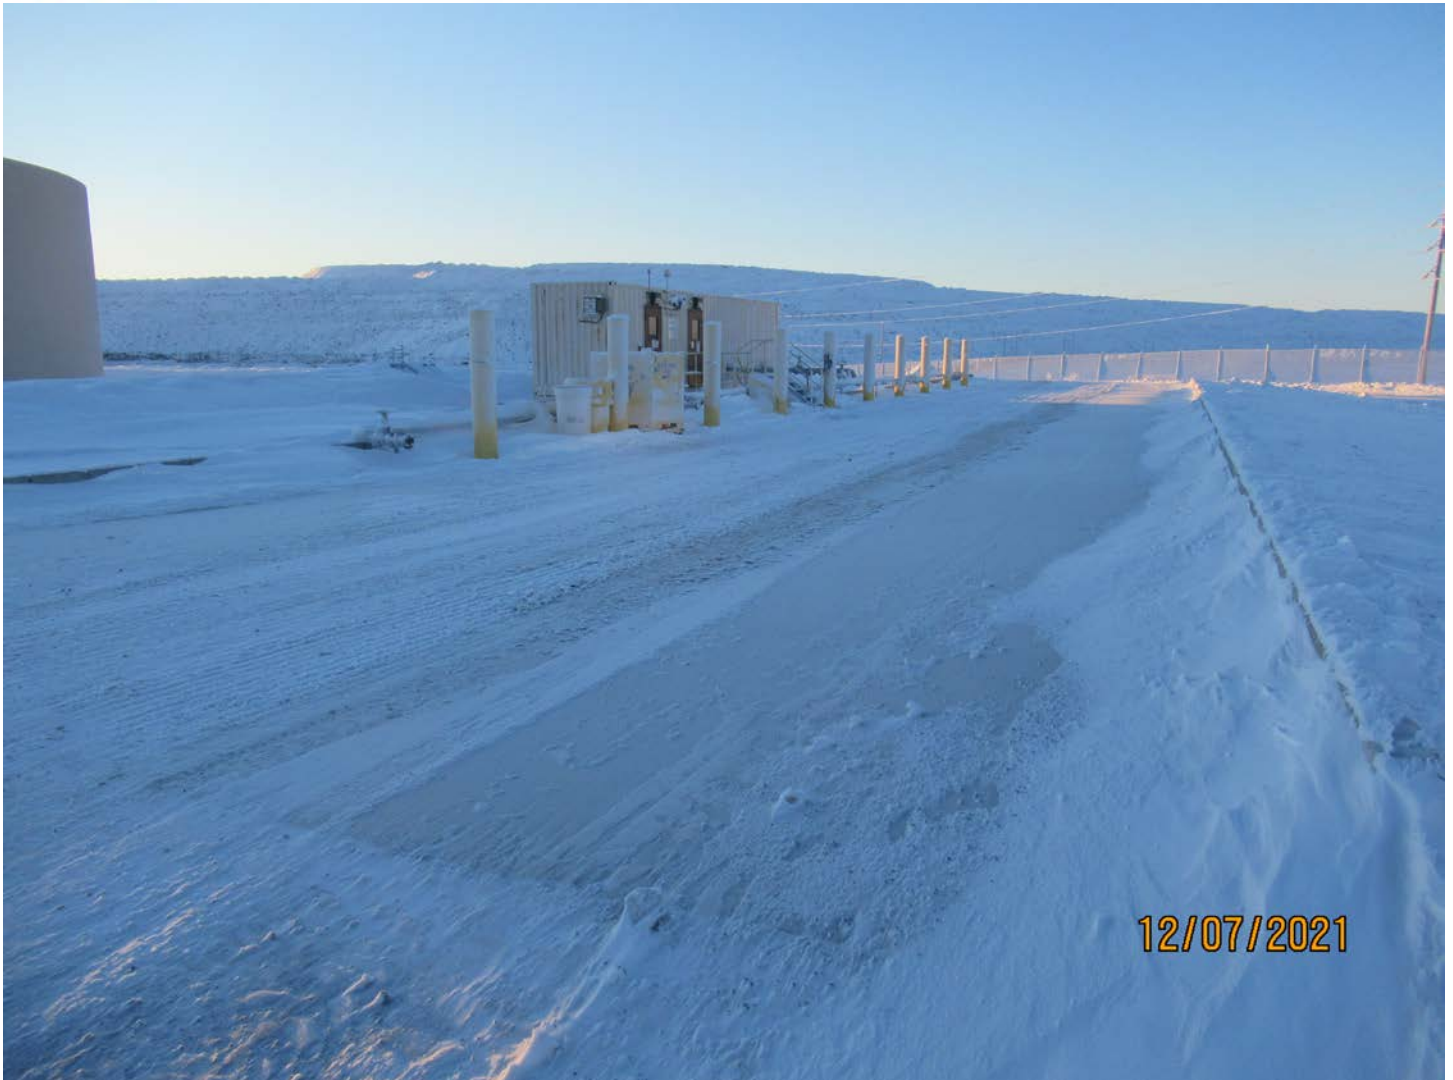
At the Misery Camp (Photos #15 & #16), the bulk fuel offload station ramp was cleared of snow, there were no obvious hydrocarbon stains in the area and there were readily available and adequate spill response materials (Photos #17 & #18). At the Misery fueling station, there was also adequate spill response materials available and secondary containment was also in use (Photos #19 & #20). At both the bulk fuel offload station and fueling station, it appeared there was no hydrocarbon impacted snow being tracked off the fueling pads. However, the Inspector did note some spilled hydrocarbons on the ground at the light vehicle fueling pad. Once the spilled fuel was noticed by an employee, it was immediately scraped up and put in the contaminated snow bin located at the station (Photos #21 & #22).

Photo 17: As seen, the snow was cleared from the bulk fuel offload ramp and there were readily available spill response materials staged on the ramp.

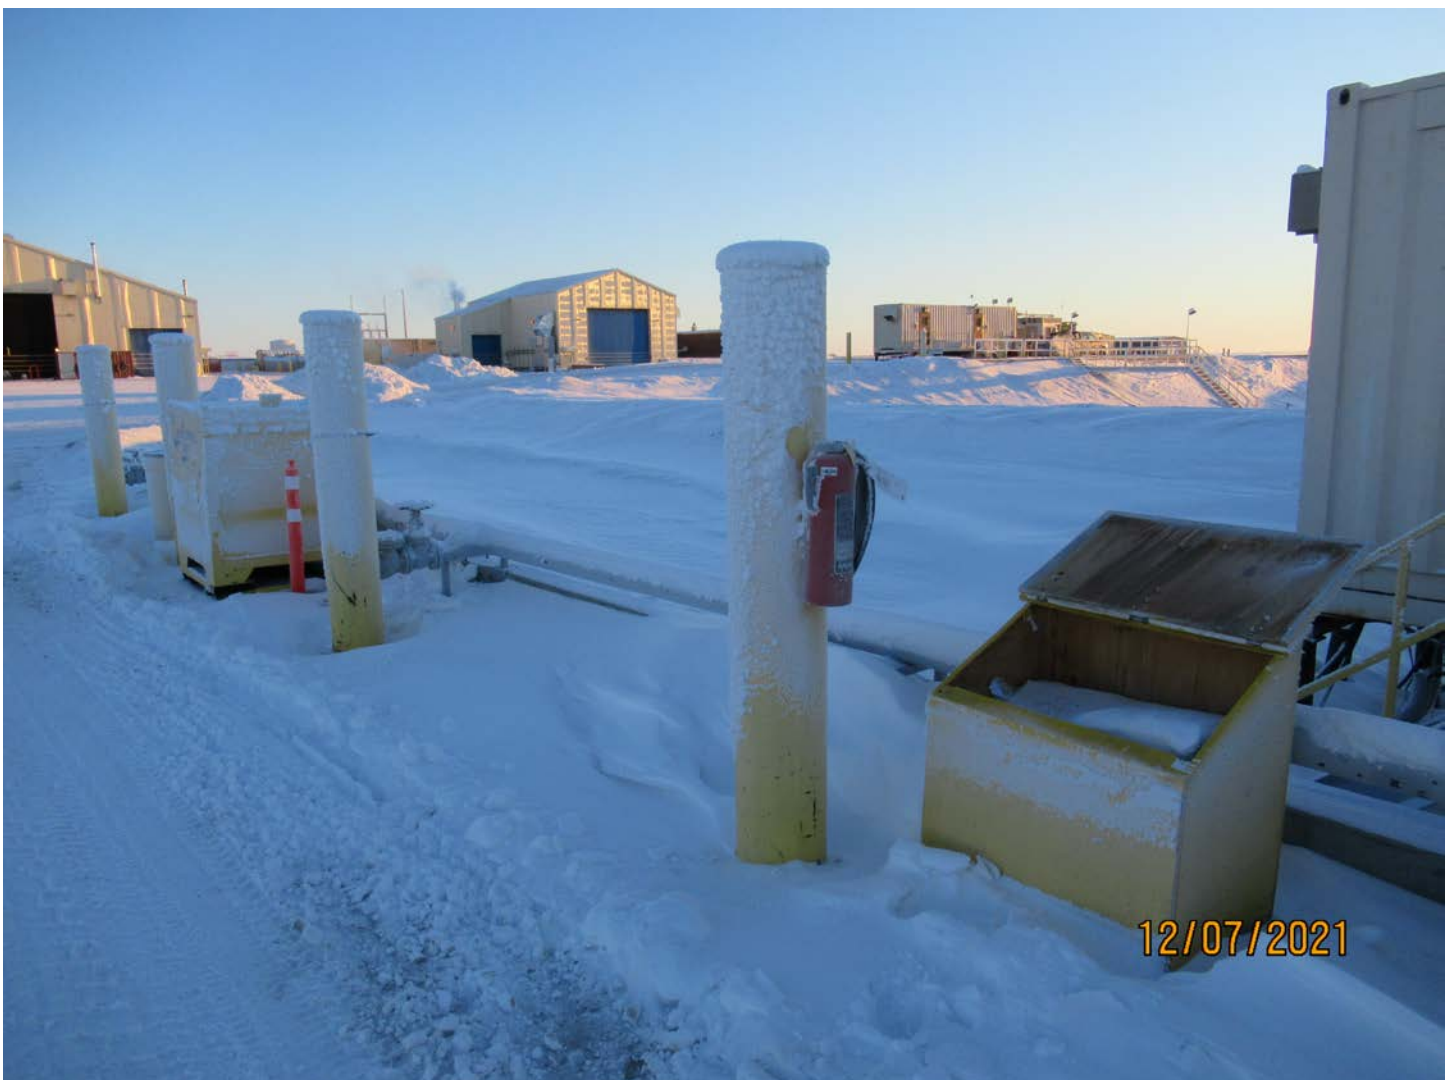
Photo 18: The spill pads bin was well stocked and ready for spill response.

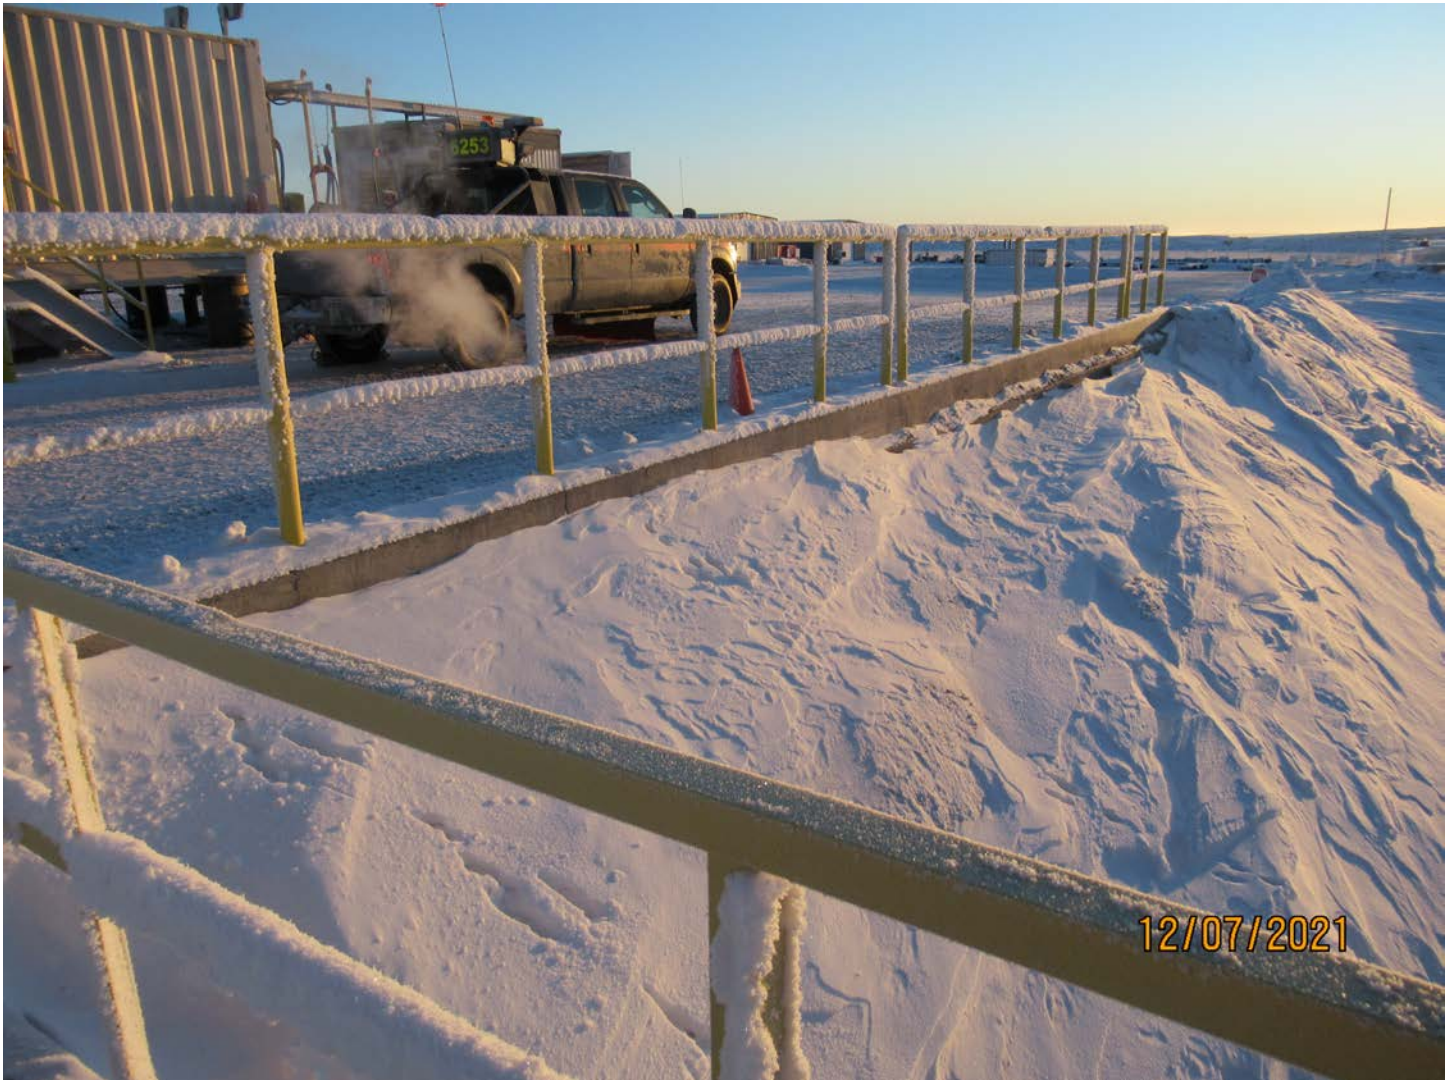
Photo 19: Looking south along the light vehicle offload ramp. The cone indicates the location of the ramp sump.

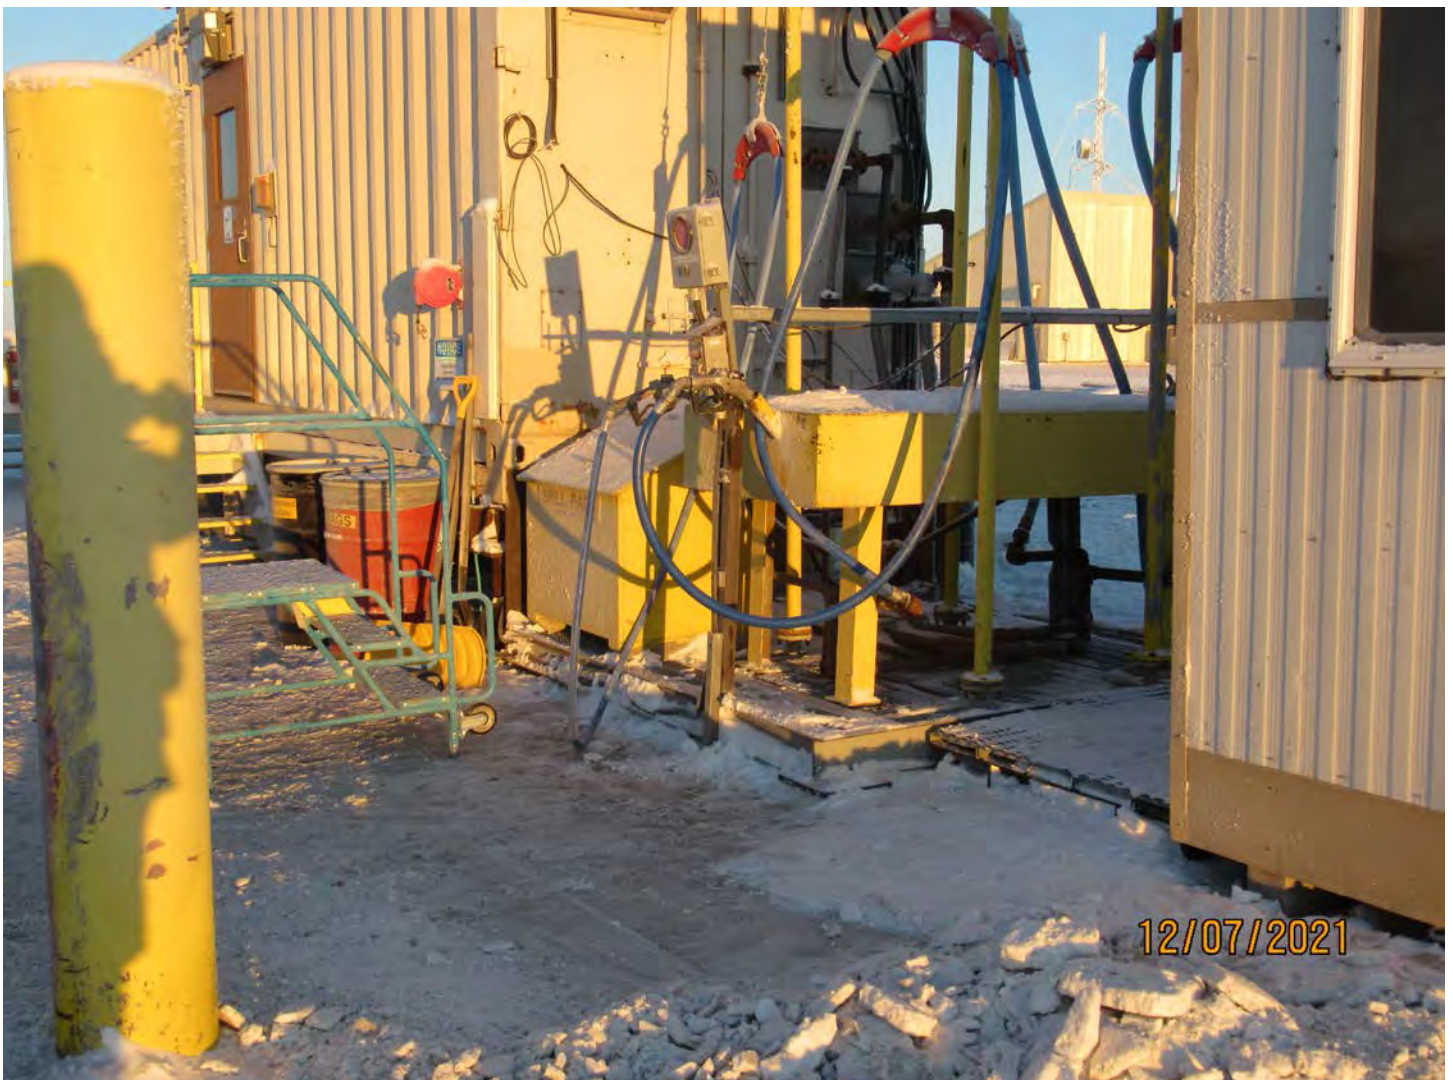
Photo 20: There was secondary containment for the fuel nozzles on the ramp and readily available spill response materials.

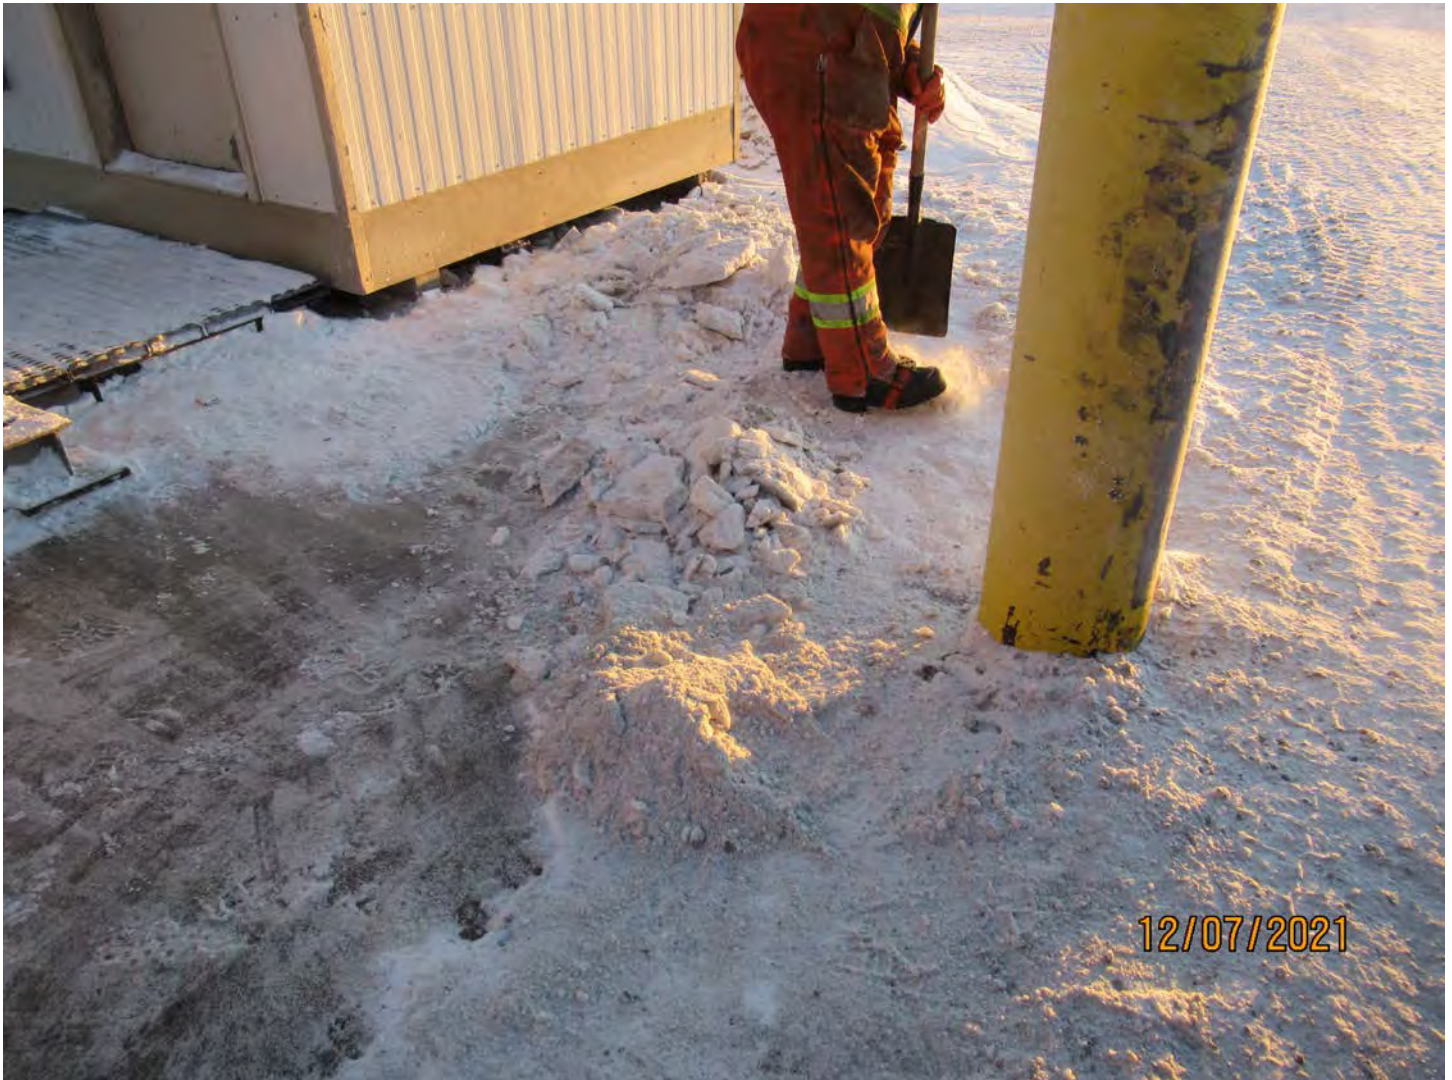
Photo 21: A mine employee was scraping up hydrocarbon impacted snow at the light vehicle fueling area.

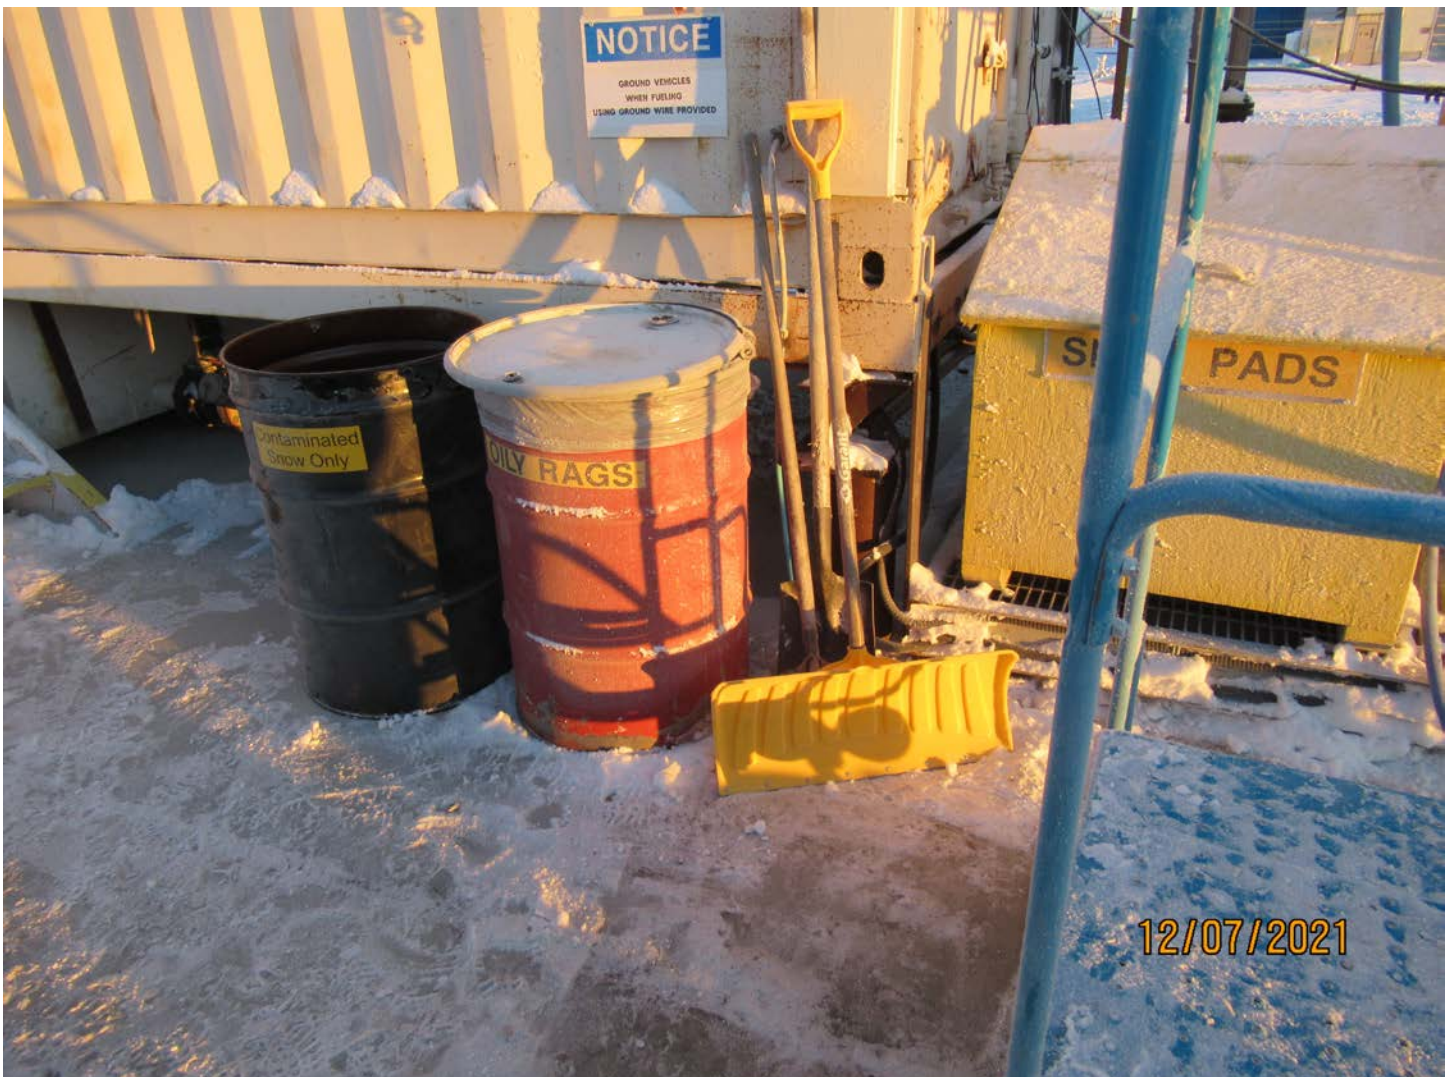
Photo 22: Hydrocarbon impacted waste is being placed in designated waste containers at the fueling ramp.

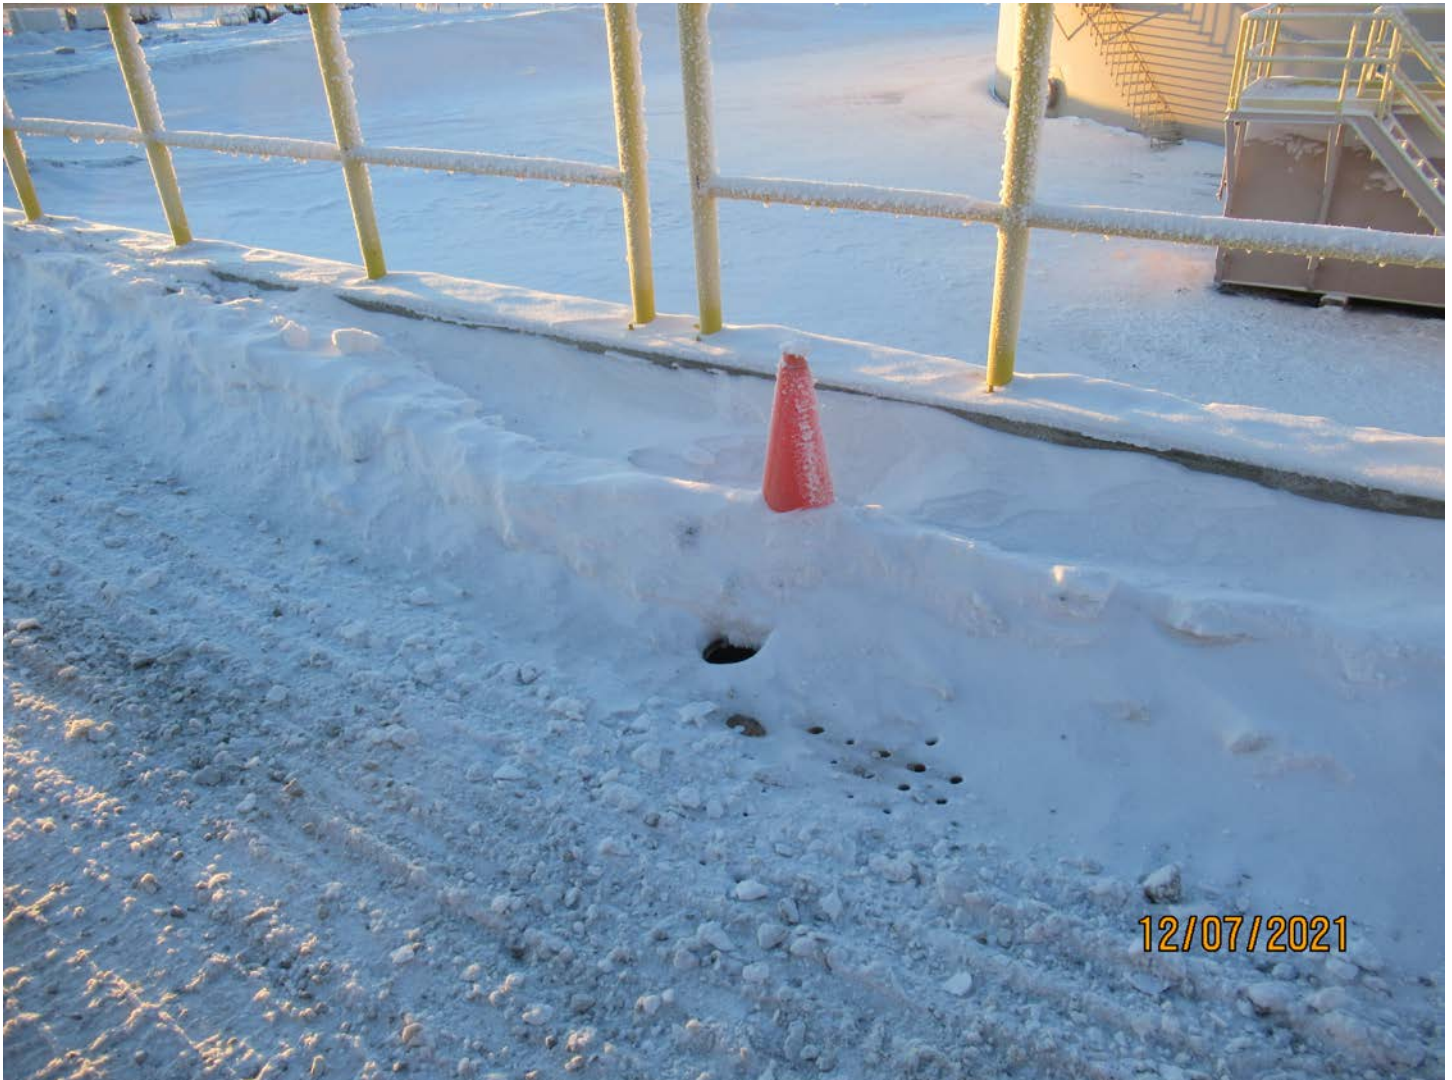
Photo 23: The sumps on the fueling ramps must be diligently monitored and cleared of snow & ice throughout the winter season.

The Permittee must ensure the sumps at the fuel stations are kept free and clear of snow to ensure they are working as designed: to catch fuel and direct it towards the bulk fuel tank berm in the event of spills (Condition #33 – Photo #23). Keeping the sumps clear is important as it will help divert the hydrocarbons away from the surrounding lands, particularly during the winter road bulk fuel hauls. No further concerns were noted by the Inspector at the Misery fuel transfer facilities.

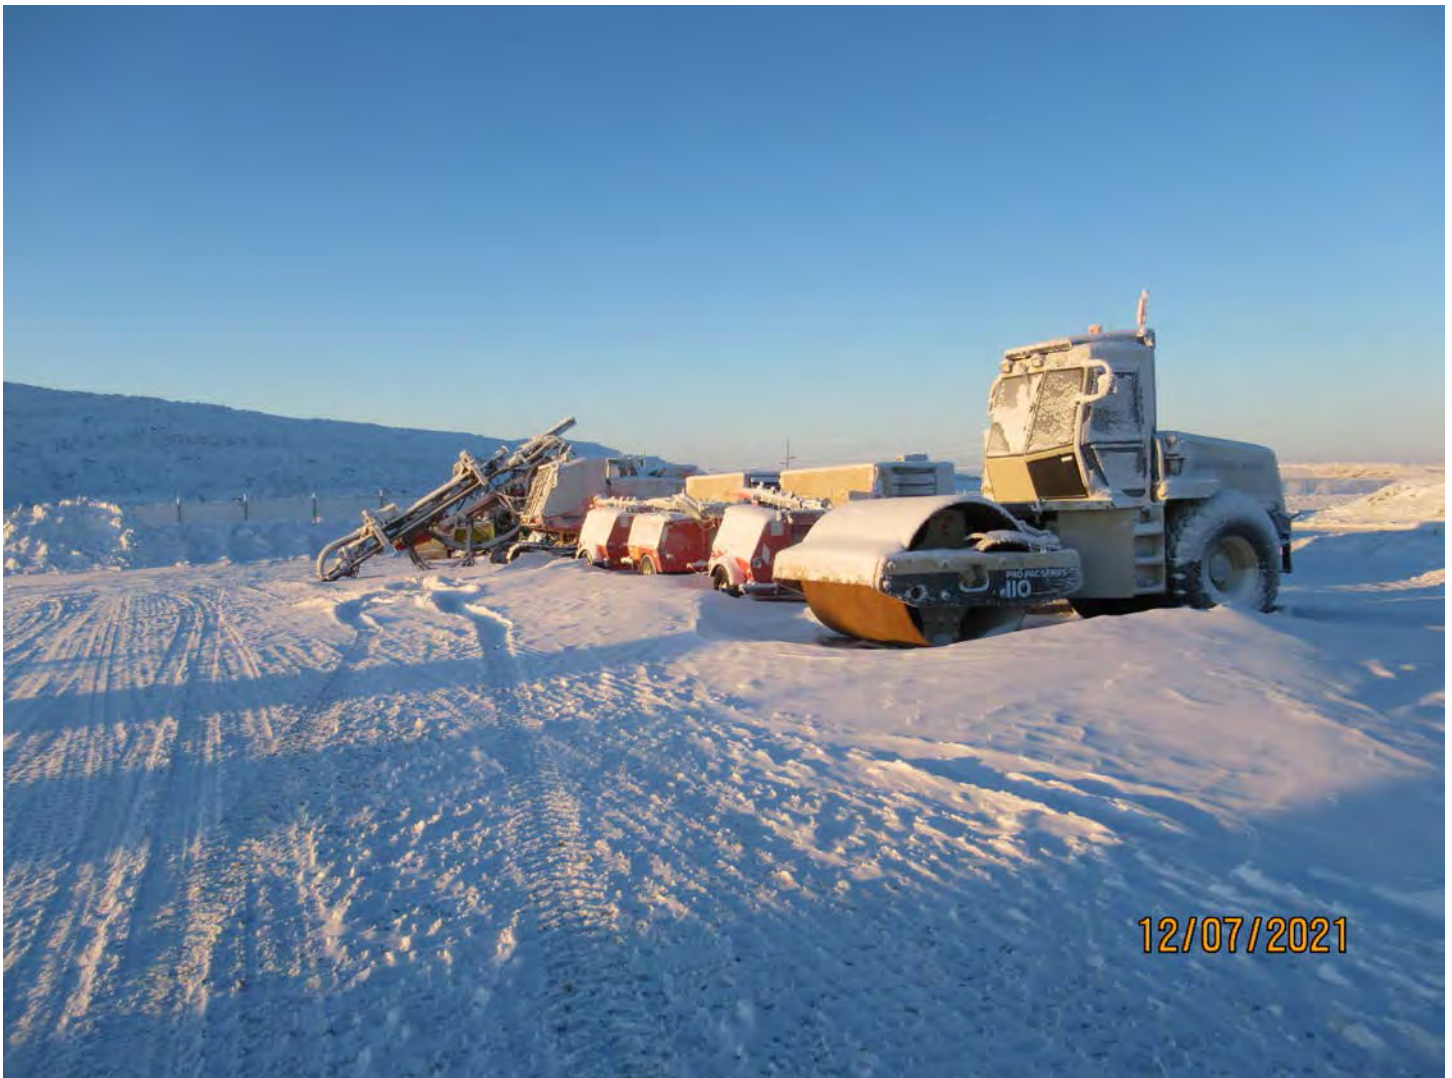
The Inspector noted secondary containment was not being used under some of the parked and staged equipment (Condition #37 – Photos #24-#30). It is imperative that when equipment is parked for more than two hours, secondary containment is placed under the equipment to mitigate hydrocarbon leaks and spills. Additionally, the secondary containment structures must be diligently monitored to ensure they are being properly maintained (ie: deteriorated drip boards, containment filled with snow/ice, etc.) to remain effective in preventing hydrocarbons from spilling onto the ground and impacting the surrounding lands and waters (Condition #33). All spills must be properly recorded, cleaned up and disposed of at an approved facility as per the Ekati *Spill Contingency Plan*.

Photo 24: The equipment down line on the south and west of the Misery Camp compound.

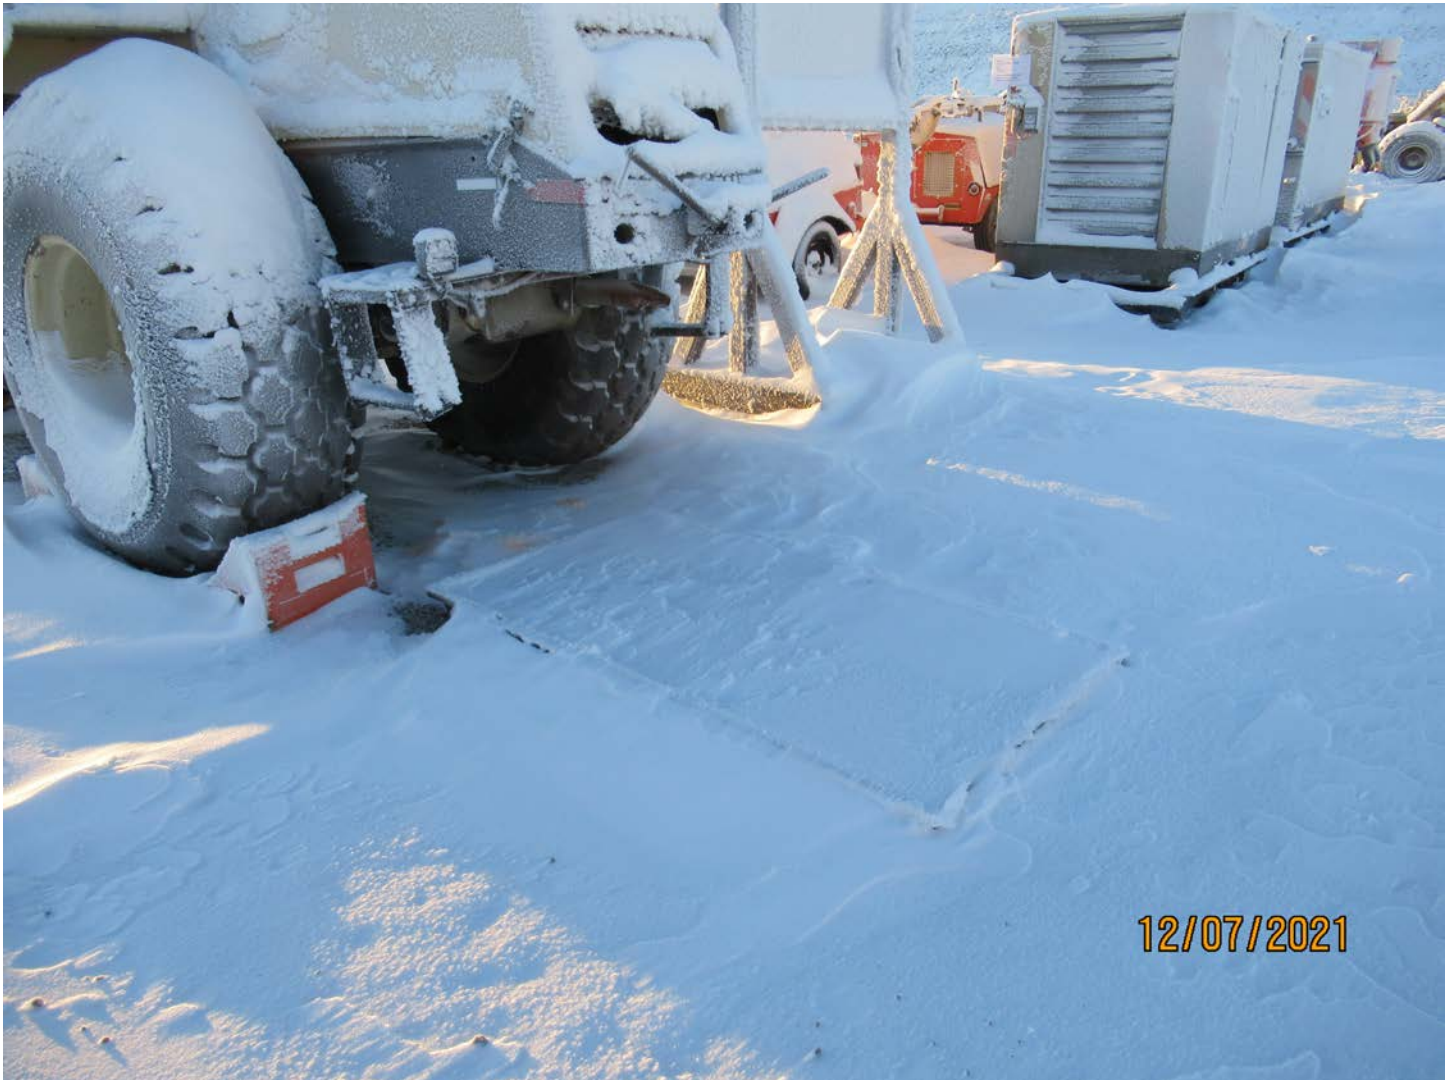
Photo 25: As seen, the secondary containment under this equipment was filled with snow and required maintenance.

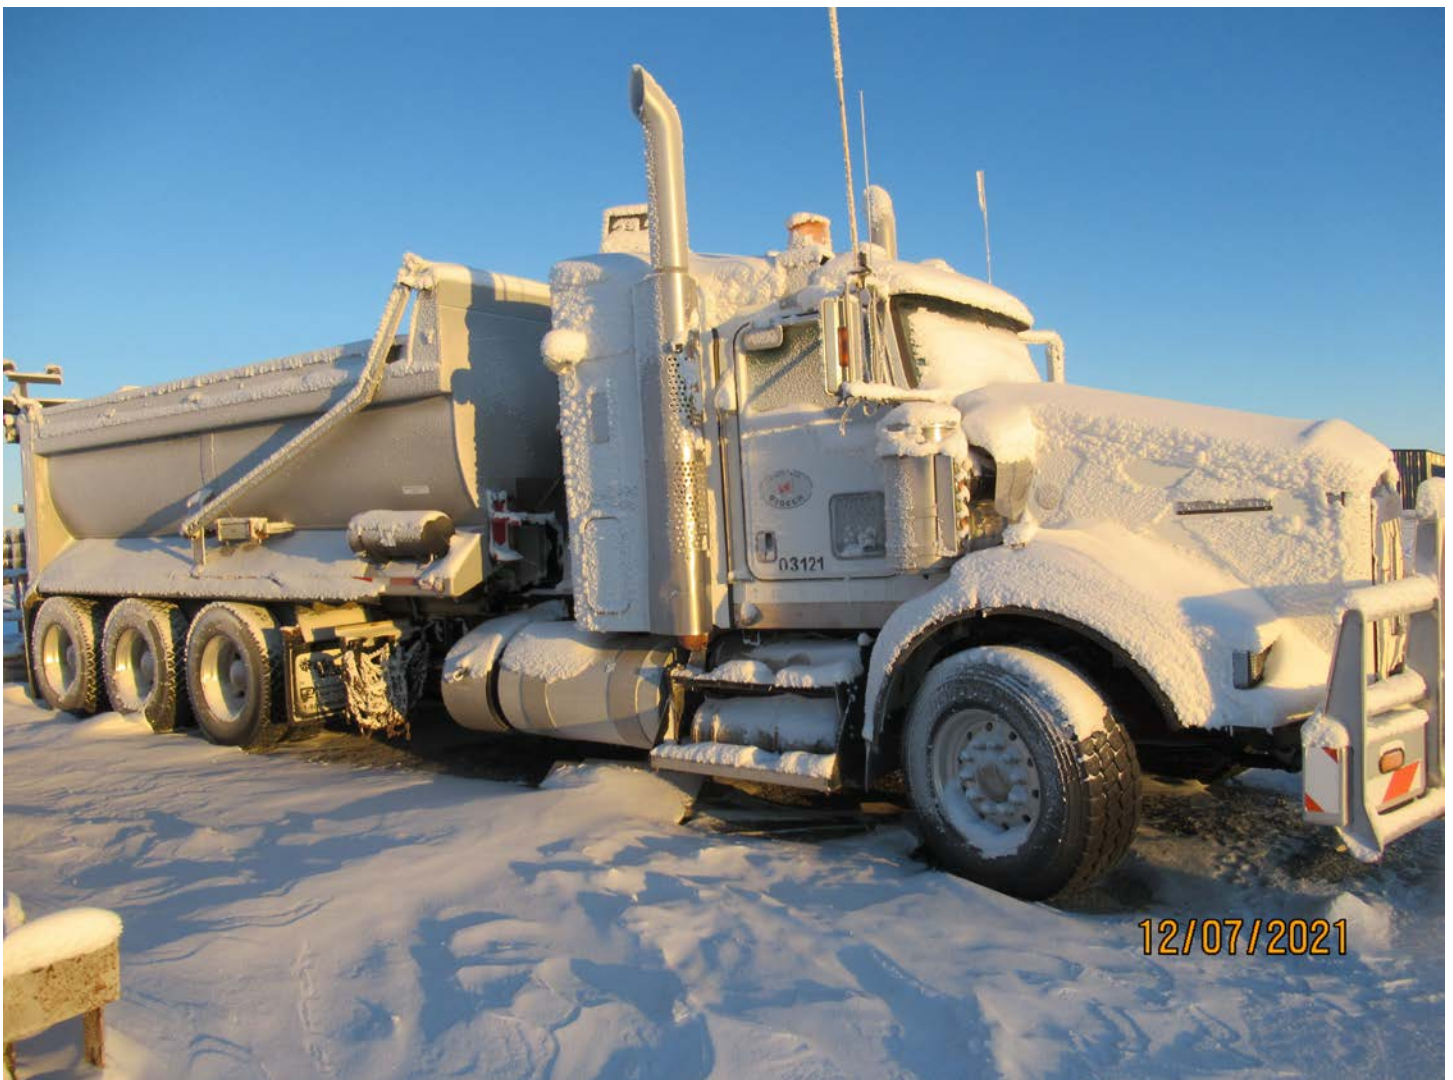
Photo 26: As seen, there was secondary containment placed under this equipment.

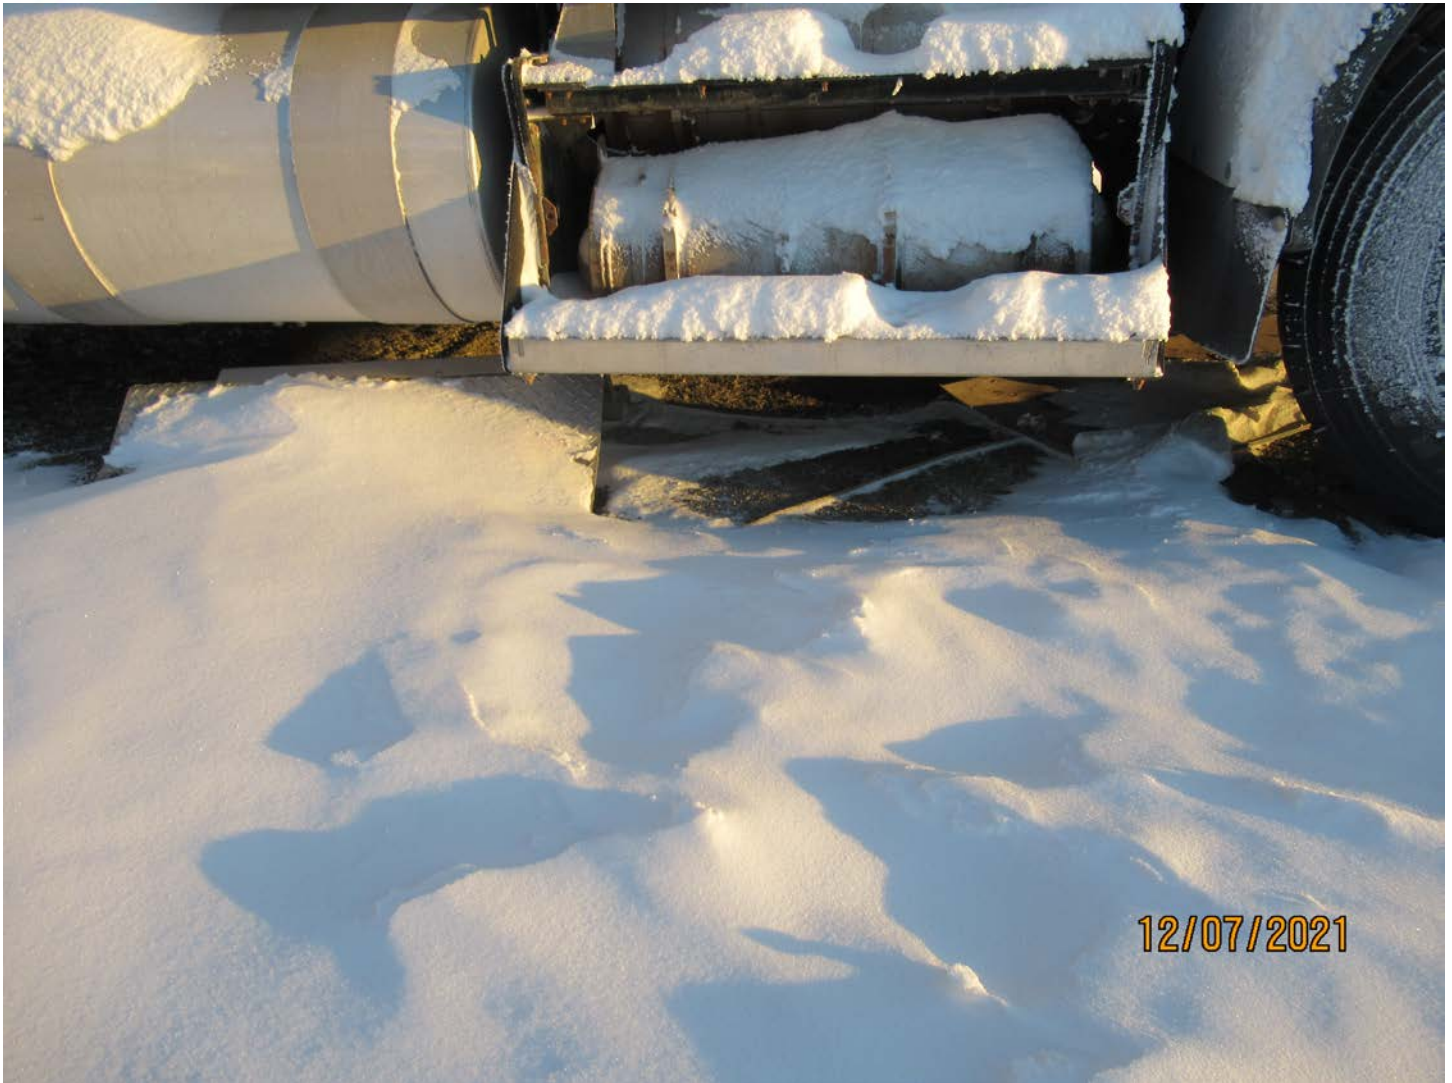
Photo 27: The secondary containment structures required maintenance (ie: drip board repairs).

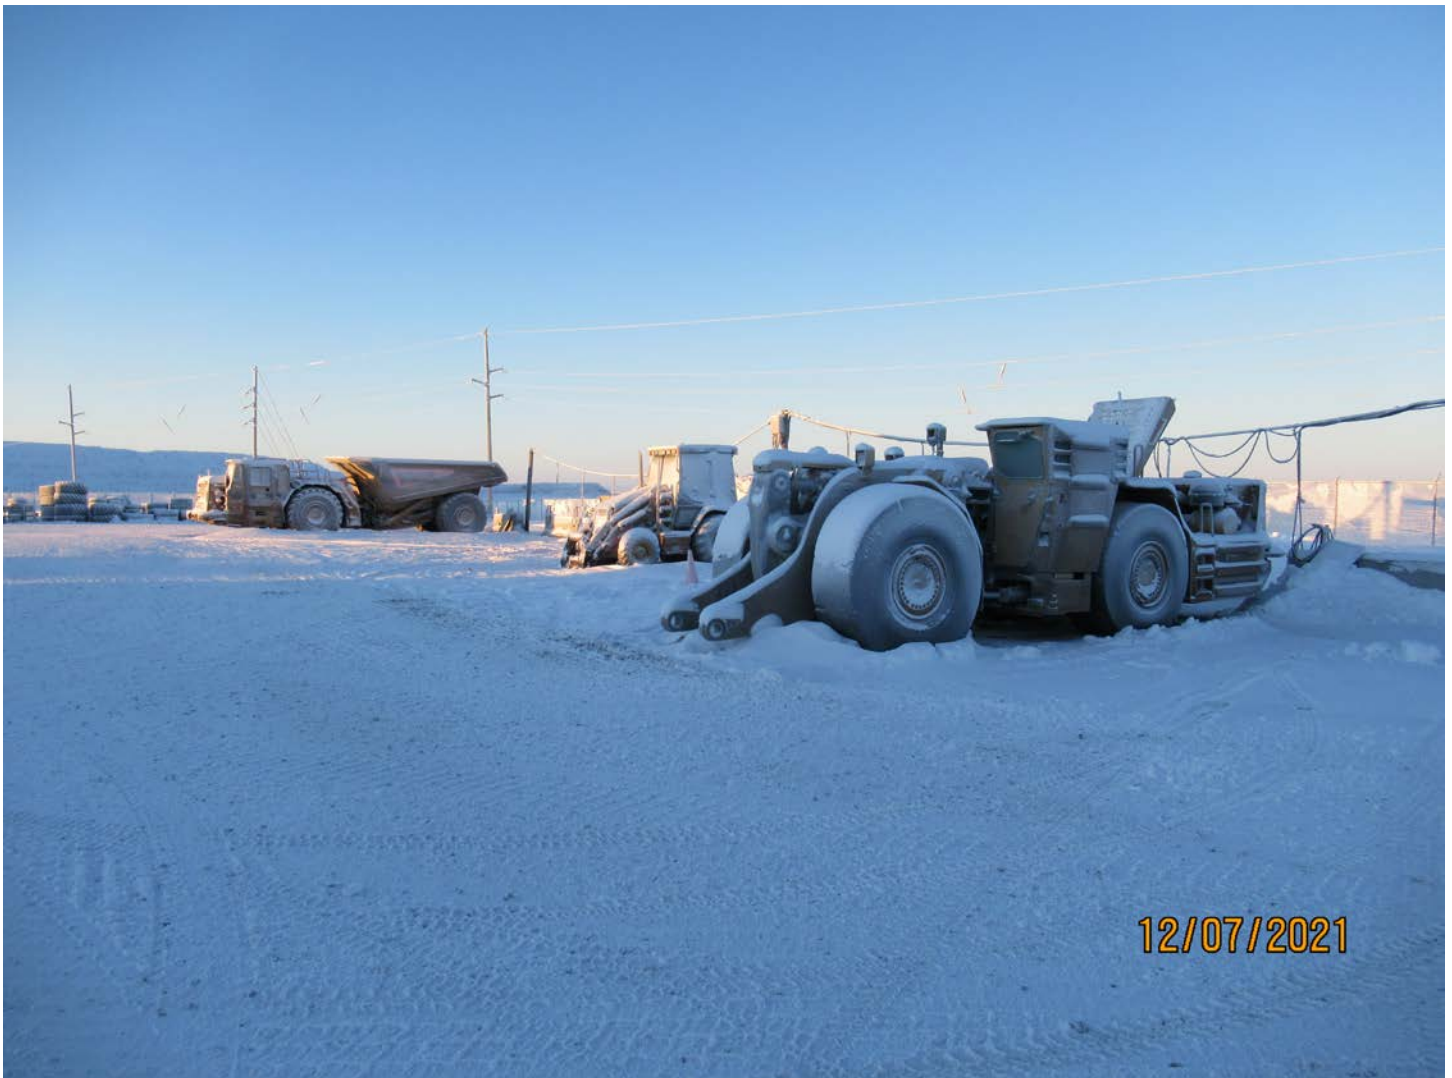
Photo 28: The equipment staging area on the north and west of the Misery Camp compound.
