**Re: Land Use Permit W2017D0004
Mining and Associated Activities
Misery Underground Project, Northwest Territories**

ENVIRONMENTAL INSPECTION REPORT

Location(s) Inspected:	The Misery Underground Project (surface) and Misery Camp.
------------------------	---

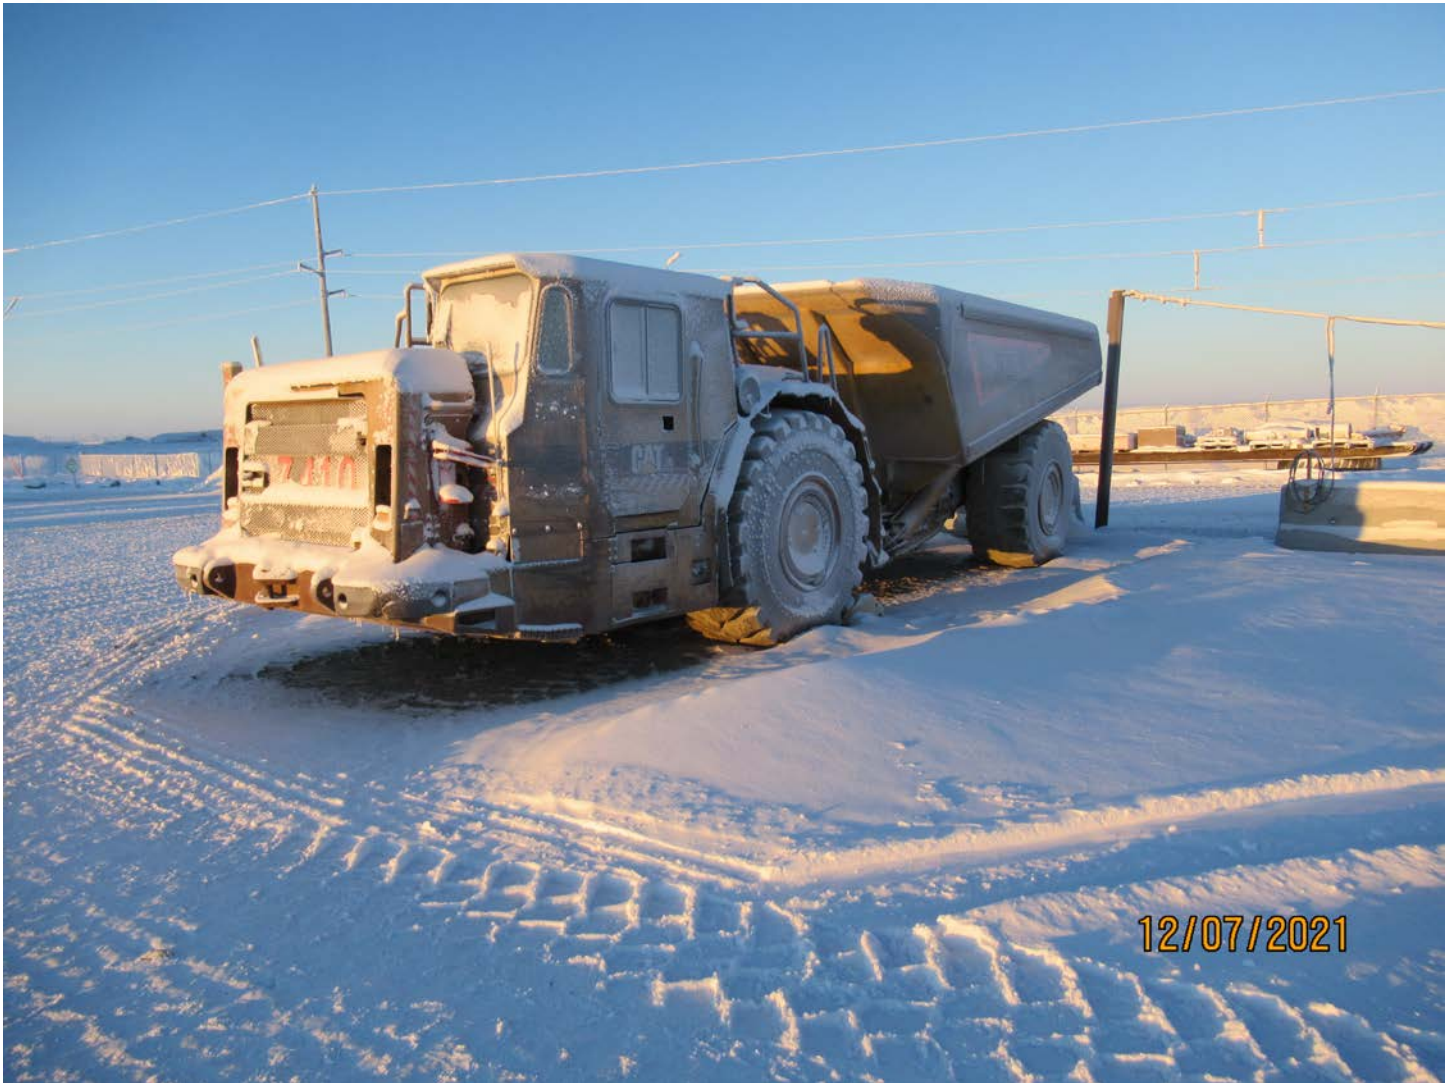
The Inspector noted secondary containment was not being used under some of the parked and staged equipment (Condition #37 – Photos #24-#30). It is imperative that when equipment is parked for more than two hours, secondary containment is placed under the equipment to mitigate hydrocarbon leaks and spills. Additionally, the secondary containment structures must be diligently monitored to ensure they are being properly maintained (ie: deteriorated drip boards, containment filled with snow/ice, etc.) to remain effective in preventing hydrocarbons from spilling onto the ground and impacting the surrounding lands and waters (Condition #33). All spills must be properly recorded, cleaned up and disposed of at an approved facility as per the Ekati *Spill Contingency Plan*.

Photo 29: An underground haul truck was parked at the laydown.

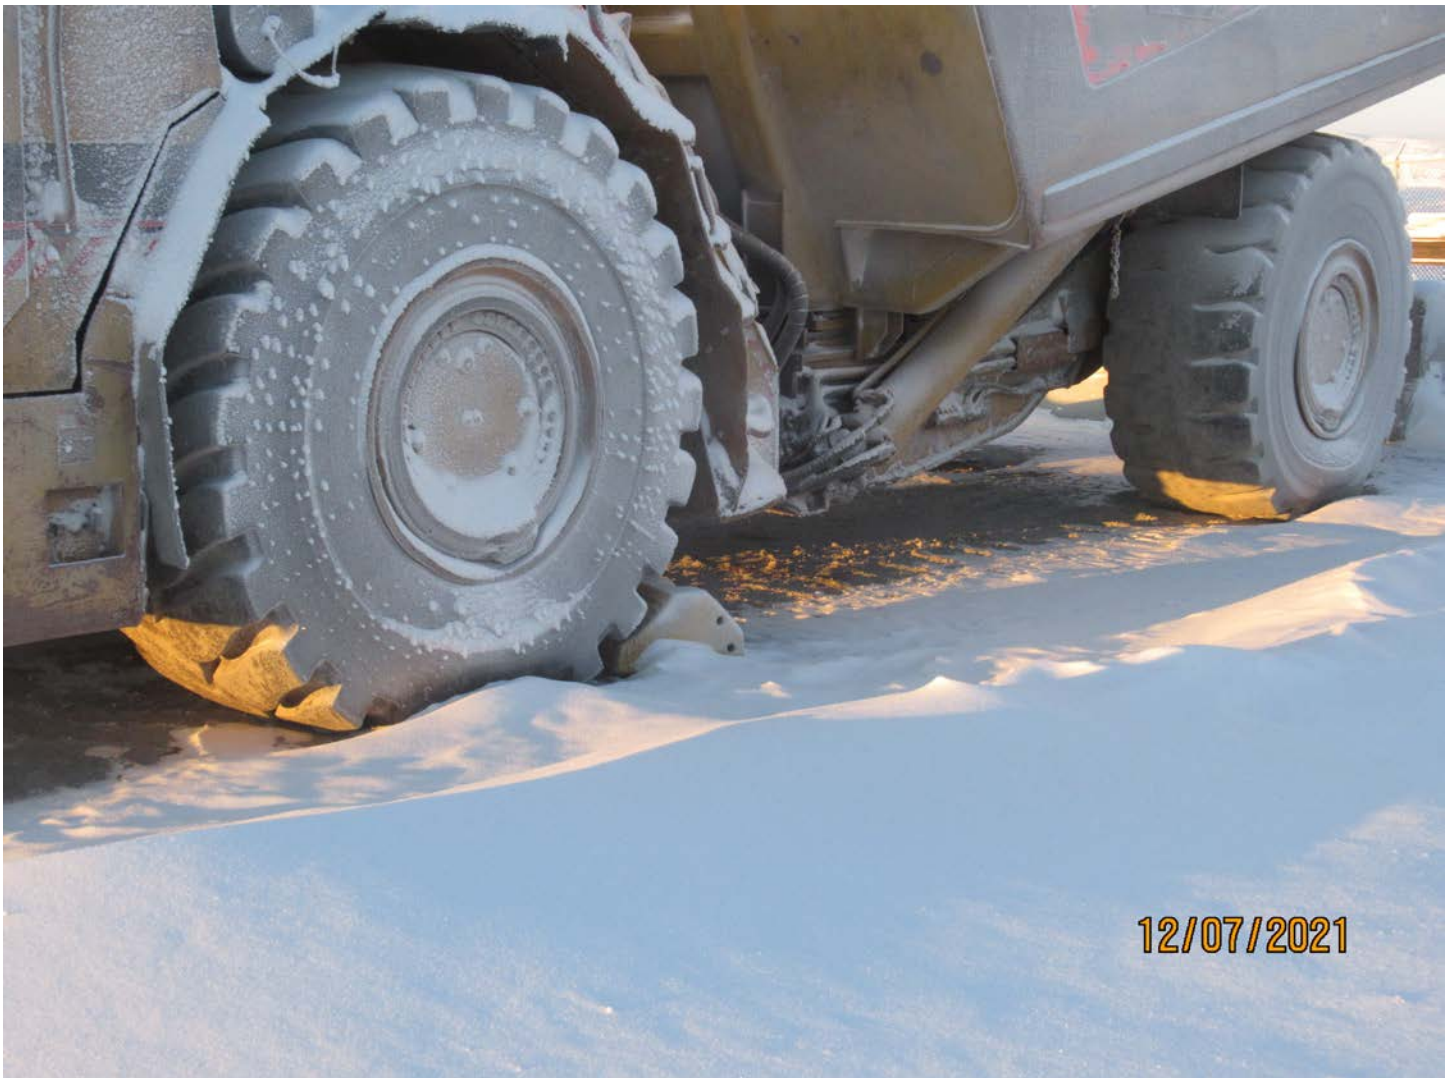
Photo 30: The Permittee must ensure secondary containment is used under parked equipment and is properly maintained.

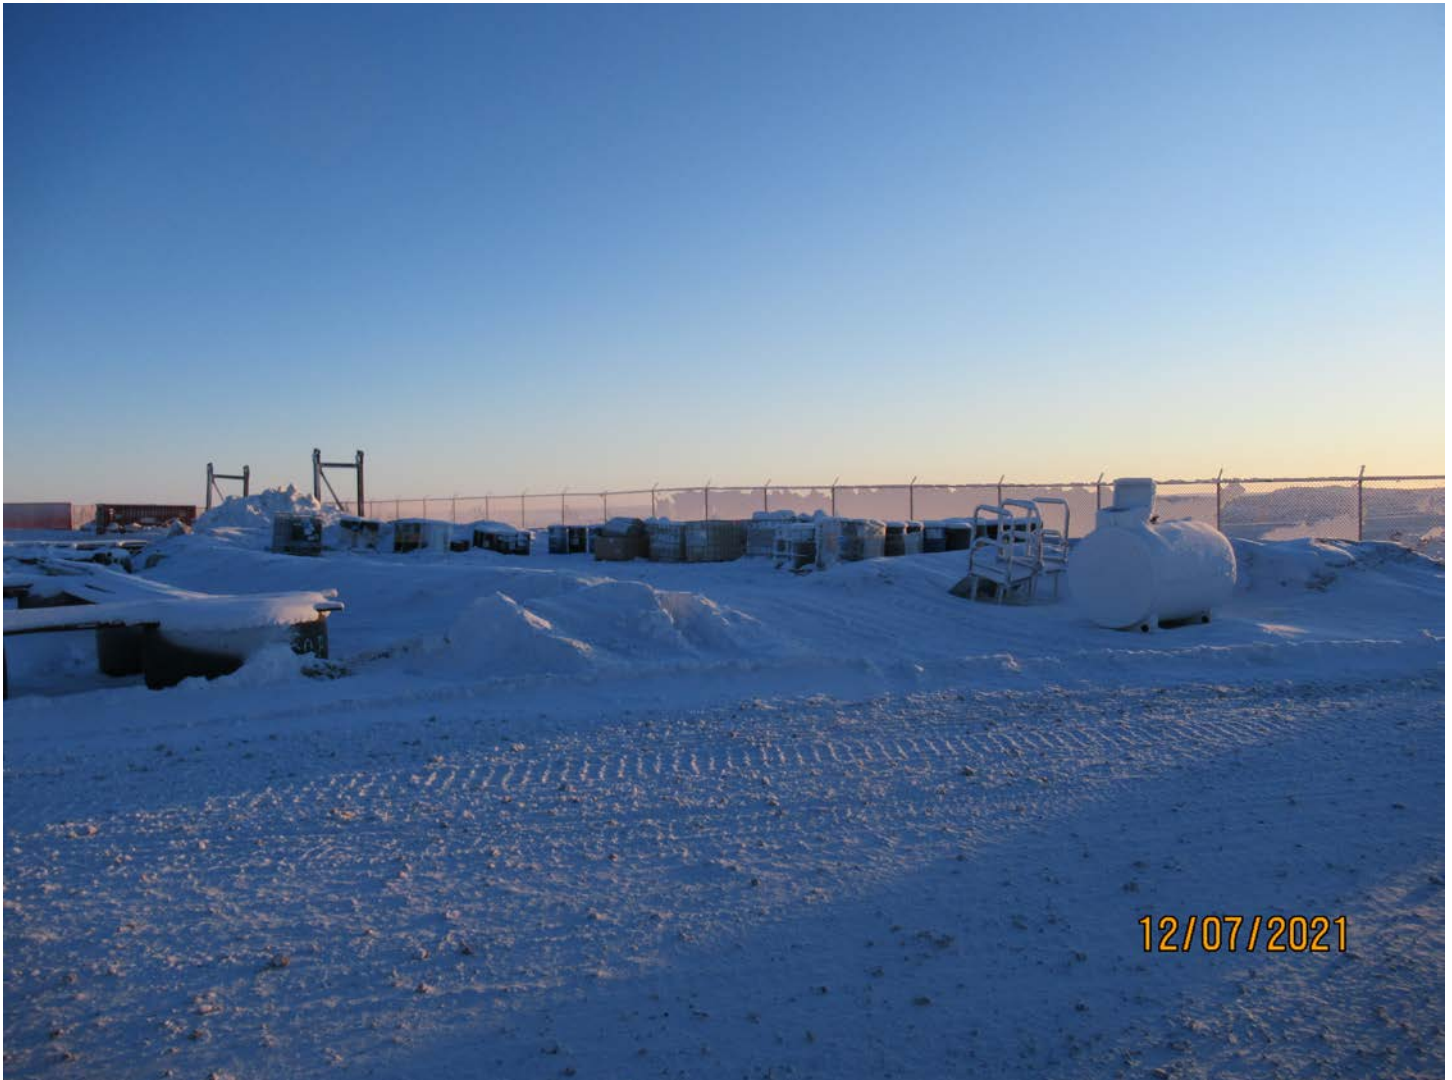
It appeared the remainder of the hydrocarbons at the camp were being satisfactorily managed. Hydrocarbons in containers were being staged within a lined containment berm and were properly labeled (Photo #31). There were no major hydrocarbon spills and no spilling was noted within or outside of the fuel tank containment berms around the camp. It appeared smaller fuel containers were being properly managed and there were adequate spills response materials staged throughout the camp (Photos #32 & #33).

Photo 31: Various hydrocarbons in containers are staged in this lined and bermed area in the south of the compound.

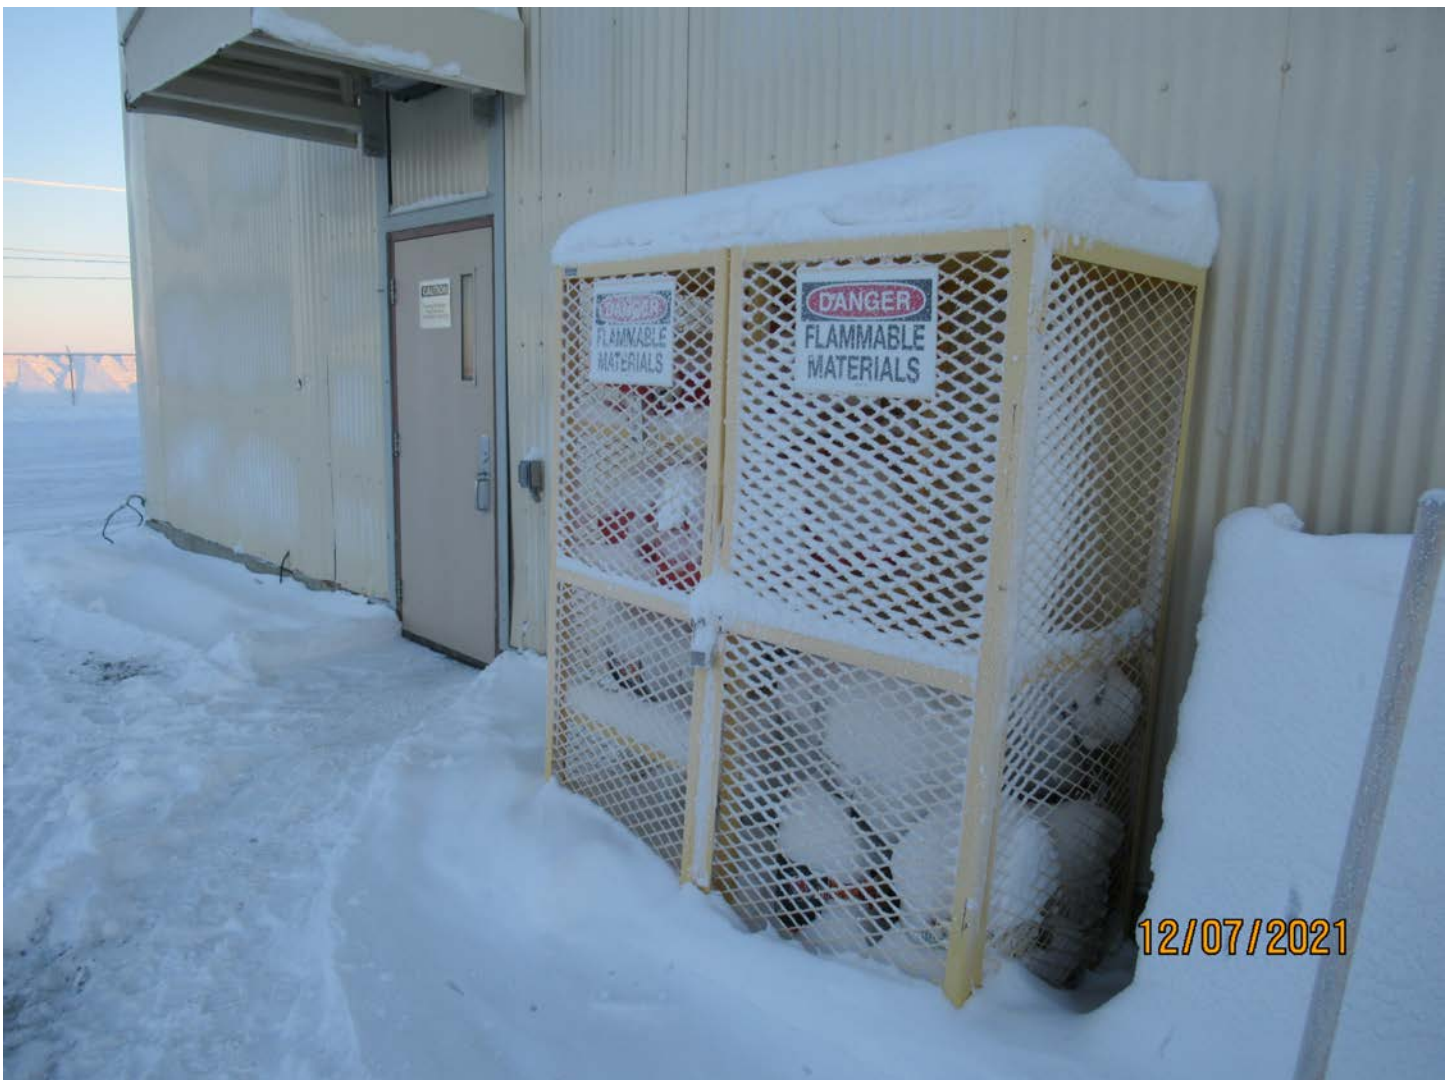
Photo 32: Smaller containers of hydrocarbons were staged in this lockup.

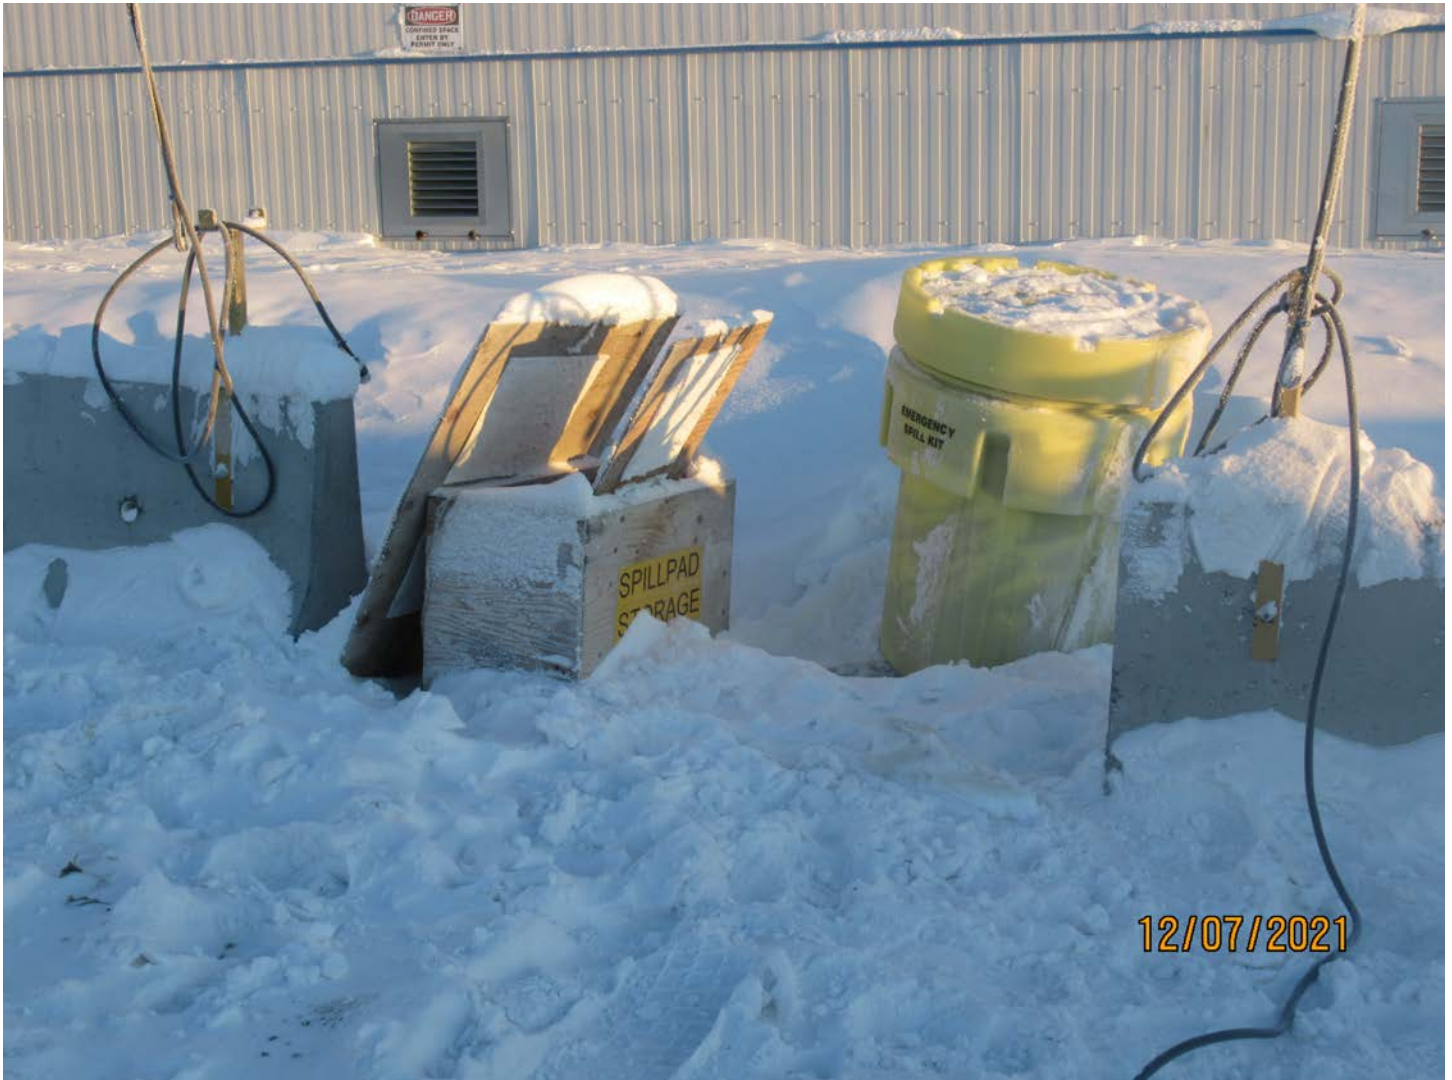
Photo 33: Drip boards and a spill kit at the Misery Camp parking area.

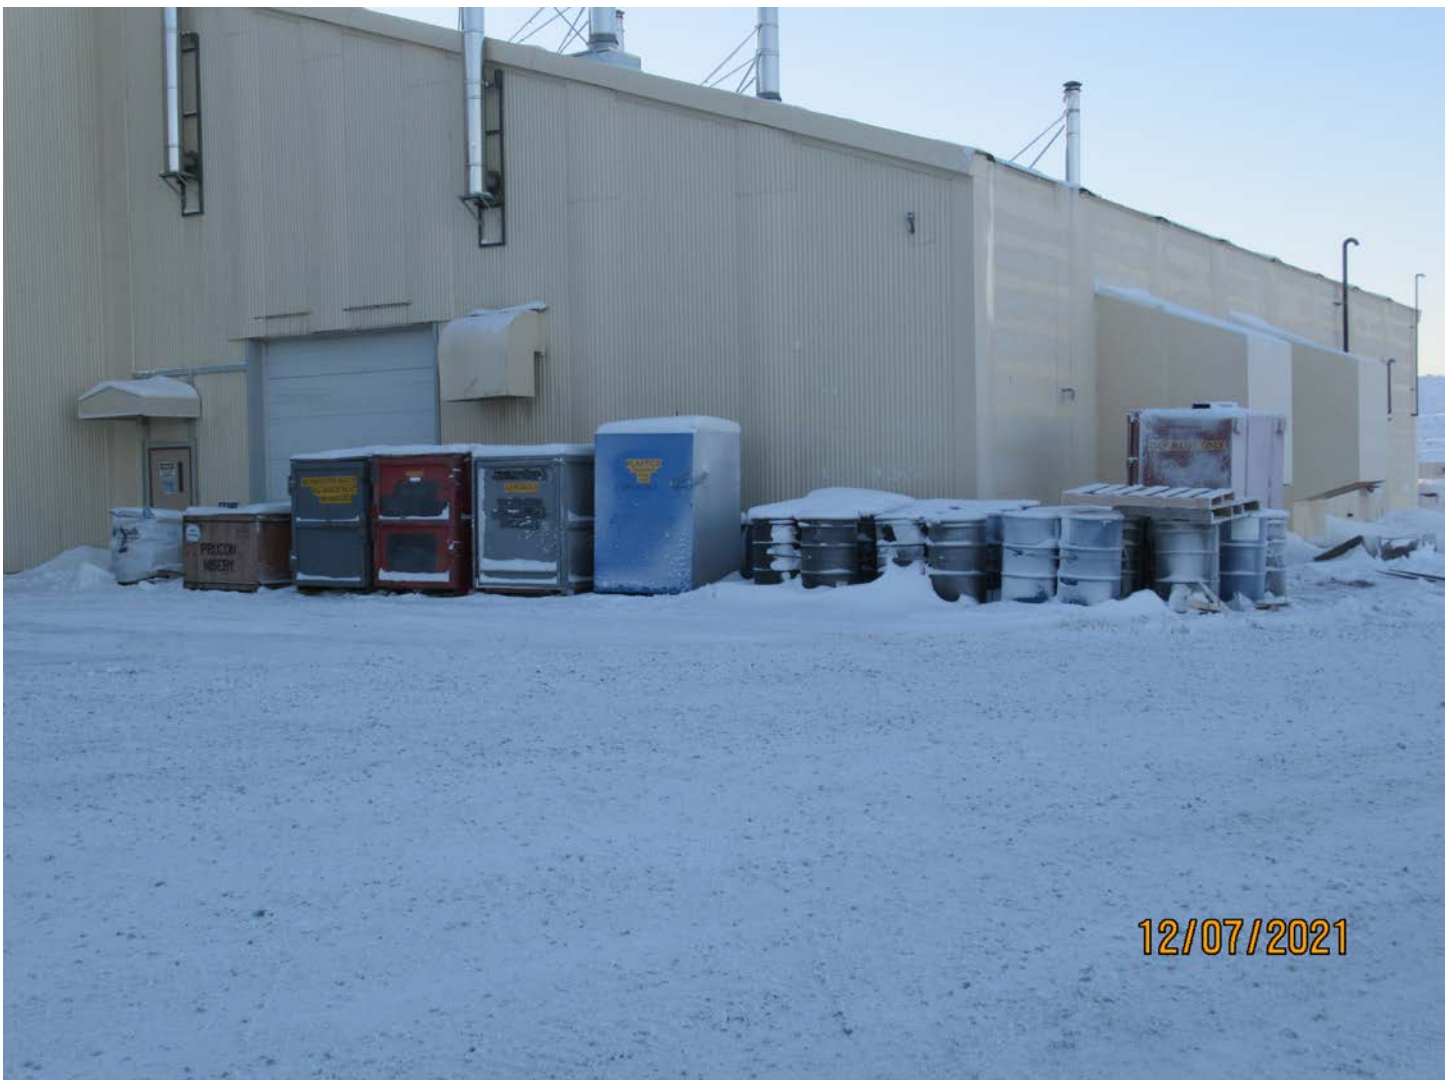
As seen in Photos #34-#36, waste at Misery Camp continues to be segregated into its different waste streams prior to disposal at the main camp incinerators/burn bin, at the landfill or is containerized for shipment and disposal offsite at approved facilities. Sewage produced at the camp reports to a holding tank before it is pumped out with a vacuum truck and transported to the Ekati sewage treatment plant (Photos #37 & #38). There, it is treated and separated into sewage effluent and bagged solid waste. The treated effluent reports to the Ekati process plant where it is further processed prior to disposal into the mine Long Lake Containment Facility and the bagged solids are disposed of at Zone S. All sewage and waste at the Ekati mine is managed in accordance with the Ekati *Waste Management Plan*.

Photo 34: The waste station at the Misery Camp truckshop.

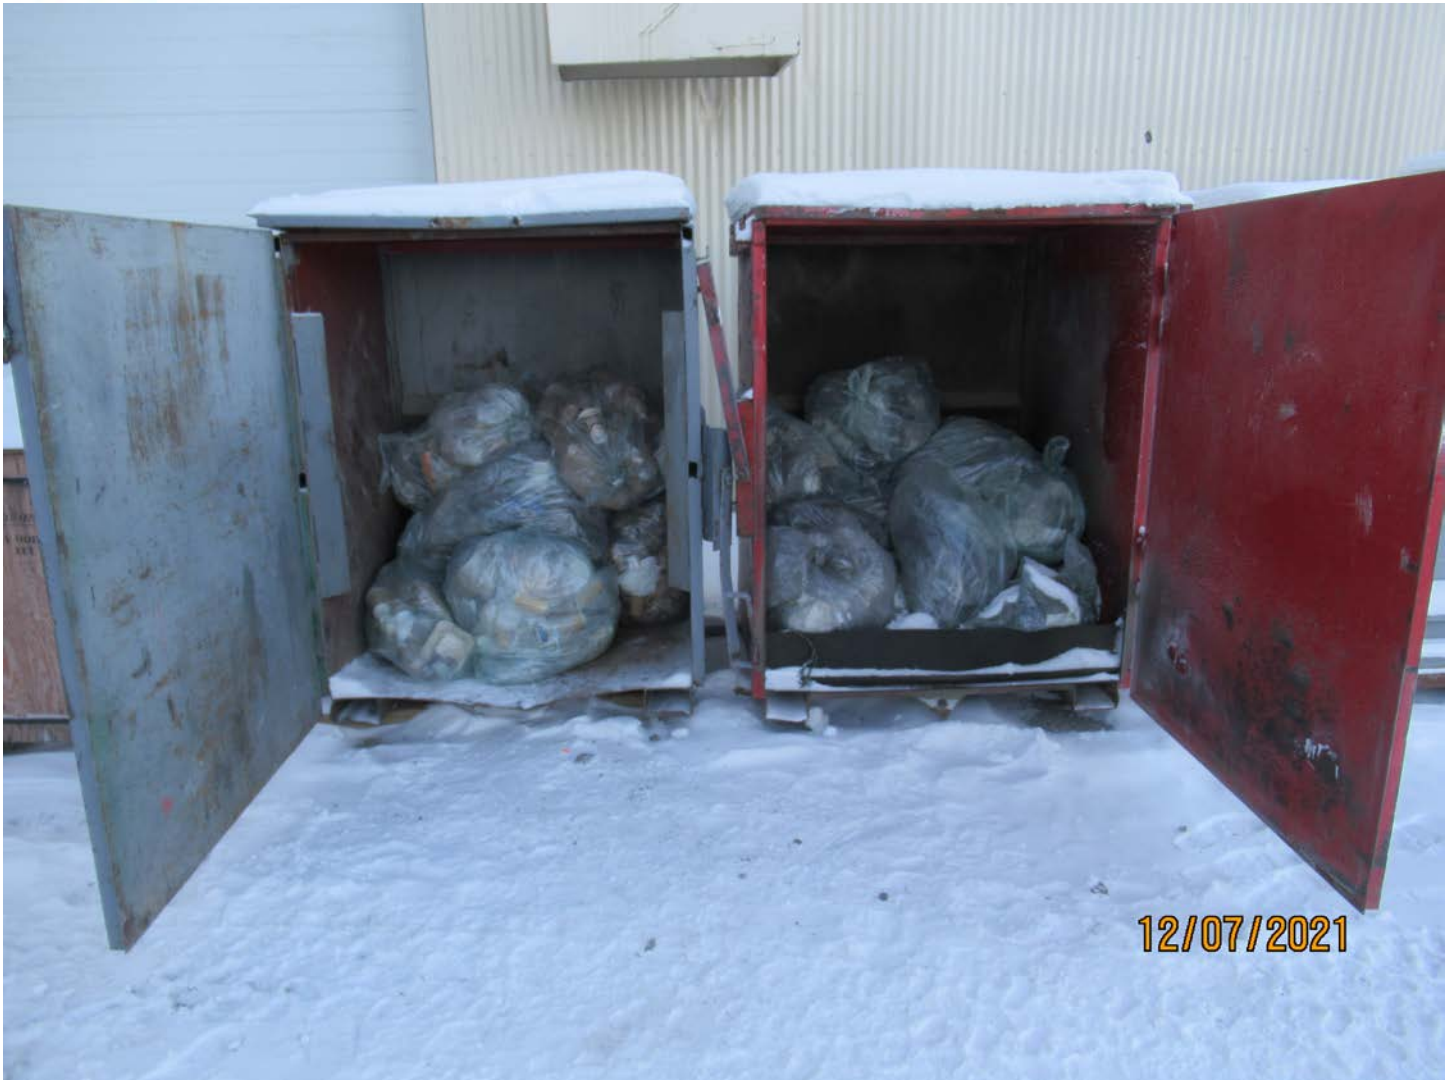
Photo 35: It appears waste at the station was being properly segregated into its designated bins.

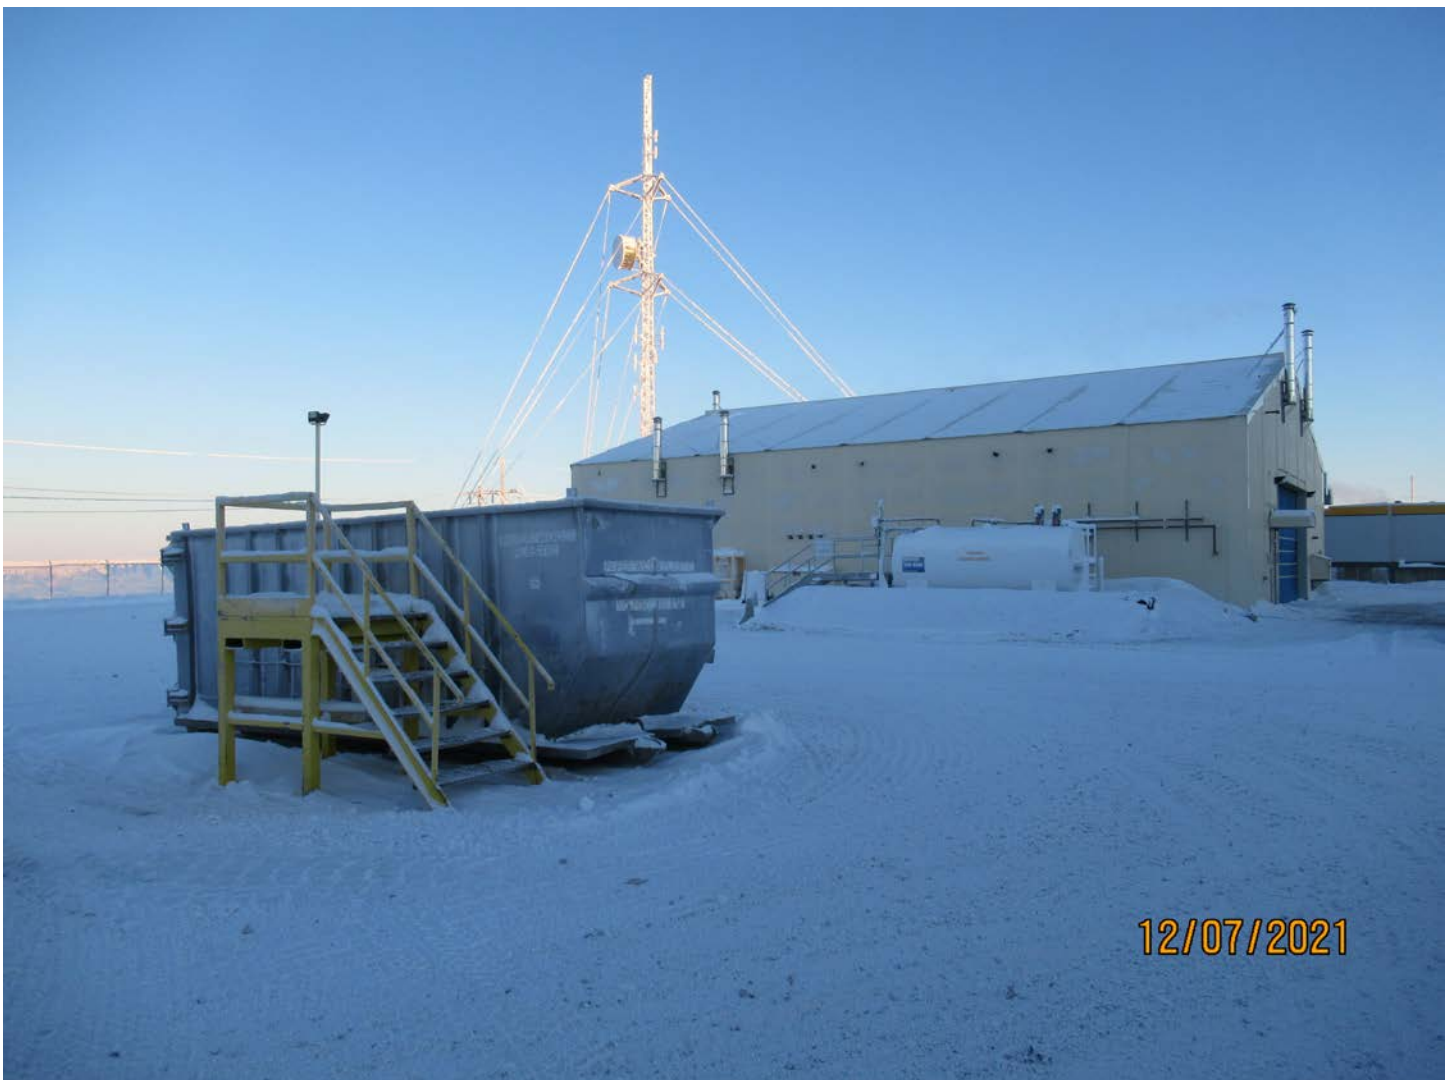
Photo 36: This paper, wood and plastic waste bin contained only acceptable waste materials.

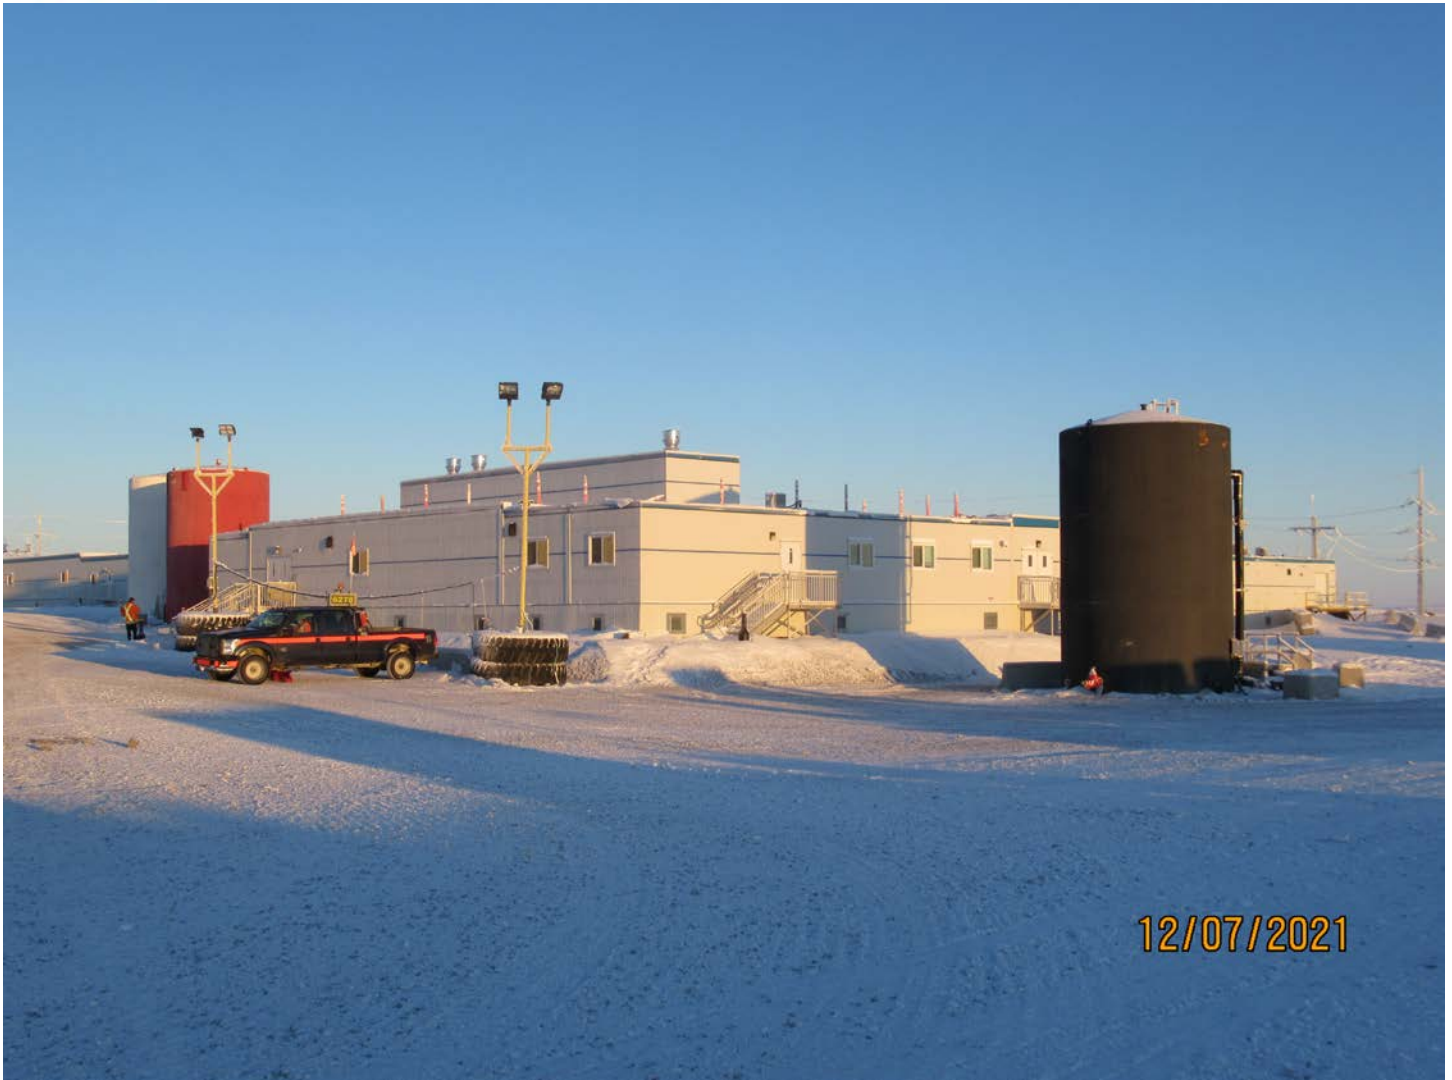
Photo 37: The Misery Camp parking area. The white tank holds potable water, the red tank contains fire suppression water and the camp sewage reports to the black tank on the right.

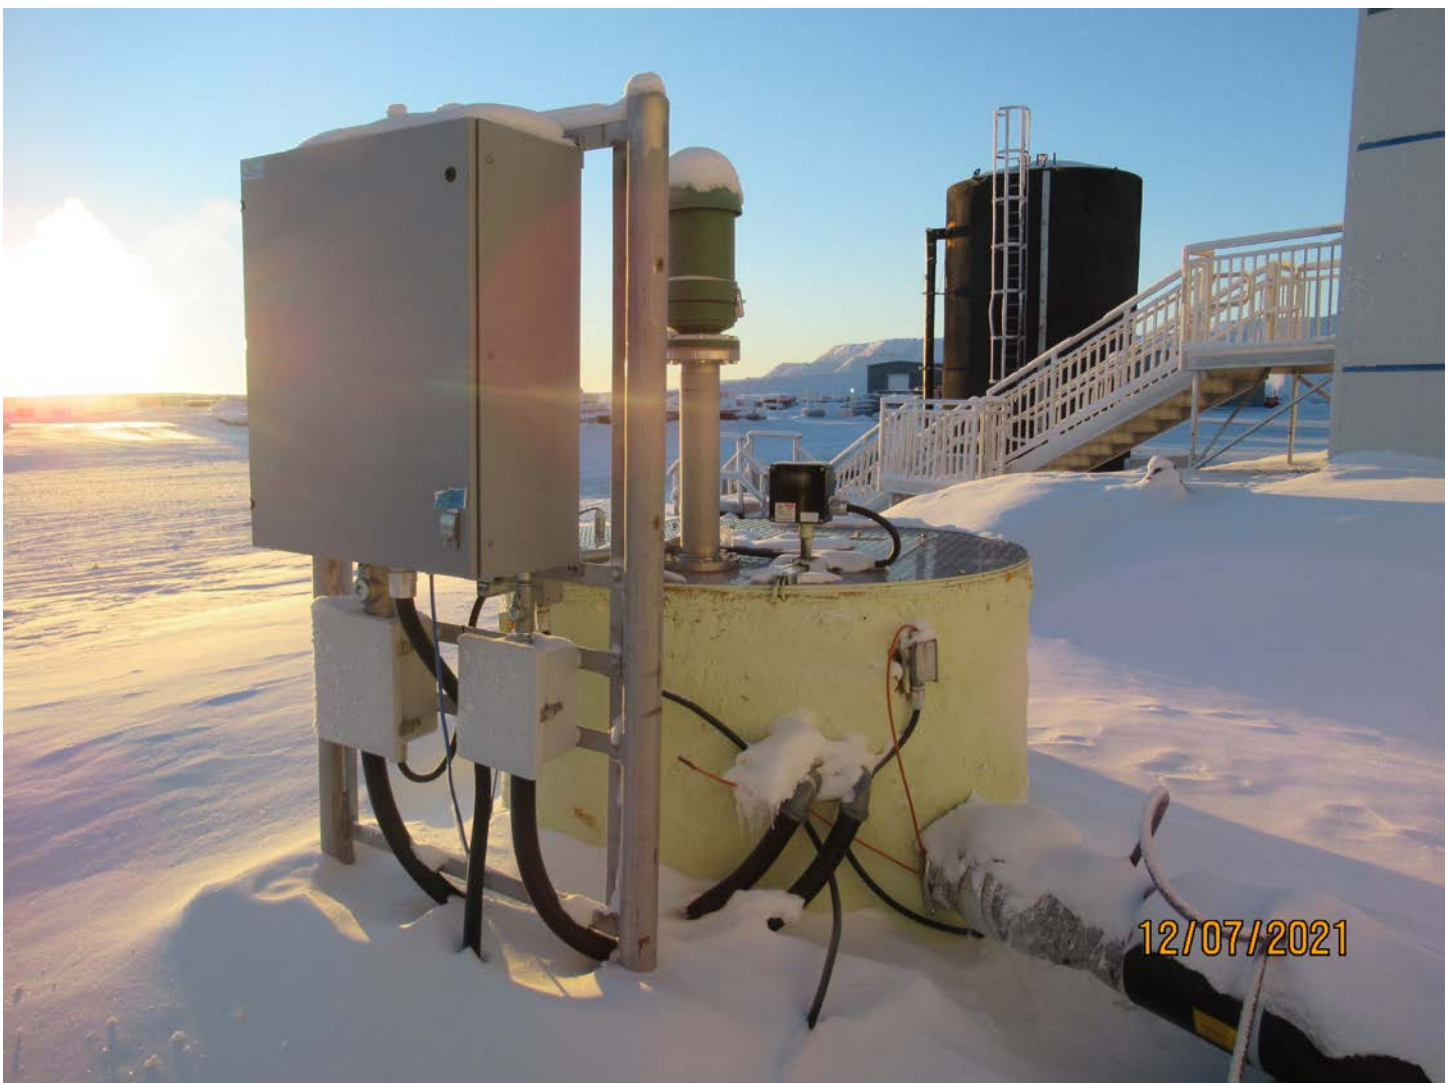
Photo 38: The sewage lift station located east of the sewage holding tank outside the camp buildings.
