**Re: Land Use Permit MV2017D0004
Mining and Associated Activities
Ekati Mine, Northwest Territories**

ENVIRONMENTAL INSPECTION REPORT

Permittee:	Burgundy Diamonds Limited – Ekati	Inspection Date: February 1, 2024
------------	-----------------------------------	-----------------------------------

Location(s) Inspected:	Misery Surface
------------------------	----------------

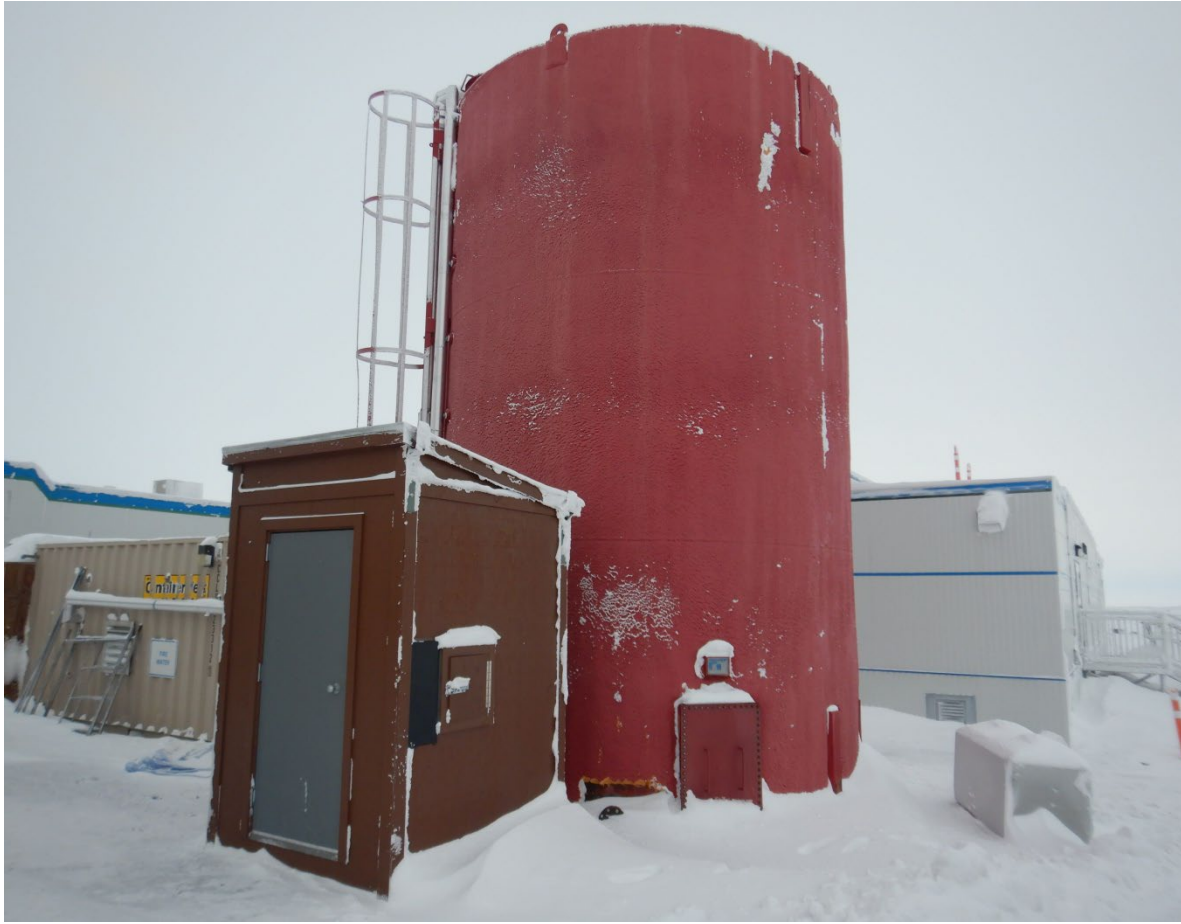
Photo 1 – Misery surface – fire suppression water tank.

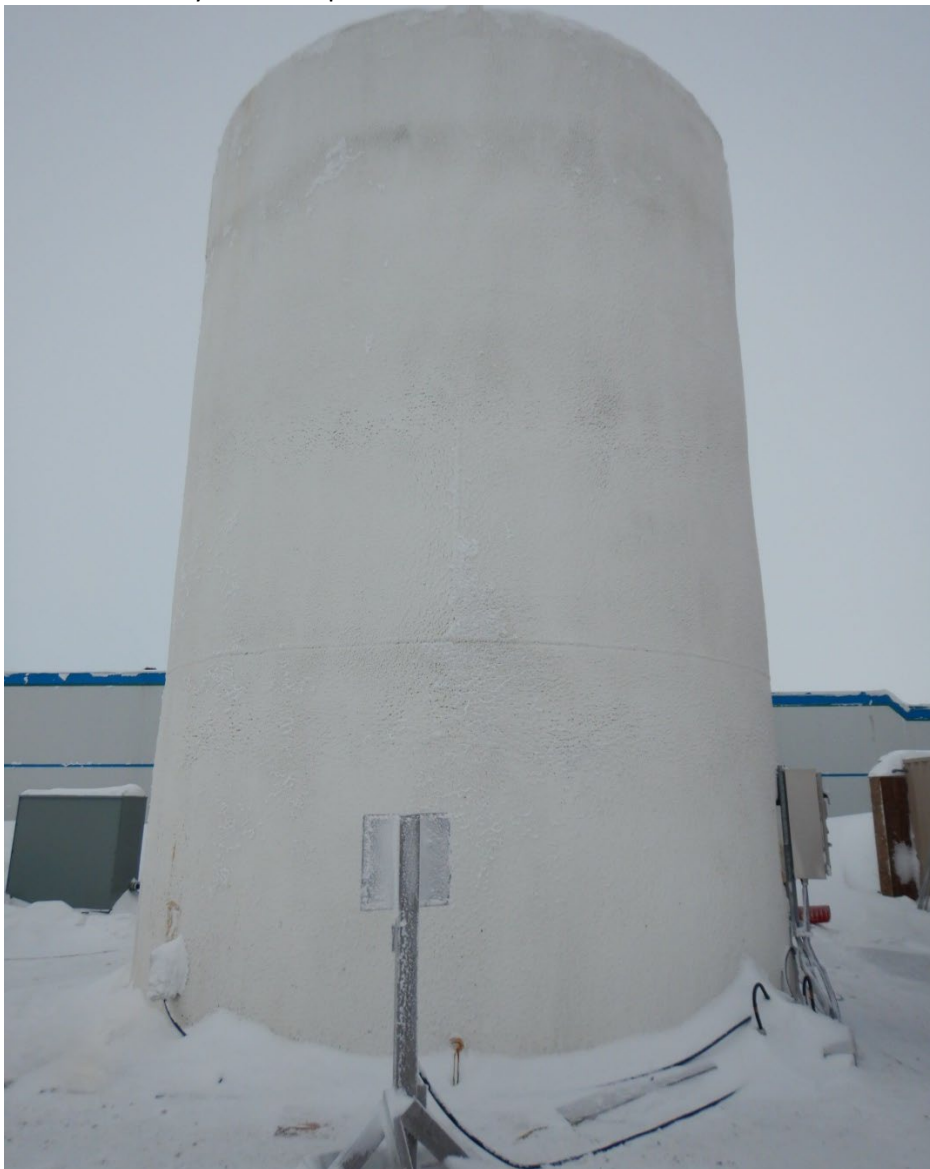
Photo 2 – Misery surface – potable water tank

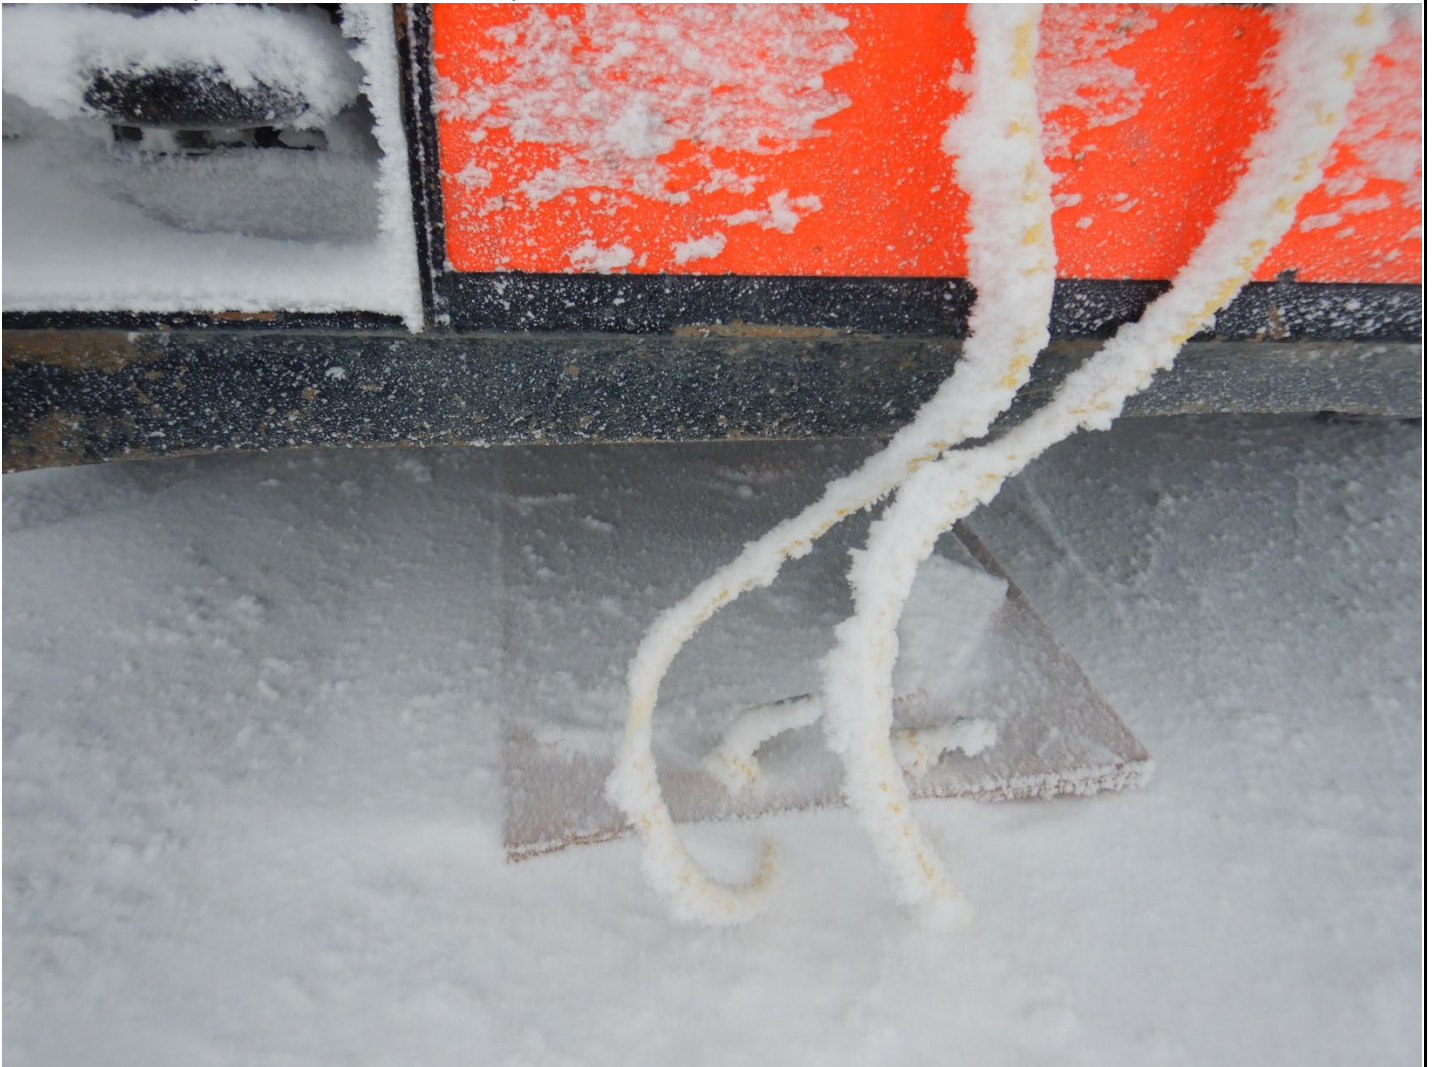
Photo 3 – Misery surface – Absorbents for parked vehicles (1).

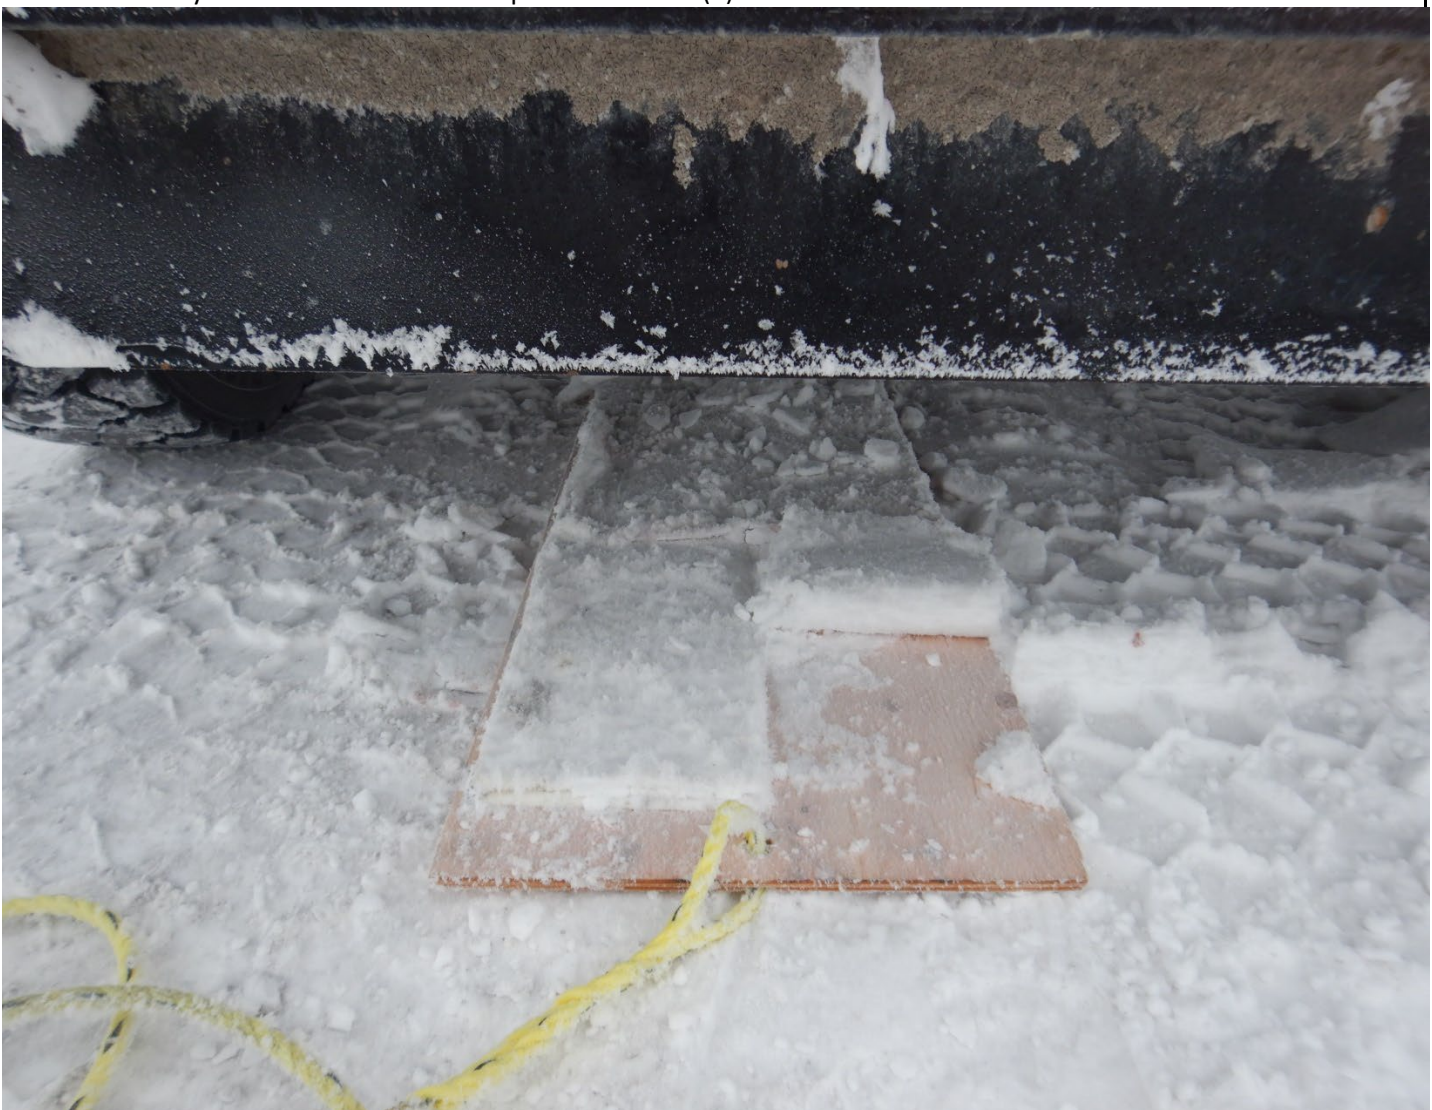
Photo 4 – Misery surface – Absorbents for parked vehicles (2).

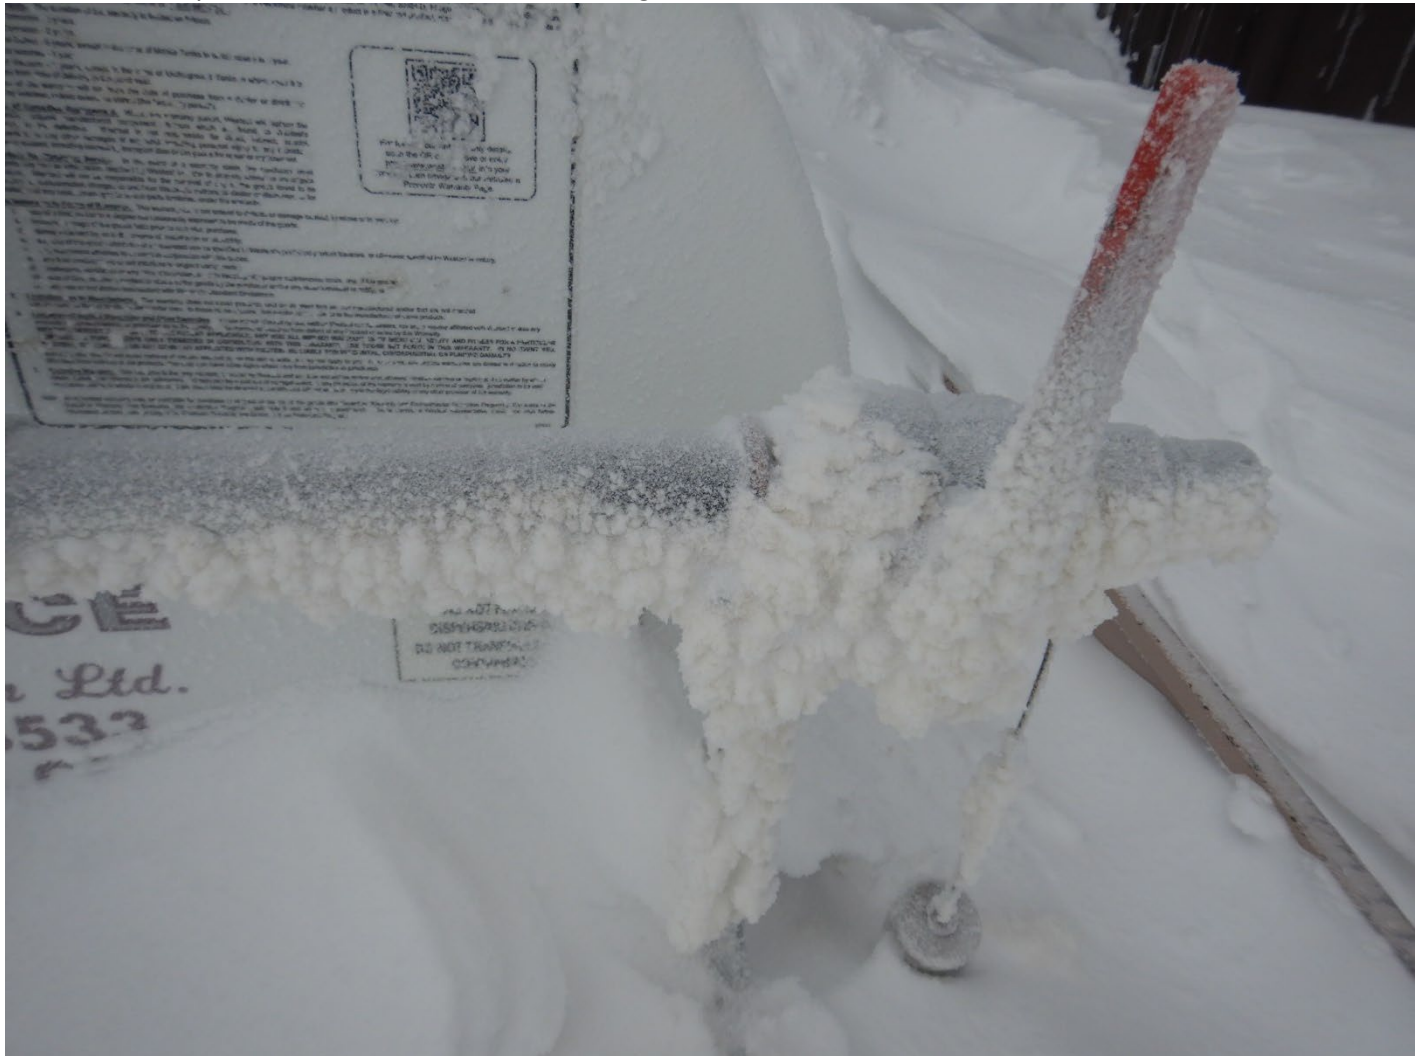
Photo 5 – Misery surface – Bulk diesel fuel tank leakage.

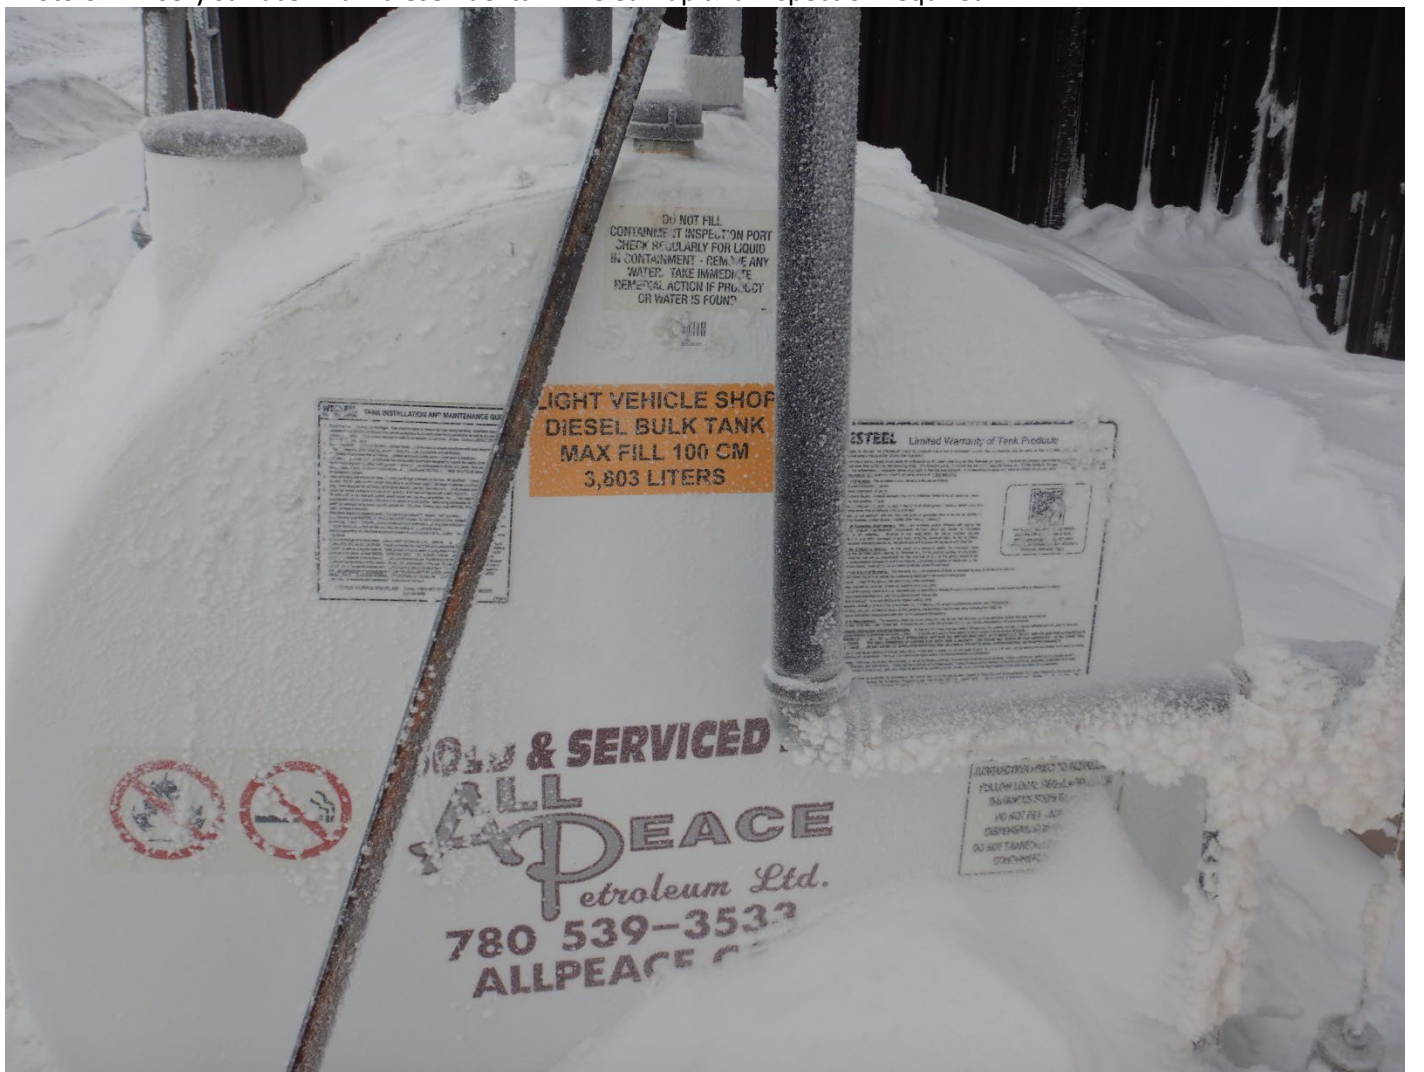
Photo 6 – Misery surface - Bulk diesel fuel tank – Clean-up and inspection required.

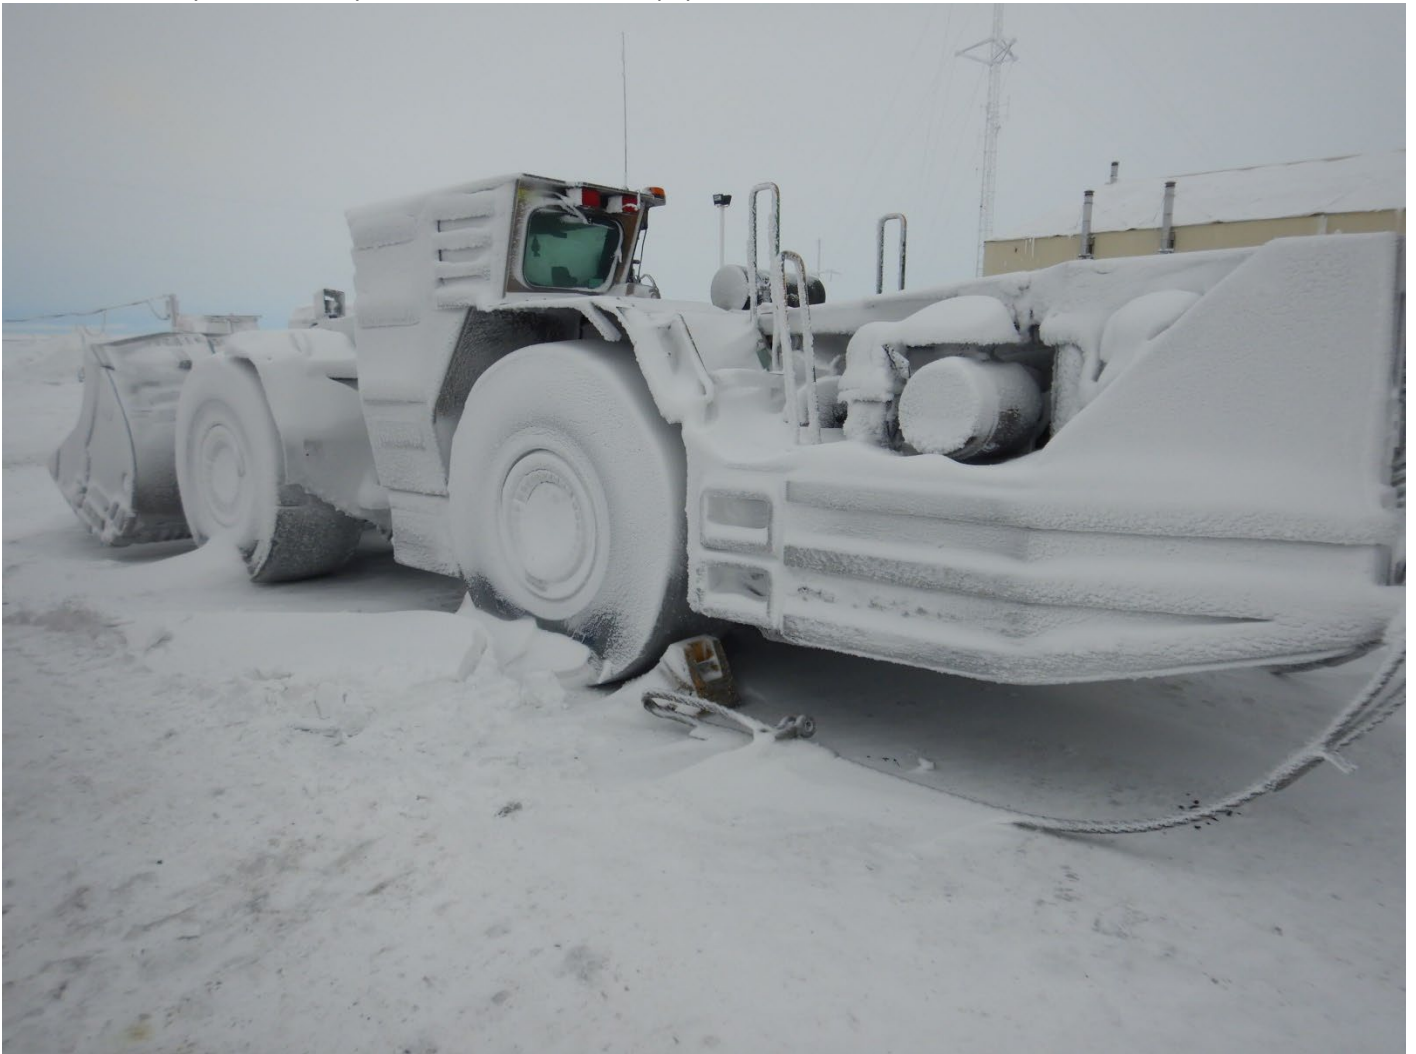
Photo 7 – Misery surface – Laydown – Out of service equipment.

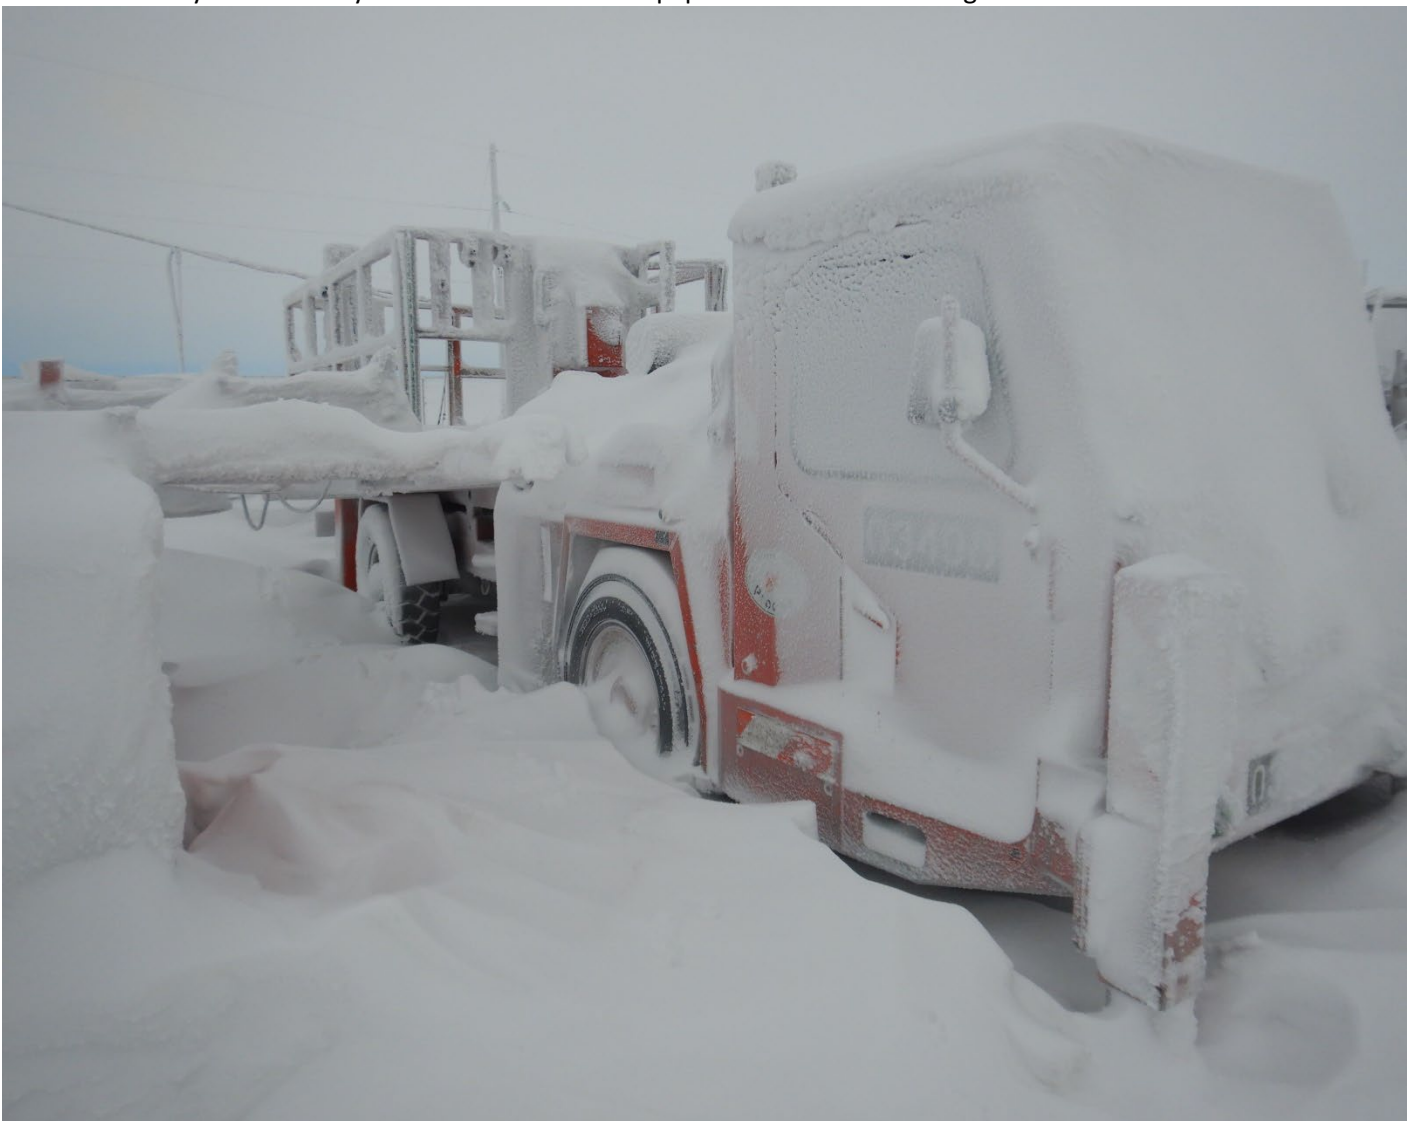
Photo 8 – Misery surface – Laydown – Out of service equipment #03498 – Leaking fluids.

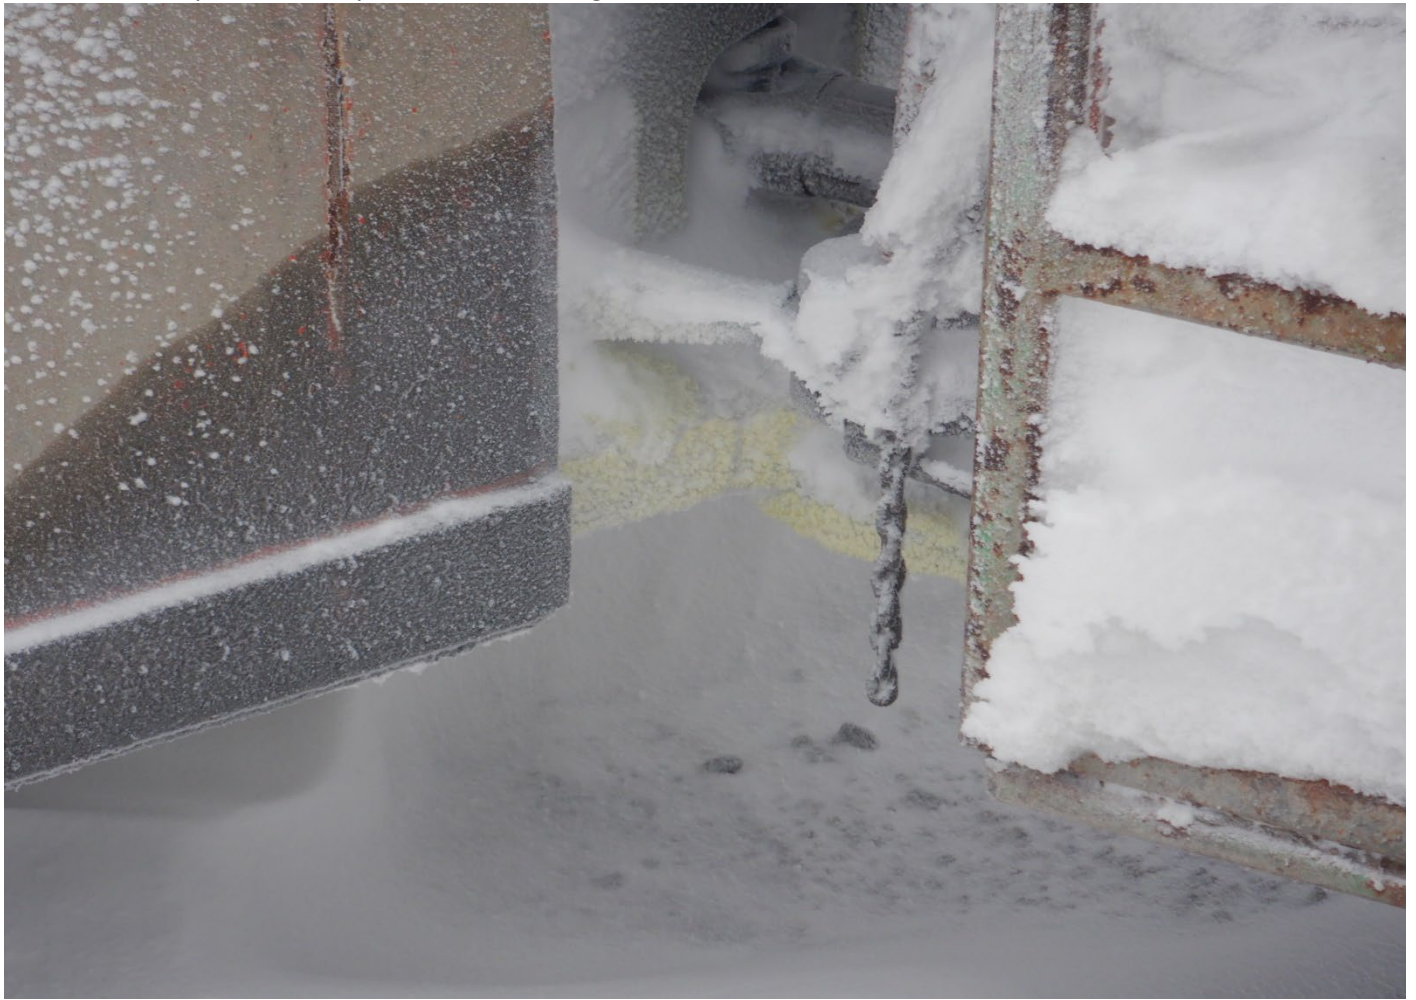
Photo 9 – Misery surface – Laydown – Fluid leakage from vehicle #03498

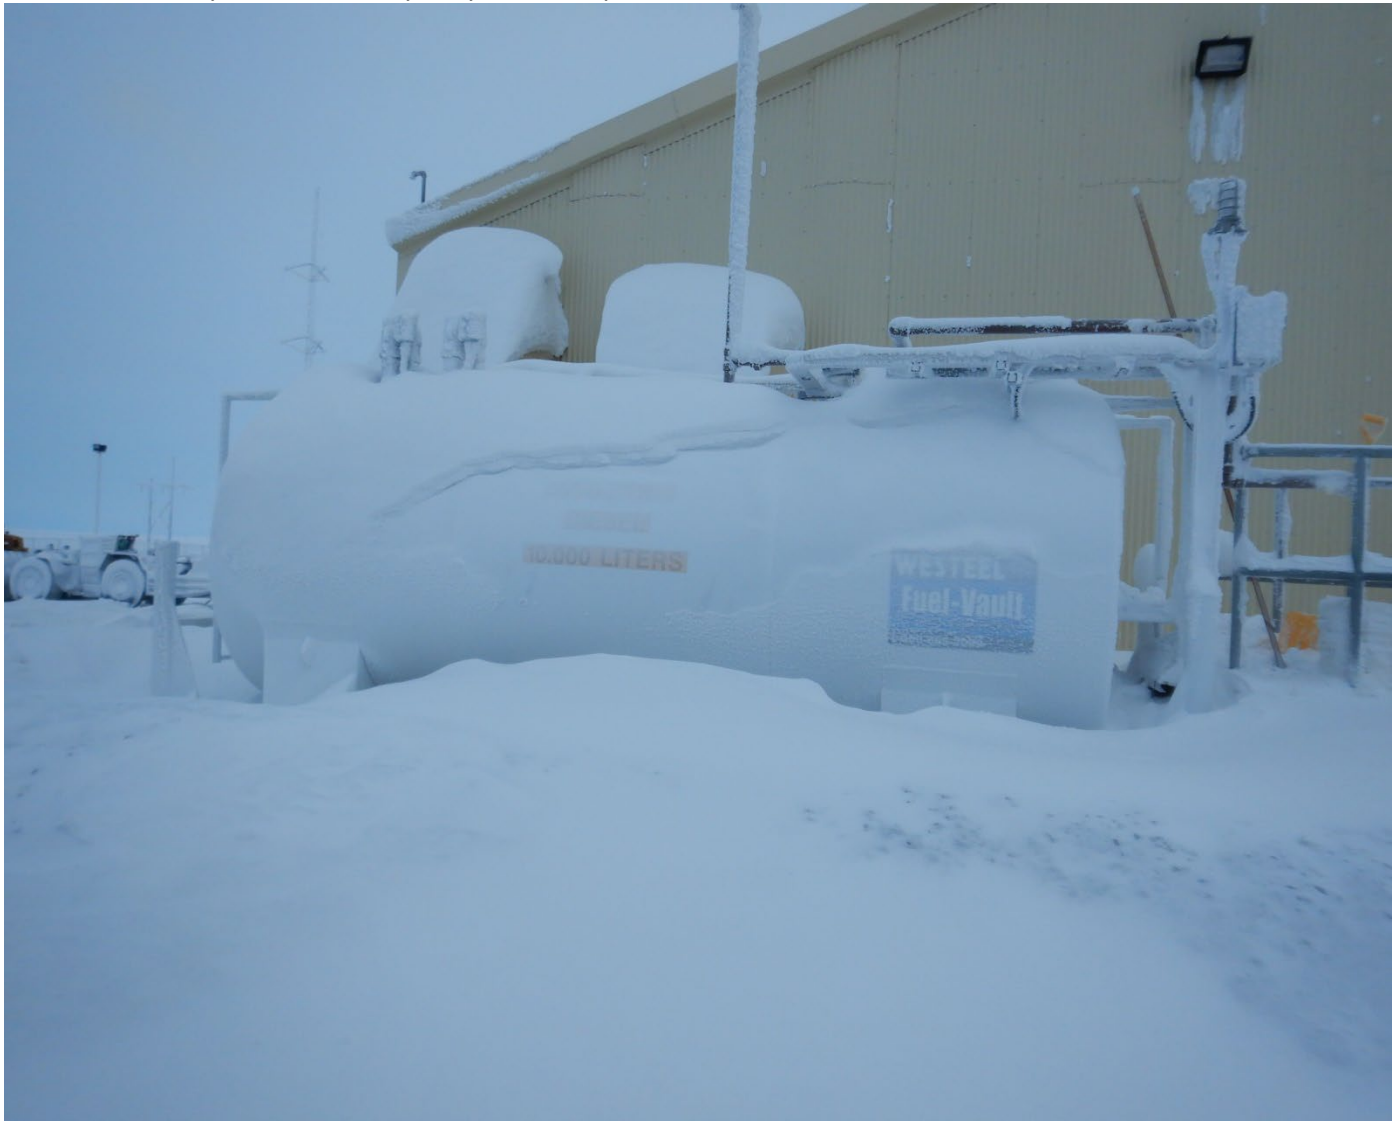
Photo 10 – Misery surface – Heavy Duty Truck Shop – 10,000L tank.

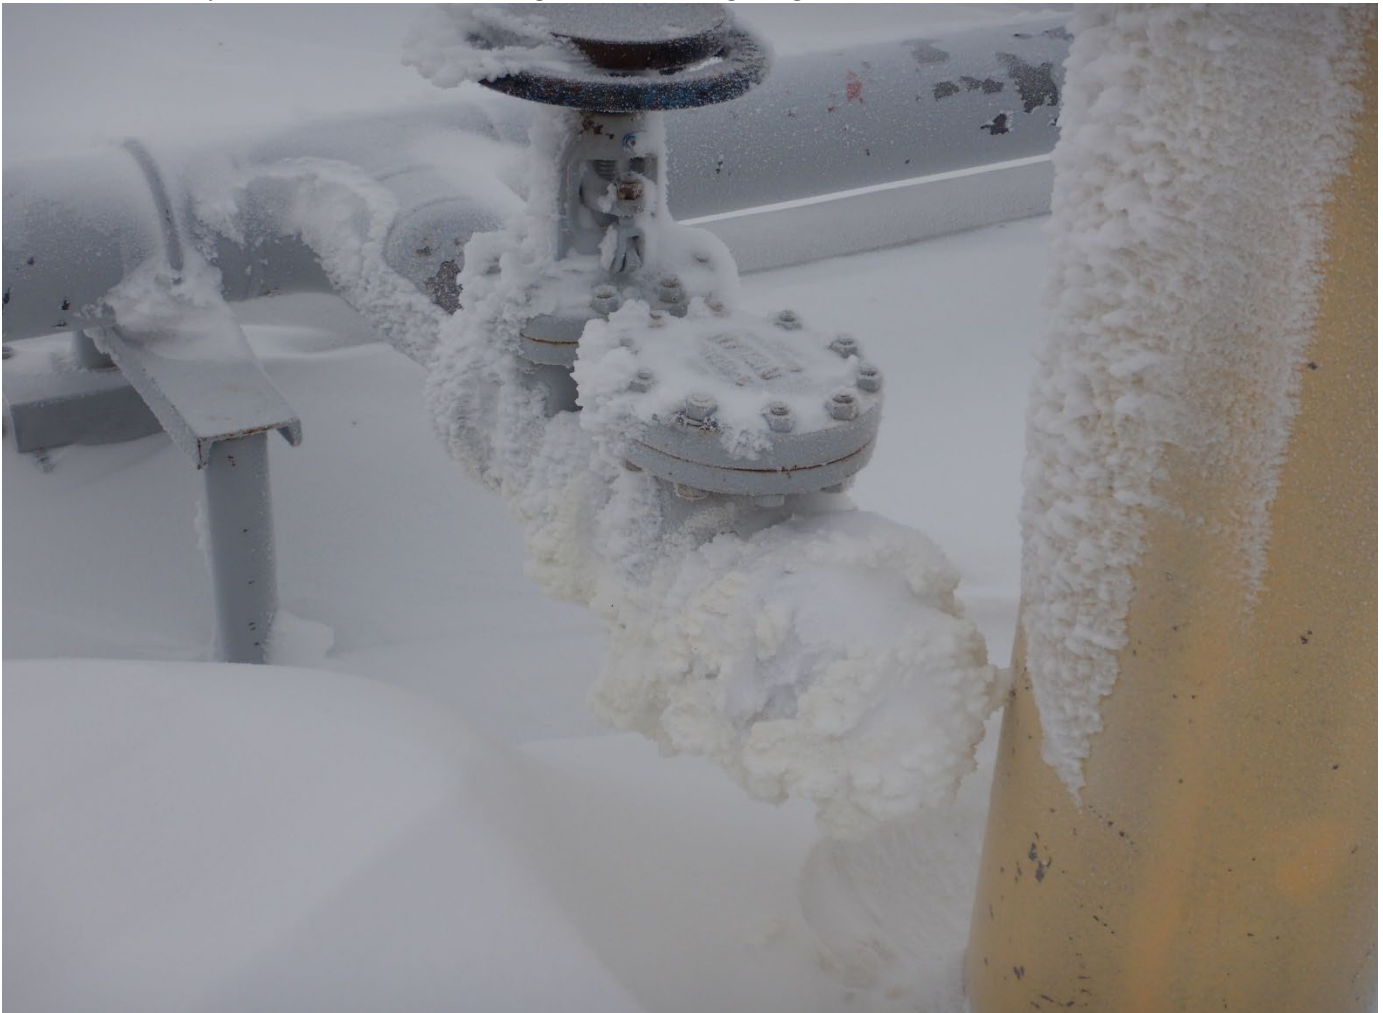
Photo 11 – Misery surface – Diesel fuel storage area – Leaking flange.

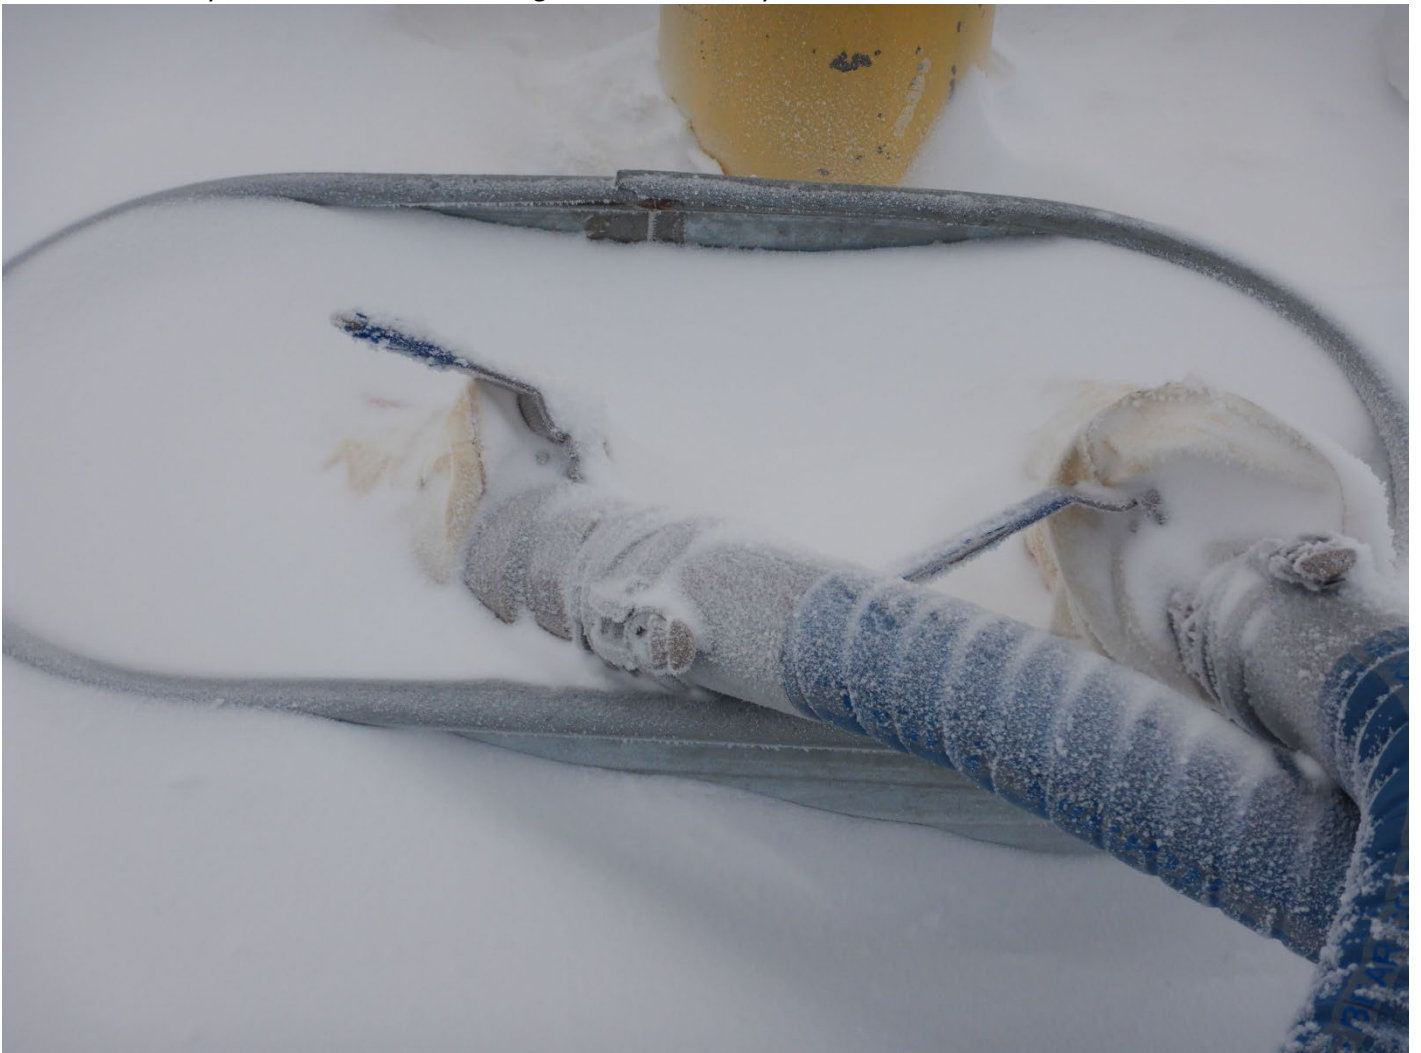
Photo 12 – Misery surface – Diesel fuel storage area – Secondary containment blown in with snow.

The Inspector is pleased with the efforts of Ekati personnel to adhere to the operating conditions annexed to Land Use Permit W2017D0004. The Permittee is reminded to ensure secondary containment practices are implemented at all fueling areas during fuel transfer and that areas remain cleared of snow before fuel transfer occurs. There were no major concerns noted during the inspection. Your copy of the Inspection Report is enclosed for your review and records.

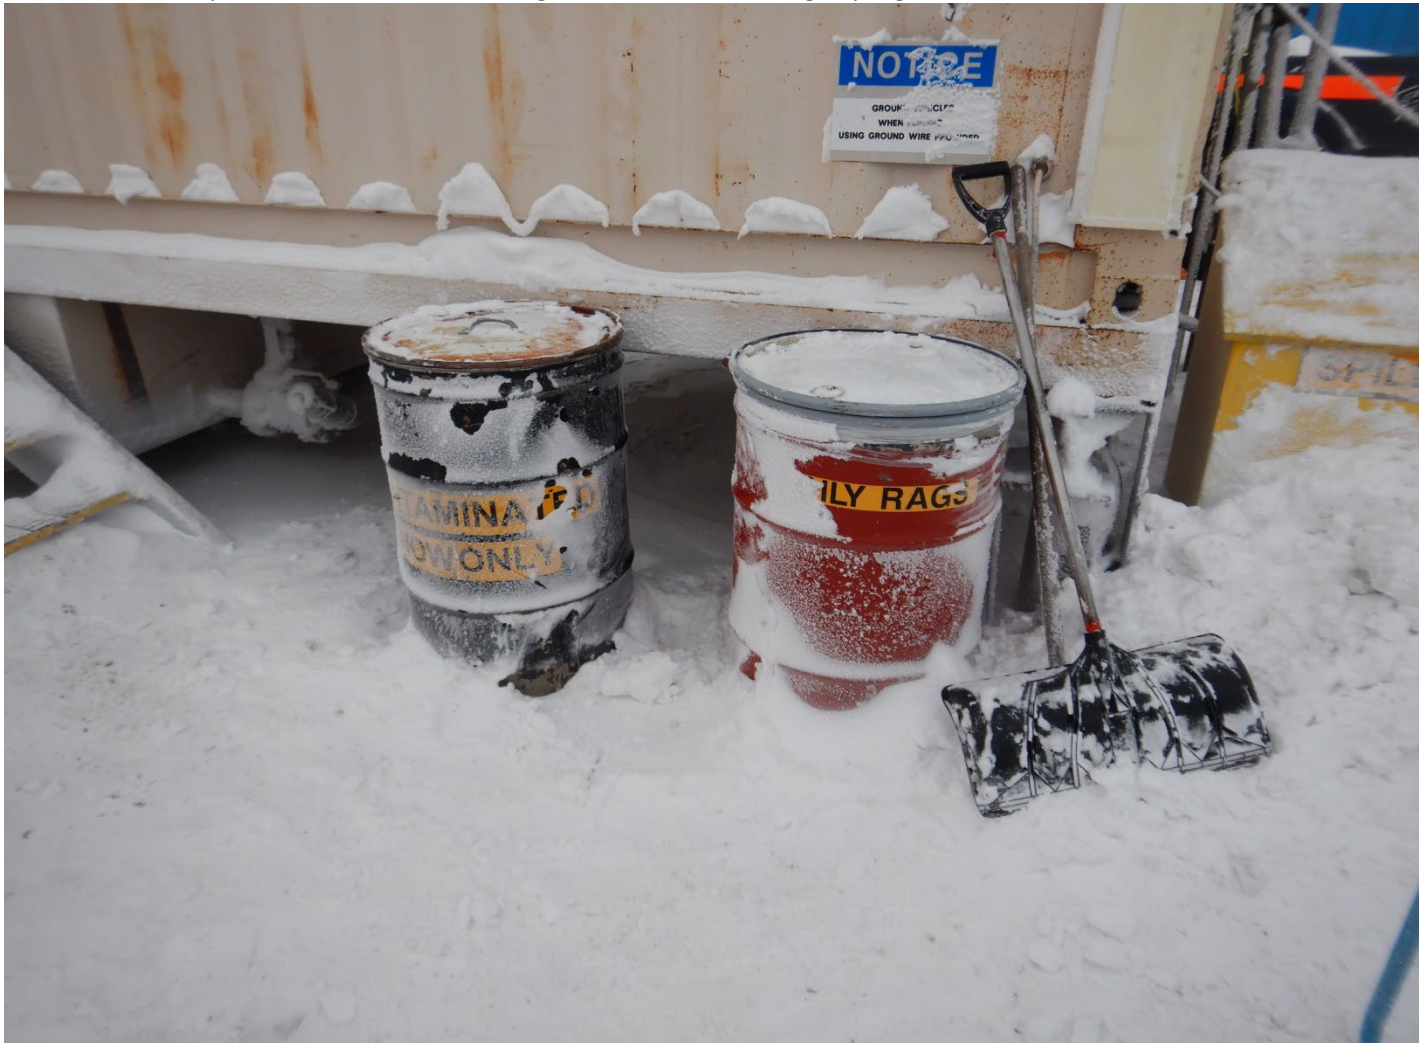
Photo 13 – Misery surface – Diesel fuel storage area – Snow clearing in progress (1).

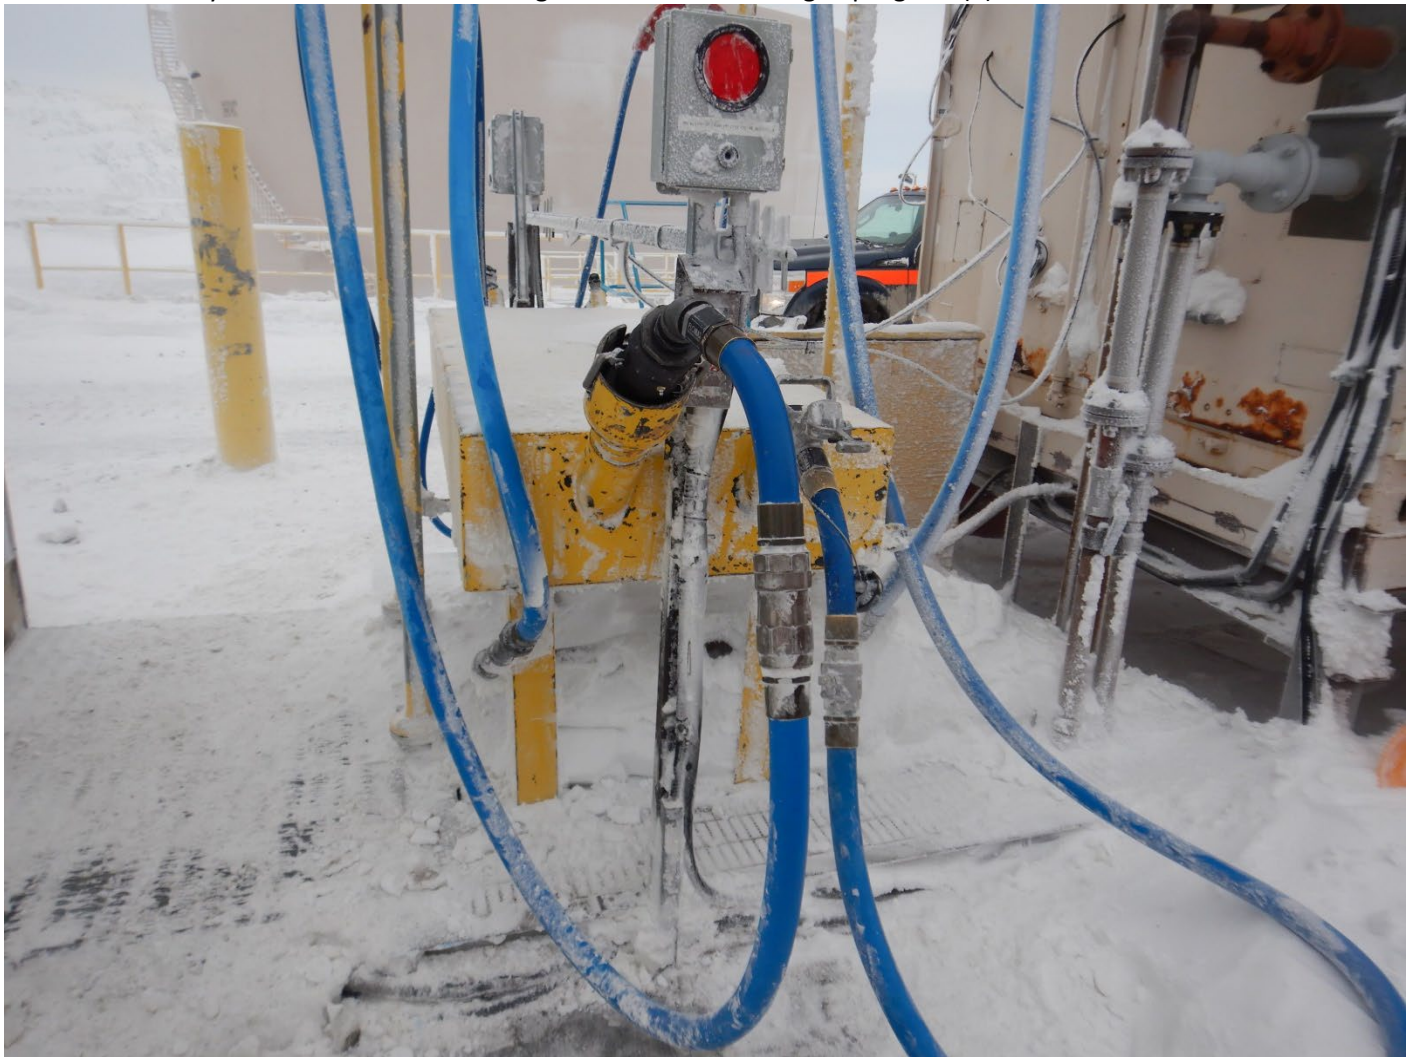
Photo 14 – Misery surface – Diesel fuel storage area – Snow clearing in progress (2).
