**Re: Land Use Permit MV2017D0004
Mining and Associated Activities
Ekati Mine, Northwest Territories**

ENVIRONMENTAL INSPECTION REPORT

Permittee:	Burgundy Diamonds Limited – Ekati	Inspection Date: February 1, 2024
------------	-----------------------------------	-----------------------------------

Location(s) Inspected:	Misery Surface
------------------------	----------------

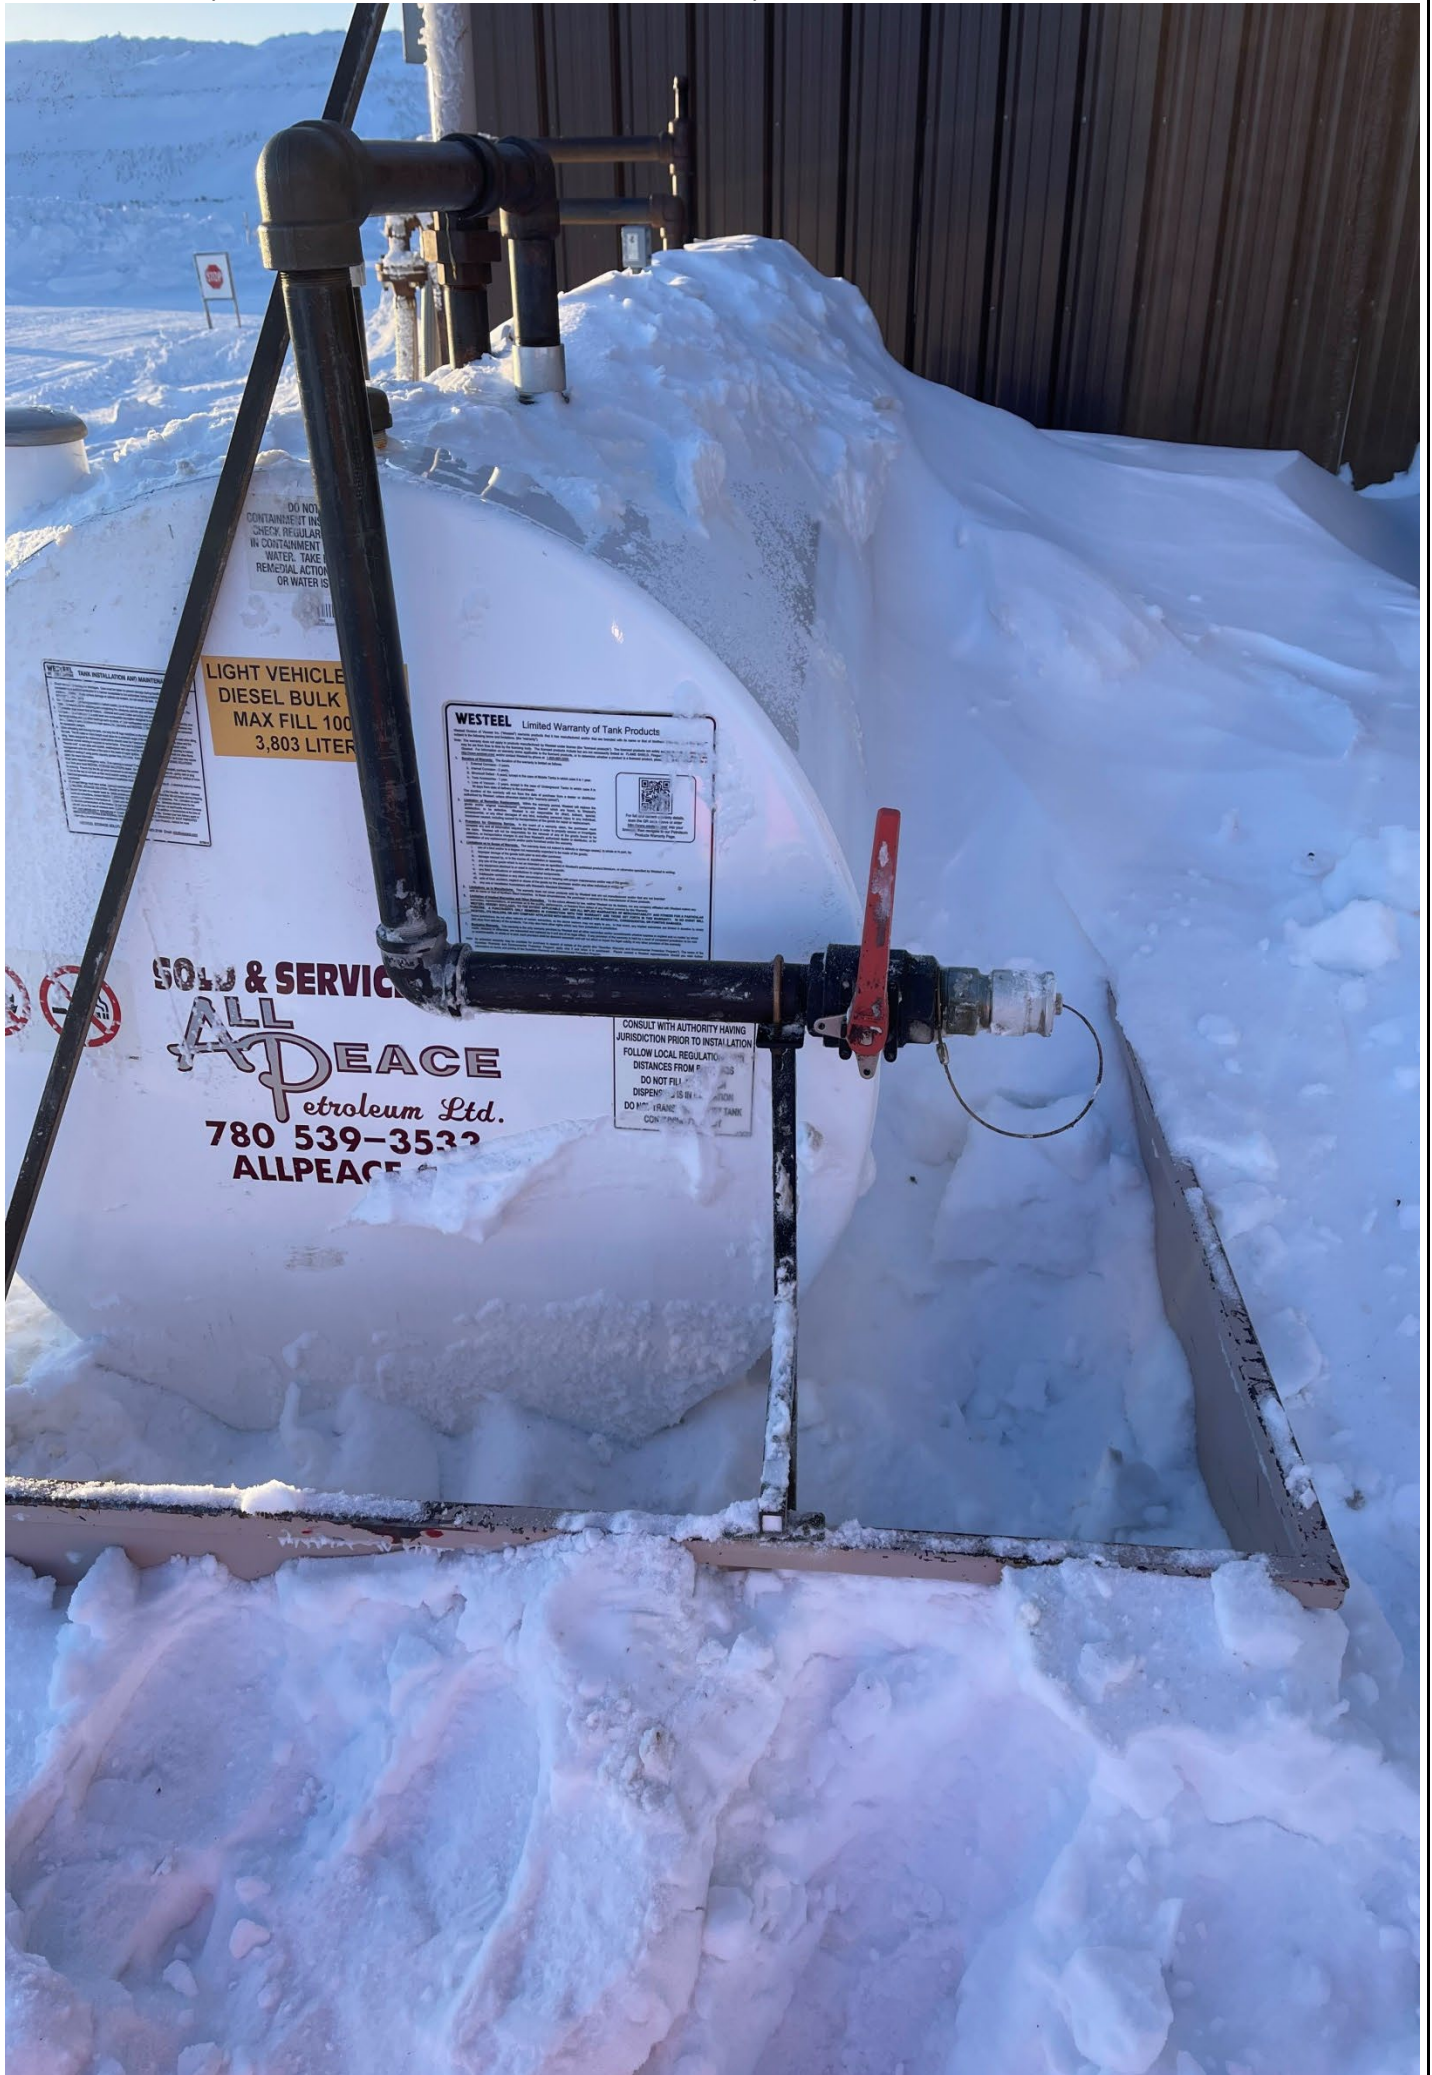
Photo 15 – Misery surface - Bulk diesel fuel tank – Post clean-up.

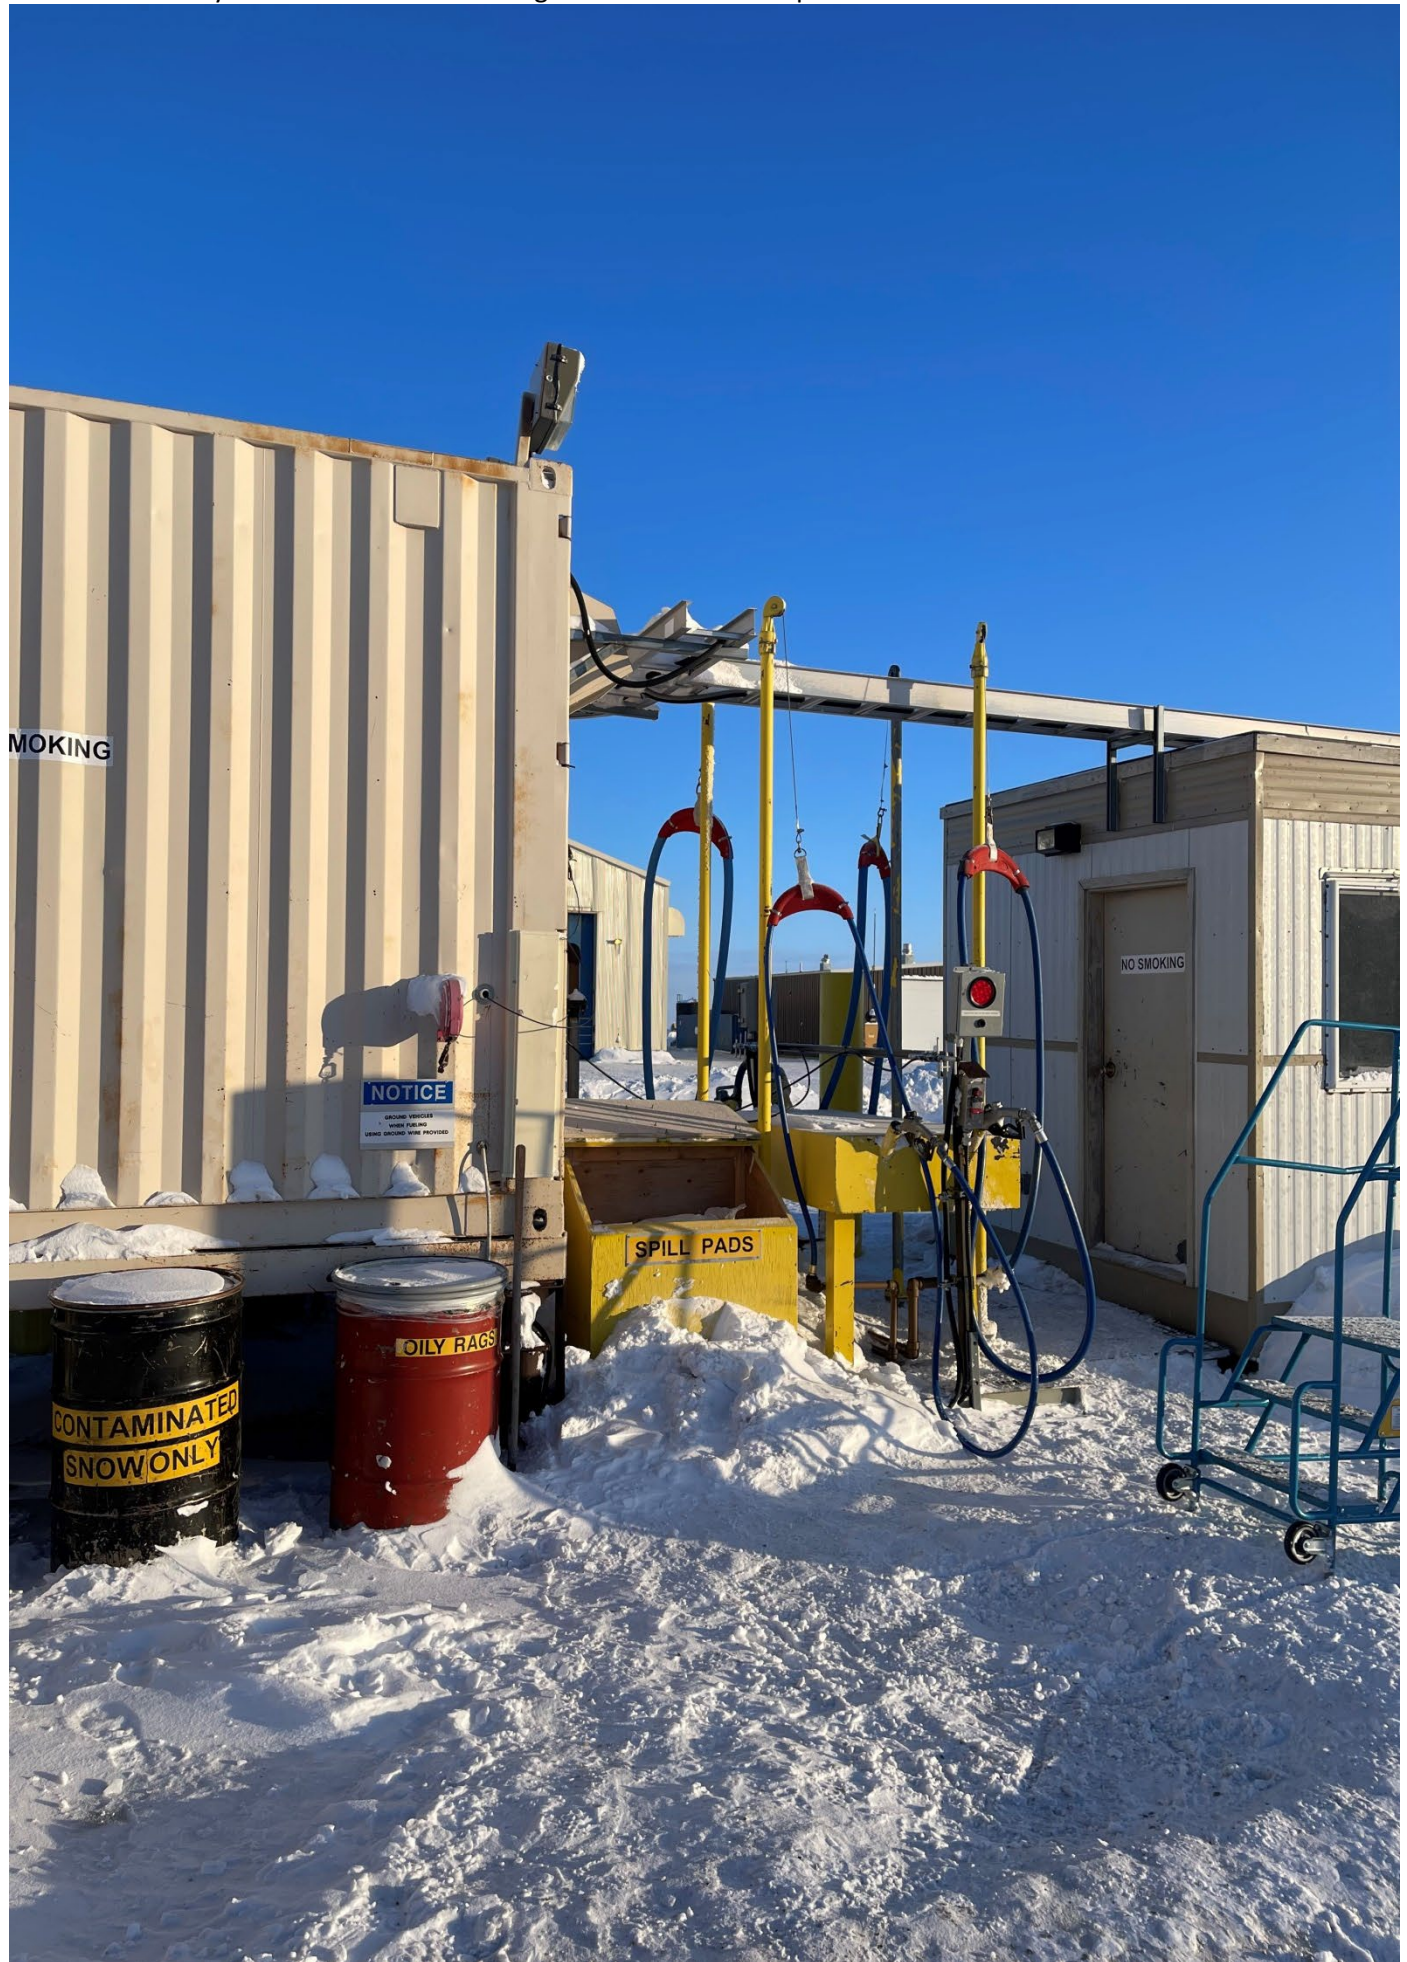
Photo 16 – Misery surface - Diesel fuel storage area – Post clean-up.

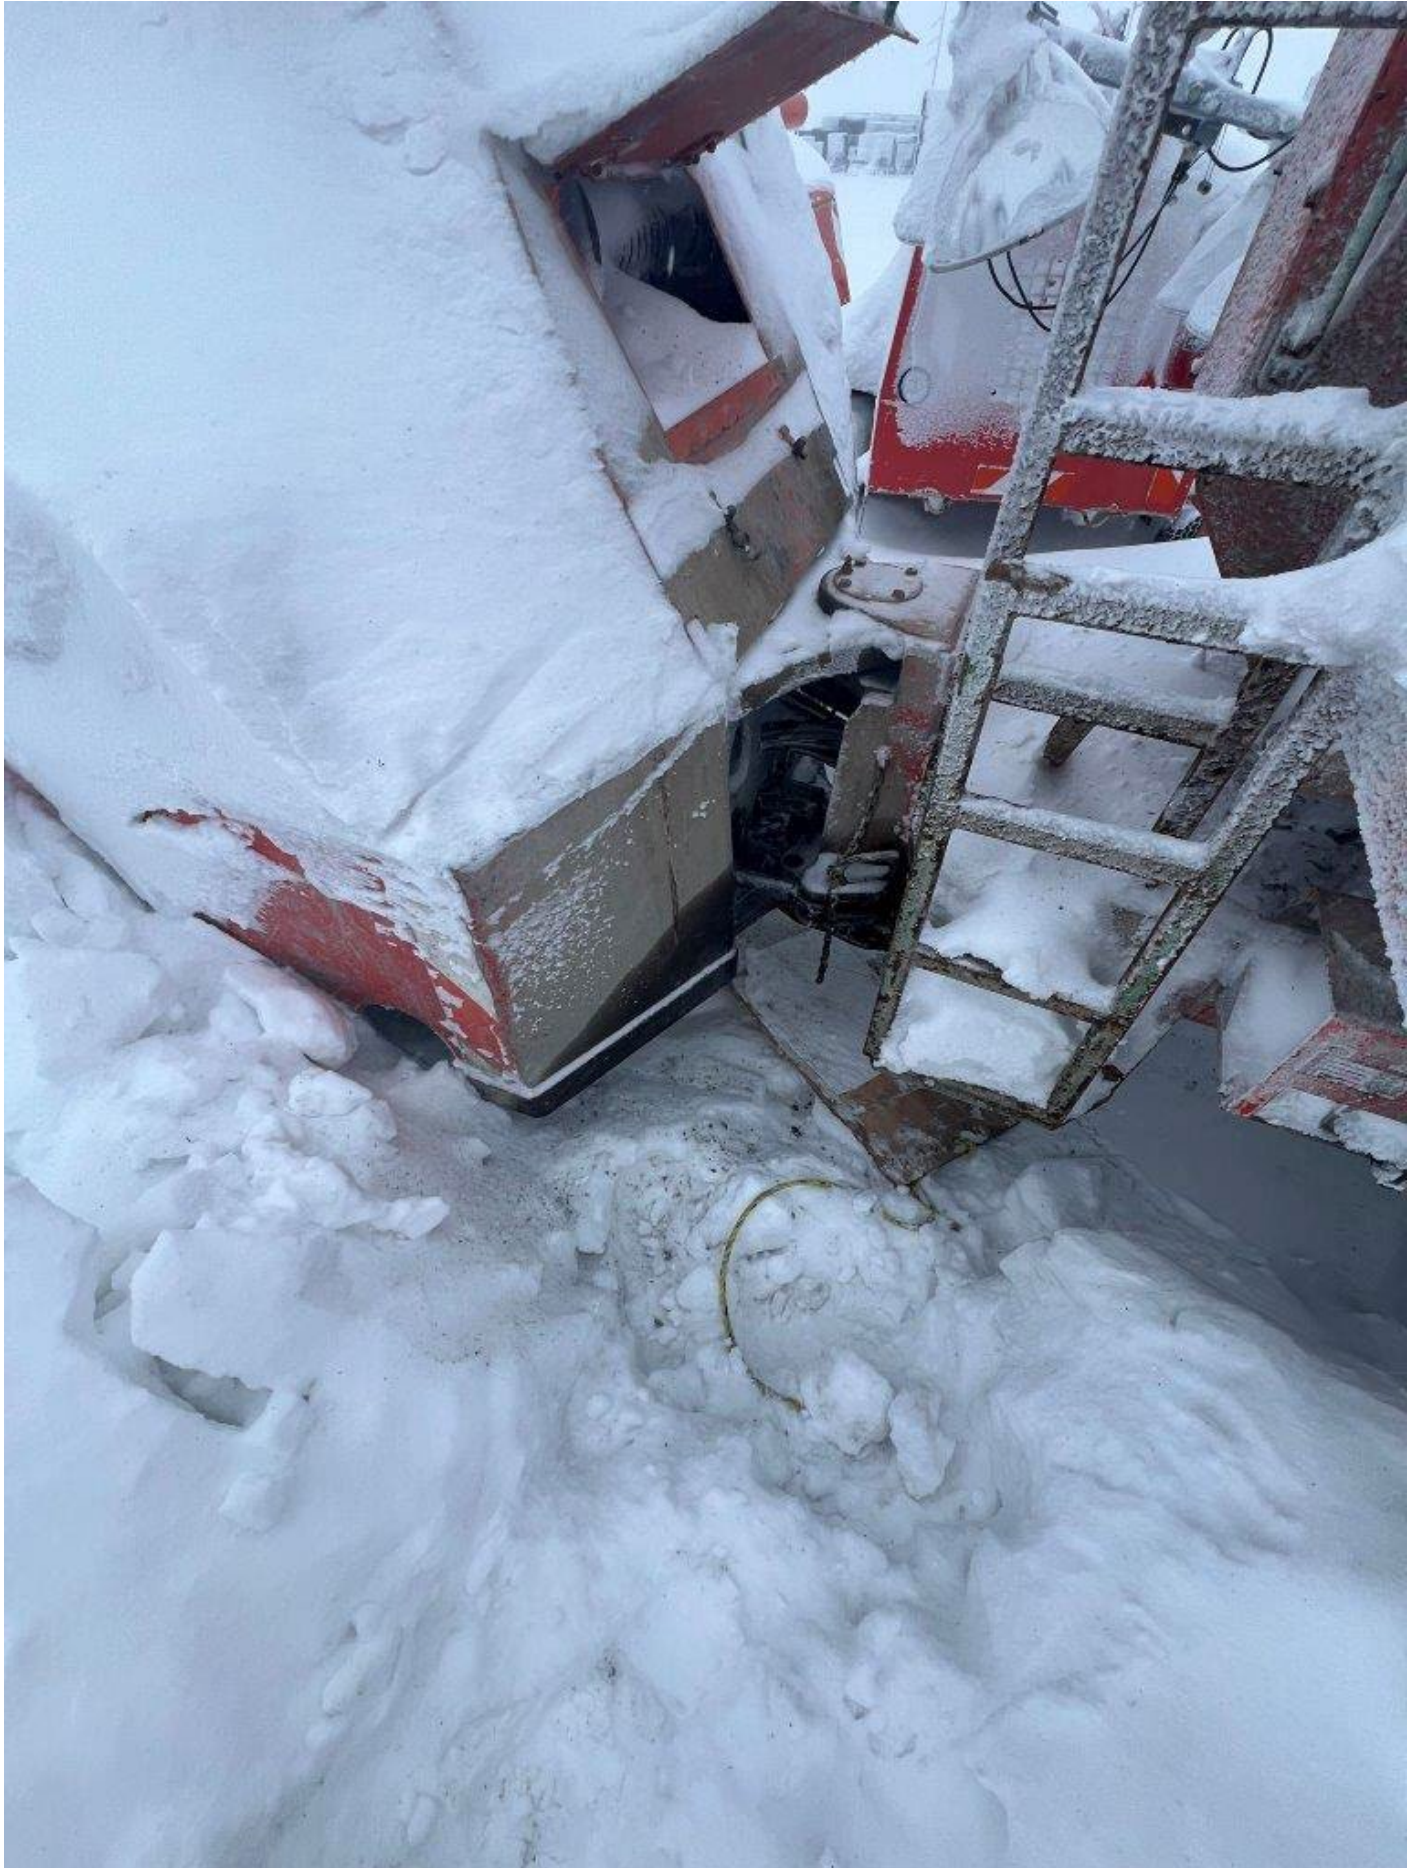
Photo 17 – Misery surface – Laydown – Fluid leakage from vehicle #03498 - Post clean-up.
