**Re: Land Use Permit W2017D0004
Mining & Associated Activities
Ekati Diamond Mine, Northwest Territories**

ENVIRONMENTAL INSPECTION REPORT

Permittee:	Dominion Diamond Mines ULC – MUG Project	Inspection Date(s): February 6 th , 2020
------------	--	---

Location(s) Inspected:	The Ekati Mine Misery Underground Project and Misery Camp.
------------------------	--

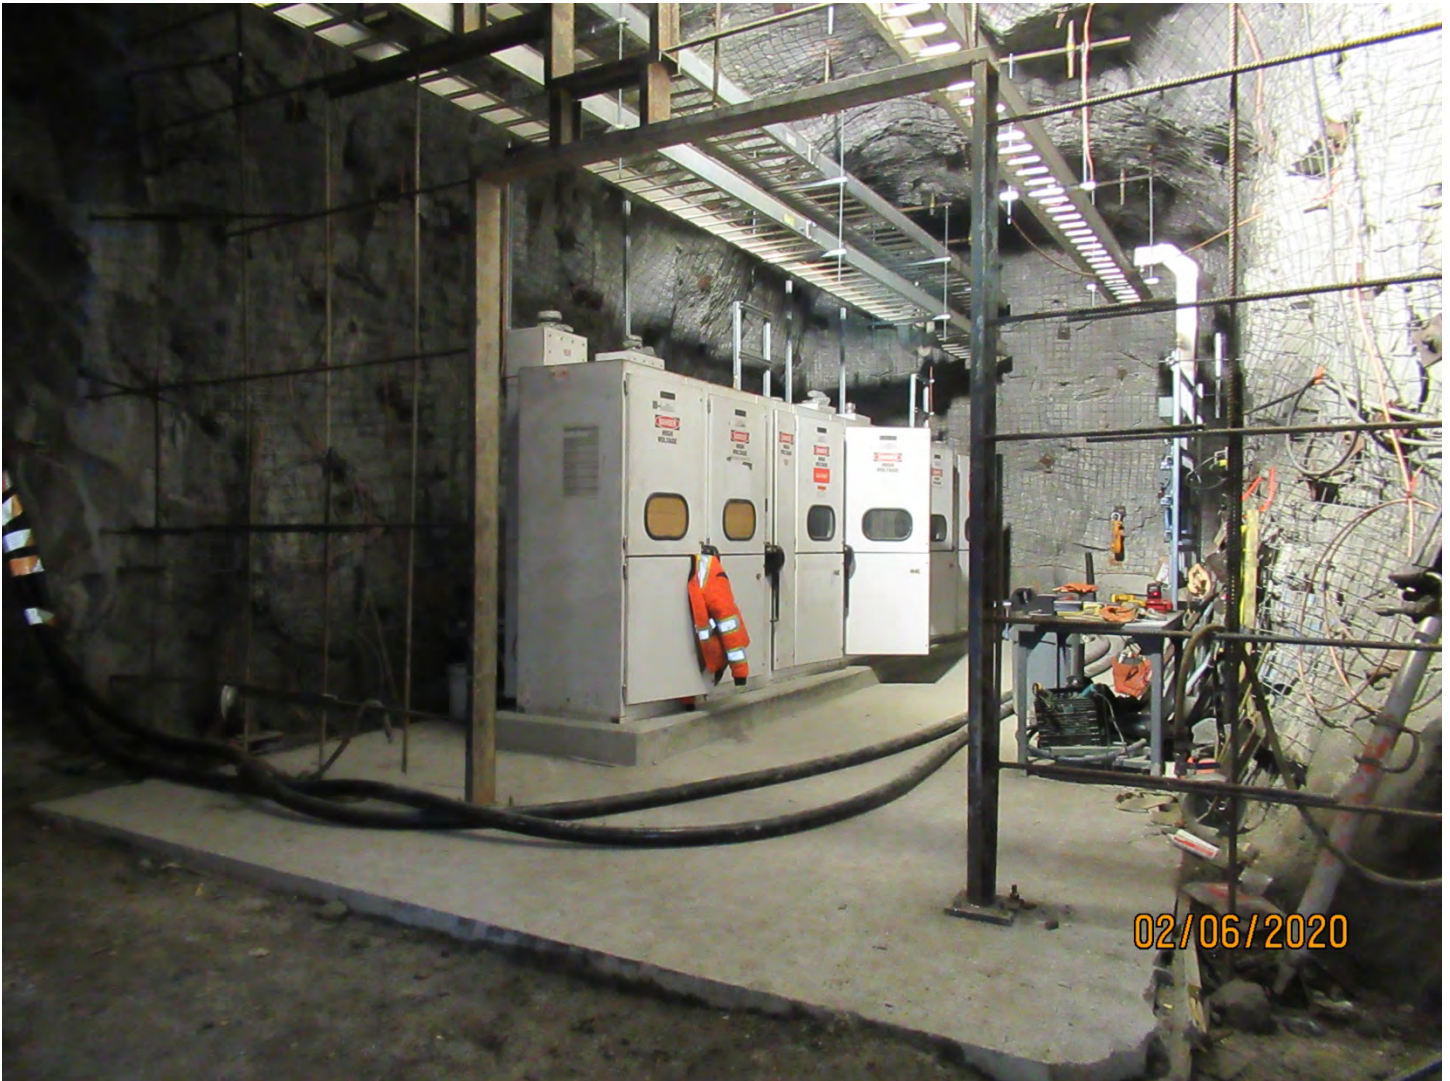
Photo 1: This electrical sub-station at the UG 2150 Level will step down electricity from an electrical transformer located on the Misery Pit 440 Bench.

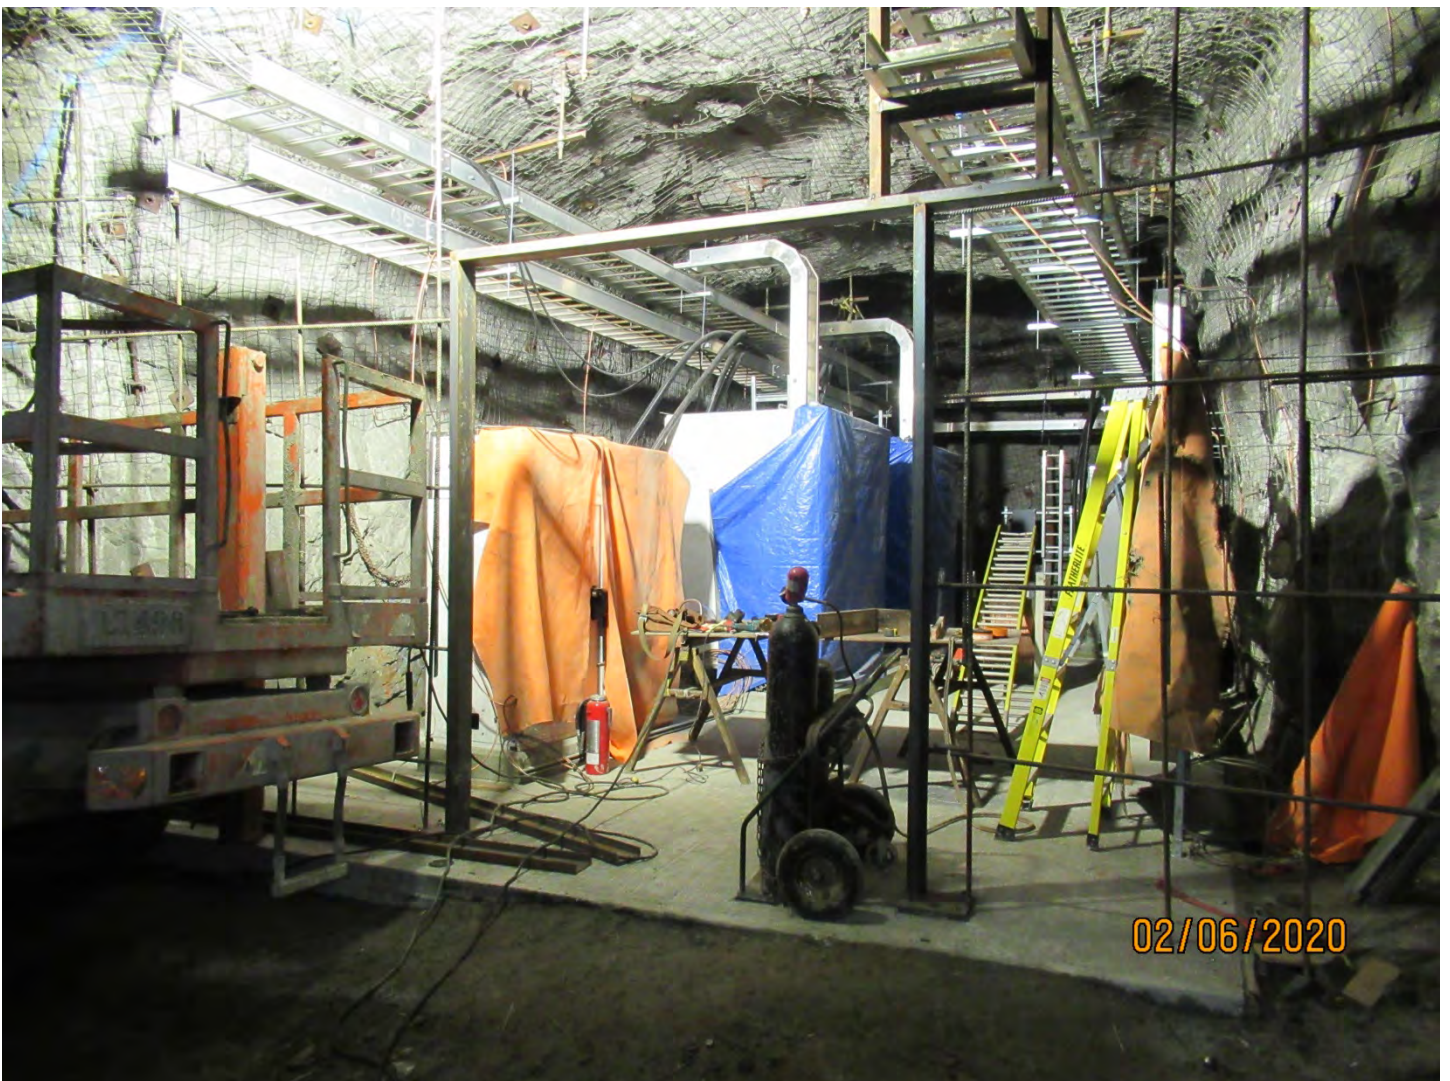
Photo 2: Electricity from the sub-station in Photo 1 reports to this electrical distribution station. Electricity will then be directed throughout the underground to support mining operations.

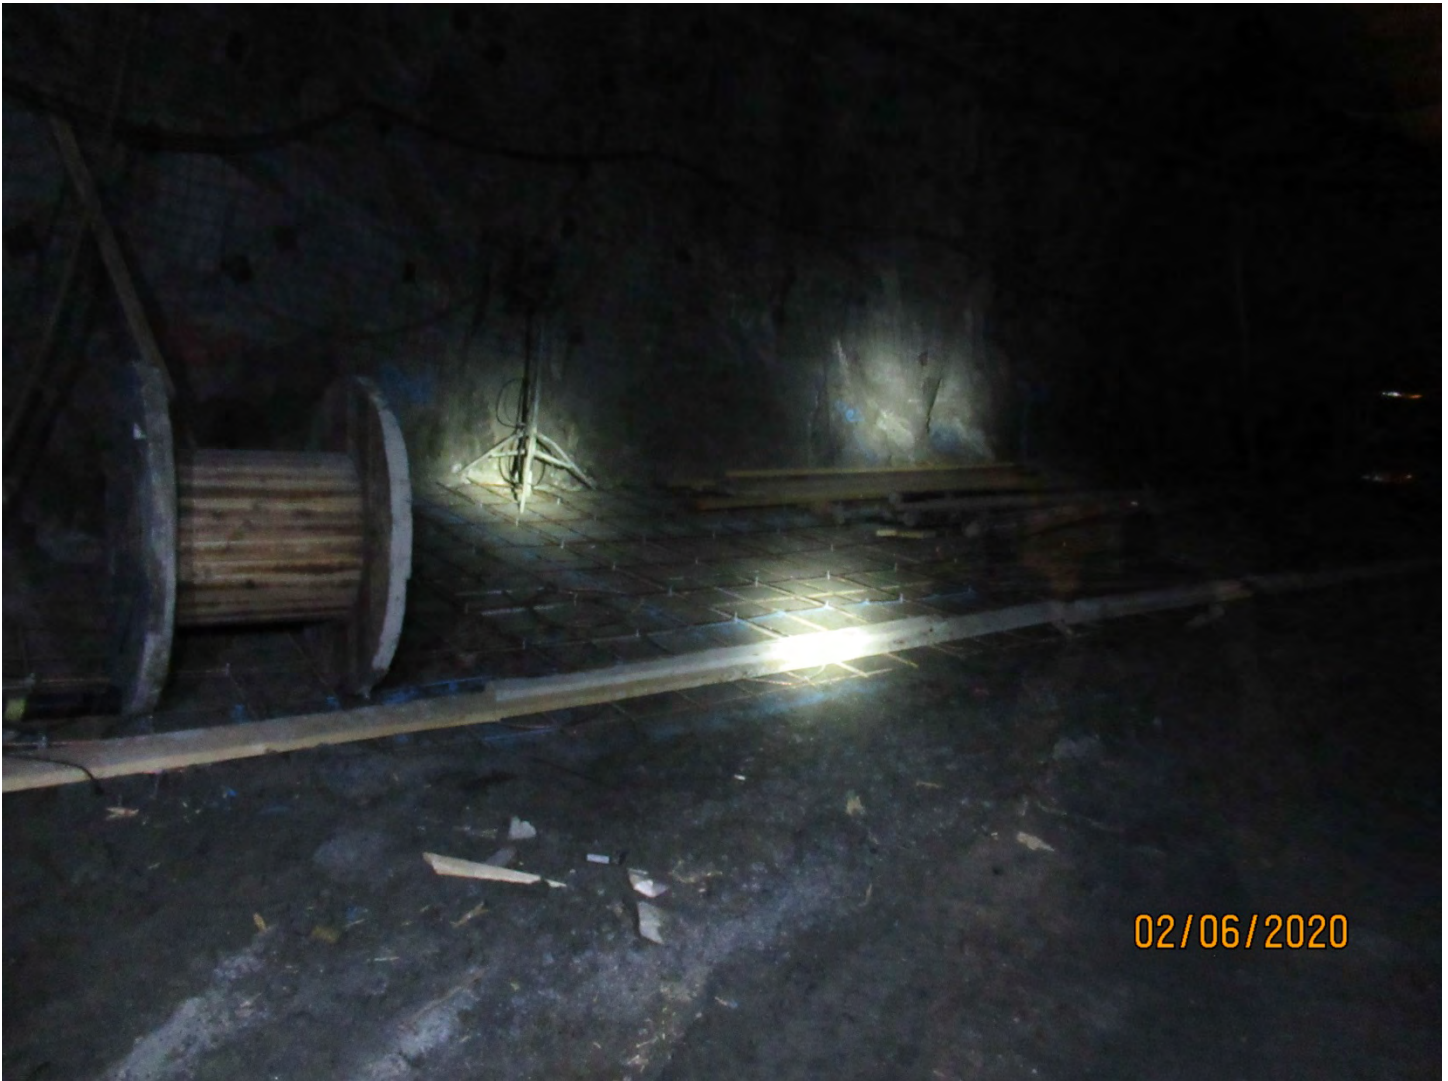
Photo 3: A concrete pad for the underground compressor station was being construction at the UG 2150 Level.

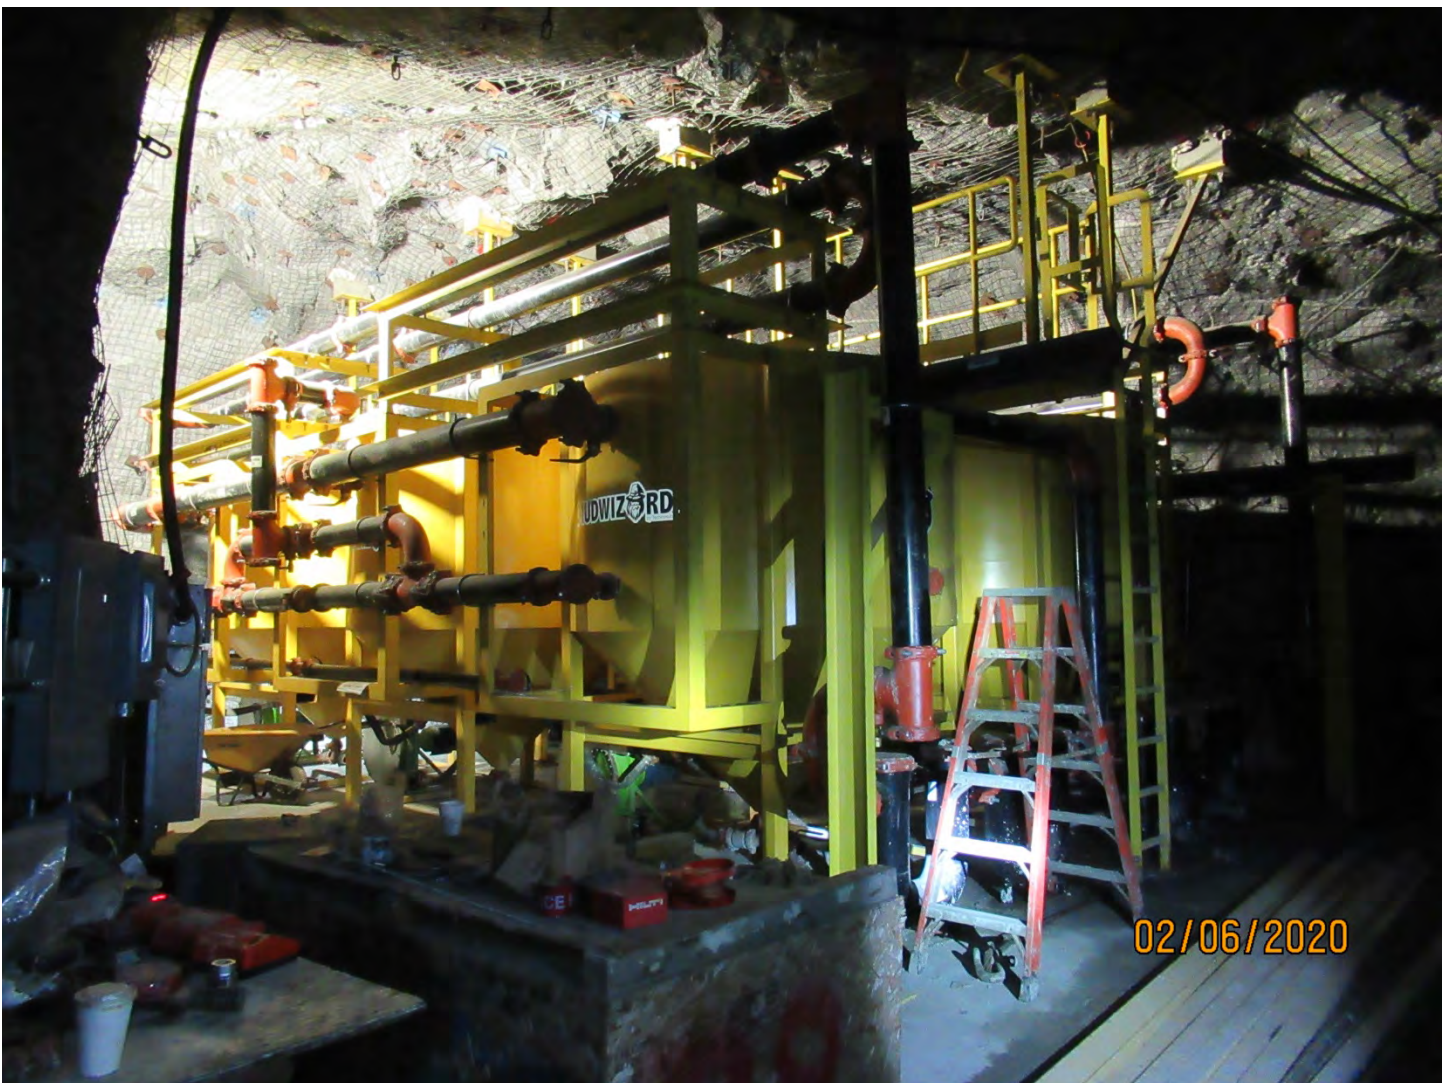
In addition to the other equipment being set up at the 2150 Level, work on the MudWizard mud treatment system continues (Photo #4). Once operational, the MudWizard system will be used to recapture water for use during underground operations. Currently, water that is required for underground operations is being trucked to site and reused whenever possible. As seen in Photo #5, trucked water is being pumped into the underground sump system from the 2235 Lower Portal.

Photo 4: This MudWizard mud treatment system was being installed at the UG 2150 Level.

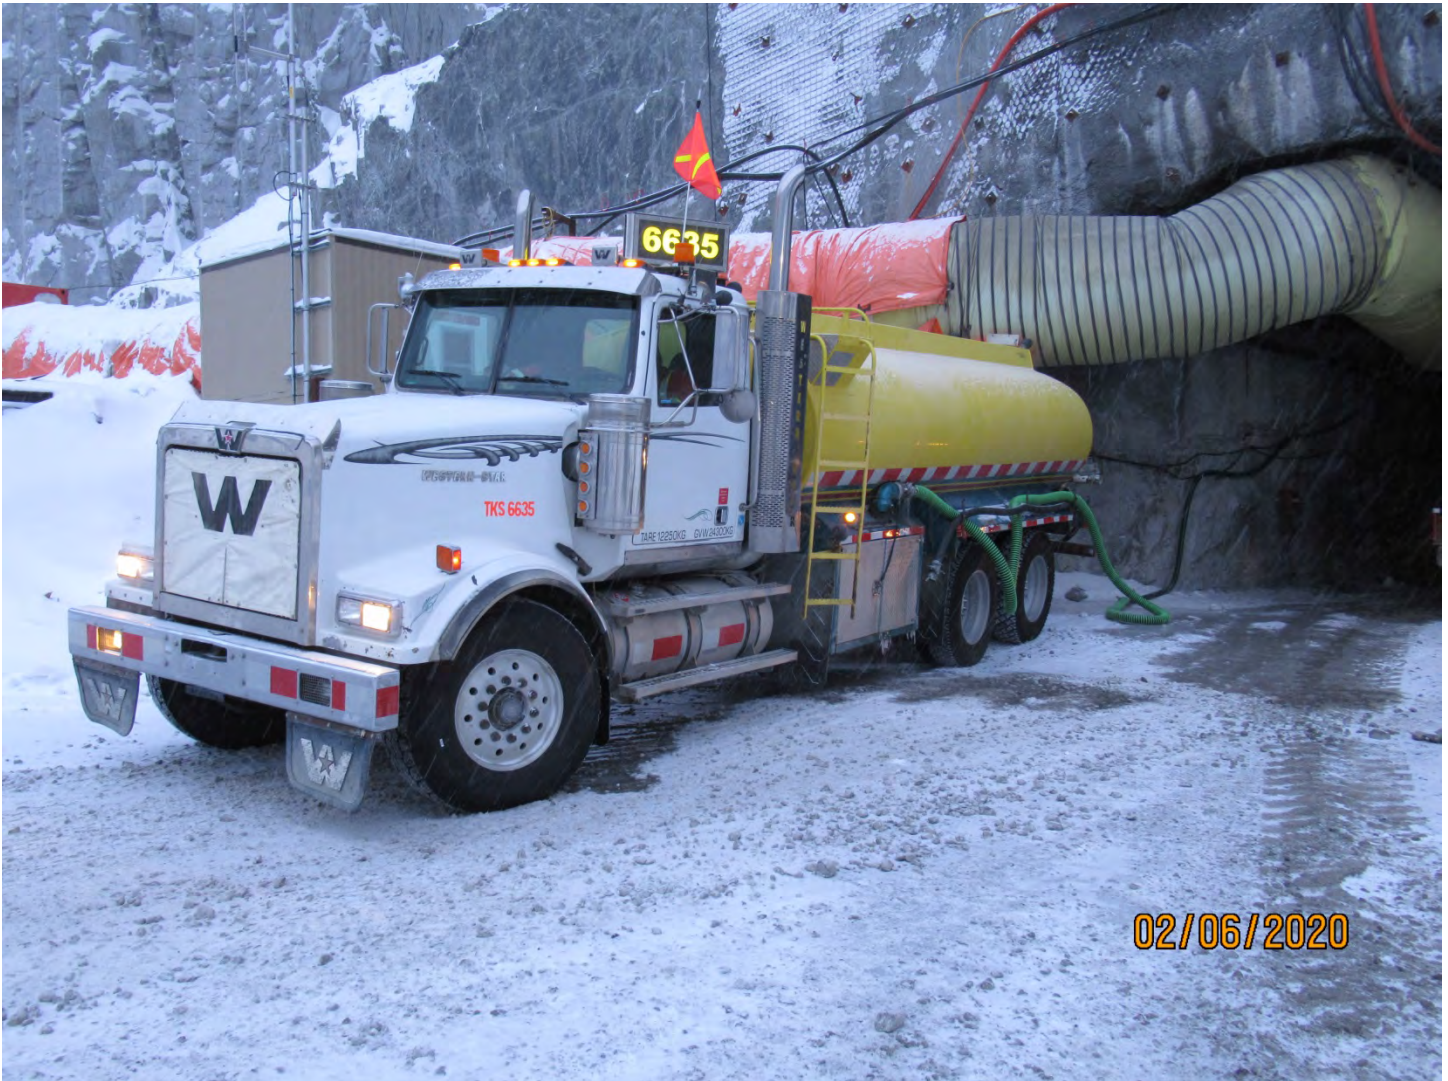
Photo 5: Trucked water was being pumped into the UG water system in support of the UG mining operations.

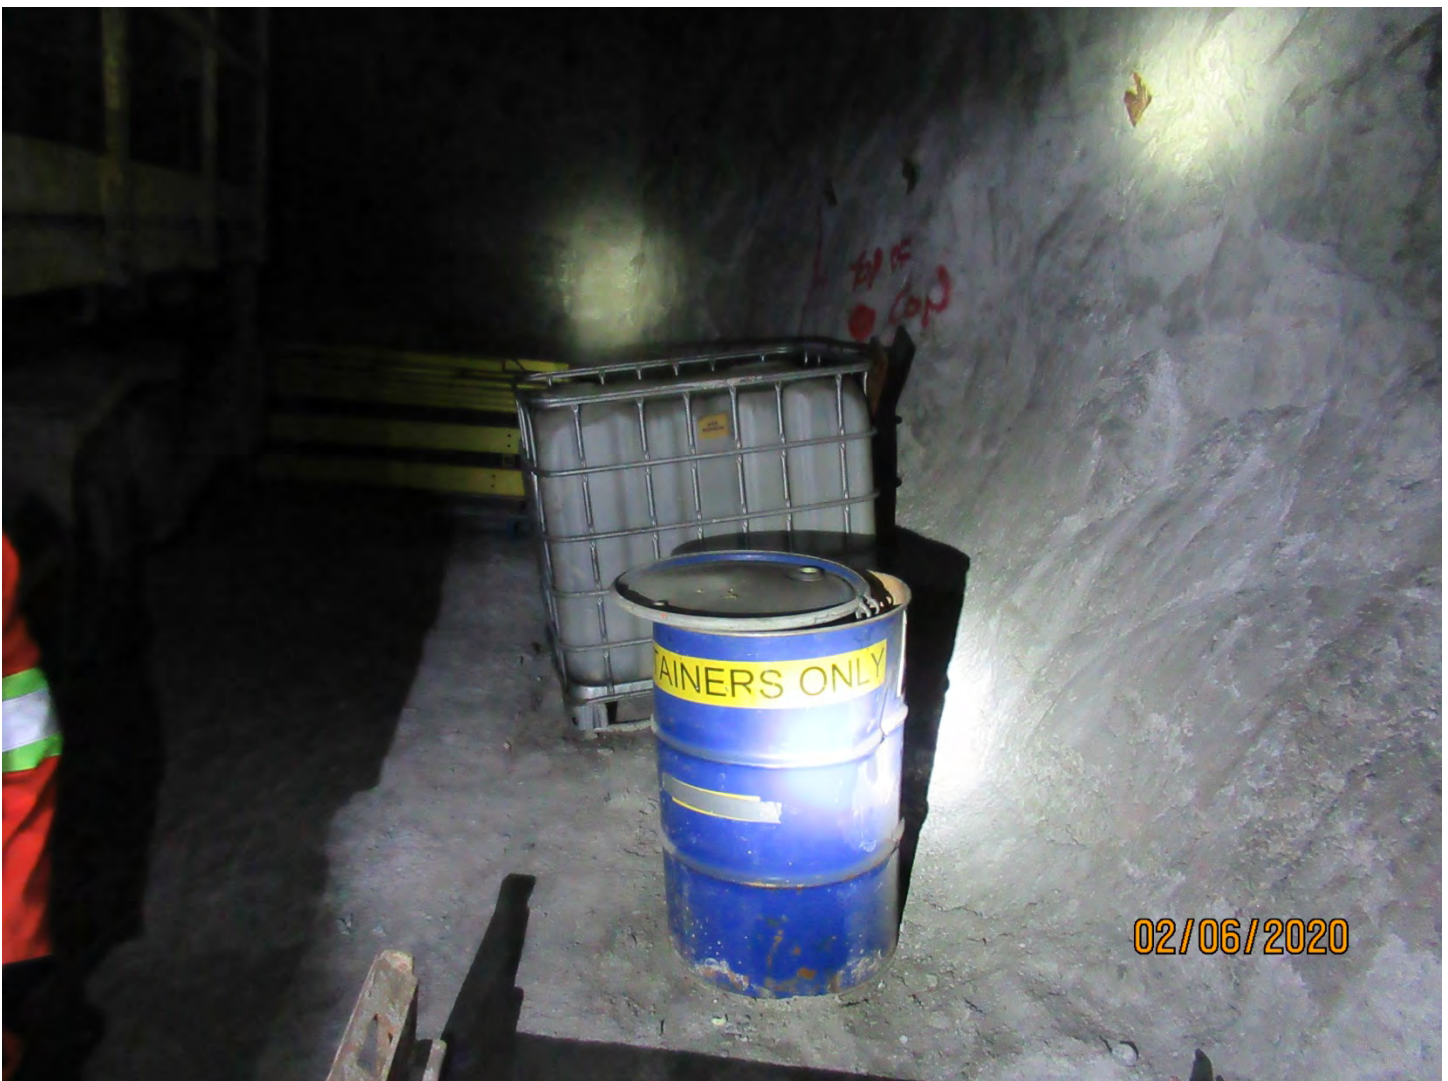
Only a minor concern was noted by the Inspector regarding the need to have an appropriate waste management station setup and made available at the 2150 Level (Photo #6). The use of a properly setup waste management station will allow for the segregation of waste prior to its disposal and will prevent waste items from being discarded on the ground in the area (Photo #7). Waste generated during the underground operations must be disposed of on an ongoing basis and conform to the approved Ekati Mine *Waste Management Plan* (Condition #23).

Photo 6: Containers used to manage aerosol can waste and staged hydrocarbons at the UG 2150 Level.

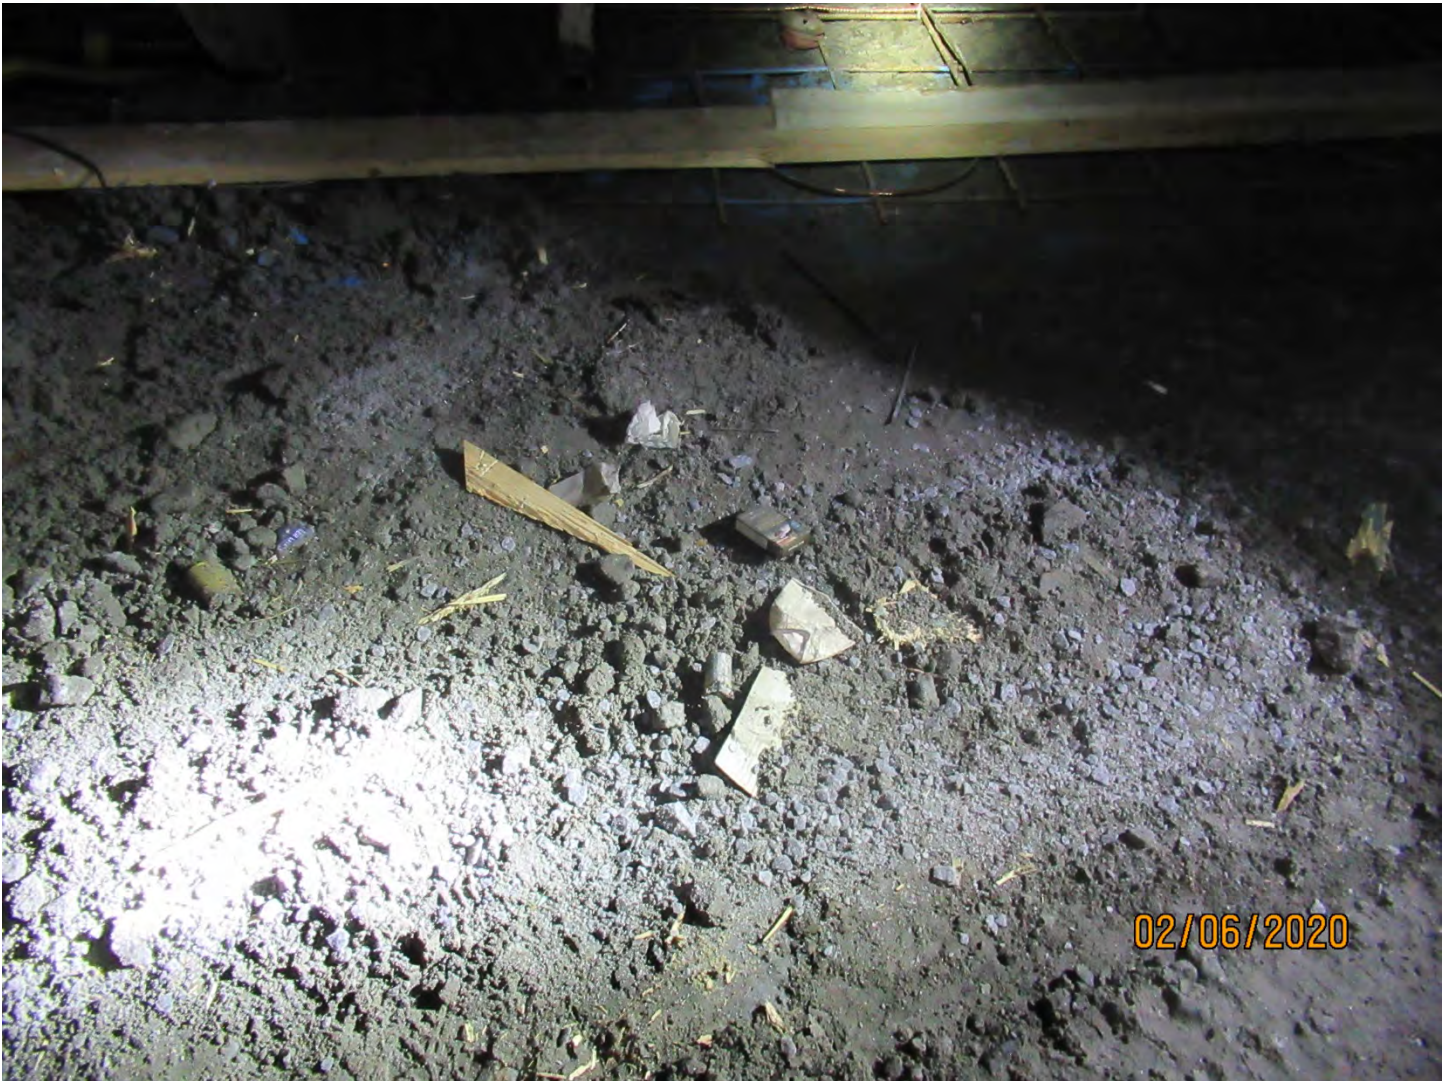
Photo 7: The Inspector noted there was no visible waste bin at the UG 2150 Level and there was a minor amount of produced waste on the ground.

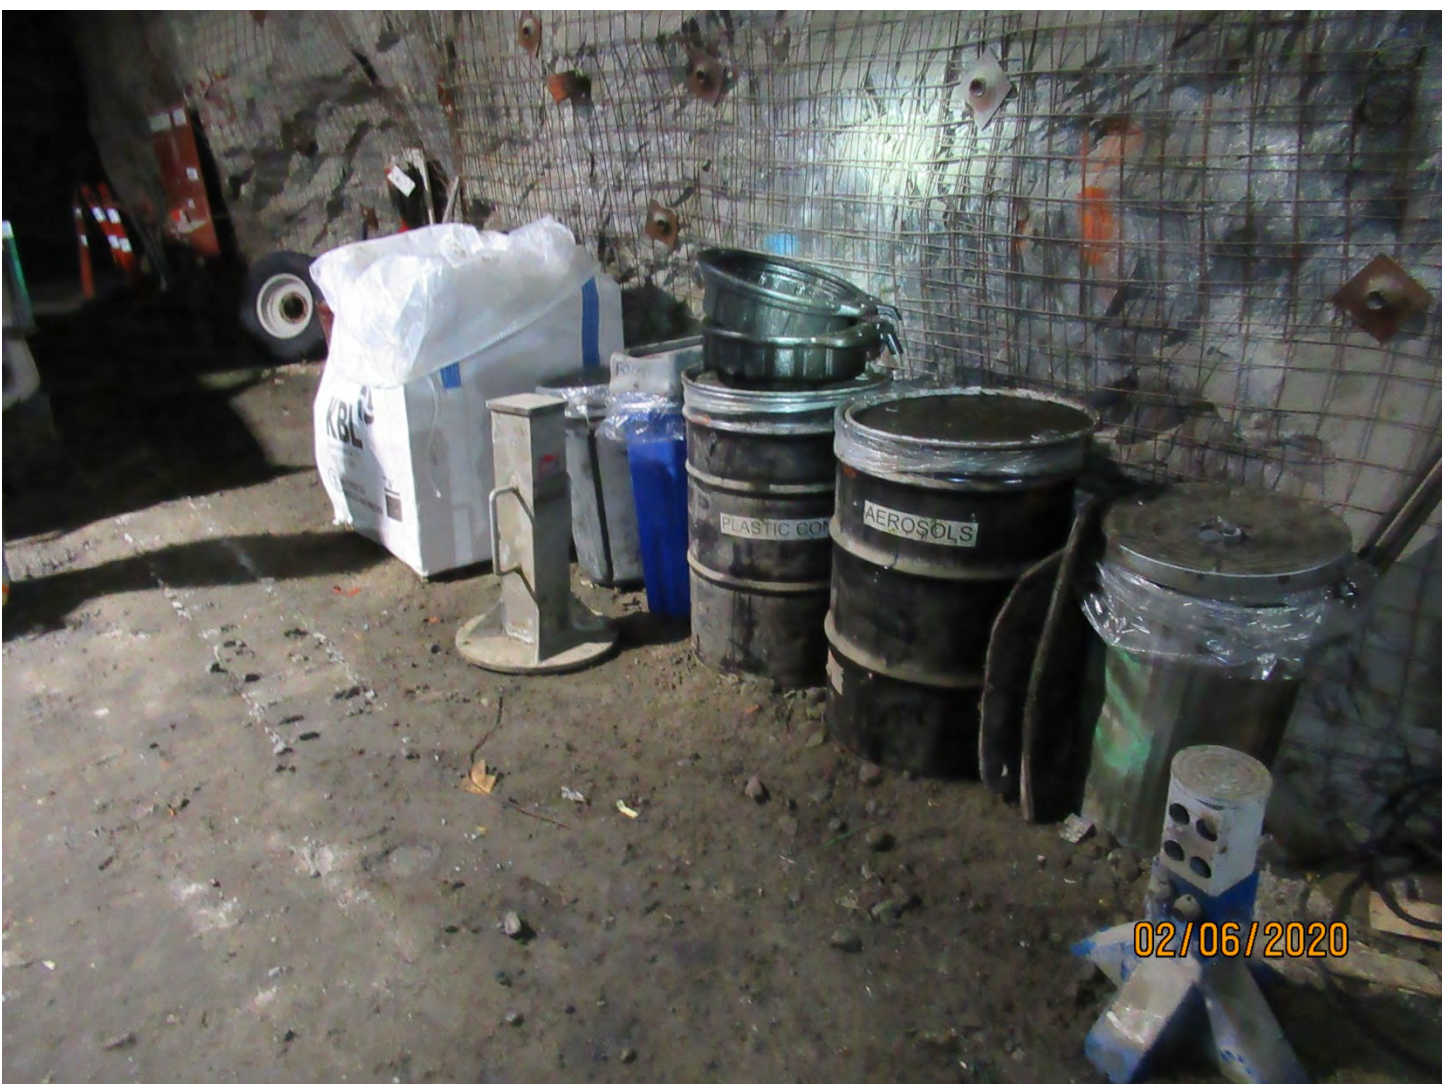
Photo 8: There was a properly set-up waste management station being used at the UG 2155 Maintenance Bay.

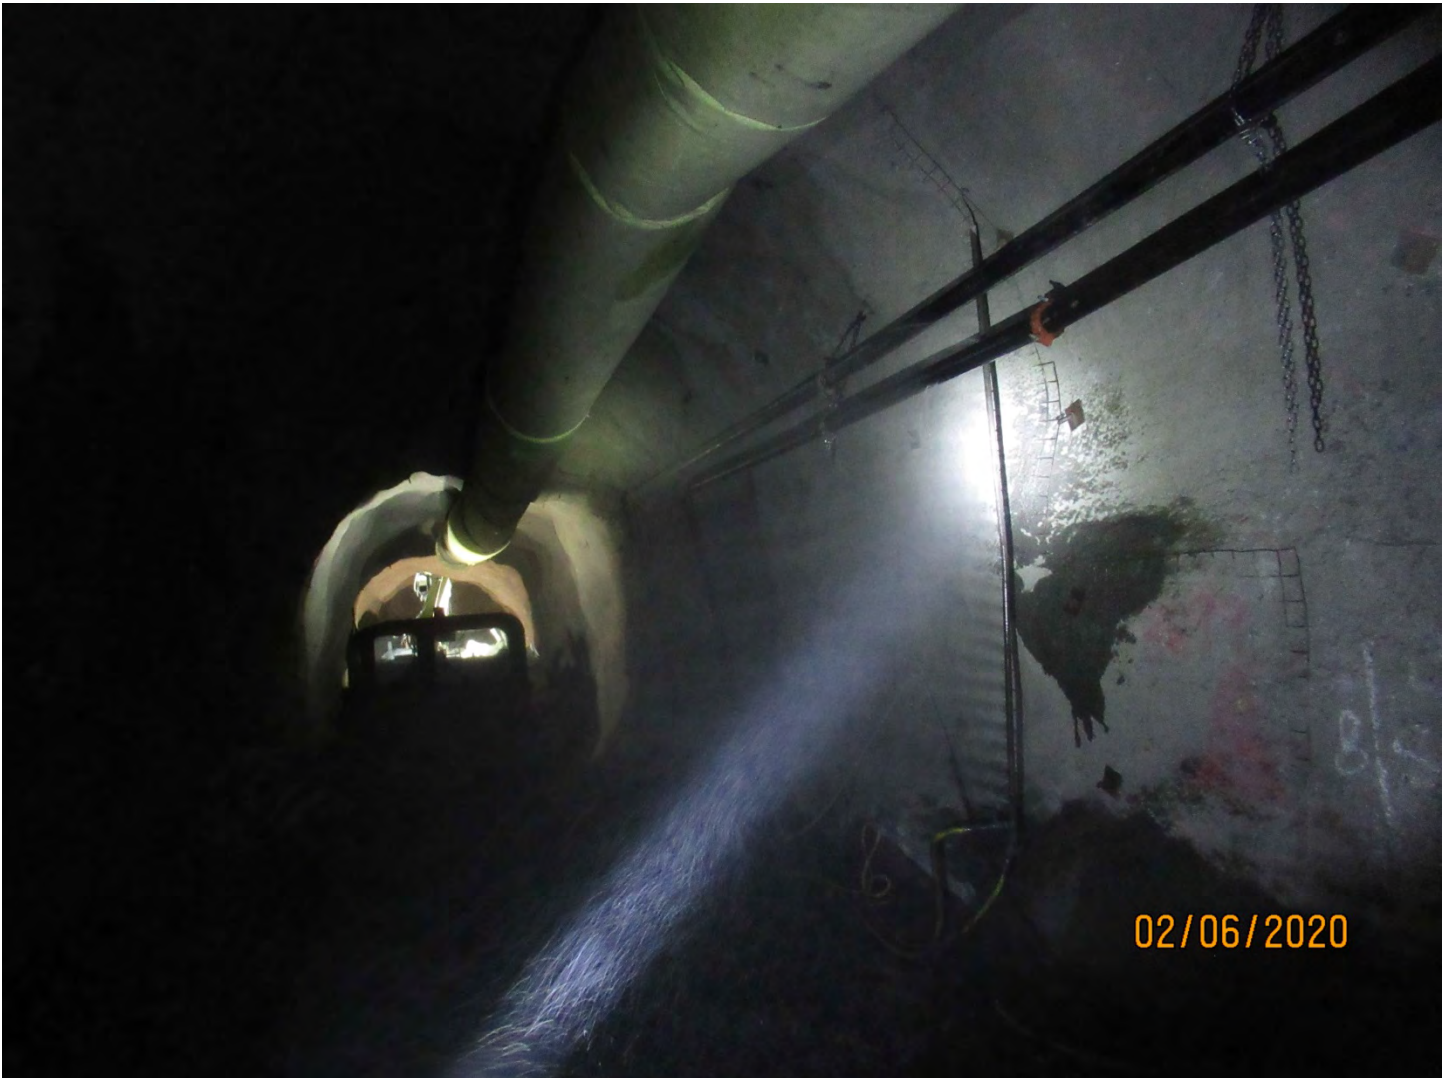
Photo 9: As part of their ground support operations, crews at the UG 2100 Level were spraying shotcrete on the surface of this drift known as Drawpoint 3. As seen in the foreground, a spray bar was being used to help suppress dust levels in the work area.

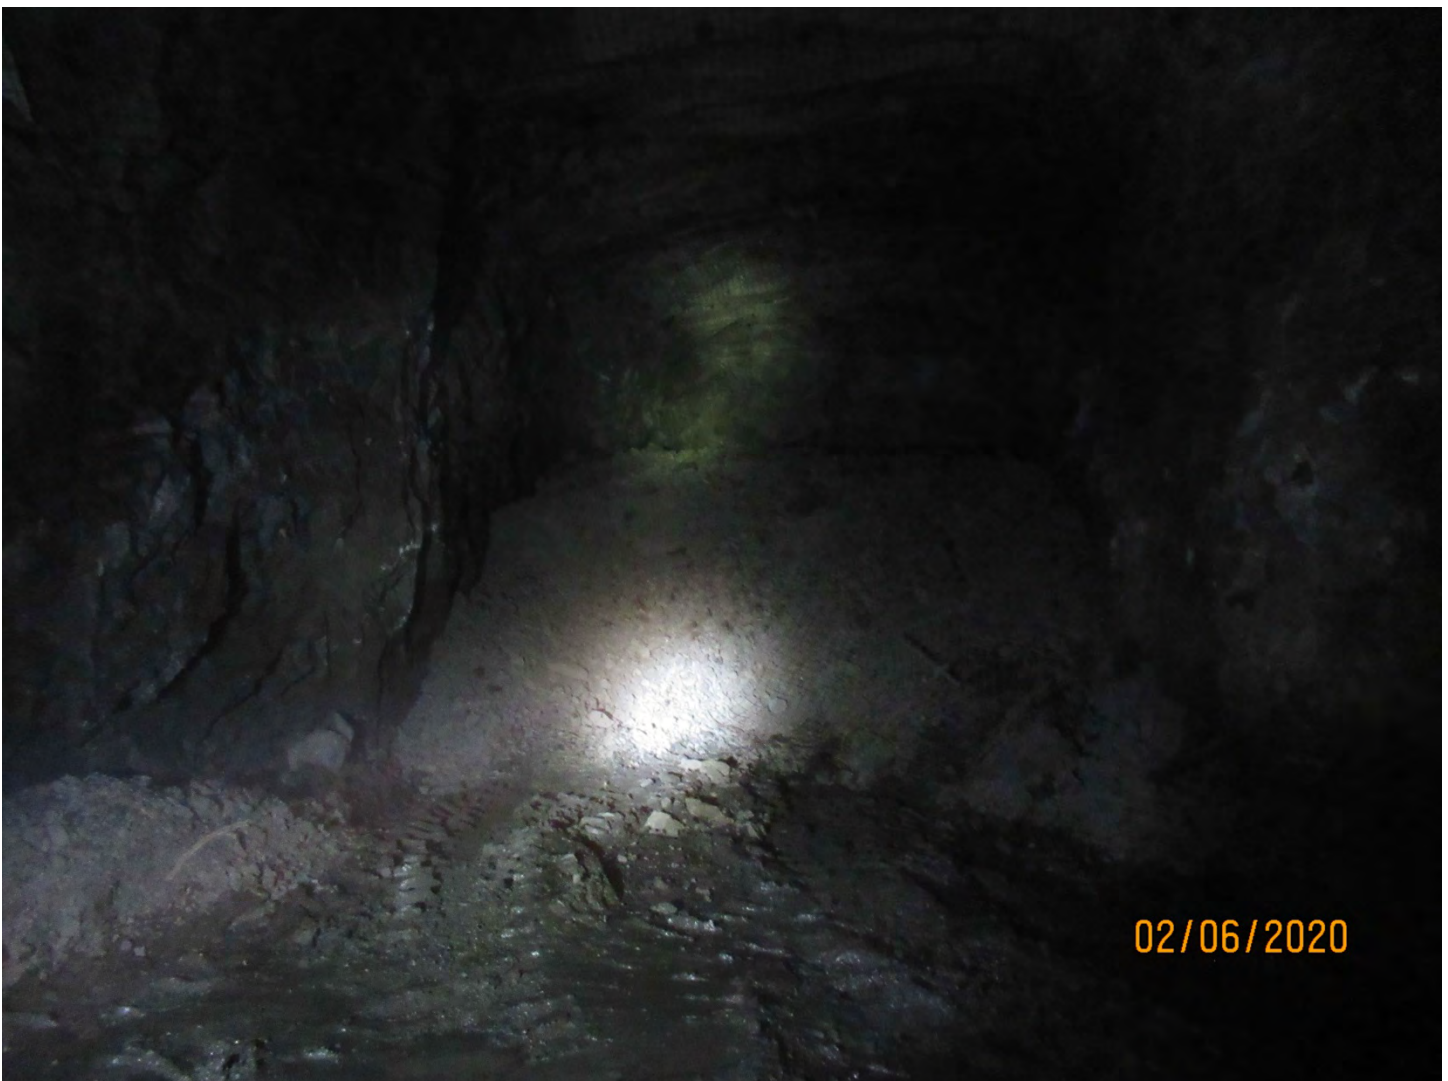
Photo 10: Mined kimberlite is being staged underground prior to its transport to surface.

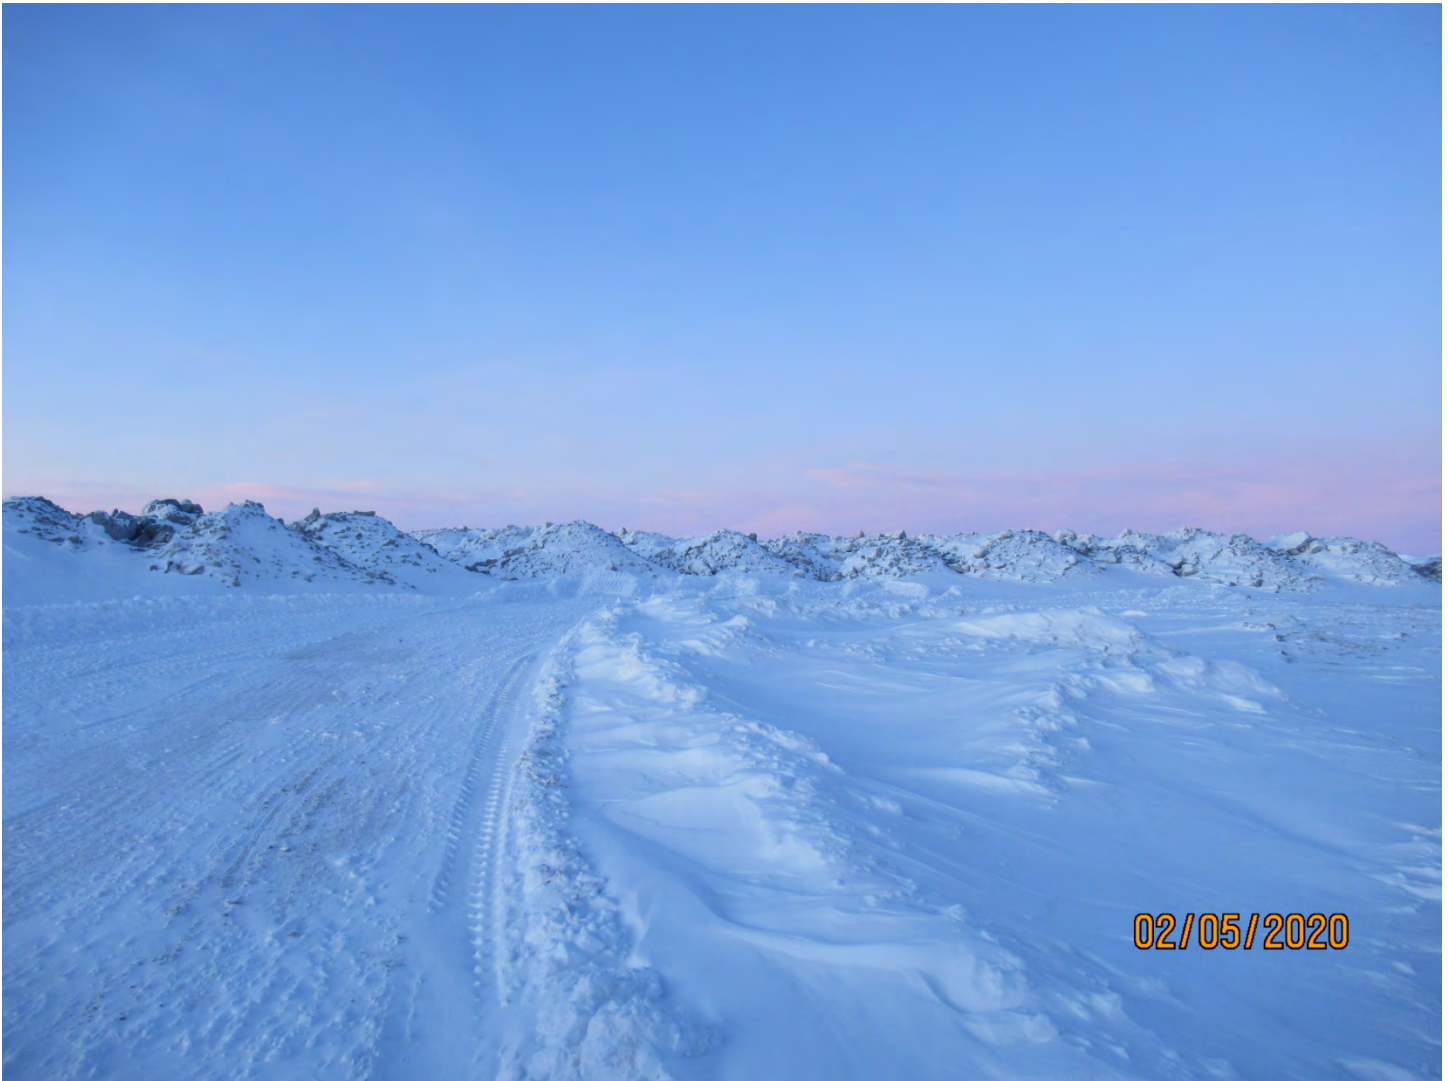
Photo 11: Metasediments (PAG material) from the UG was being deposited on the Misery Waste Rock Storage Area (WRSA).

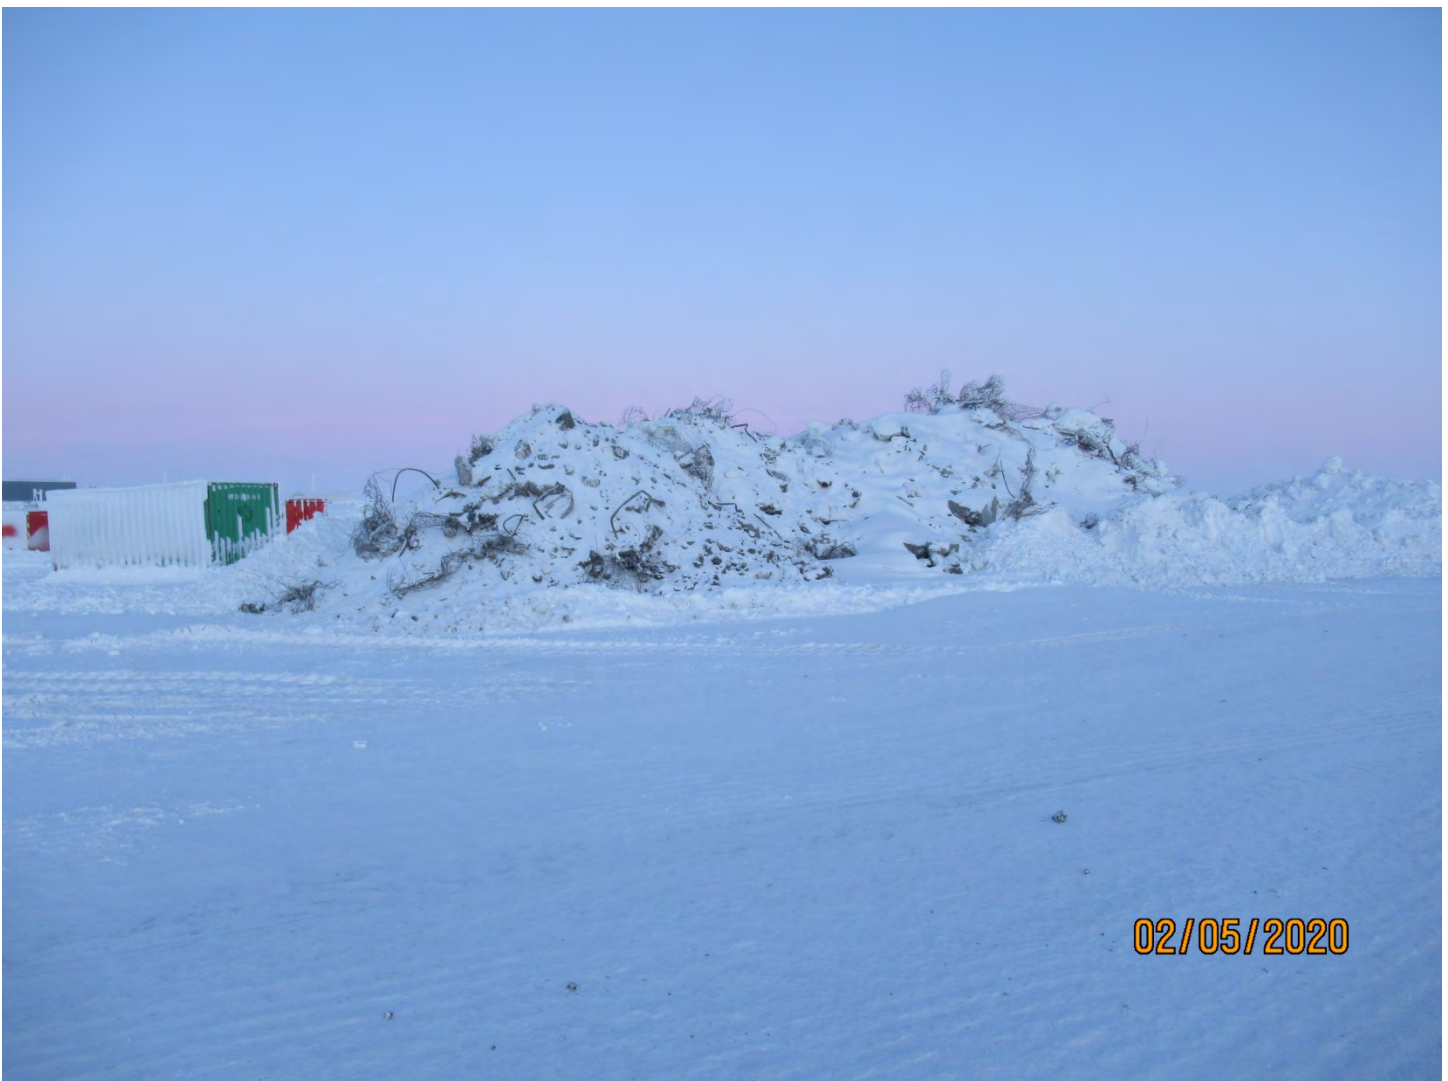
Photo 12: Inert waste from the UG was being staged south of the Misery WRSA.

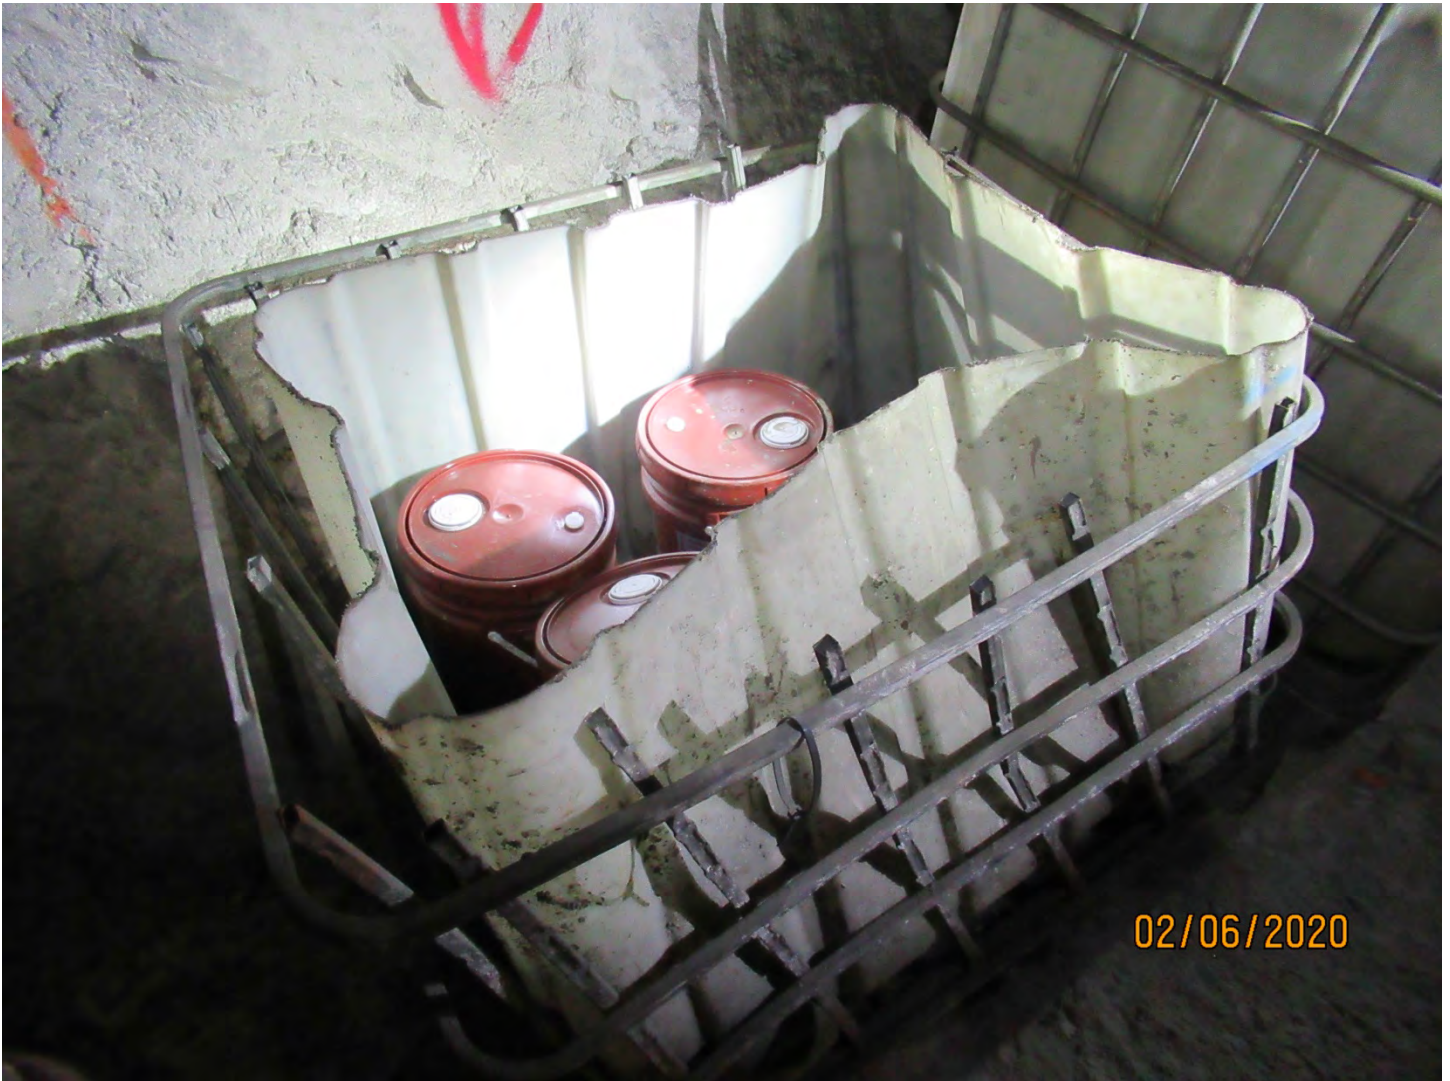
It appeared the majority of hydrocarbons throughout the MUG Project were being properly placed in containment and hydrocarbon impacted waste was properly labeled and staged (Photos #13 & #14). However, as seen in Photos #15-#18, deficiencies noted during the inspection included:

Photo 13: Hydrocarbons at the UG were properly staged and within secondary containment.

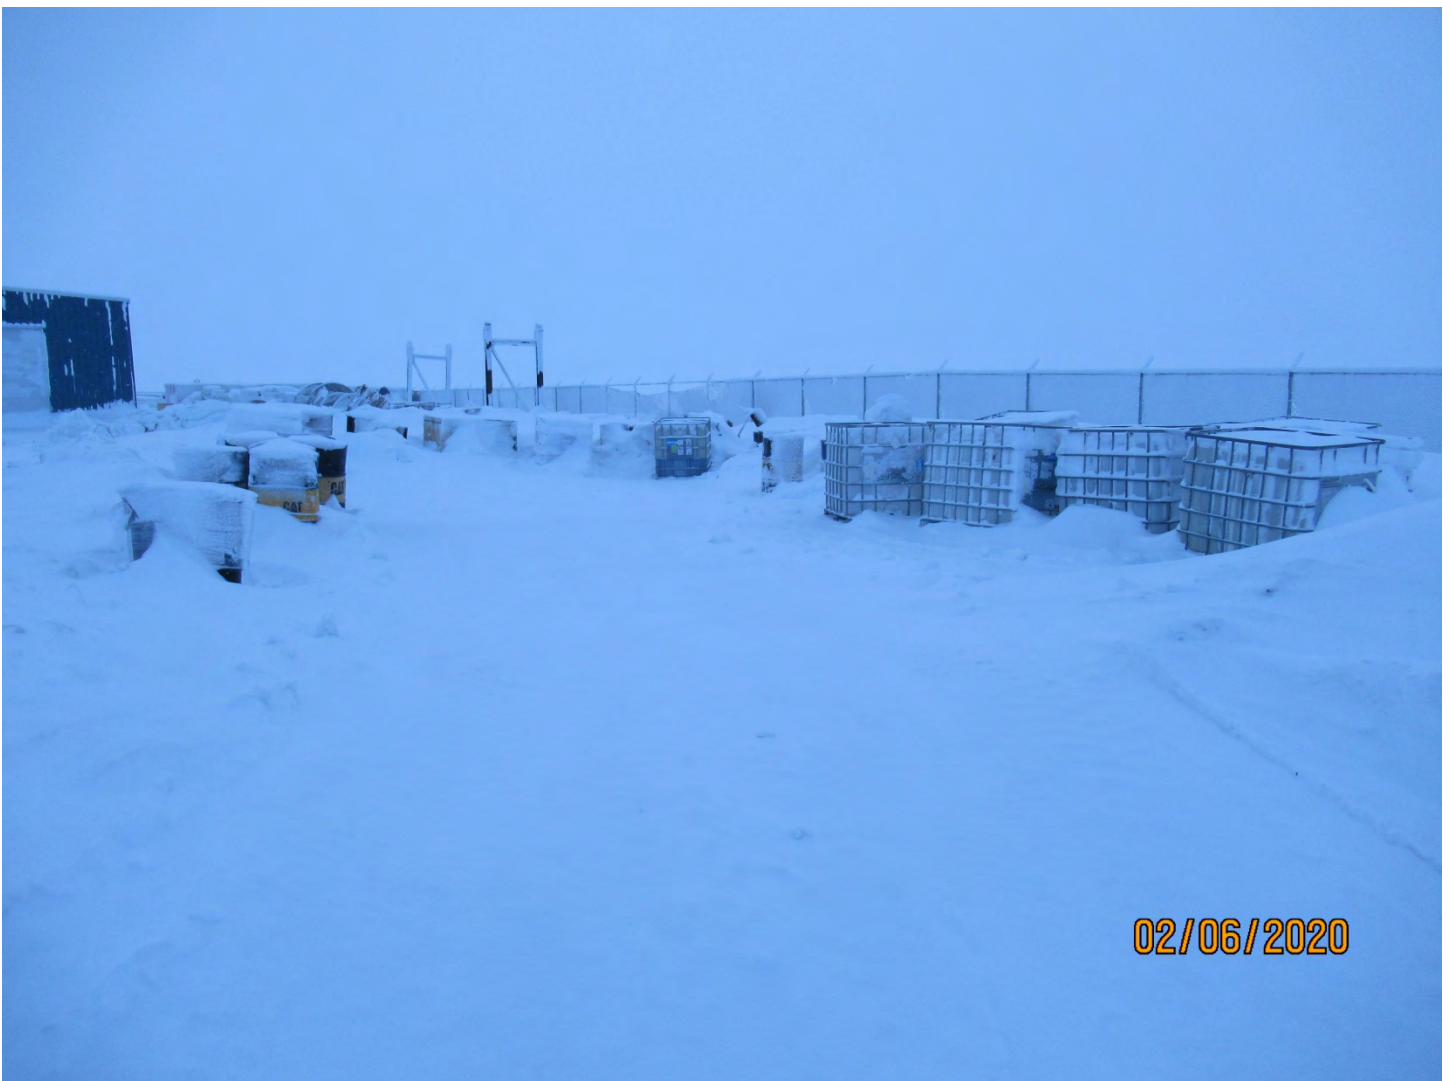
Photo 14: Properly labeled and staged hydrocarbons in a lined containment area on the west of Misery Camp.
