**Re: Land Use Permit W2017D0004
Mining & Associated Activities
Ekati Diamond Mine, Northwest Territories**

ENVIRONMENTAL INSPECTION REPORT

Permittee:	Dominion Diamond Mines ULC – MUG Project	Inspection Date(s): February 6 th , 2020
------------	--	---

Location(s) Inspected:	The Ekati Mine Misery Underground Project and Misery Camp.
------------------------	--

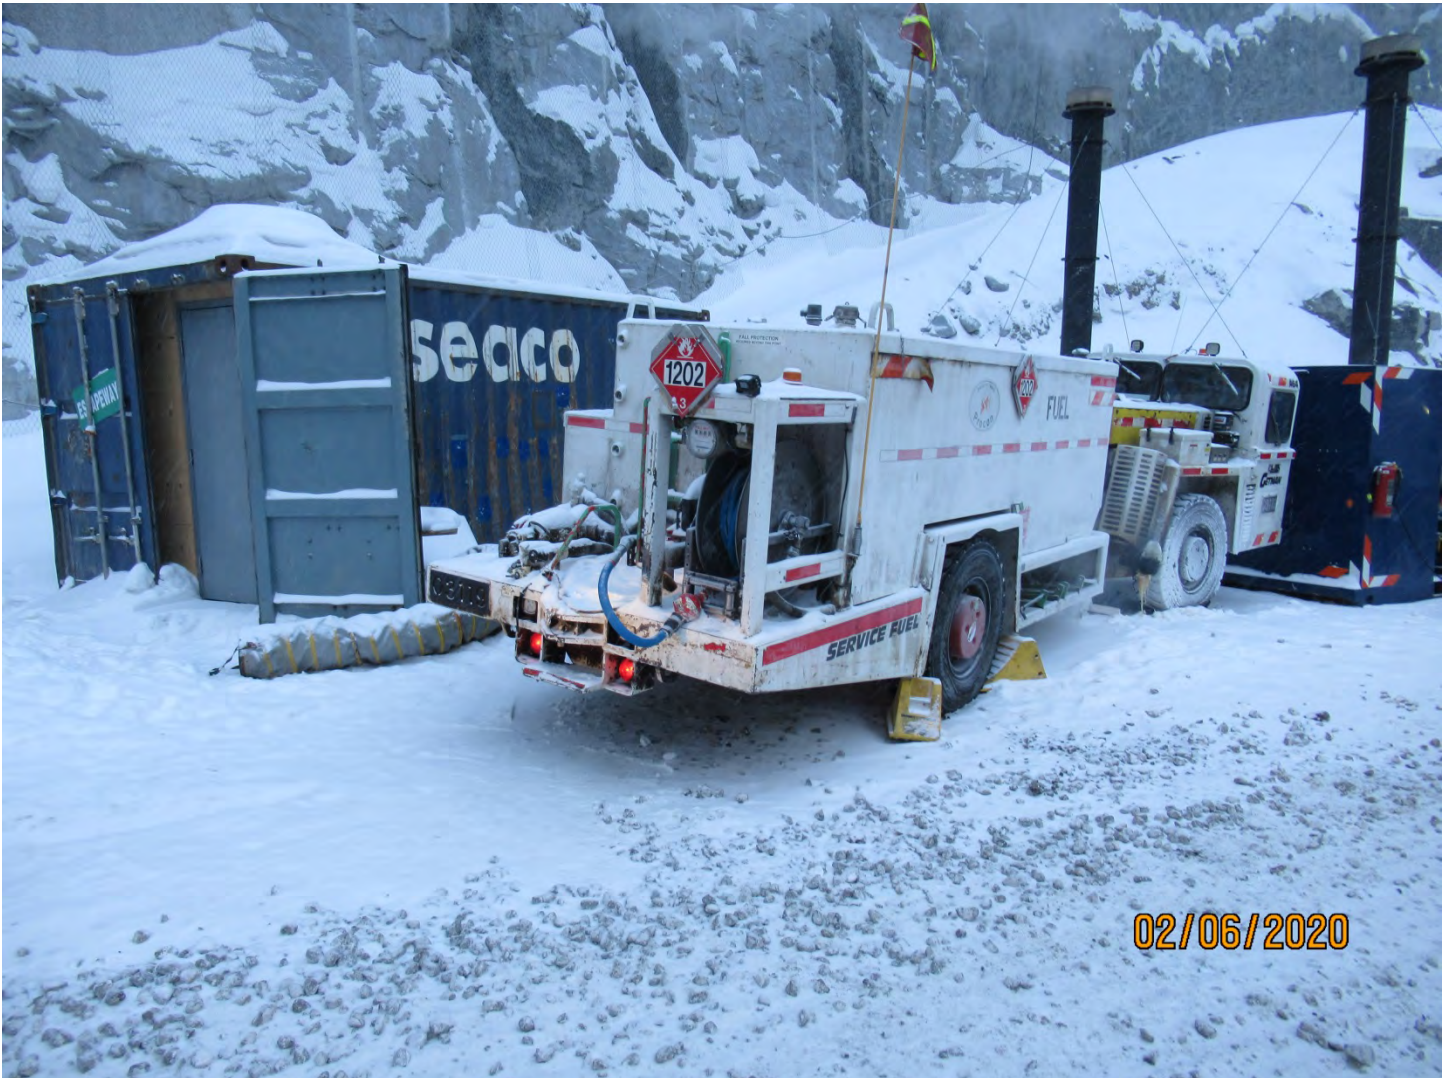
- Secondary containment was not being used at the Getman (fuel truck) on the Lower Portal 2235 ramp and fuel was present around the area of the transfer nozzle.
- Secondary containment trays under the Frost Fighters on the 2235 ramp were full of snow and hydrocarbons were out of containment and impacting the underlying snow/soils.
- There was no secondary containment under the parked equipment on the east of Misery Camp (Photo #19).
- Spilled fuel was on the ground at the Misery Camp fuel transfer station (Photos #20 & #21). The Permittee must ensure spilled hydrocarbons are cleaned up as spills occur to prevent fuel tracking off the fuel pad (Photo #22).
- The sump at the fuel transfer station was full of snow and must be kept cleared to ensure adequate capacity in the event of larger spills.

Photo 15: There was no secondary containment in place under this Getman on the 2235 Lower Portal ramp.

The Permittee is also reminded that spilled hydrocarbons and hydrocarbon impacted materials are to be cleaned up and disposed of in a timely manner (Condition #38). Proper hydrocarbon management practices will help prevent the introduction of hydrocarbons into the surrounding receiving environment. No further concerns were noted by the Inspector.

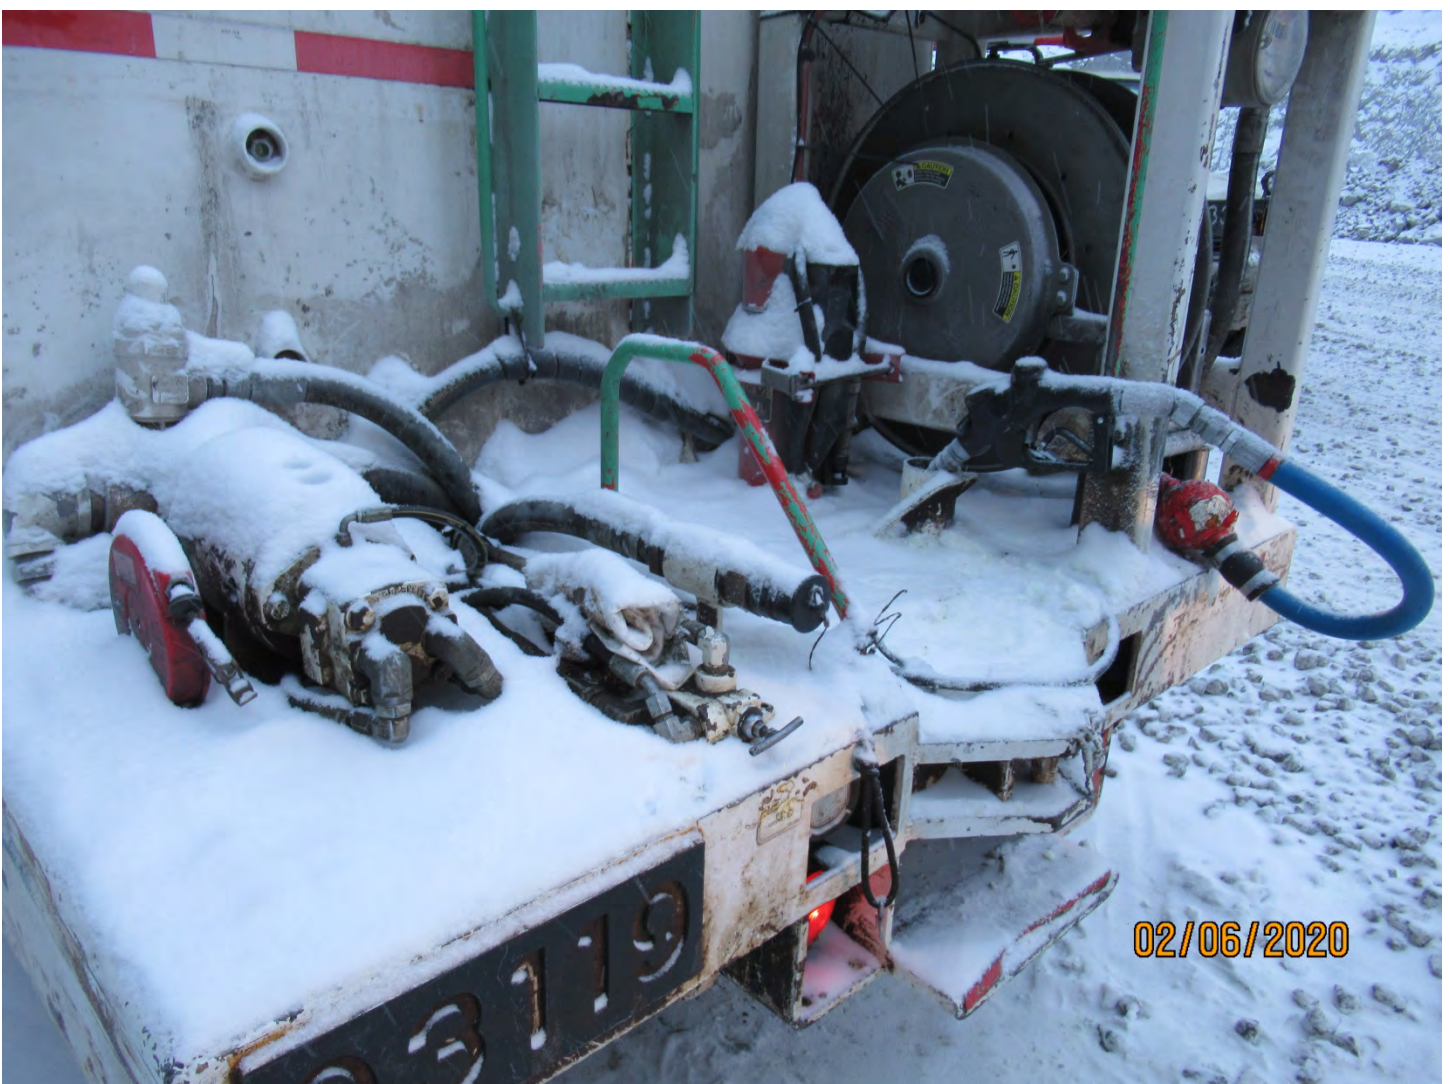
Photo 16: Though the fuel nozzle was stored in containment when not in use, it appeared secondary containment was not being used during fuel transfers at the Getman.

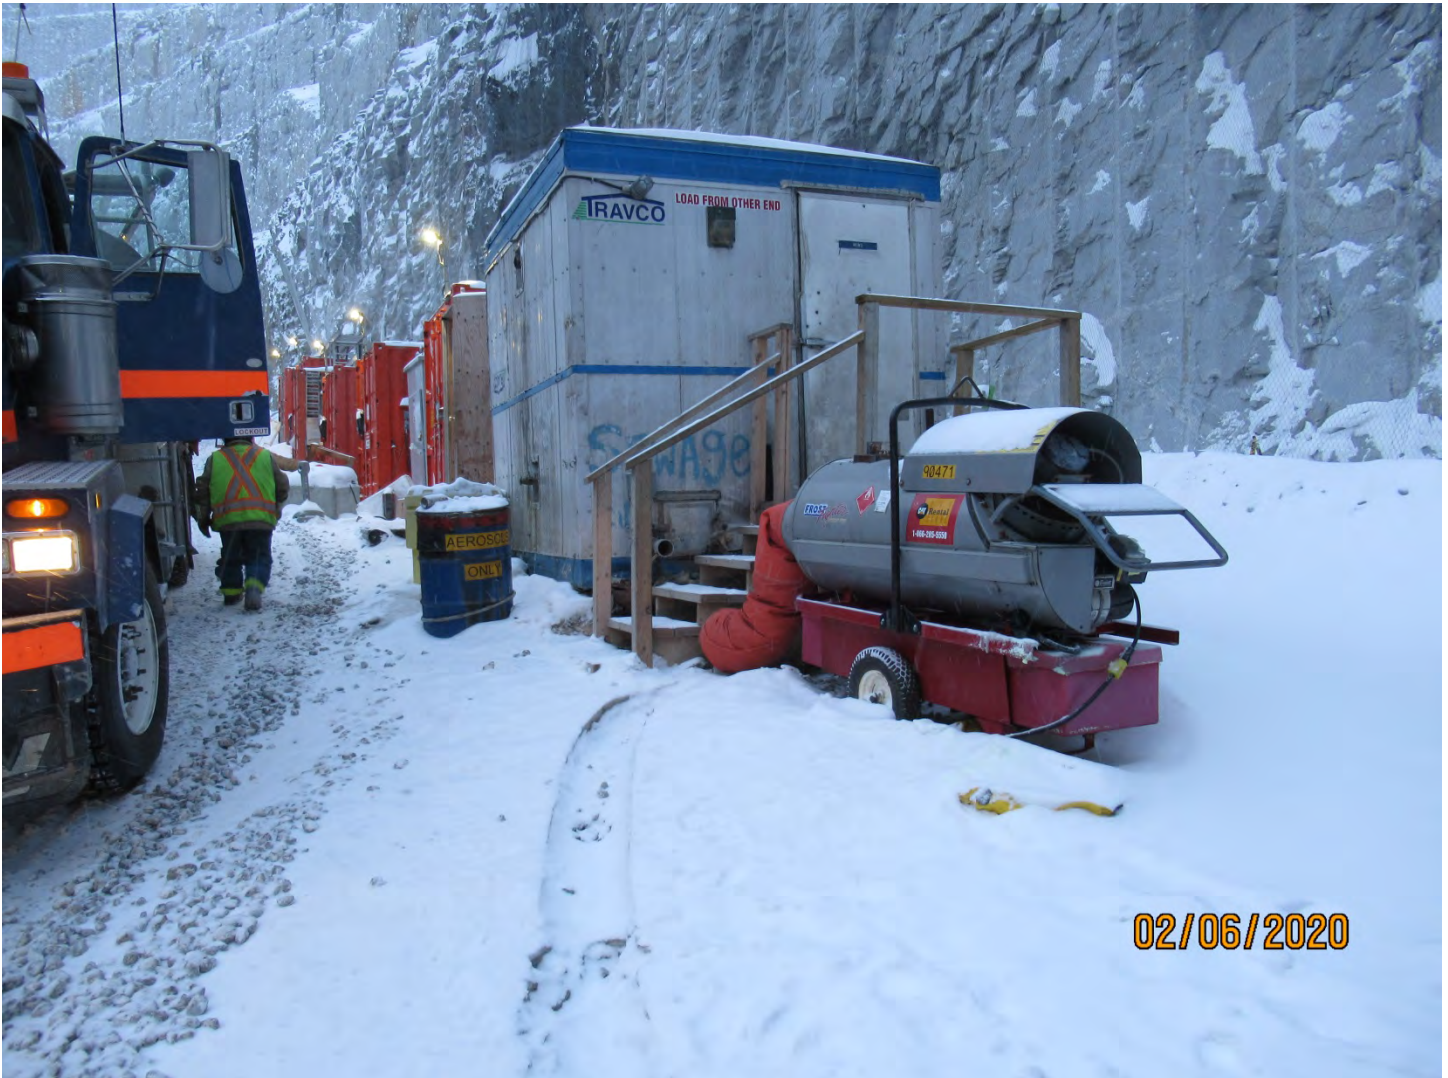
Photo 17: As seen, the secondary containment tray under this Frost Fighter was filled with snow and required maintenance.

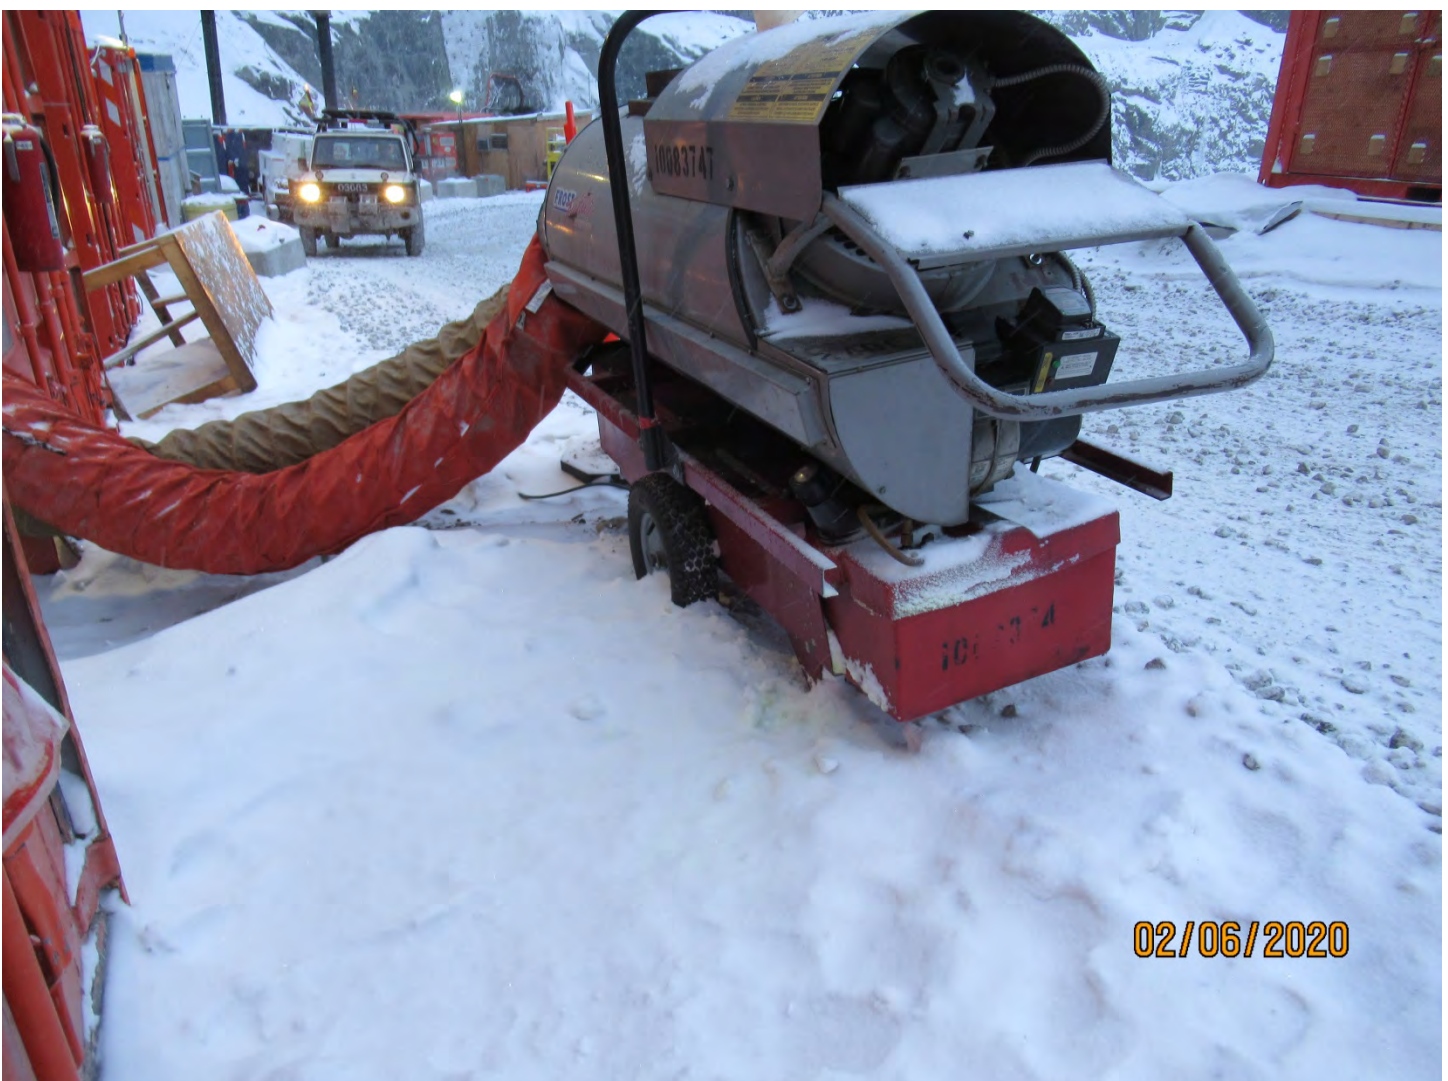
Photo 18: There was not secondary containment under this Frost Fighter and hydrocarbons were present on the ground under the area of the refueling nozzle.

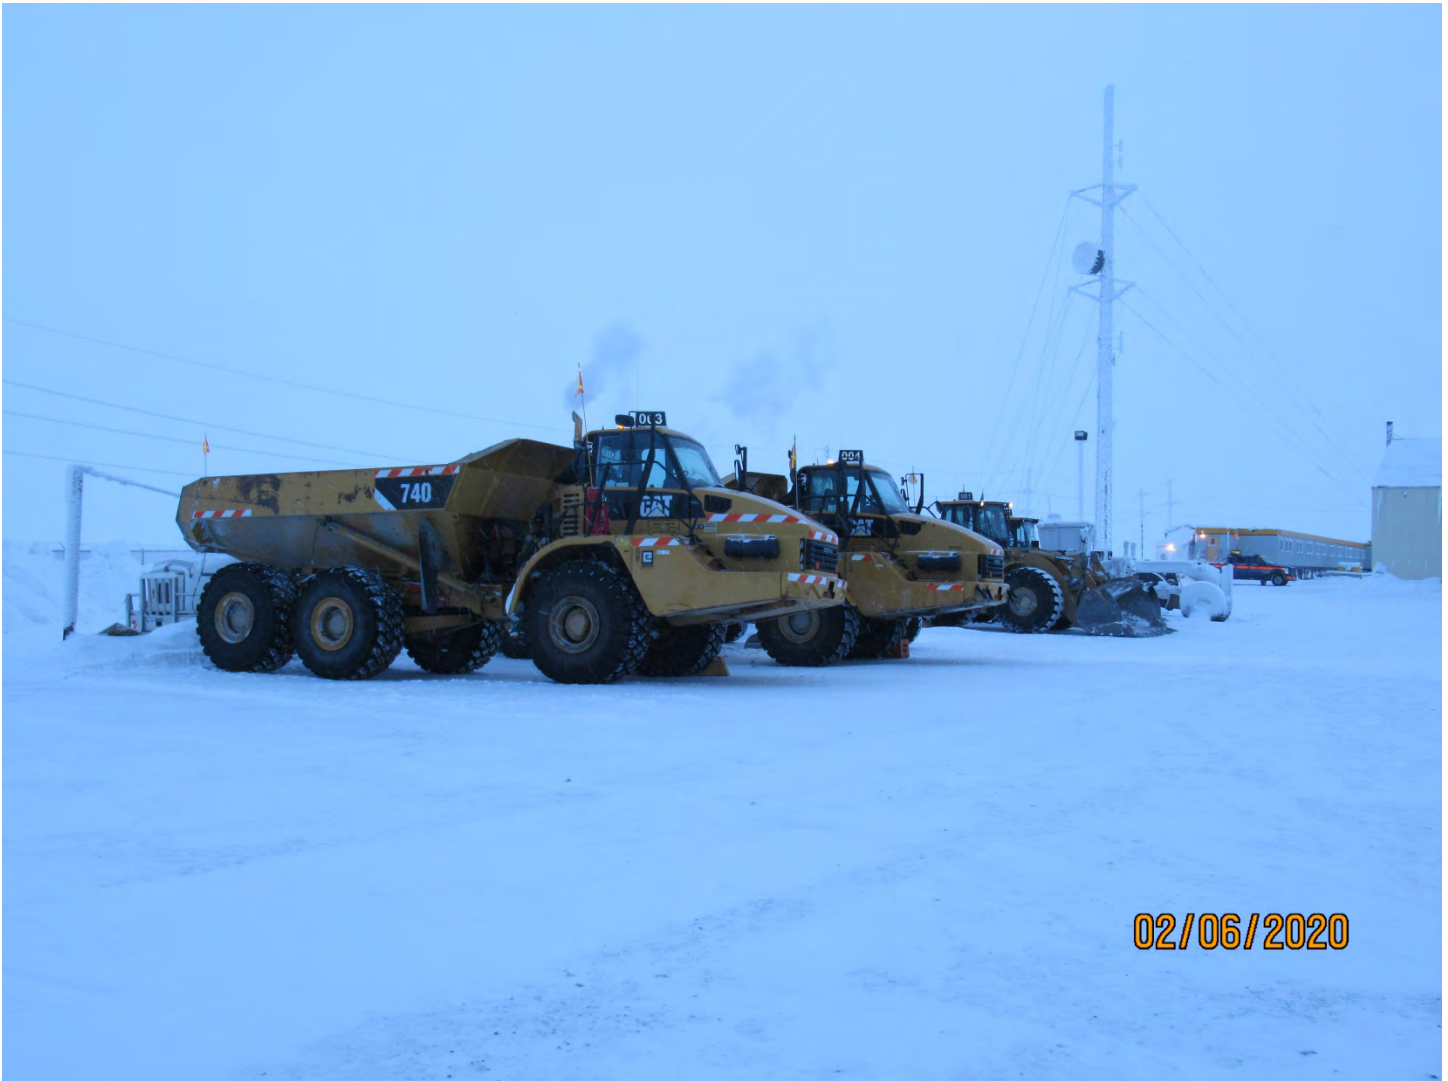
Photo 19: There was no secondary containment in place under this parked equipment on the east of Misery Camp.

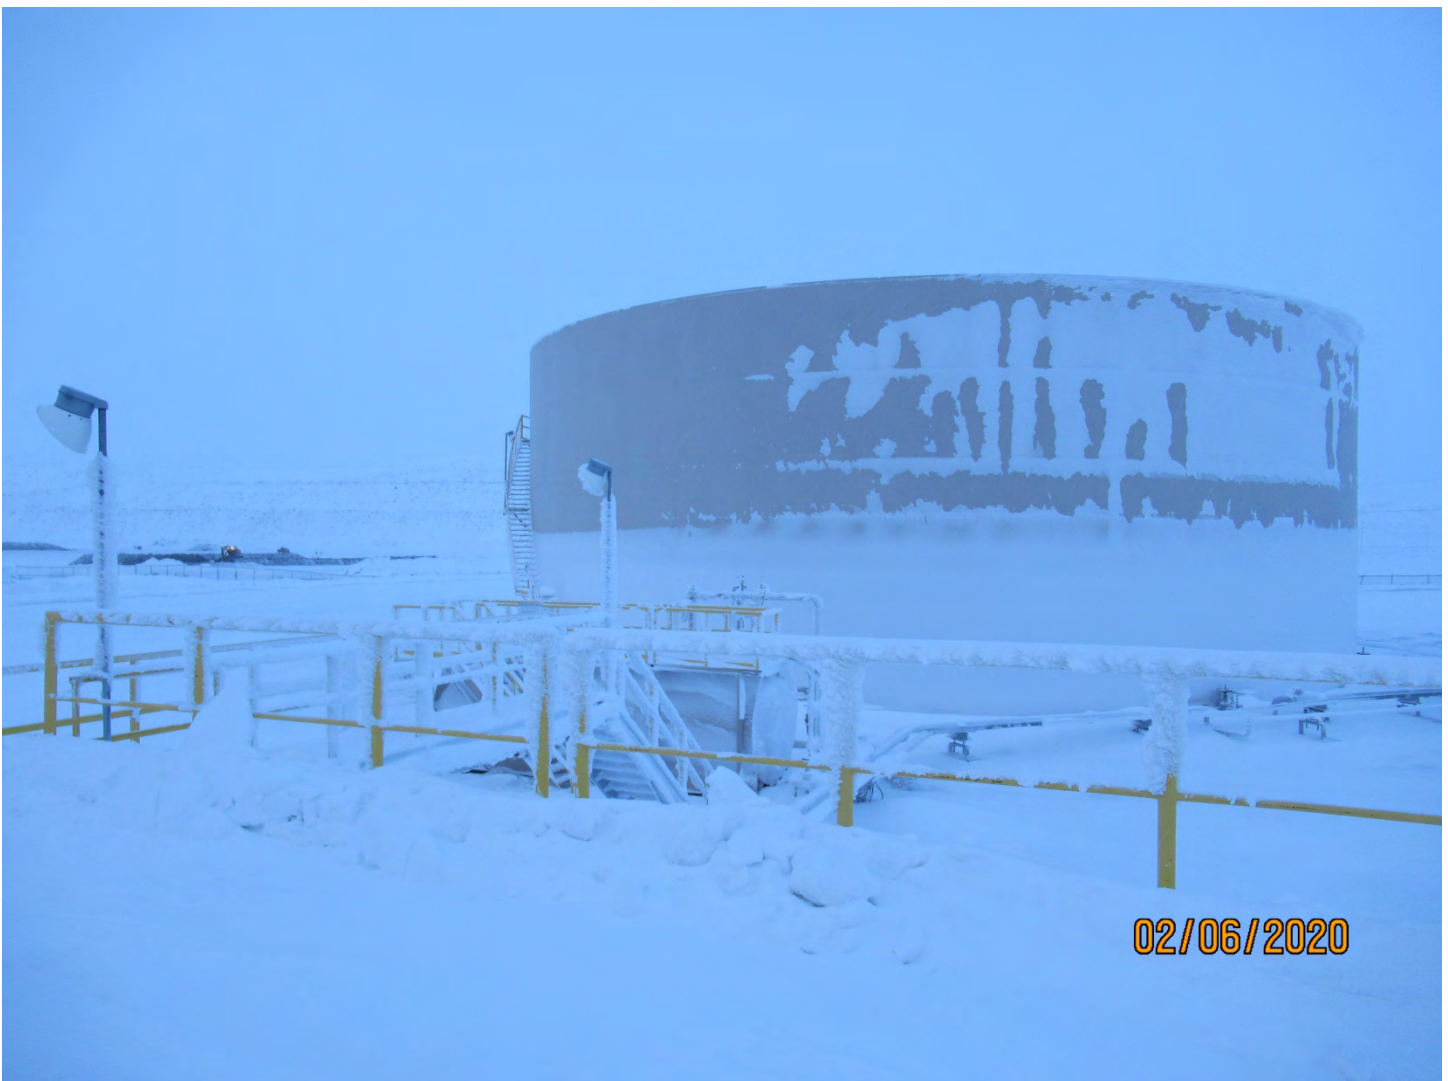
Photo 20: The main fuel storage facility at Misery Camp.

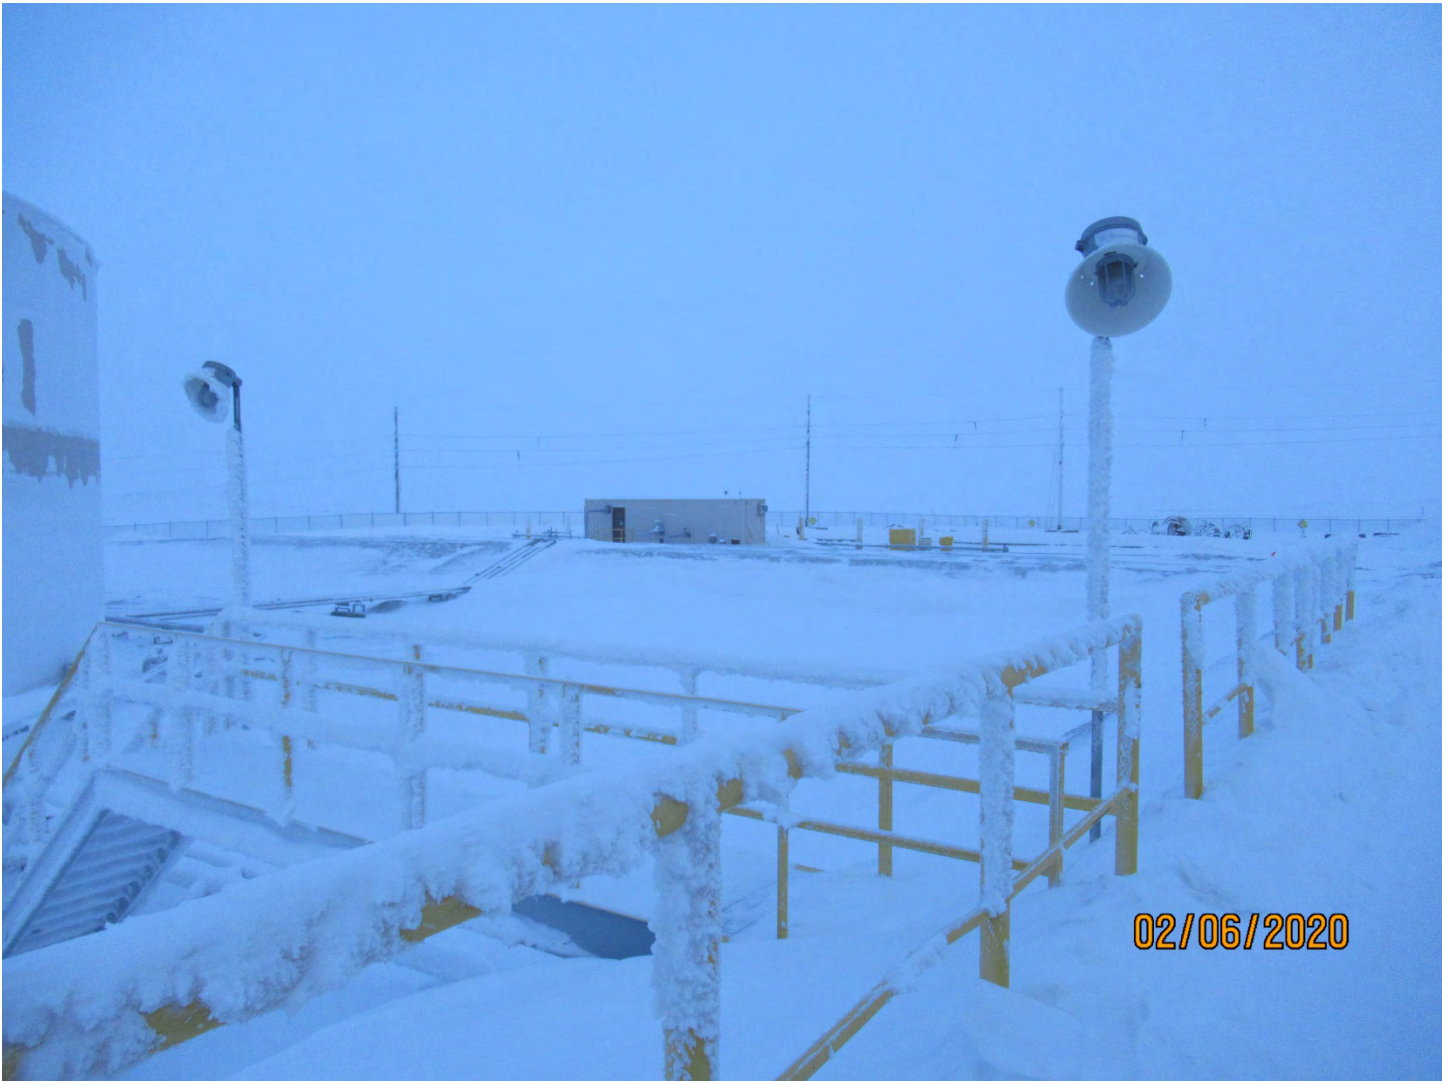
Photo 21: Looking at the bulk fuel offload station on the east of Misery Camp.

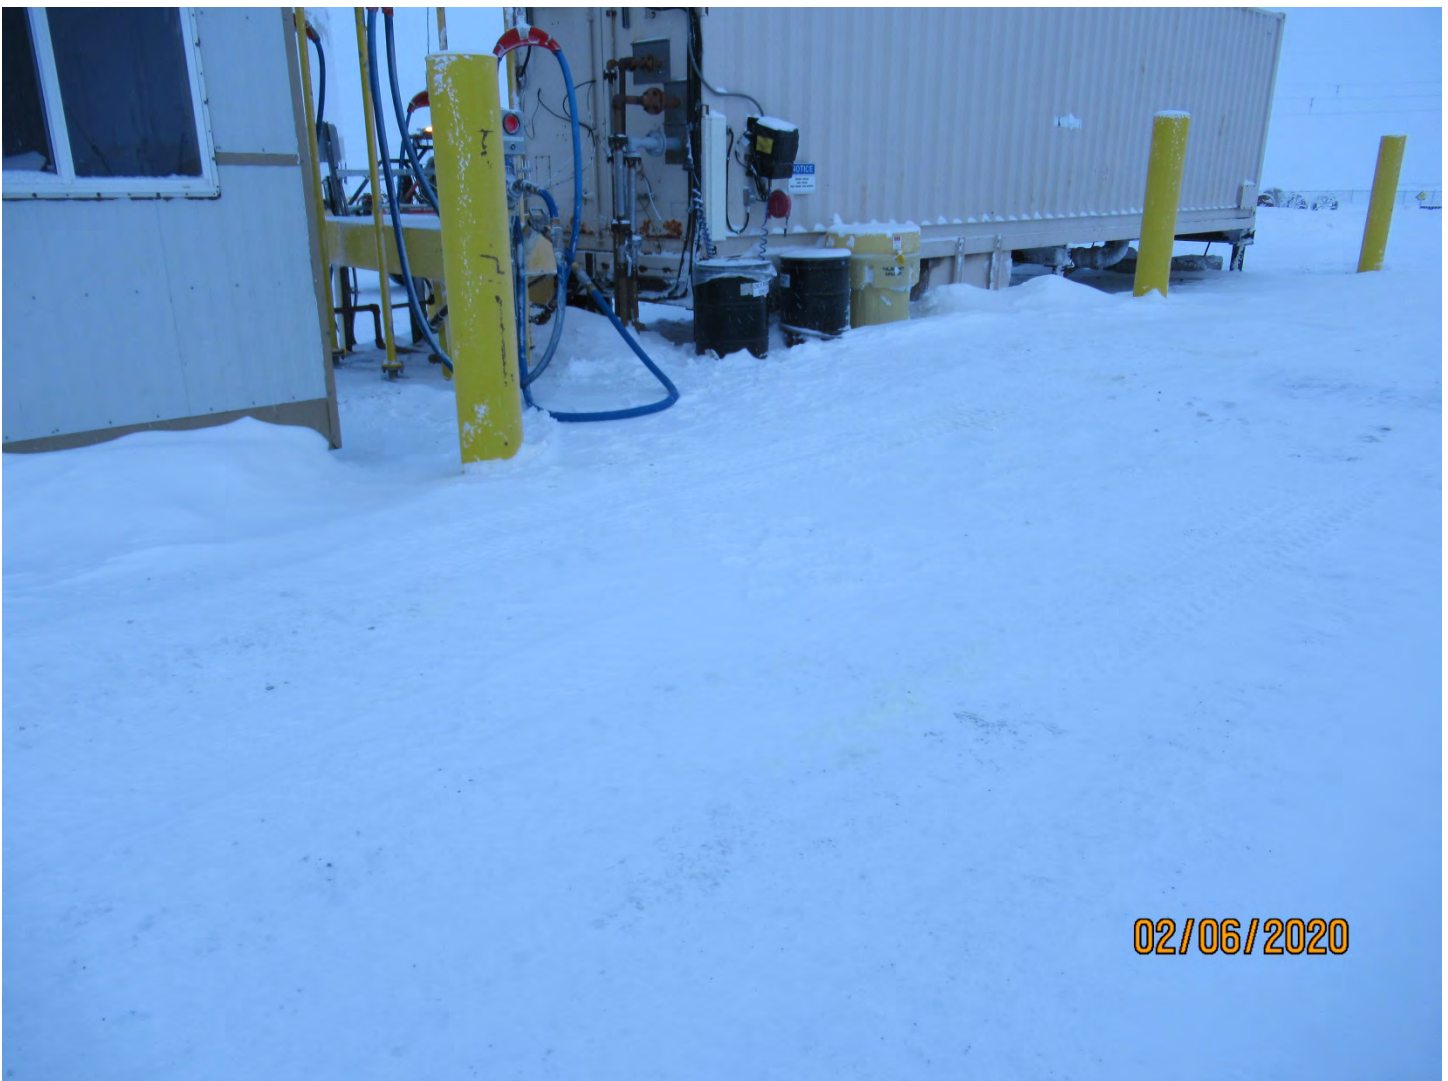
Photo 22: Though hard to see in this photo, there were hydrocarbons on the ground at the Misery Camp fuel transfer station. All spilled hydrocarbons must be cleaned up and properly disposed in a timely manner.

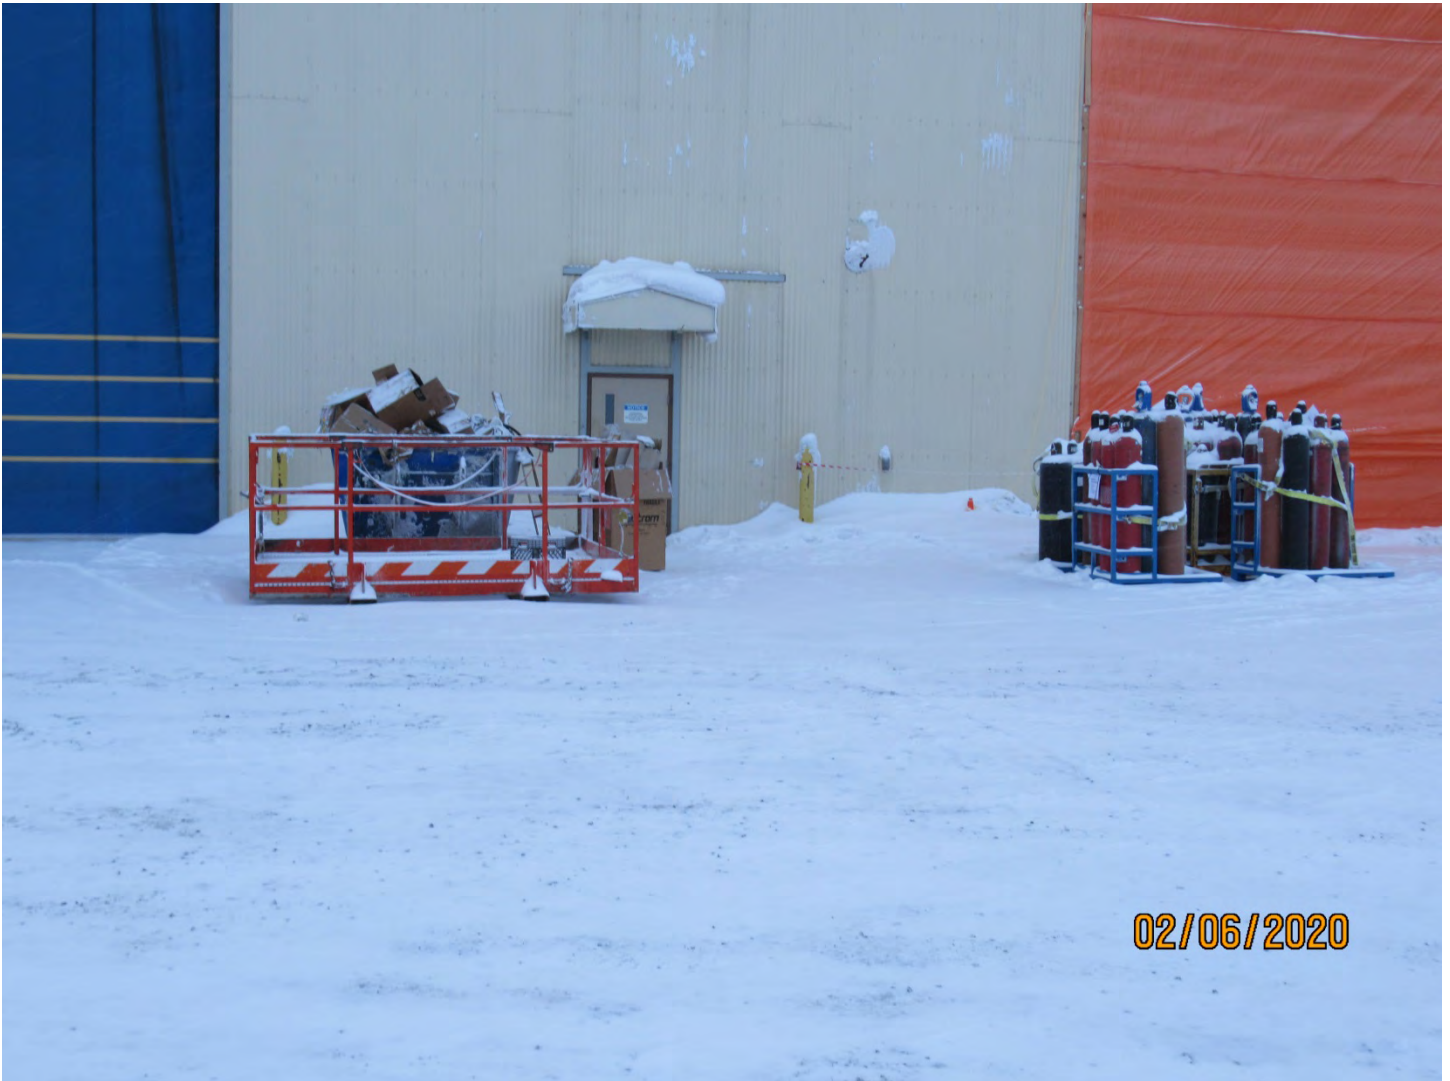
<p>Explanatory Remarks</p> <p>Misery Camp</p> <p>It seemed sewage and waste management activities at Misery Camp were acceptable with a minor concern noted. It appeared a bin on the east of the camp truckshops was overfilled with burnable waste (Photo #23). Waste must be removed and disposed of in a timely manner on an ongoing basis as per the approved Ekati Mine <i>Waste Management Plan</i> (Condition #23). It appeared the lines of the sewage, water and fire suppression tanks were intact and no spills were noted on the ground (Photo #24).</p> <p>Conclusion</p> <p>Overall, the Inspector is appreciative of the Permittees efforts to ensure adherence to the operating conditions annexed to Land Use Permit W2017D0004. However, as mentioned in the December 10th, 2019 Inspection Report, it is the expectation of the Inspector that secondary containment is properly utilized during fuel transfers and containment is placed under parked equipment as per Conditions #32 & #37 of the permit. A proper waste management station must be put in place at the underground 2150 Level and waste throughout the project must continue to be properly managed and disposed of on an ongoing basis as per the approved Ekati Mine <i>Waste Management Plan</i> (Condition #23).</p>

Photo 23: Waste at the truckshop on the east of camp required disposal.

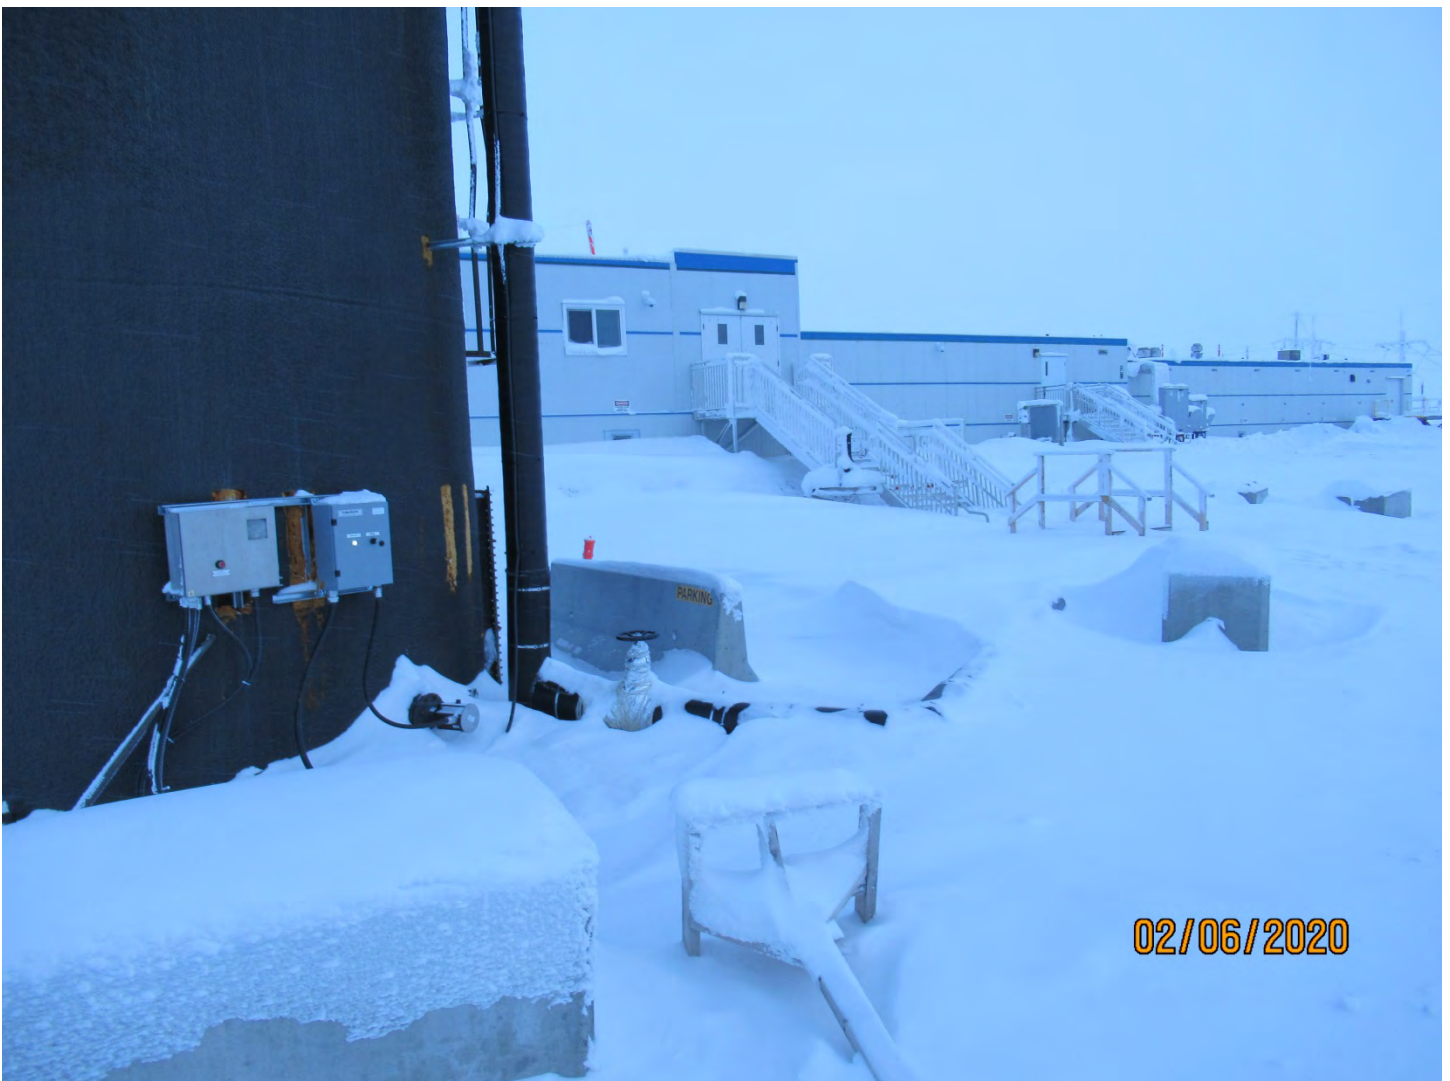
Photo 24: Sewage lines at the camp septic tank appeared intact and no spills were noted by the Inspector.
