**Re: Land Use Permit W2017D0004
Mining & Associated Activities
Ekati Diamond Mine, Northwest Territories**

ENVIRONMENTAL INSPECTION REPORT

Permittee:	Dominion Diamond Ekati – Misery Underground	Inspection Dates: January 22 nd , 2019
------------	---	---

Location(s) Inspected:	The Ekati Mine Misery Underground Project and Misery Camp expansion. The inspection also included laydown areas and the 440 Bench underground infrastructure.
------------------------	---

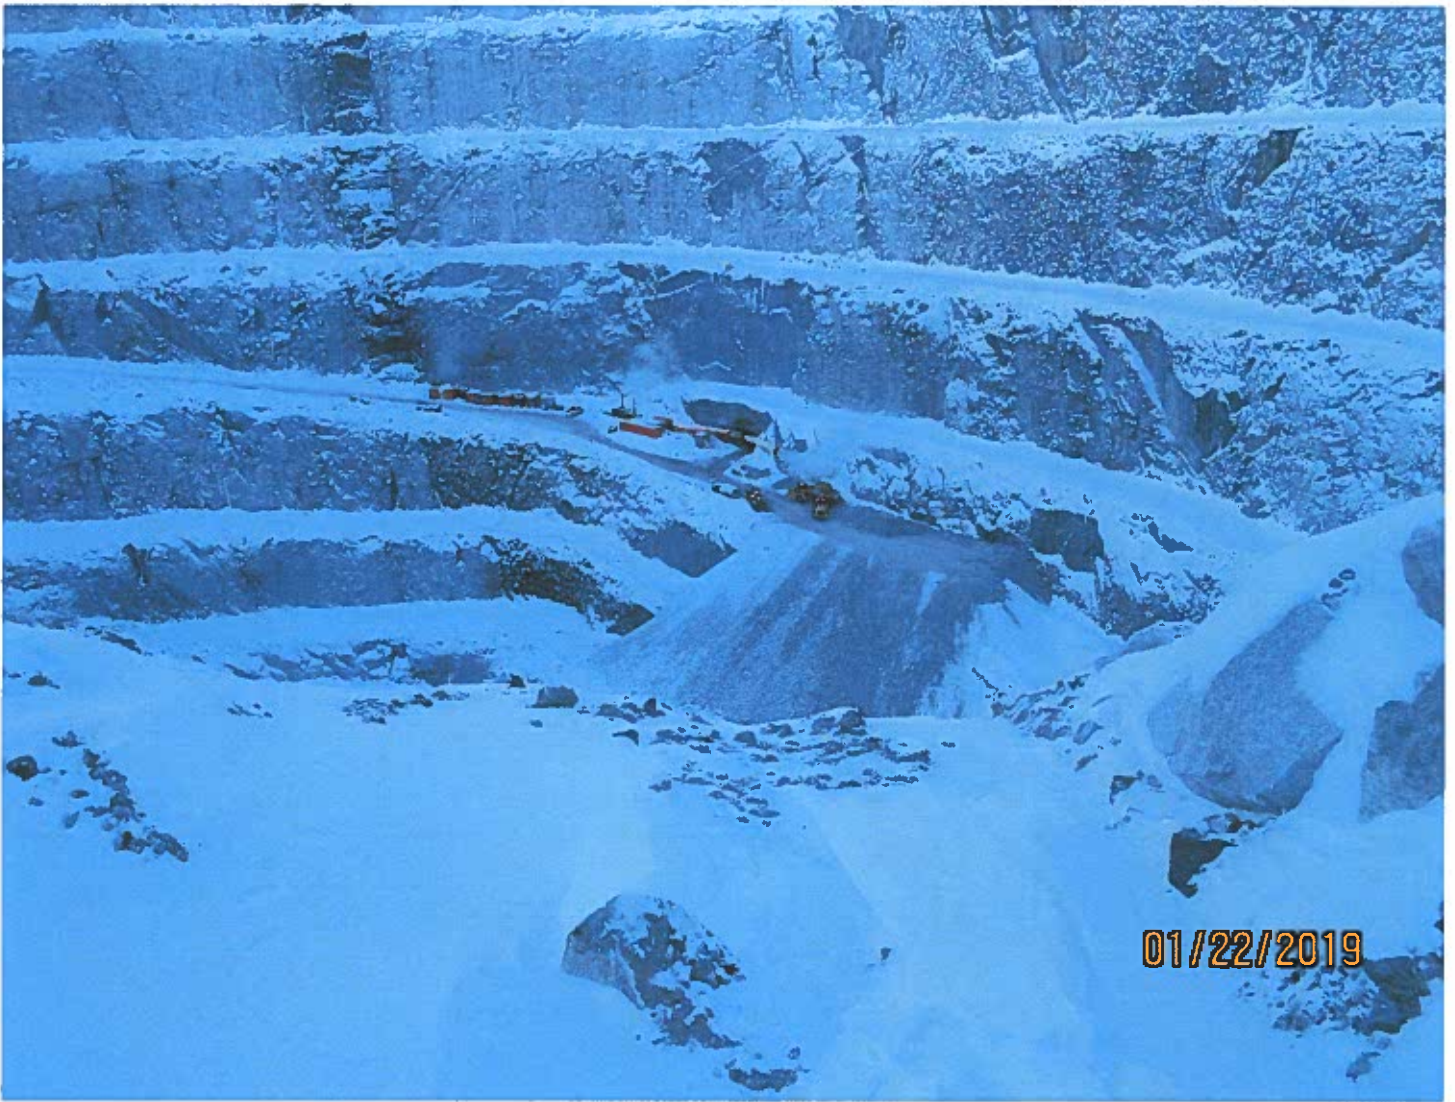
Photo #1 - W2017D0004
Temporary underground infrastructure staged on the ramp adjacent to the 2235 Portal. The rock dump area can be seen on the right.

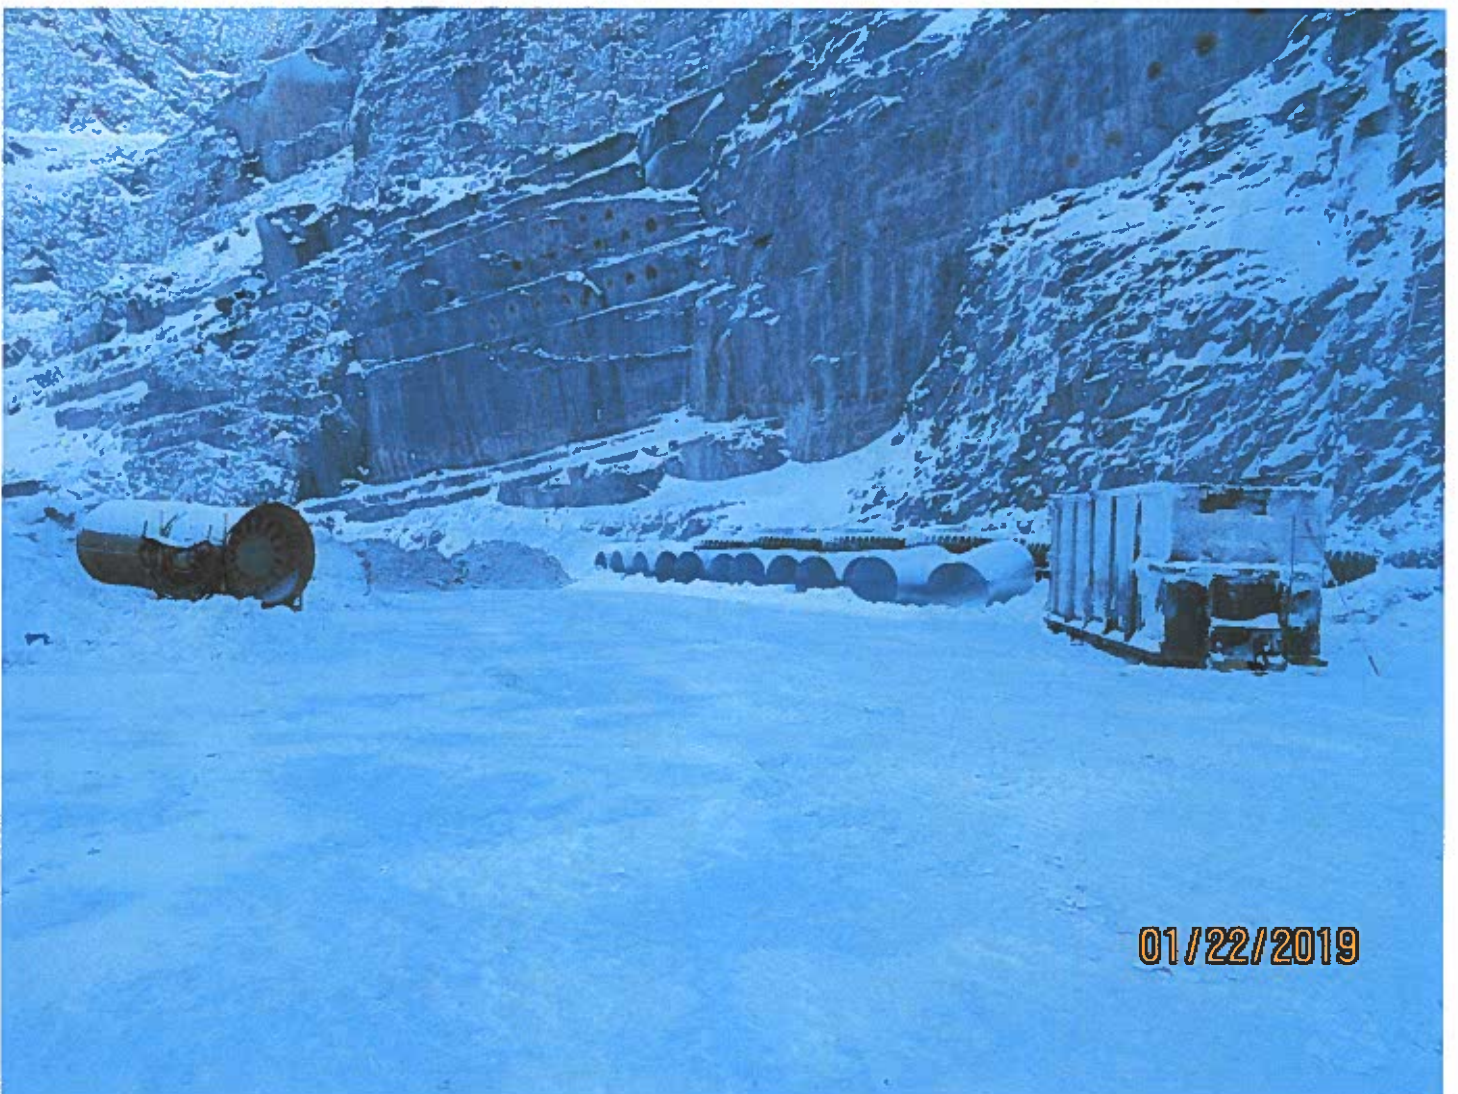
Photo #2 - W2017D0004
Materials including a waste bin and fresh air tubing for the underground staged at the switchback laydown.

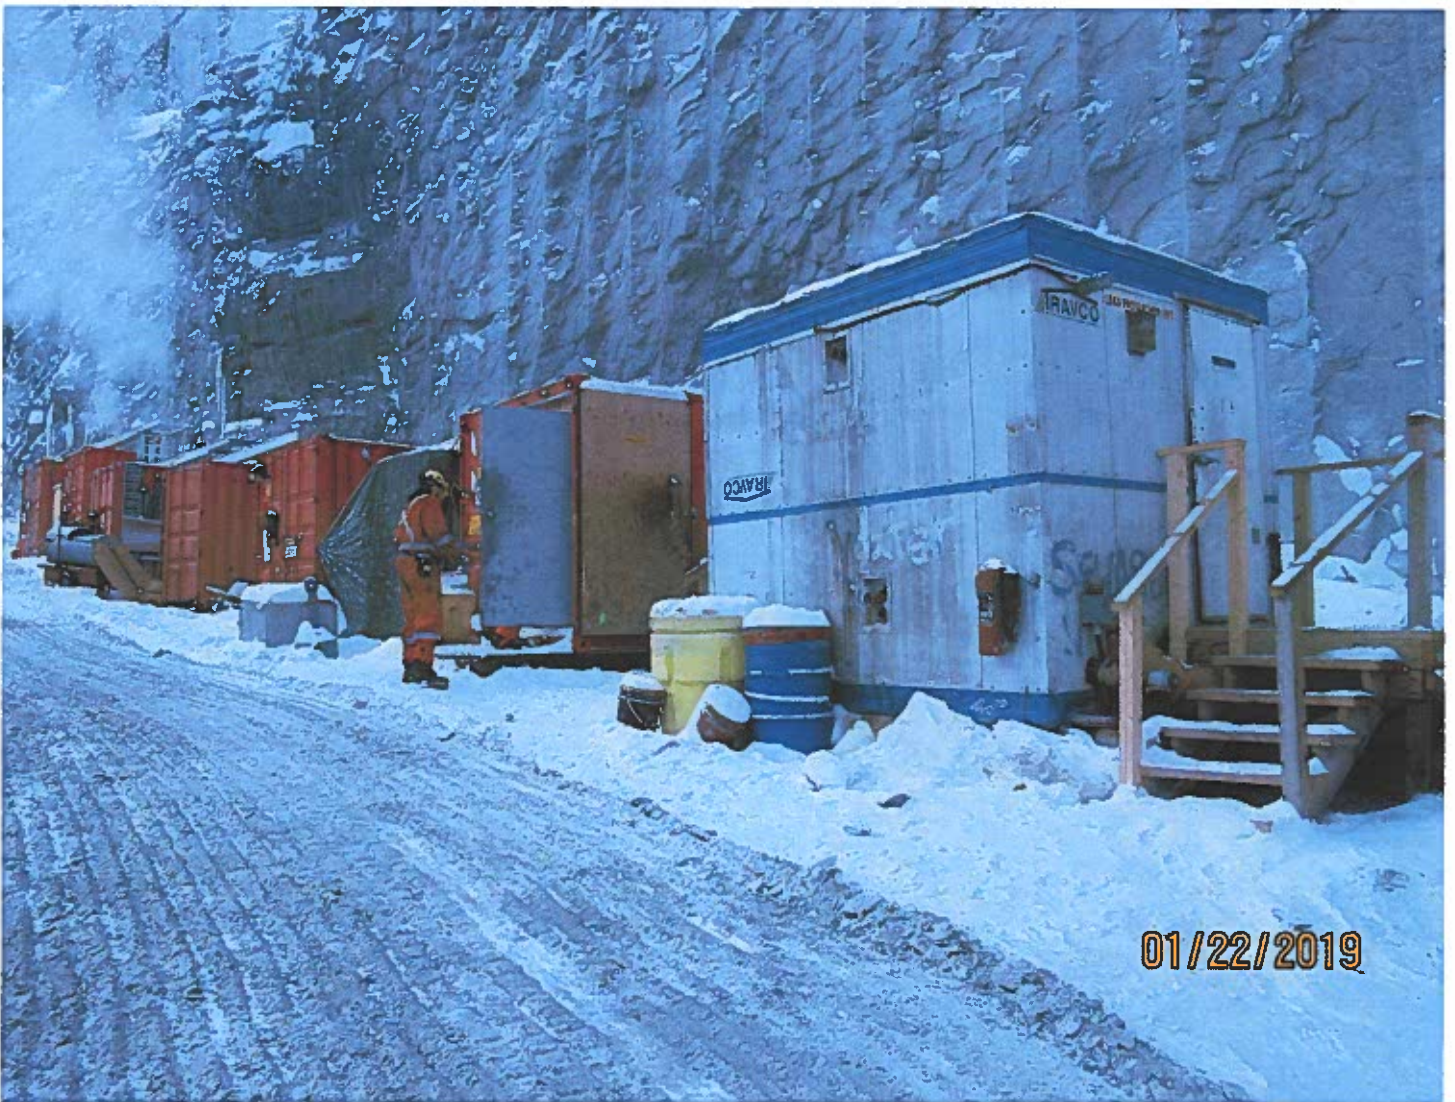
Photo #3 - W2017D0004
Another look at some of the infrastructure staged on the ramp adjacent to the 2235 Portal.

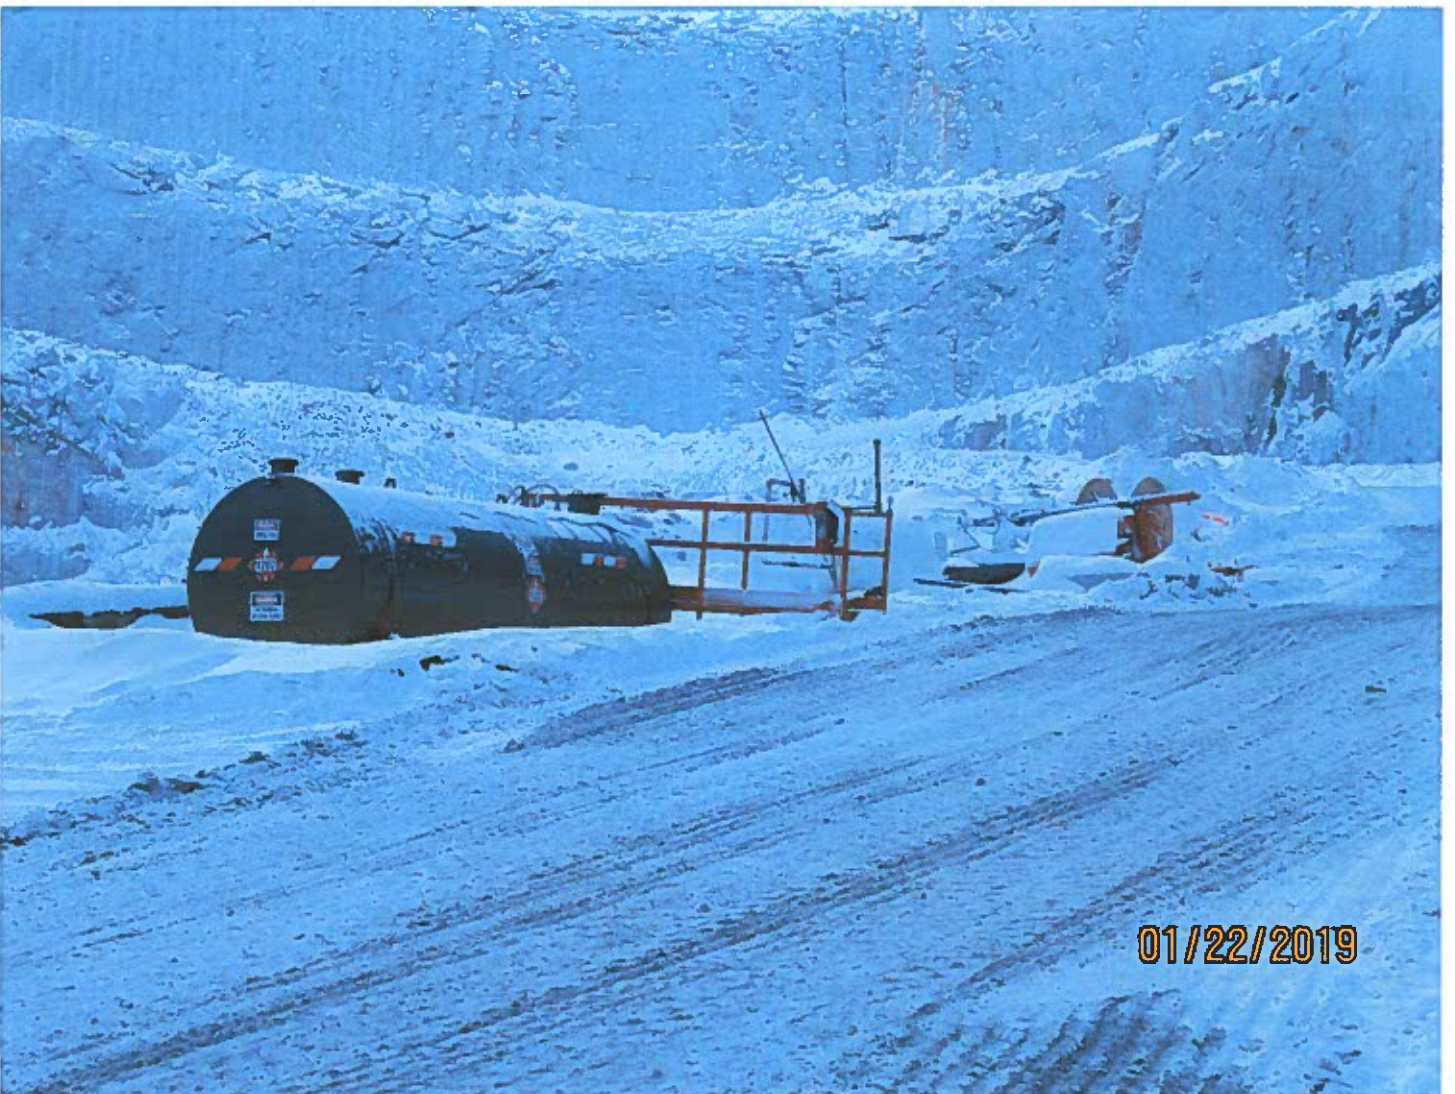
Photo #4 - W2017D0004
Additional equipment and supplies staged on the ramp.

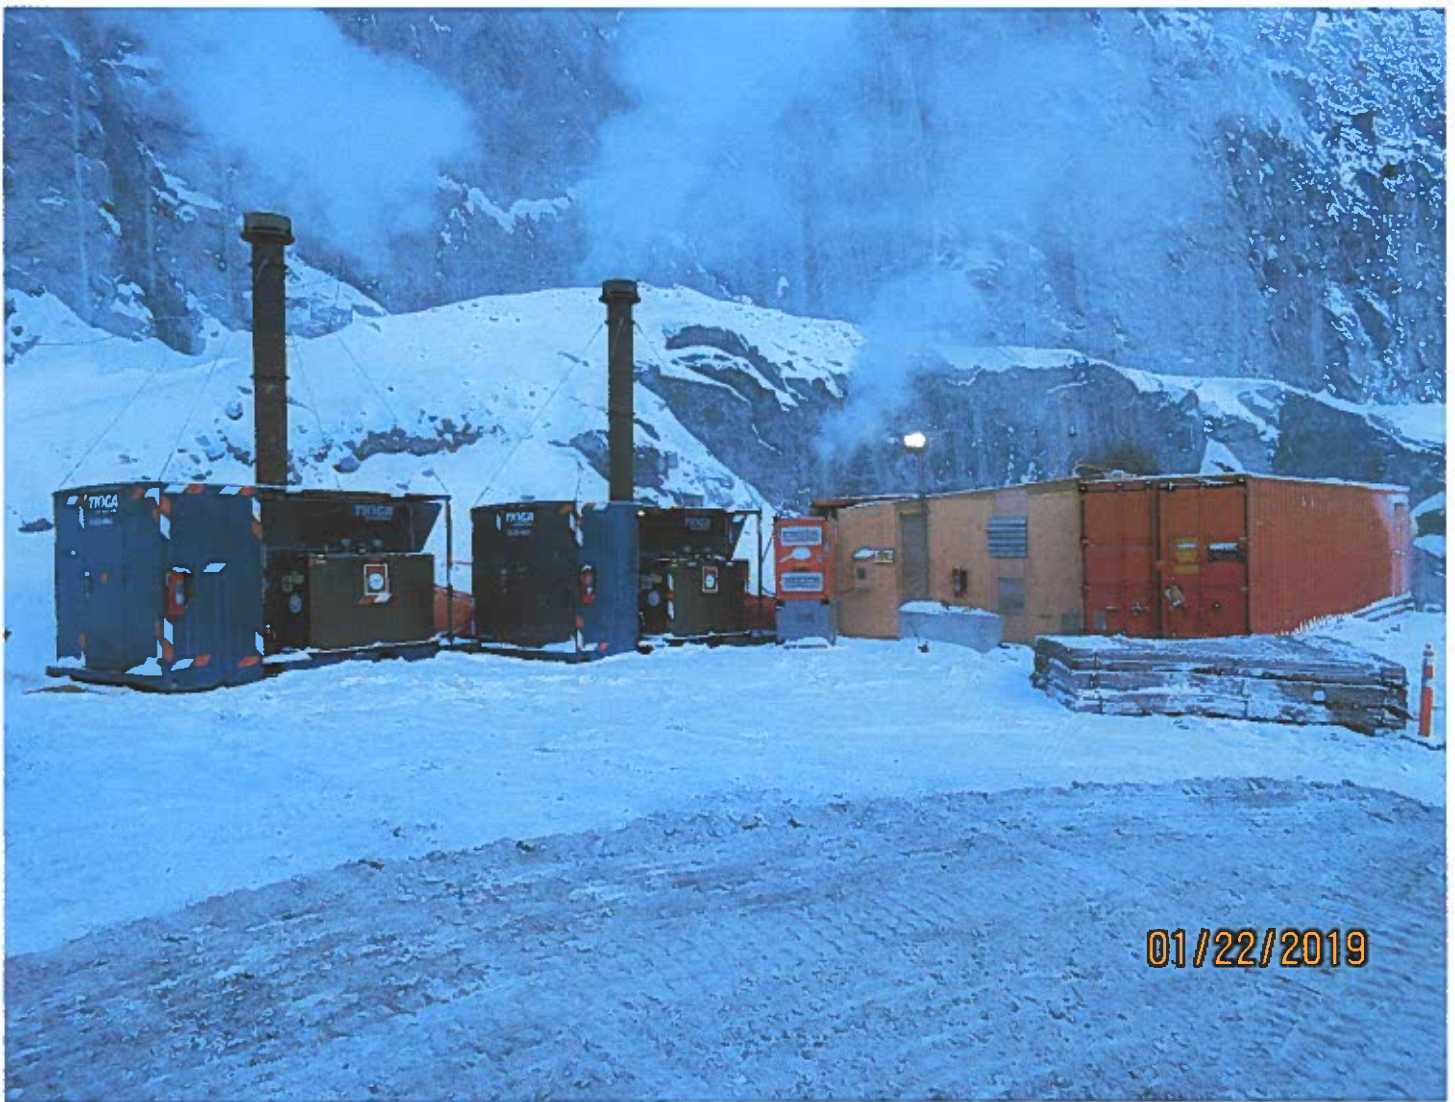
The underground infrastructure is continually being established as development progresses and at this stage, air is being pumped to the underground from heaters & fans staged on the ramp adjacent to the 2235 Portal (Photo #5). It appears an additional air heater (Photo #6) and an exhaust line from the underground are in place. As seen in Photo #7, the soft vent lines to the underground are being replaced with hardline. Water removed from the mine will be pumped up through the dewatering line in Photo #8 and deposited into King Pond.

Photo #5 - W2017D0004
The underground air heaters and fan system.

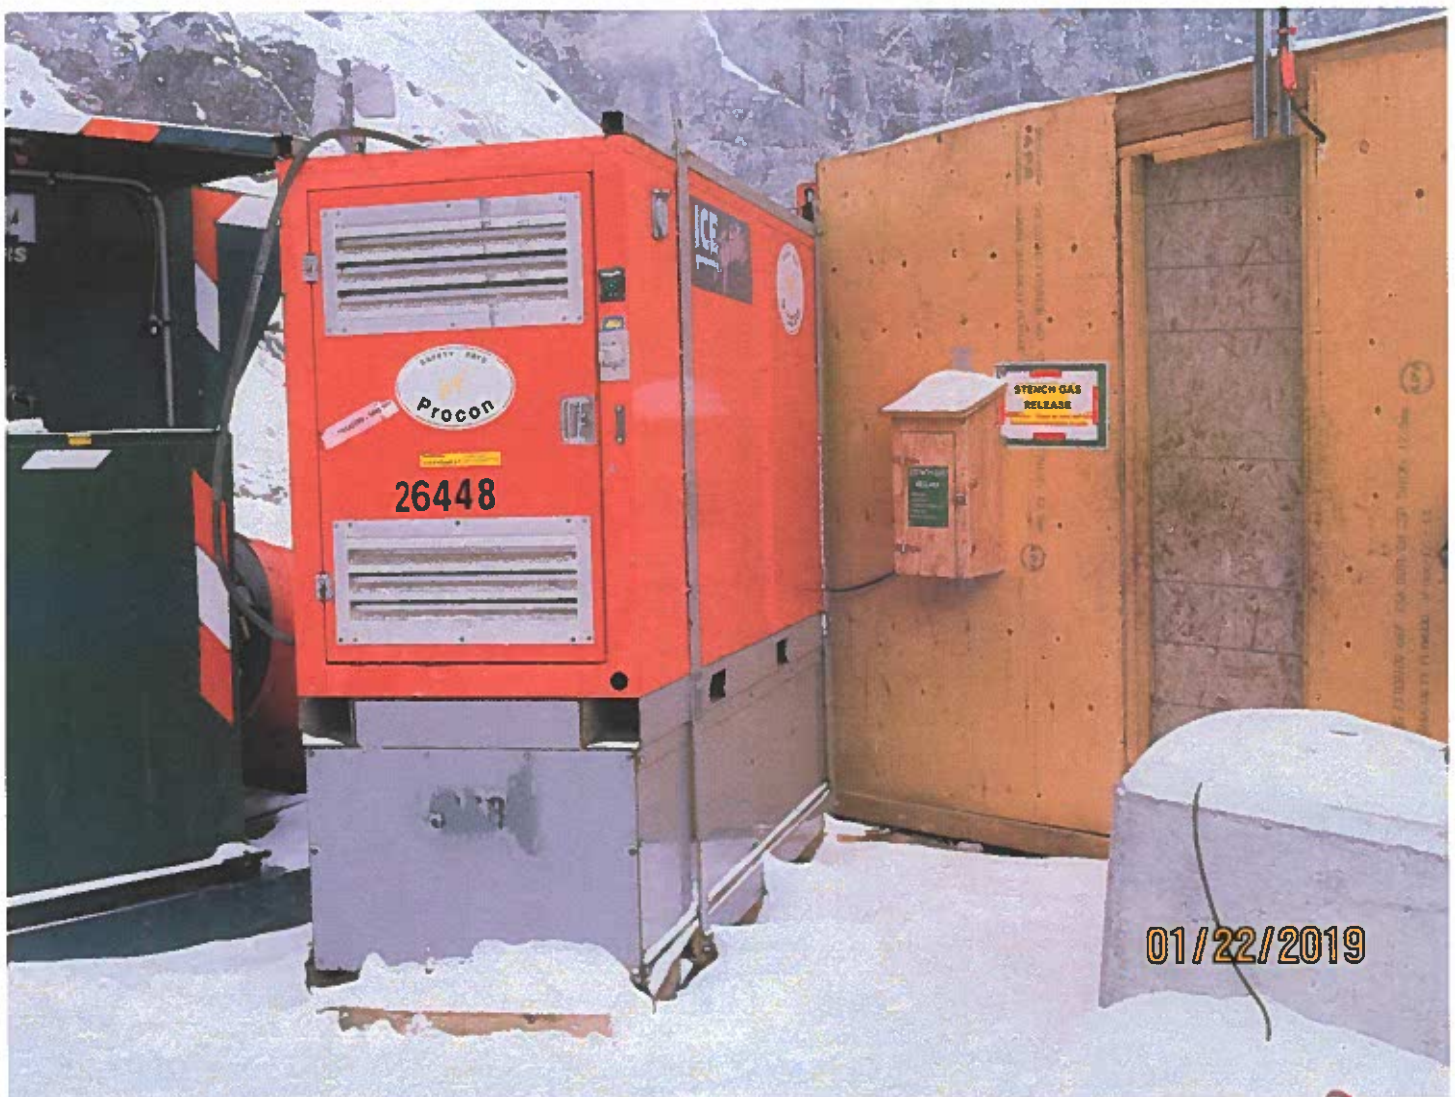
Photo #6 - W2017D0004
The added air heater (orange box) and stench gas box can be seen in this photo.

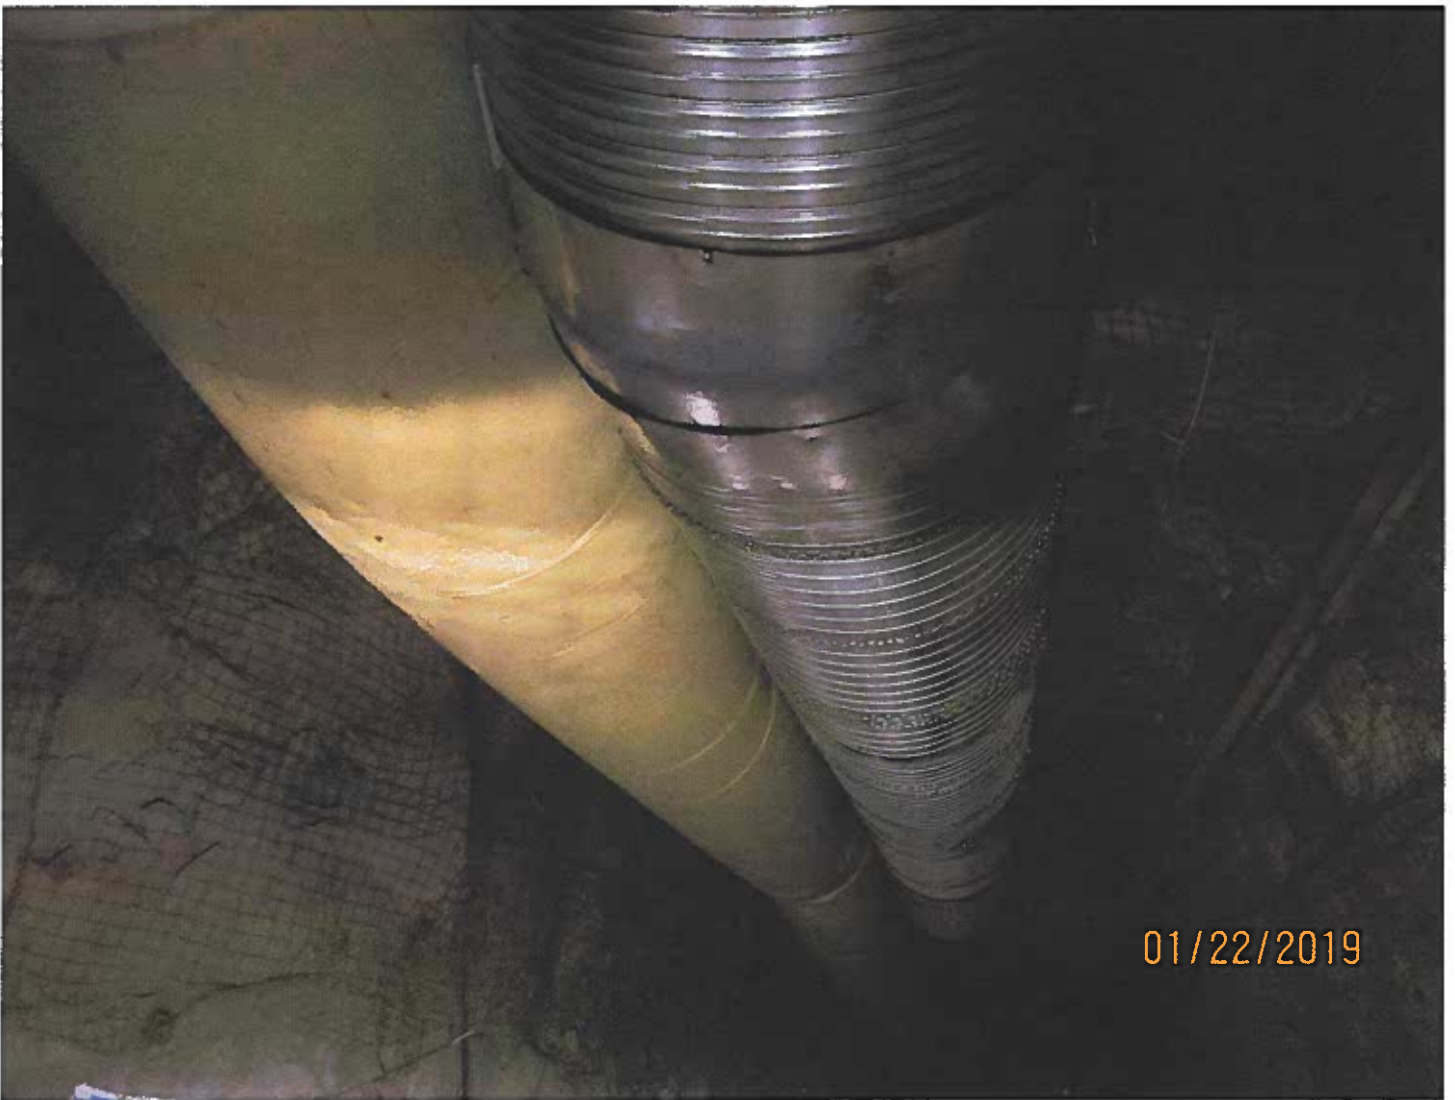
Photo #7 - W2017D0004
Air tubing within the underground is being replaced with hardline.

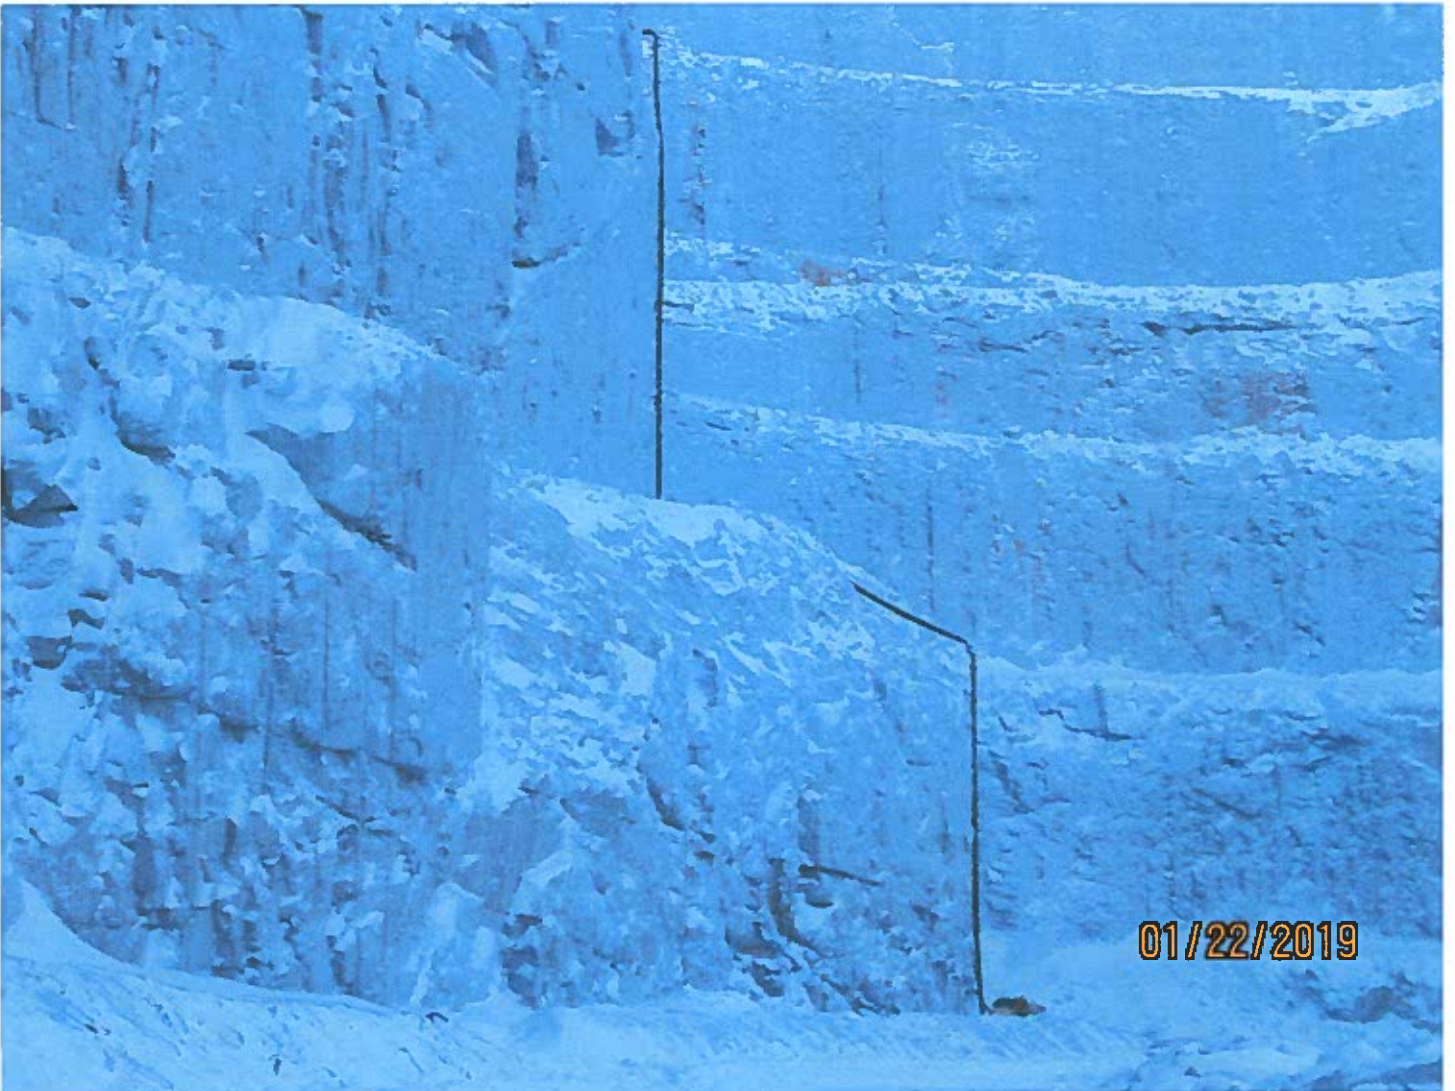
Photo #8 - W2017D0004
A dewatering line has been installed and water passed through will eventually end up in King Pond.

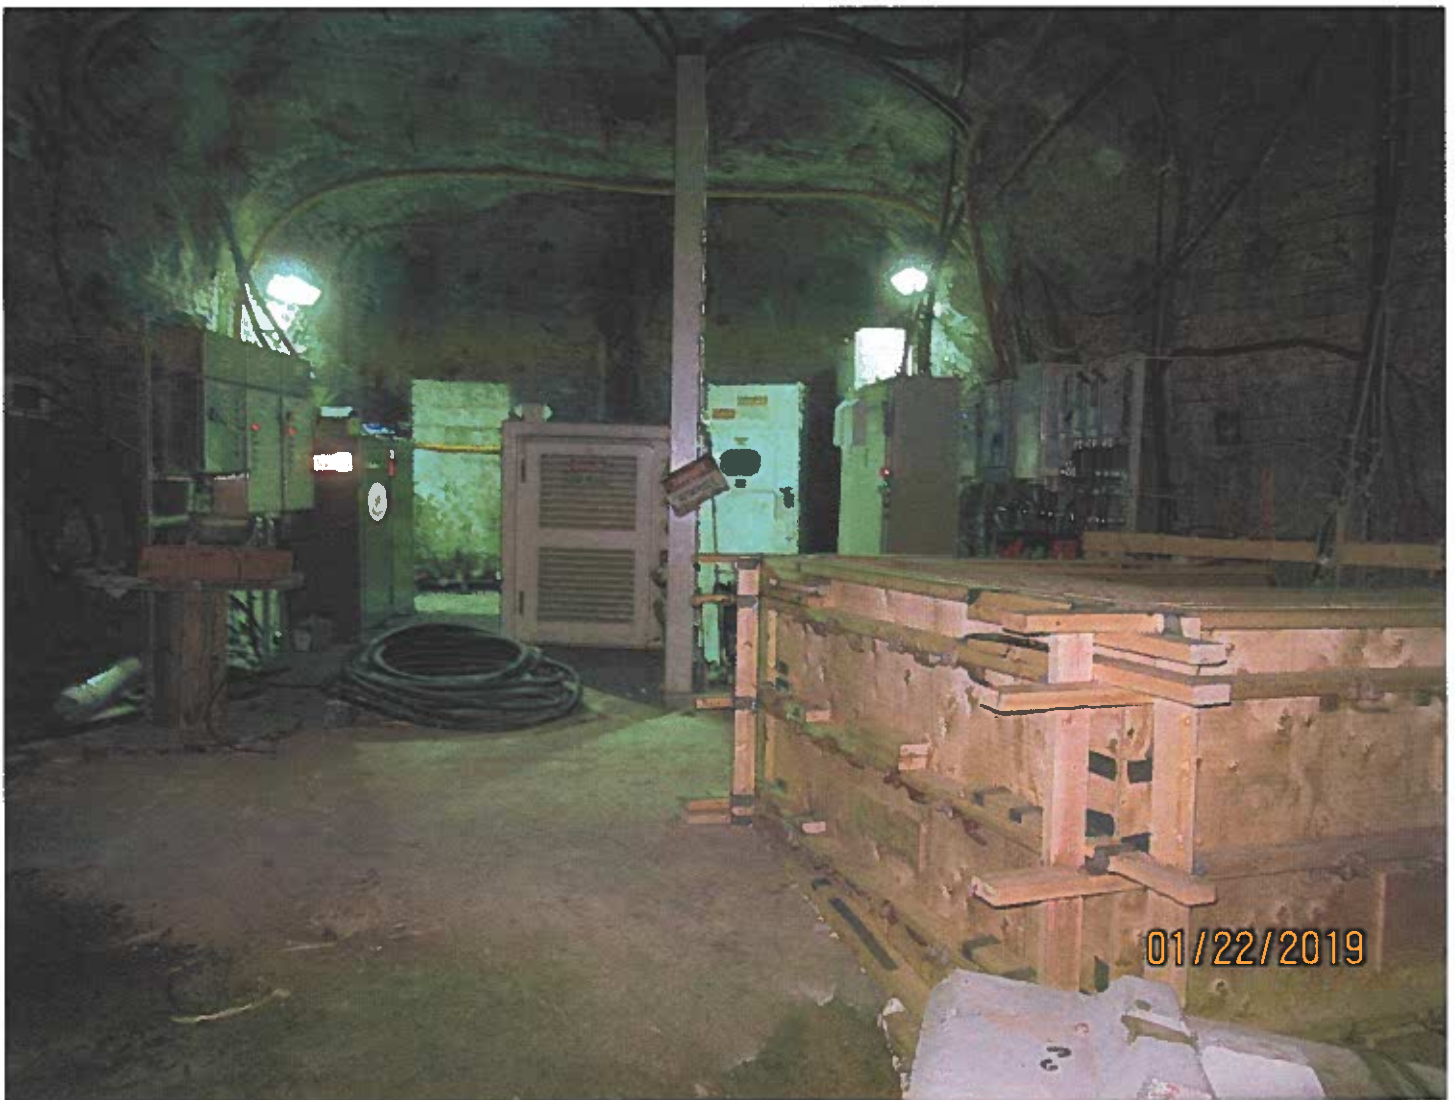
Electrical components and sub-stations were installed at key locations or were being installed to assist in powering the underground (Photos #9 & #10). As seen in Photo #11, protective tubing for electrical lines is being installed and allows for electrical lines to be routed between the working levels within the underground. Once the electrical lines are fed through the tubing and installed, a concrete barrier is being constructed to protect the electrical lines from potential vehicle & equipment impacts.

Photo #9 - W2017D0004
Electrical sub-stations are being established in key locations in the underground.

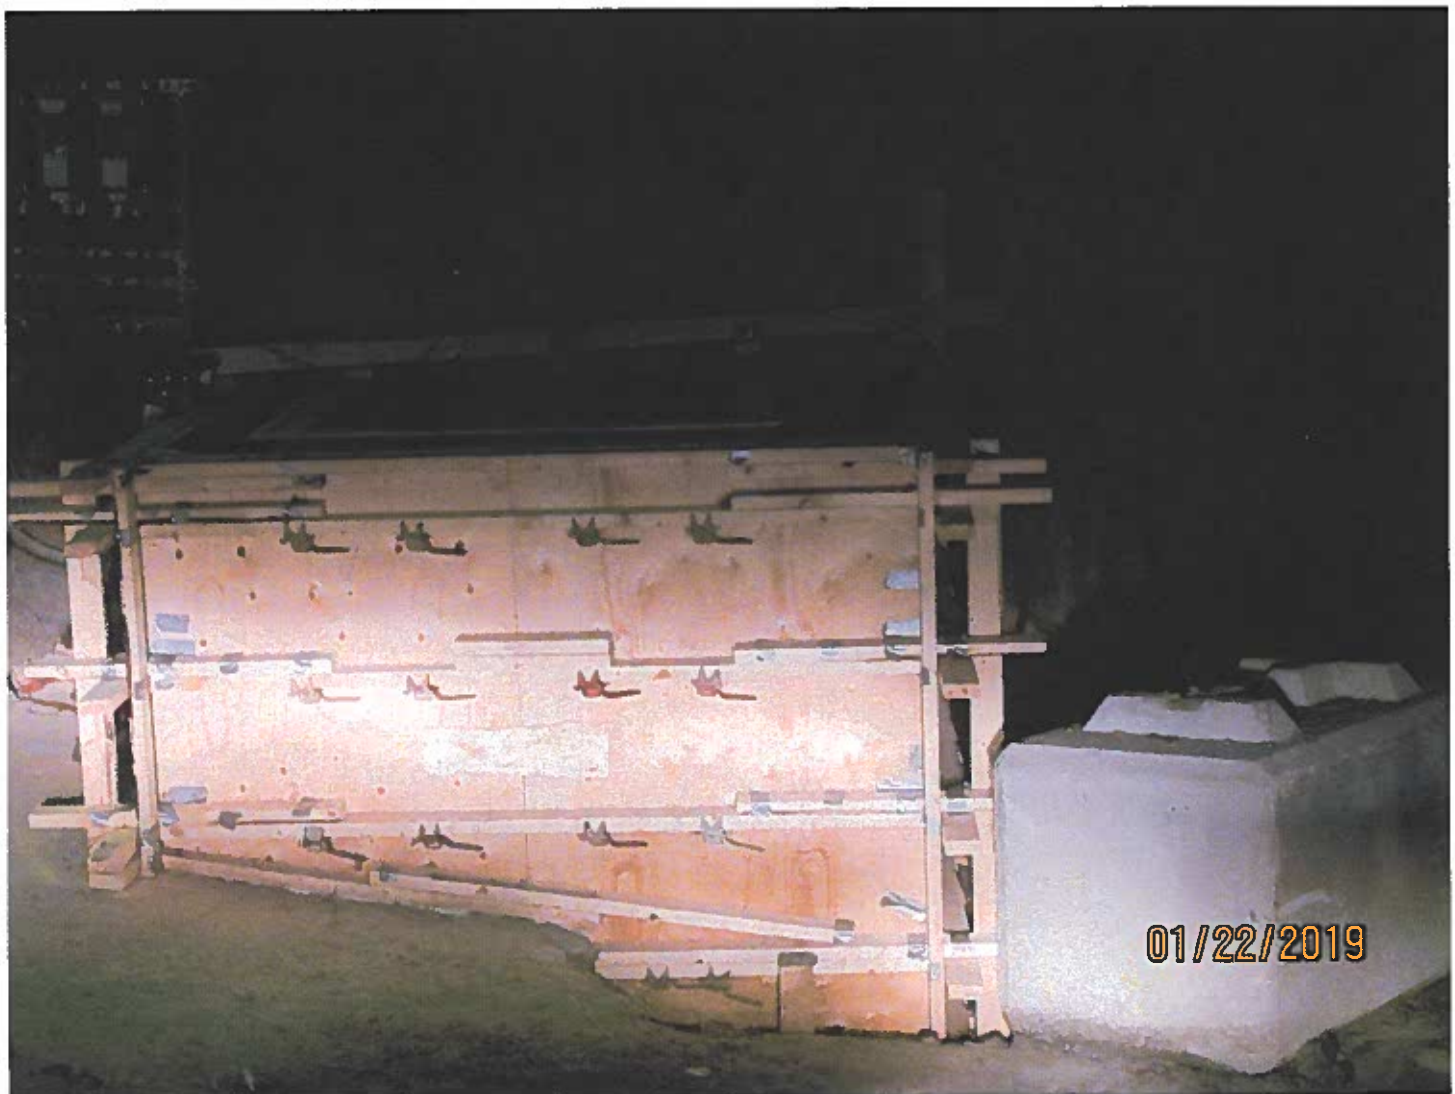
Photo #10 - W2017D0004
Concrete barriers are being put in place to protect electrical lines.

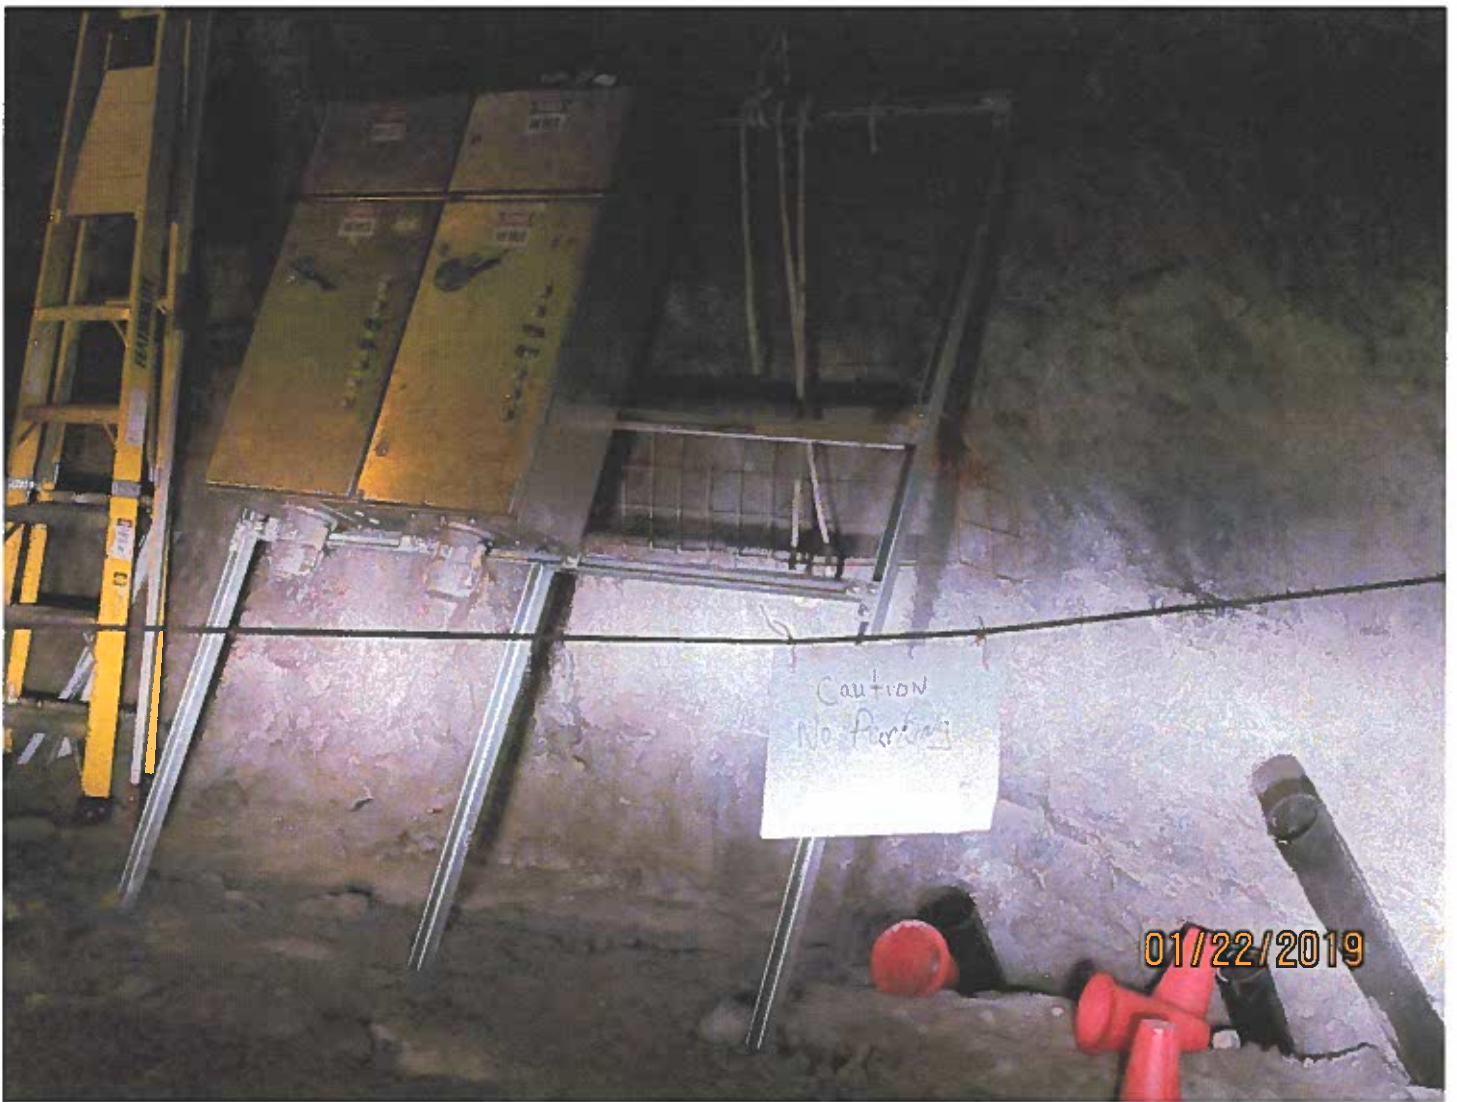
Photo #11 - W2017D0004
Electrical lines between the underground levels will be passed through protective tubing.

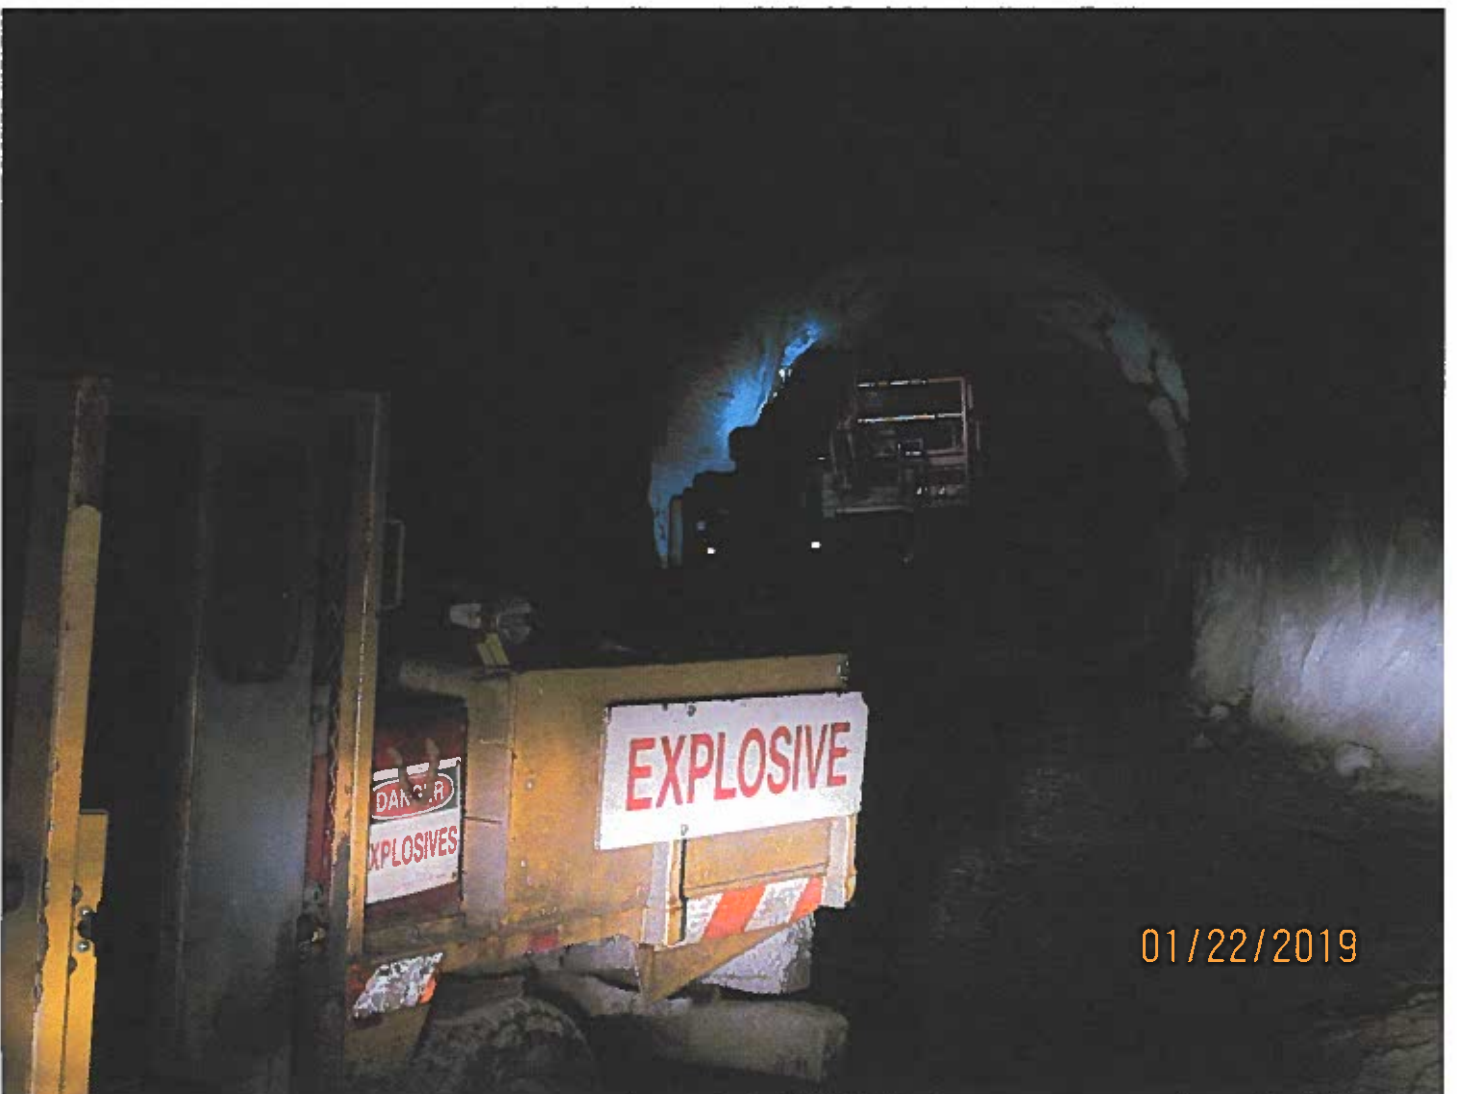
As drifts are being established in the underground, crews are installing screen to ensure the tunnel walls are being stabilized in working areas (Photo #12). The hanging of the screen is completed in stages with split-sets (~1 metre lengths) being installed to temporarily hold the screen in place prior to the rebar installation. A plate driver (aka a 'kabonker') is used to drive the rebar in to the rock to depths of approximately 2.3 metres and allows for the screen to be held in place on a permanent basis. If required, shotcrete is then used to further secure the tunnel walls and allow for increased structural integrity and more importantly, personnel safety.

Photo #12 - W2017D0004
Though hard to see, crews were hanging screen to stabilize the drifts with the use of equipment known as a telehandler.

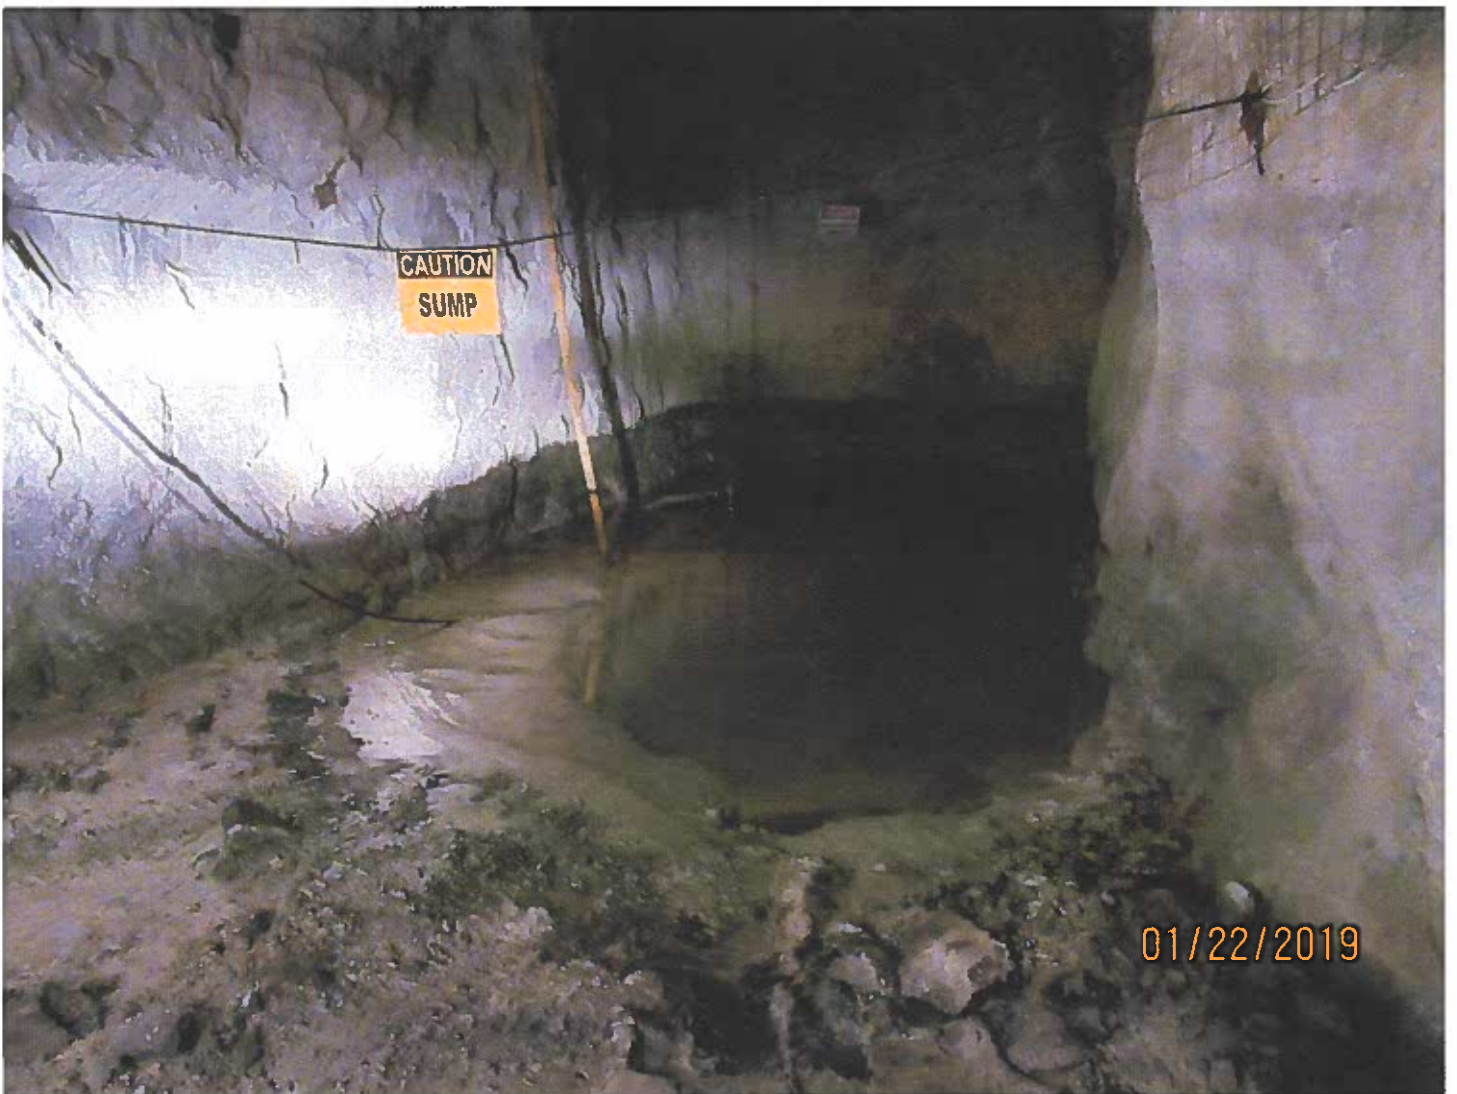
Photo #14 - W2017D0004

One of the sumps being established underground as the project progresses.
