**Re: Land Use Permit W2017D0004
Mining & Associated Activities
Ekati Diamond Mine, Northwest Territories**

ENVIRONMENTAL INSPECTION REPORT

Permittee:	Dominion Diamond Ekati – Misery Underground	Inspection Dates: January 22 nd , 2019
------------	---	---

Location(s) Inspected:	The Ekati Mine Misery Underground Project and Misery Camp expansion. The inspection also included laydown areas and the 440 Bench underground infrastructure.
------------------------	---

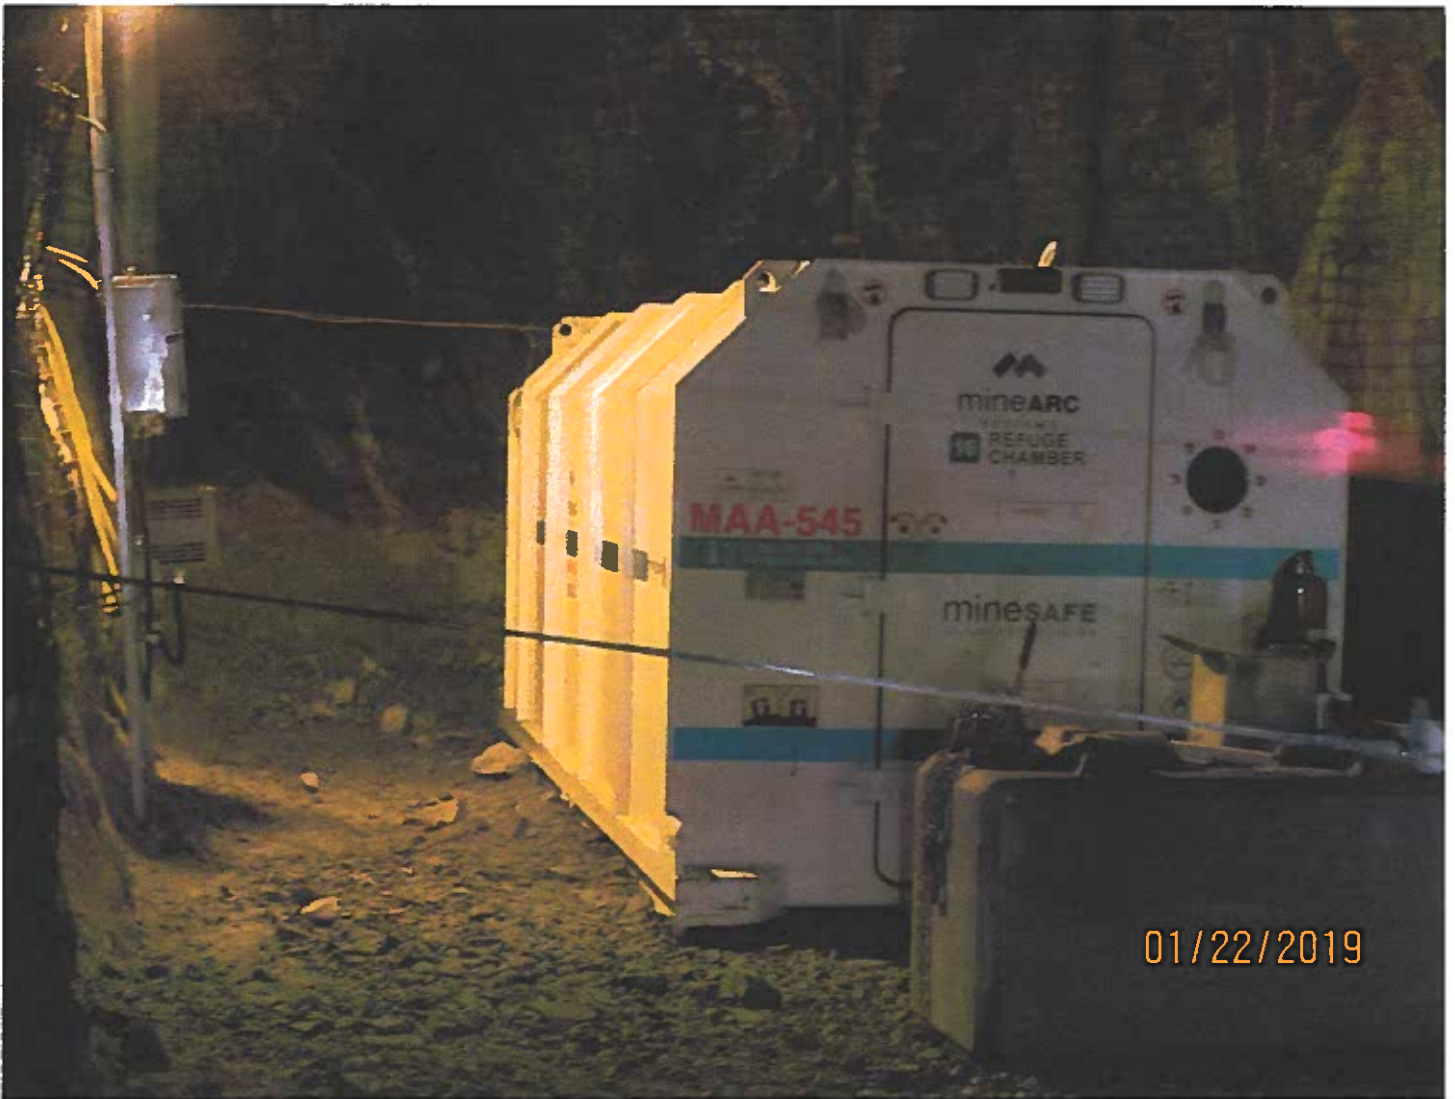
There are two (2) portable MineArc refuge chambers in place: One (1) refuge chamber is in place near the 2235 Portal ramp at the 1st Remuck and a second refuge is in place at the 2nd Remuck area on the decline portion of the development (Photo #15). Once the underground development progresses, the MineArc refuge chamber located at the 1st Remuck will be repositioned on the incline to the 2340 Portal. The MineArc refuge stations are essential pieces of equipment that allow for the personal safety of personnel working in underground mining operations.

Photo #15 - W2017D0004
This MineArc refuge station is in place on the decline from the 2235 Portal in the area of the 2nd Remuck.

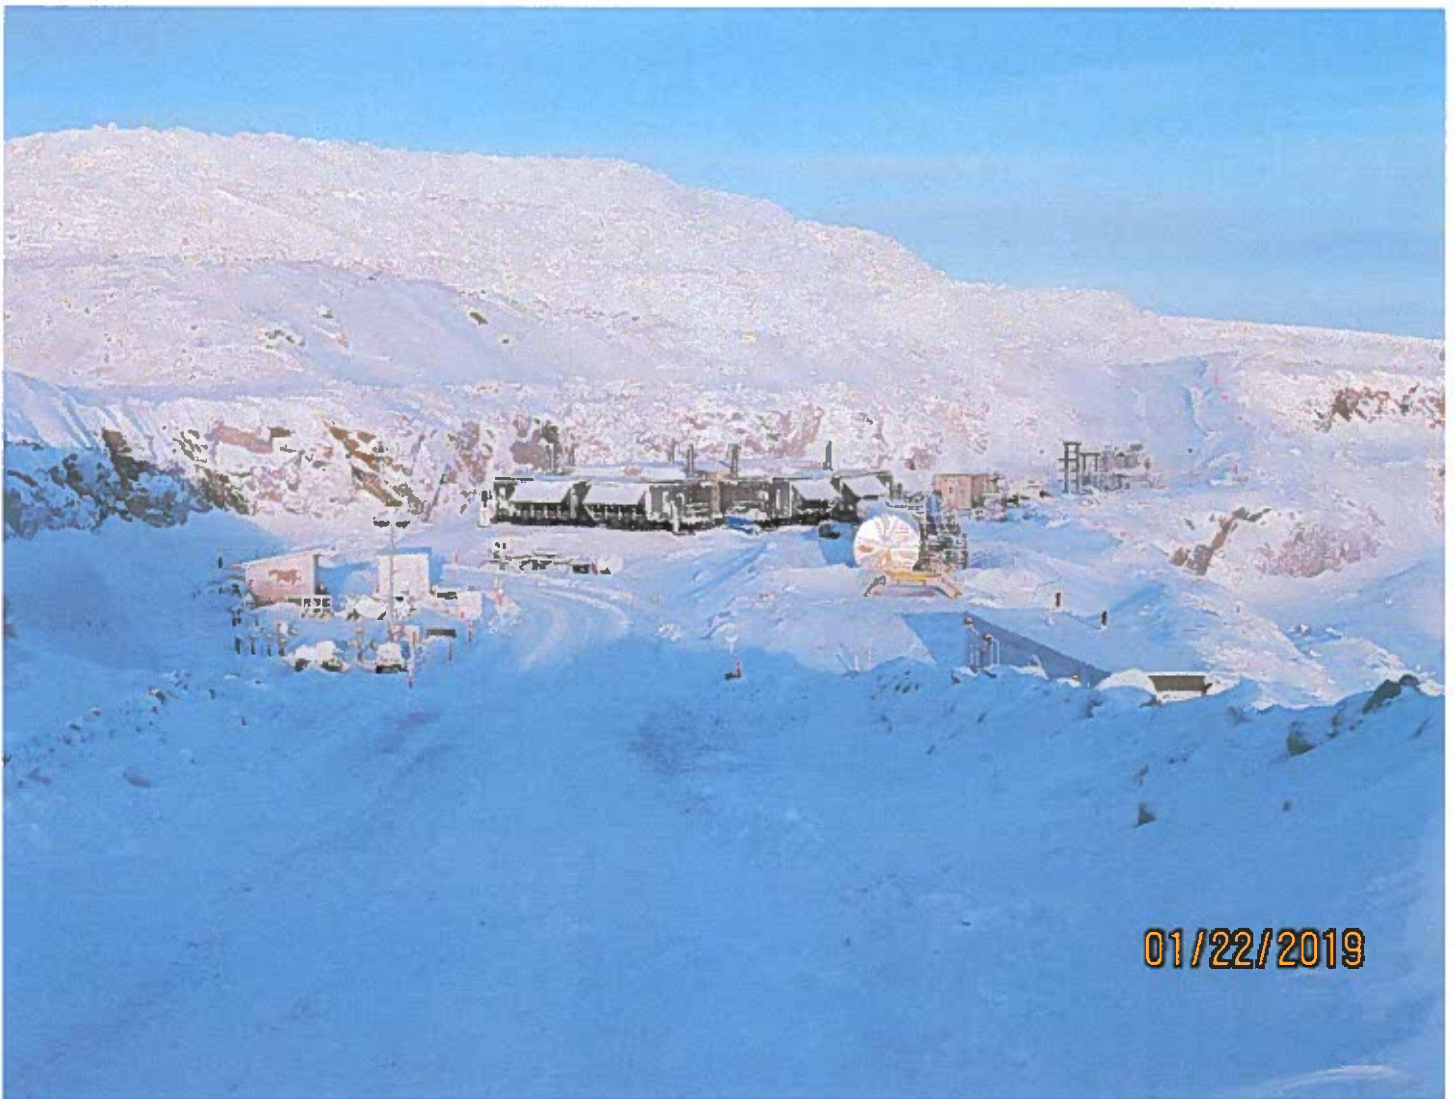
The majority of the Fresh Air Raise (FAR) construction and the electrical transformer on the Misery Pit 440 Bench has been completed (Photos #17 & #18). In addition, a 50,000 litre fuel tank that will be used to supply the FAR building air heaters is in place within a secondary containment berm (Photo #19). The tank will be plumbed in once warmed is required to be pumped into the underground through the yet-to-be-established borehole (4 metre diameter).

Photo #17 - W2017D0004
Infrastructure to support the underground operations on the 440 Bench. The large building in the centre is the FAR Building.

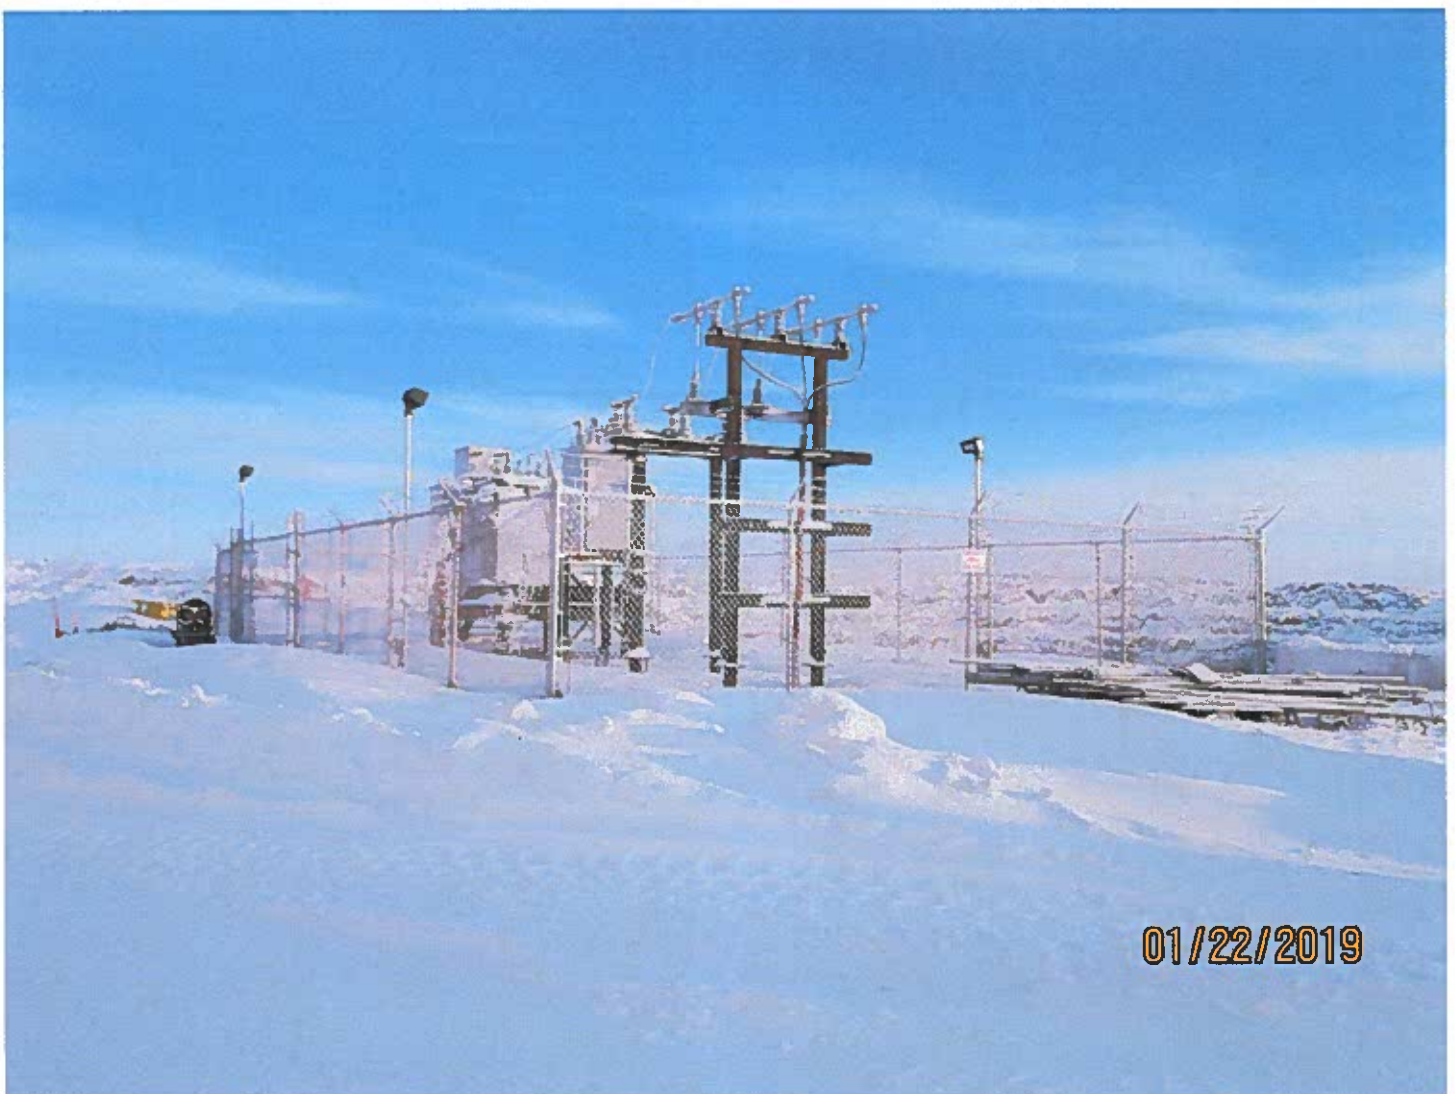
Photo #18 - W2017D0004
The Inspector was informed the 440 Bench electrical transformer is ready for operation.

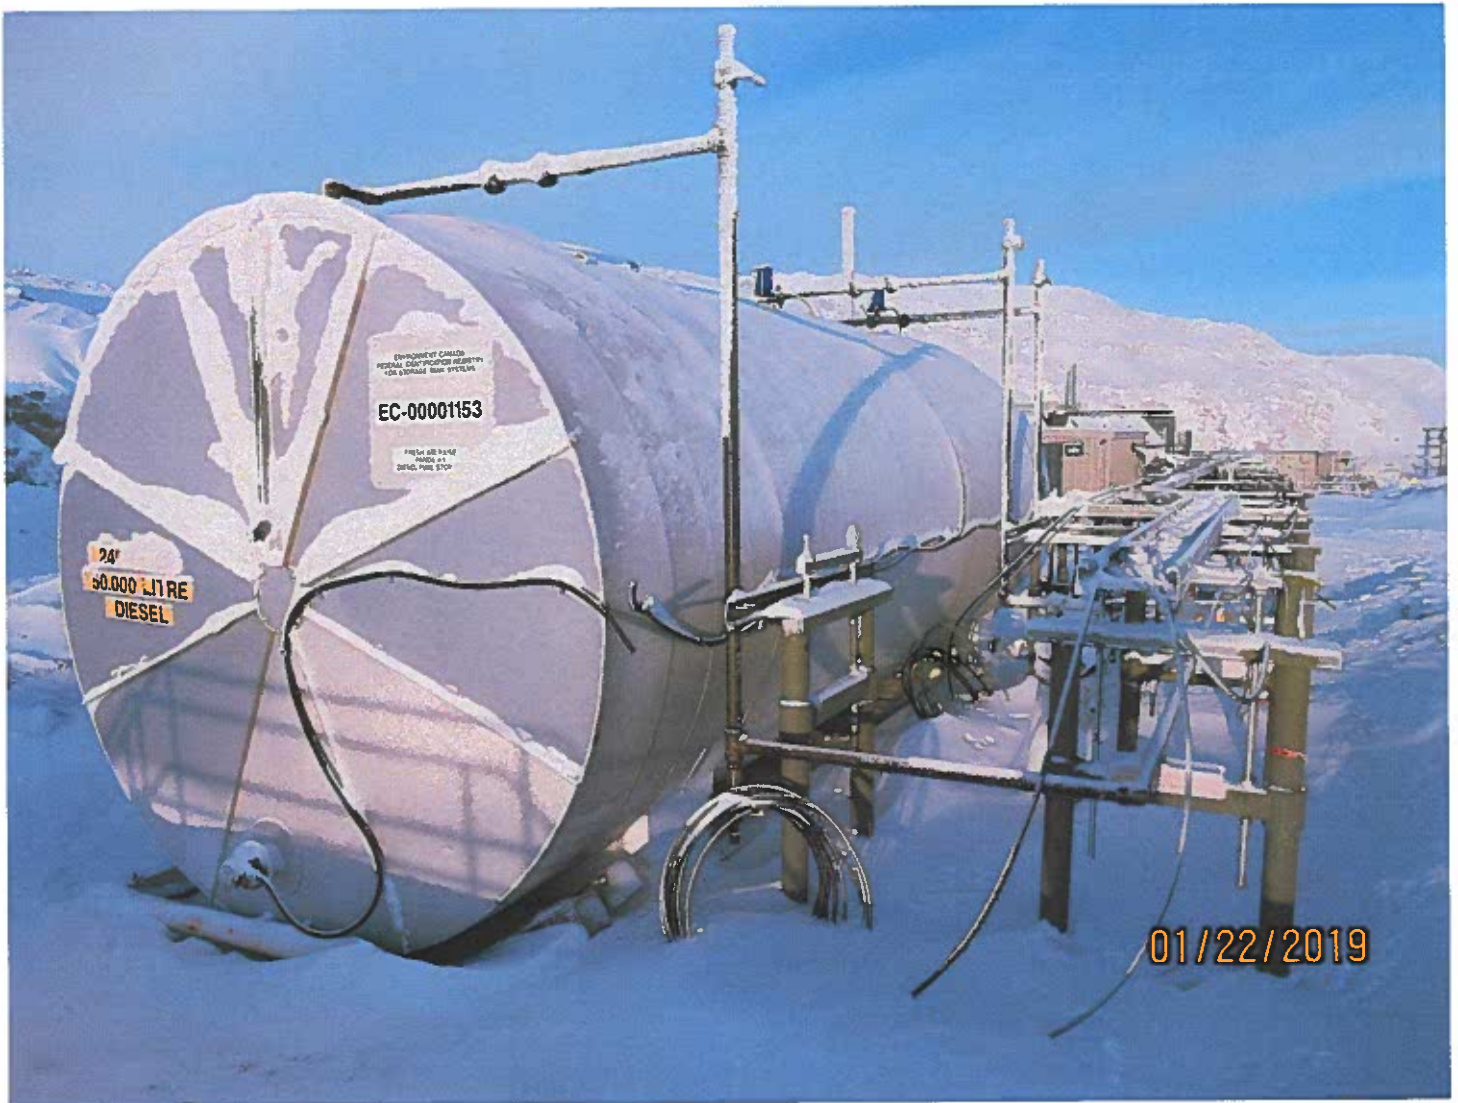
Photo #19 - W2017D0004
A 50,000 diesel tank has been put in place and will be plumbed in once the FAR becomes operational.

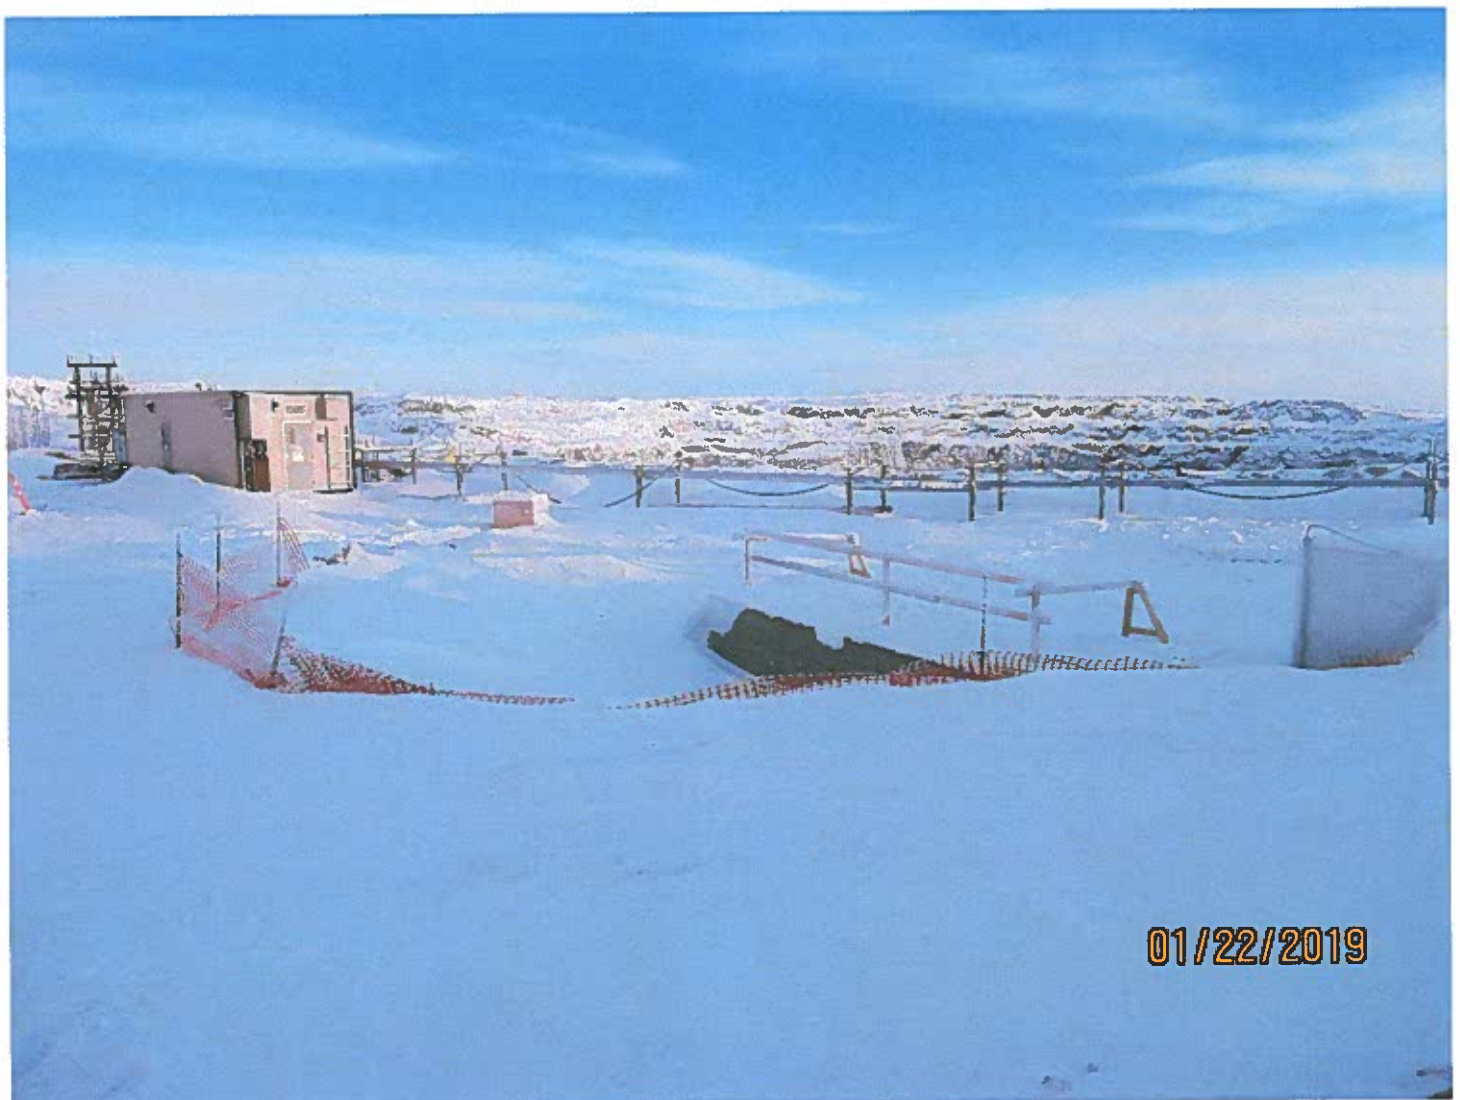
It appears a concrete pad to support the raise bore is in place and can be seen in Photo #20. The raise bore will be shipped to site along the winter road will arrive onsite early in the 2019 winter road season. Once the borehole is drilled, all ancillary equipment along the Misery Pit 440 Bench will be made operational and electrical lines will be fed from the transformer and down through the borehole to supply power to the underground.

Photo #20 - W2017D0004
Though covered in snow, the concrete pad for the raise bore can be seen in this photo.

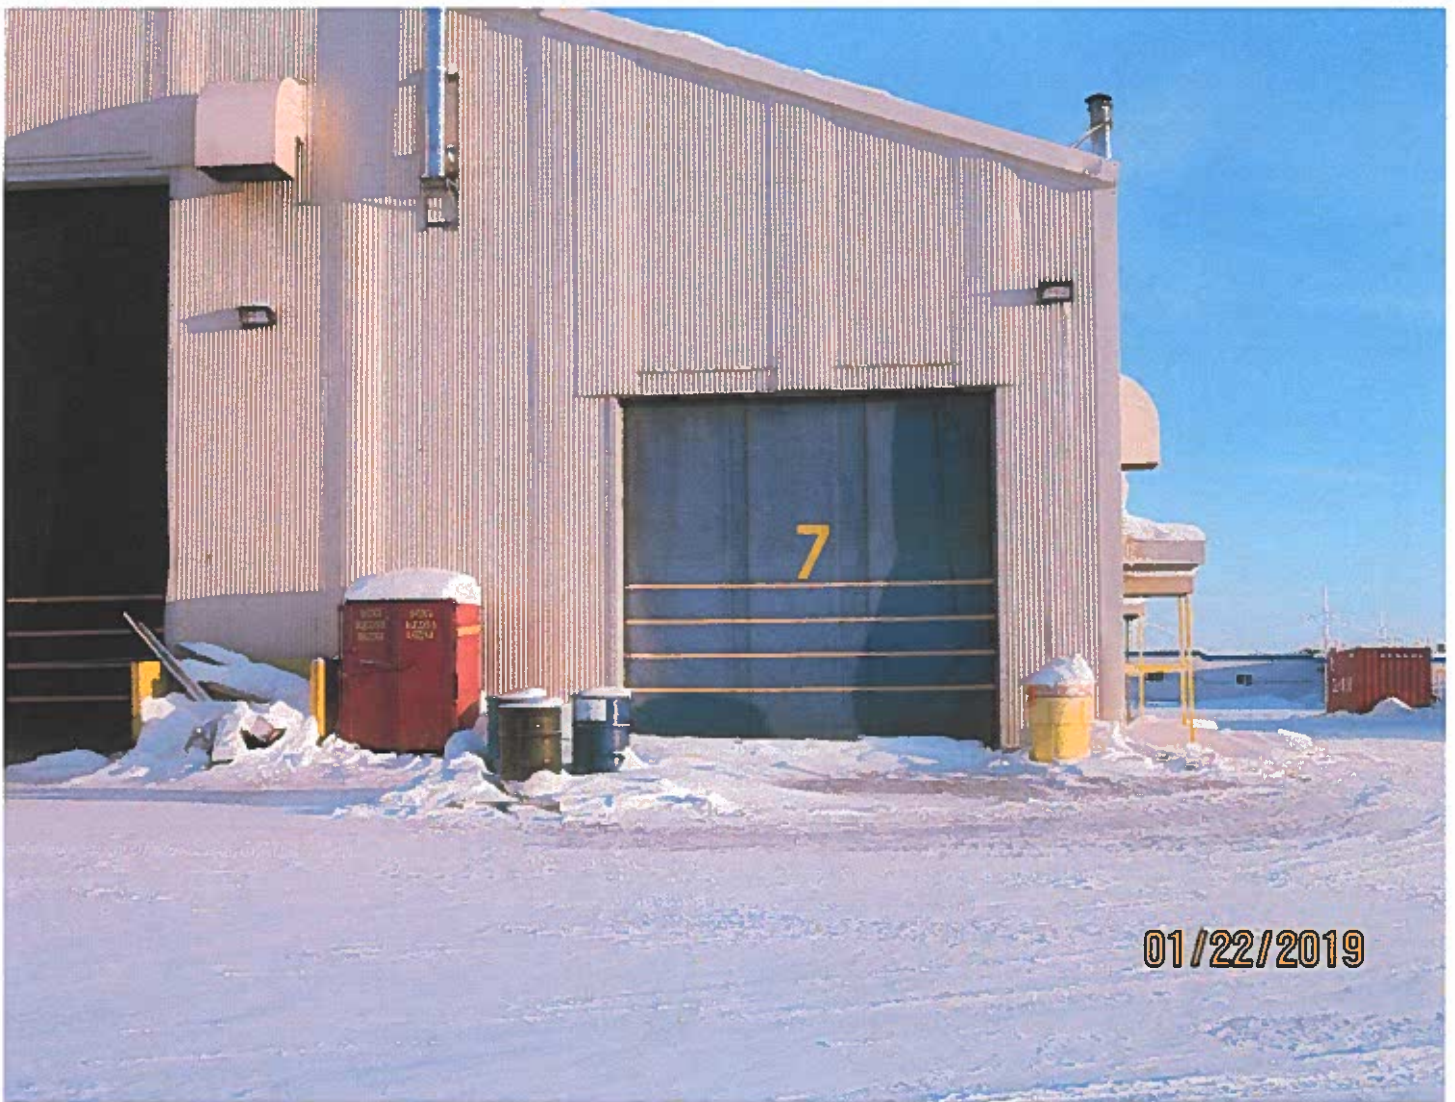
Photo #25 - W2017D0004
An example of properly segregated, staged & labeled waste and a spill kit at Misery Camp.

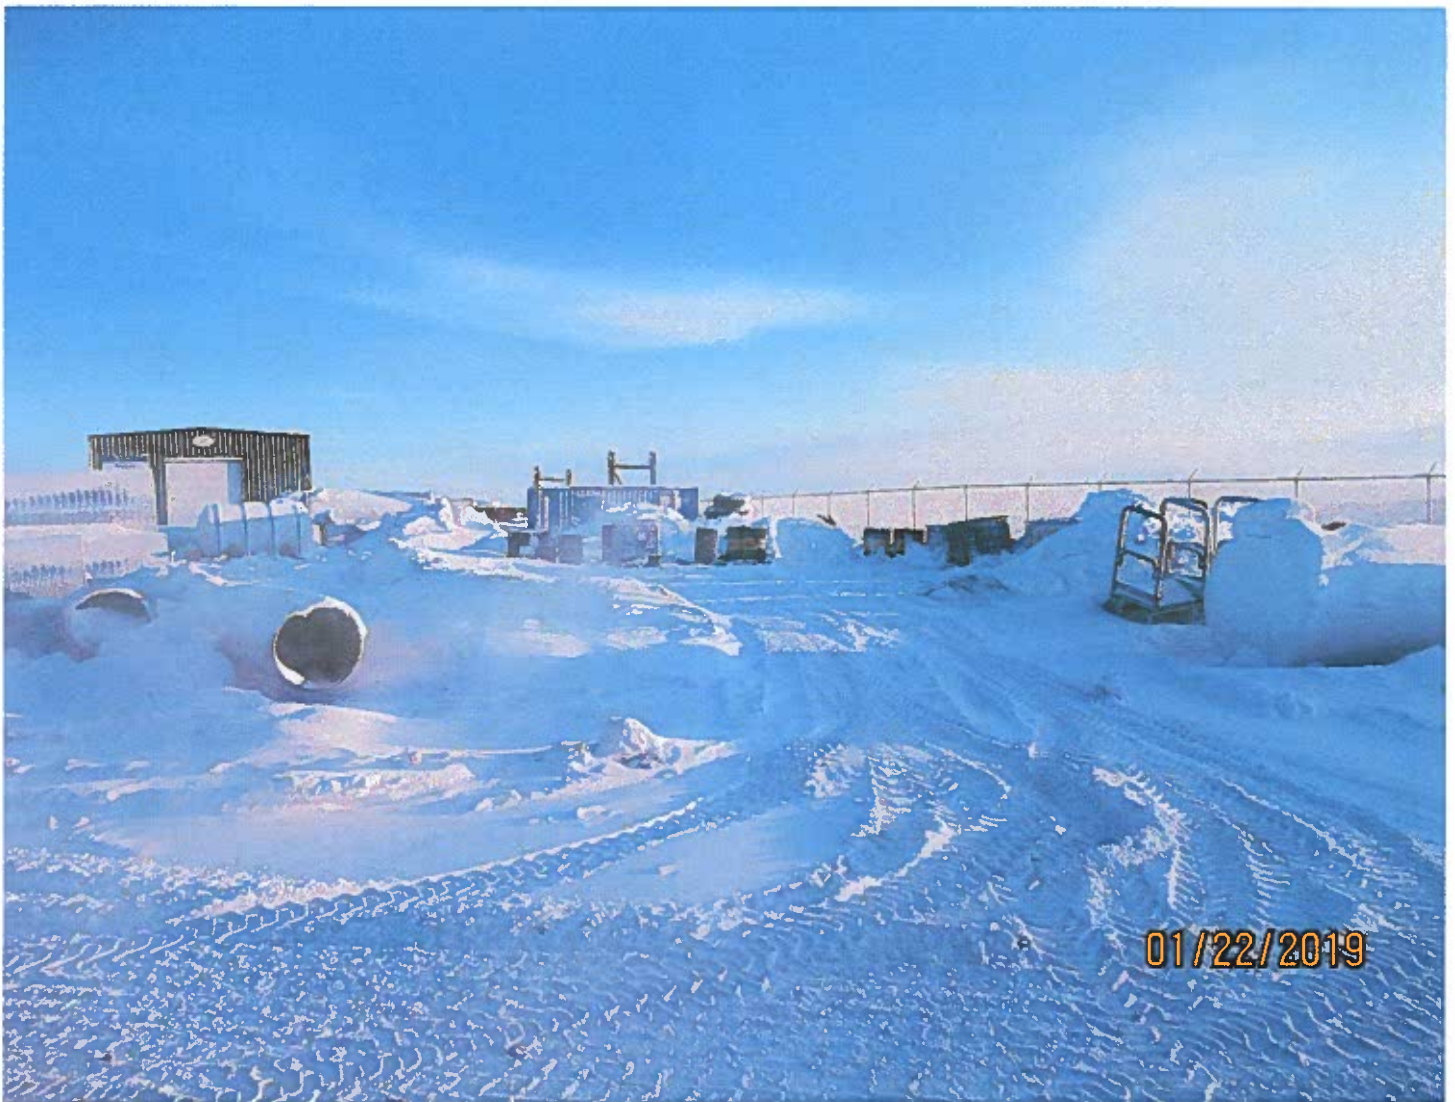
Photo #27 - W2017D0004
Waste staged in the laydown next to the Cold Storage Building was properly staged and labeled.

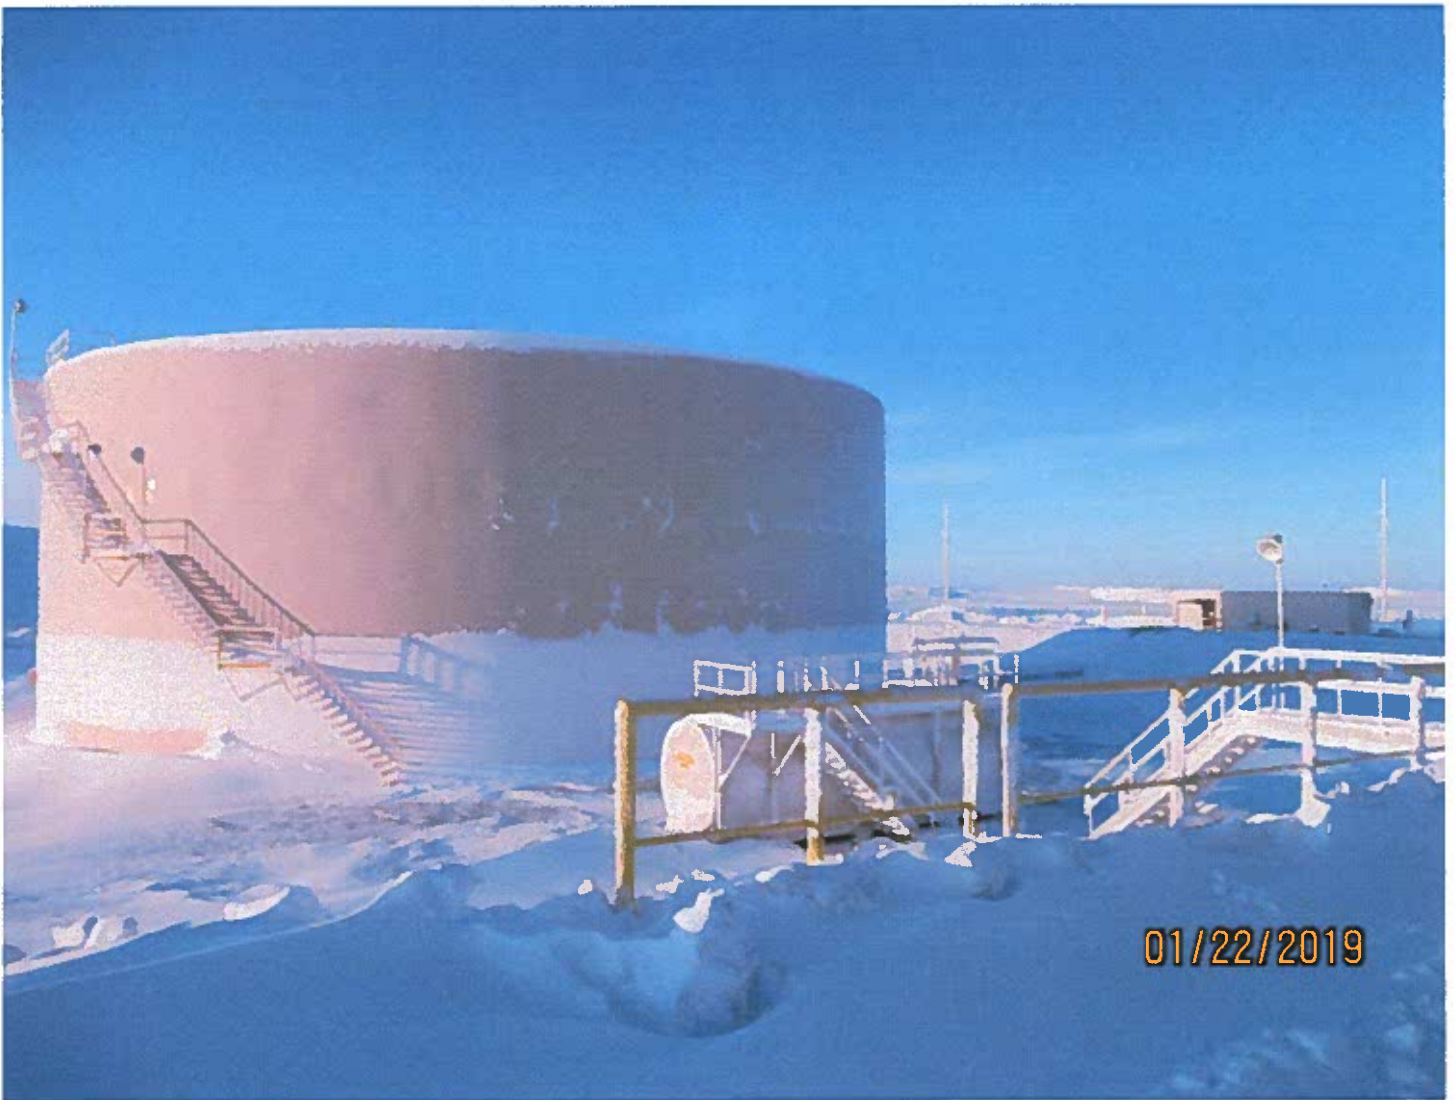
Photo #31 - W2017D0004
An additional 25,000 L diesel tank in the diesel tank berm.

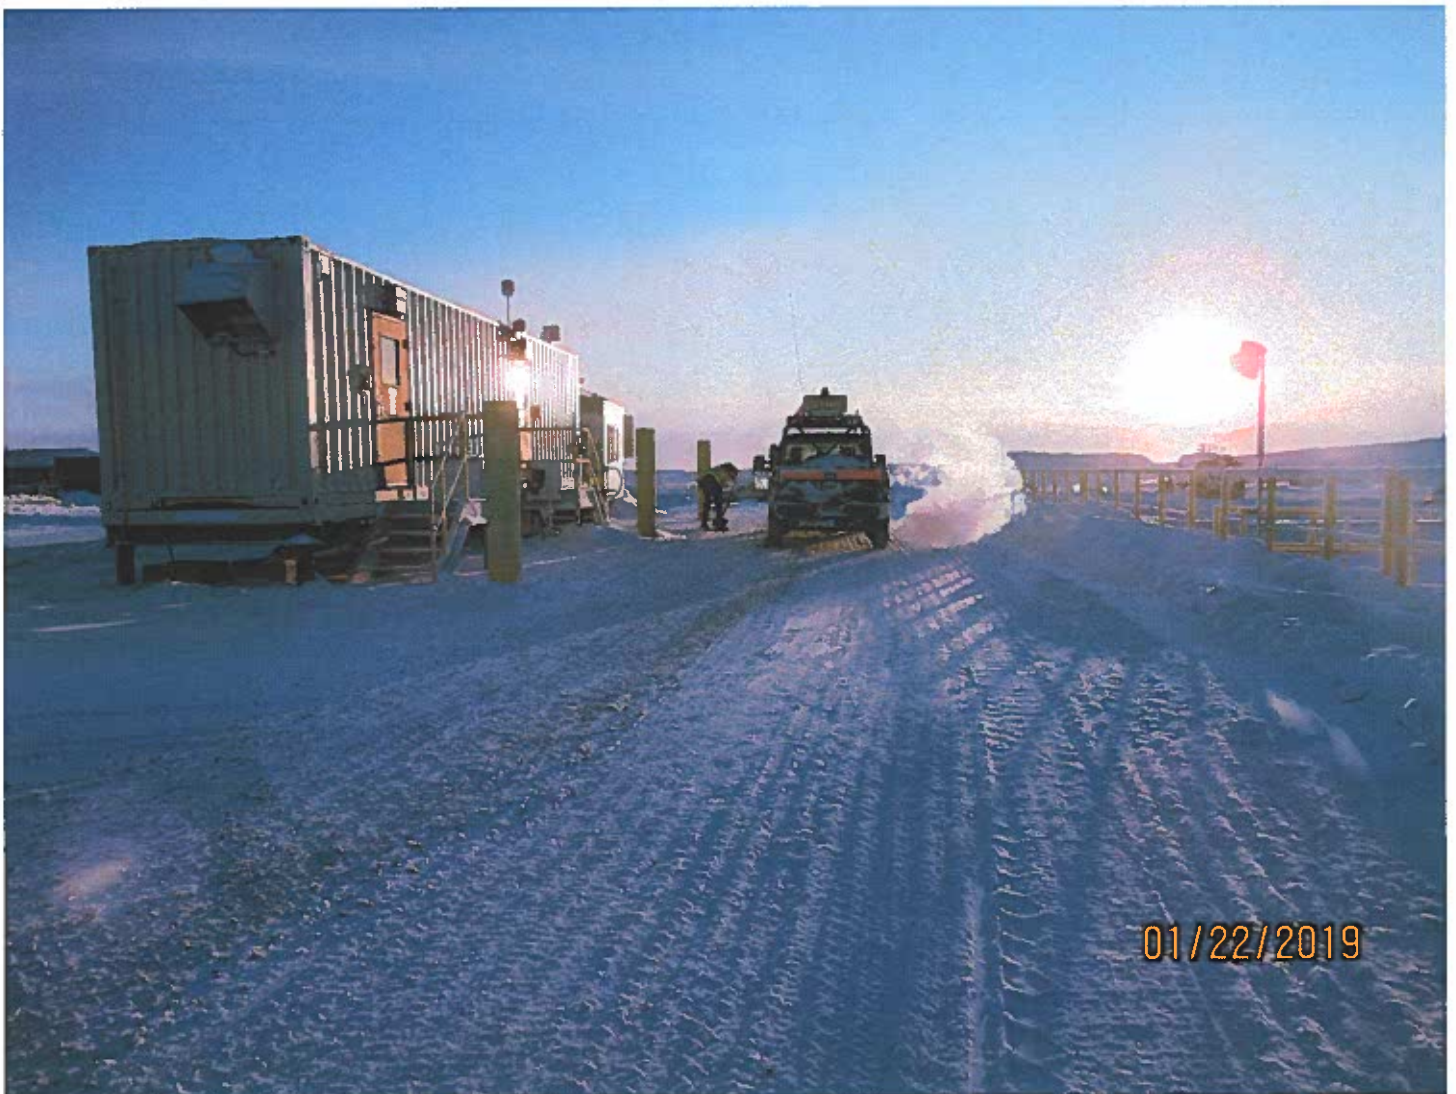
Photo #32 - W2017D0004
Though it appeared to be freshly scraped clean, there were hydrocarbons on the ground at the Misery fuel transfer station.

Overall, it appeared the land use area is being maintained in a very tidy & orderly fashion and only minor concerns were noted. The Permittee must ensure secondary containment is used during fuel transfers (Condition #32) and spilled hydrocarbons are cleaned up to comply with Condition #38 of the permit. The Permittee appears to be conducting land use operations in the Misery area to comply with the operating conditions annexed to LUP W2017D0004.

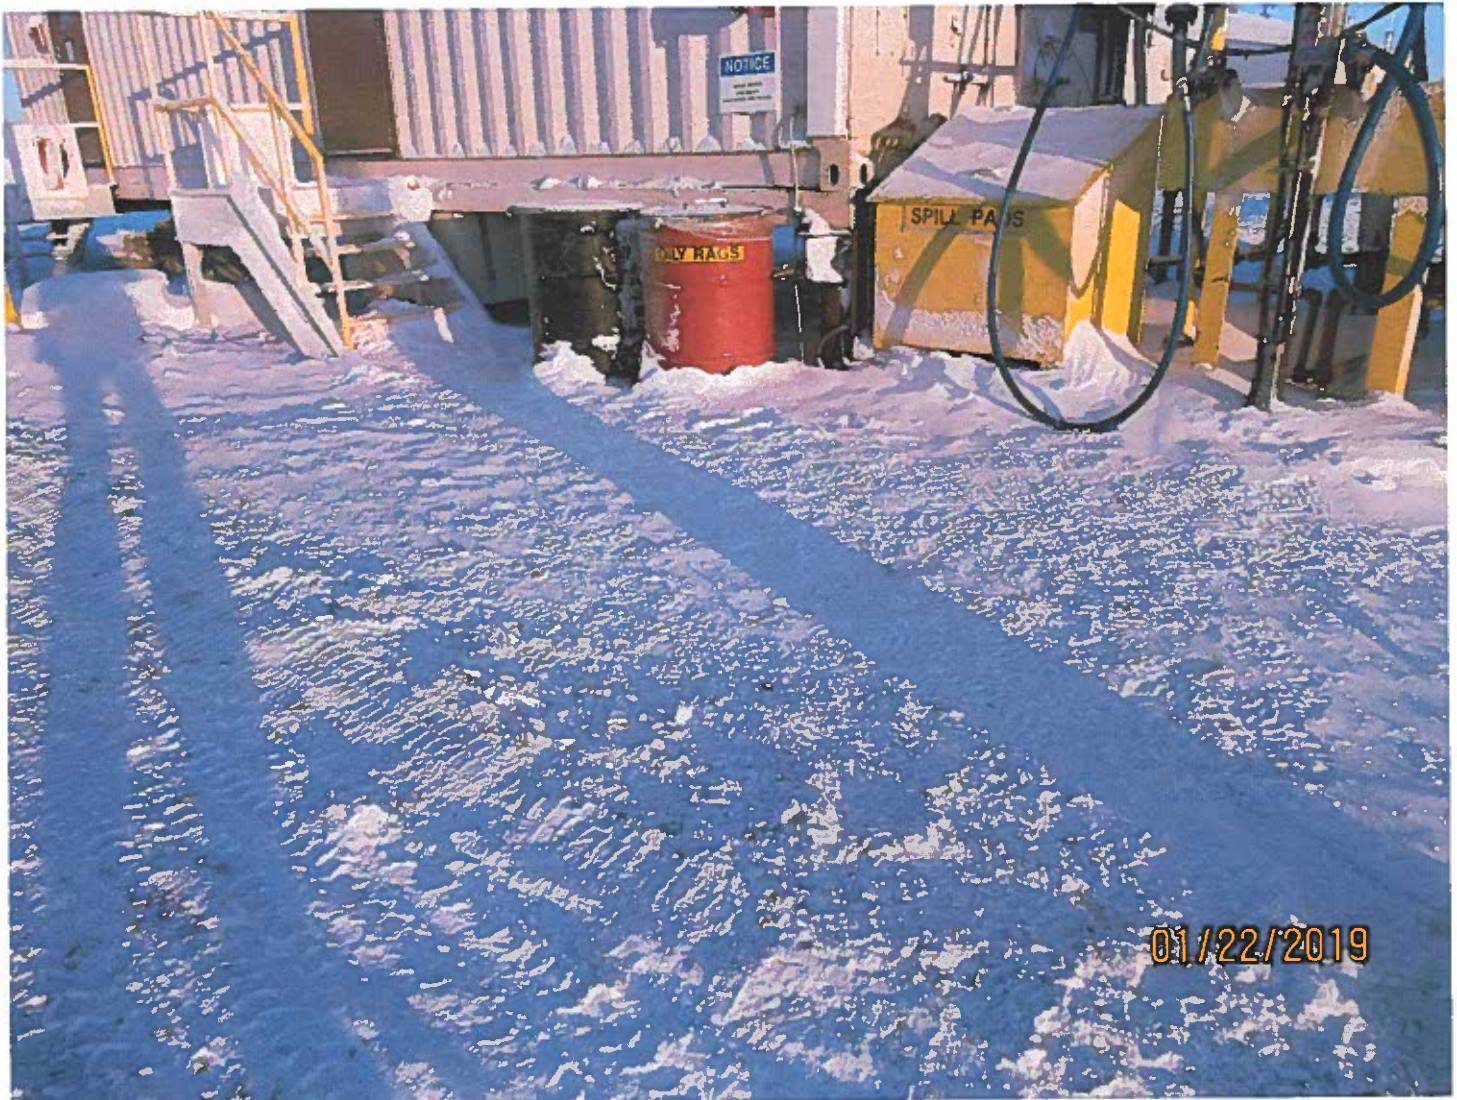
Photo #33 - W2017D0004

Fuel nozzles were in secondary containment and there were adequate spill response materials at the fuel station.

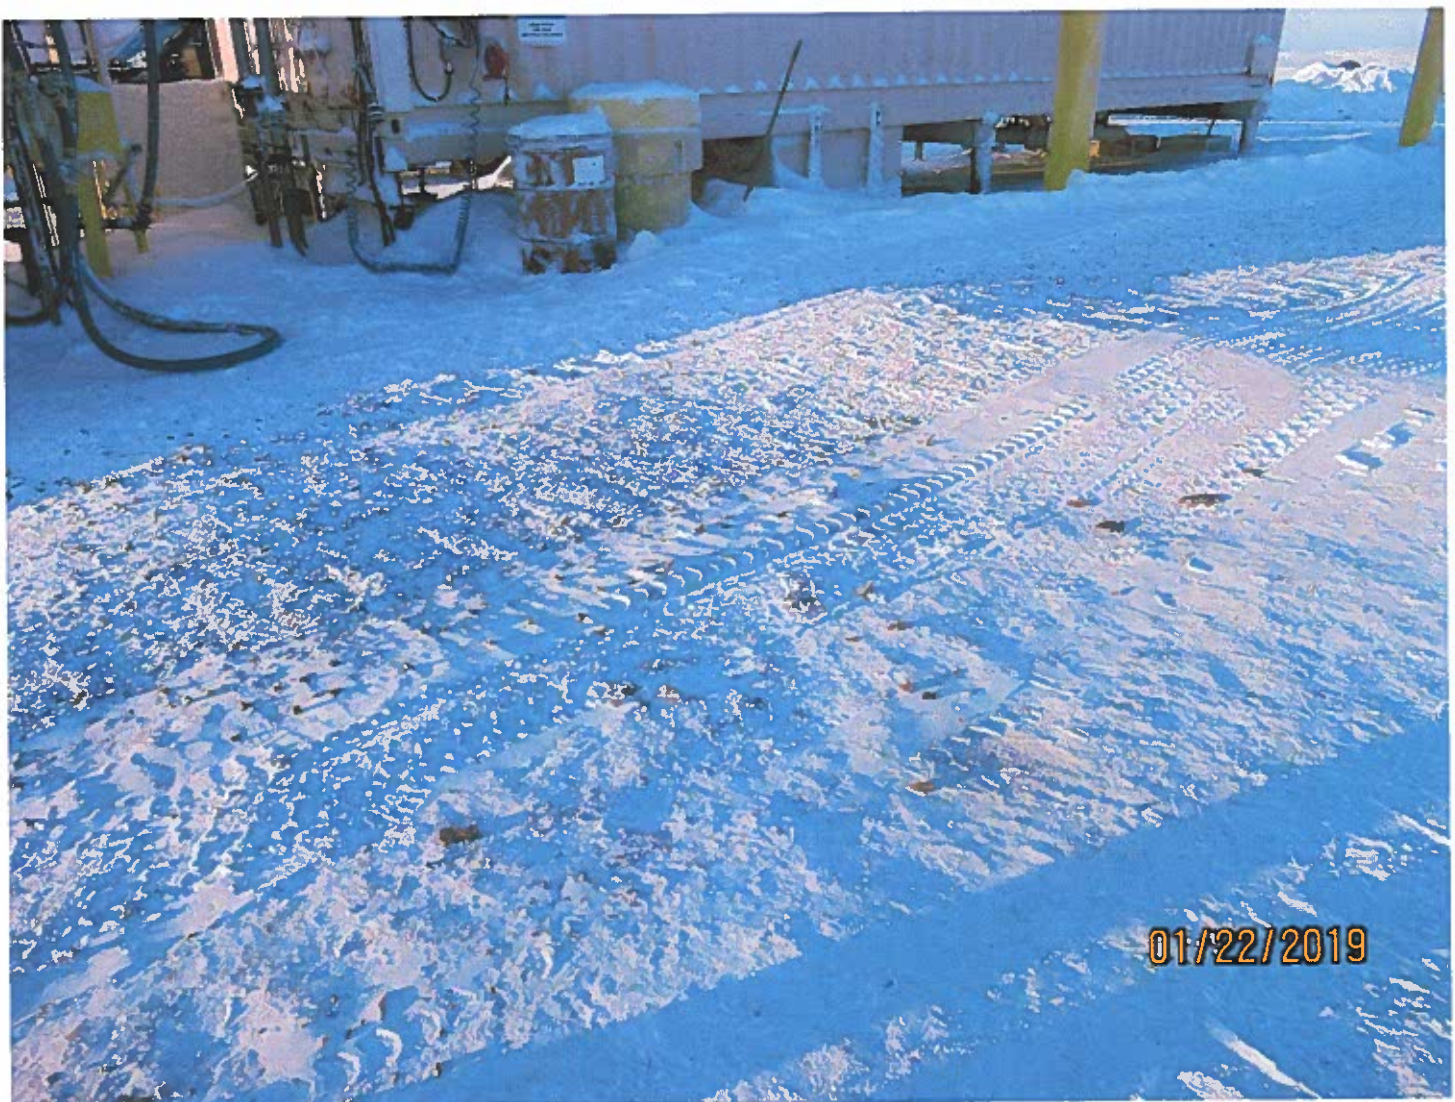
Photo #34 - W2017D0004

As seen in Photo #33 and in this photo, there was spilled fuel on the ground at the transfer station.
