**Re: Land Use Permit W2017D0004
Mining & Associated Activities
Ekati Diamond Mine, Northwest Territories**

ENVIRONMENTAL INSPECTION REPORT

Permittee:	Dominion Diamond Ekati – Misery Underground	Inspection Dates: March 19 th , 2019
------------	---	---

Location(s) Inspected:	The Ekati Mine Misery Underground Project and Misery Camp.
------------------------	--

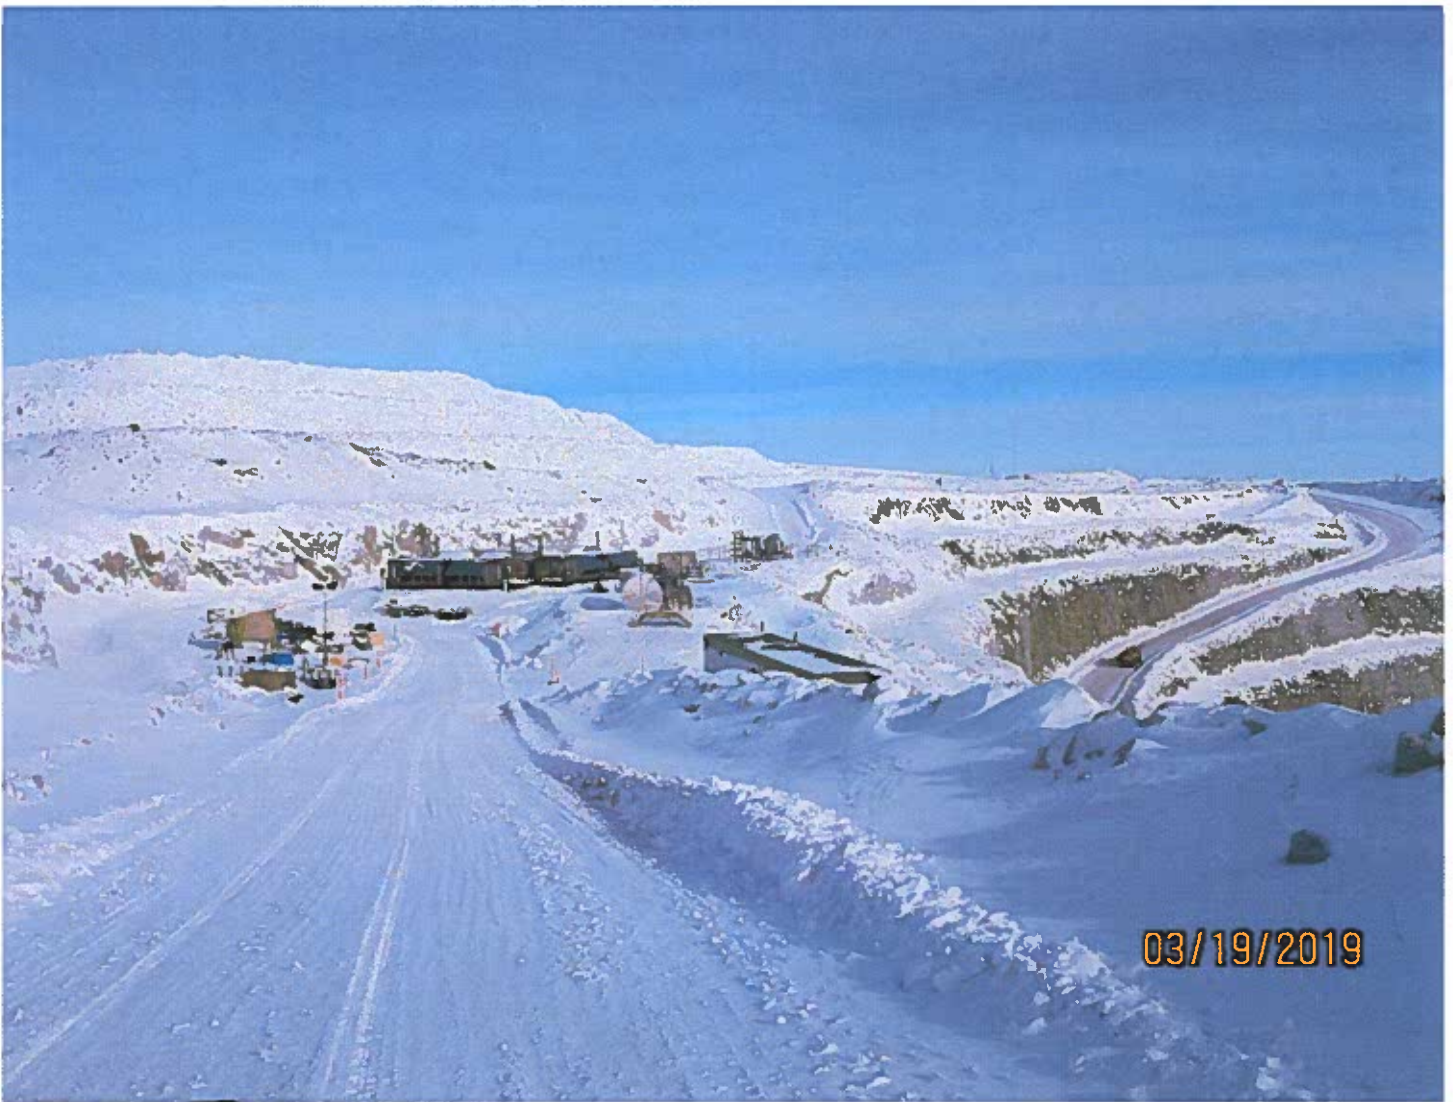
Infrastructure to supply fresh air and electrical power to the underground operations is in place along the 440 Bench (Photo #1) and is awaiting the completion of the raise bore drilling operations. Once a pilot hole is drilled from the surface down to the 2150 Level, a raise bore will drill a hole upwards towards the surface measuring approximately four (4) metres in diameter. Once complete, fresh air and electrical lines will be fed down the borehole from the 440 Bench to the underground. As seen in Photo #2, the brine tank that was staged on the 2235 Portal ramp has been moved to the 440 Bench in anticipation of use as part of the raise bore work.

Photo #1 - W2017D0004 MUG Project
A look at the infrastructure along the 440 Bench that will be used for the underground operations.

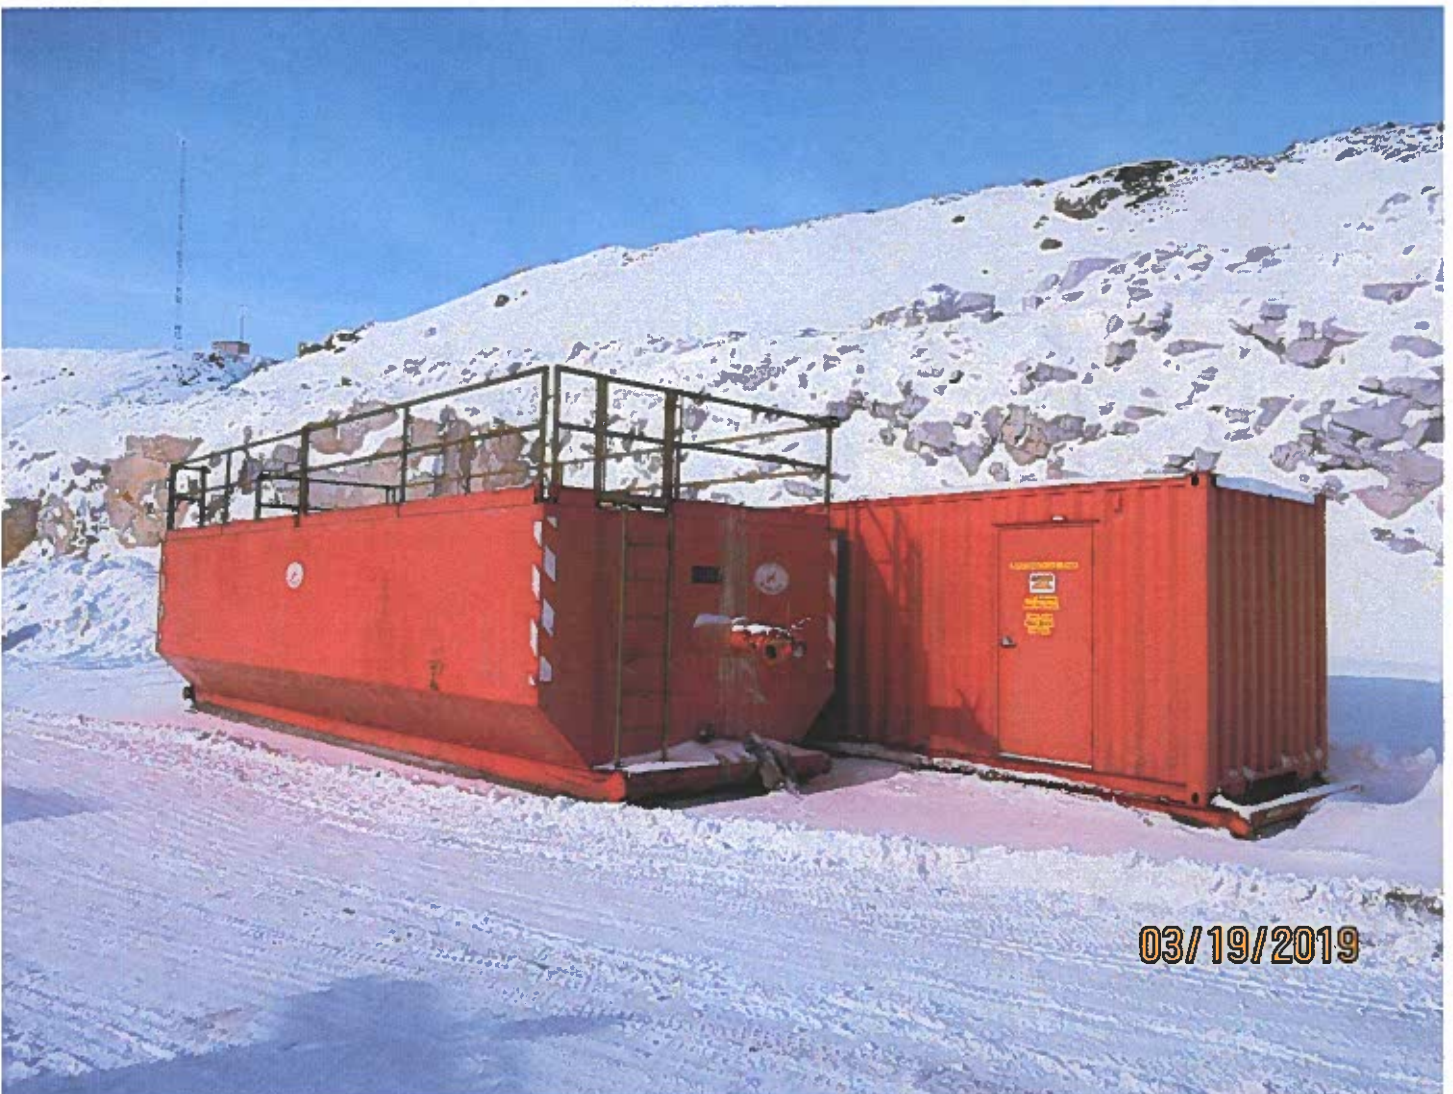
Photo #2 - W2017D0004 MUG Project
This brine tank will be used during the raise bore drilling activities.

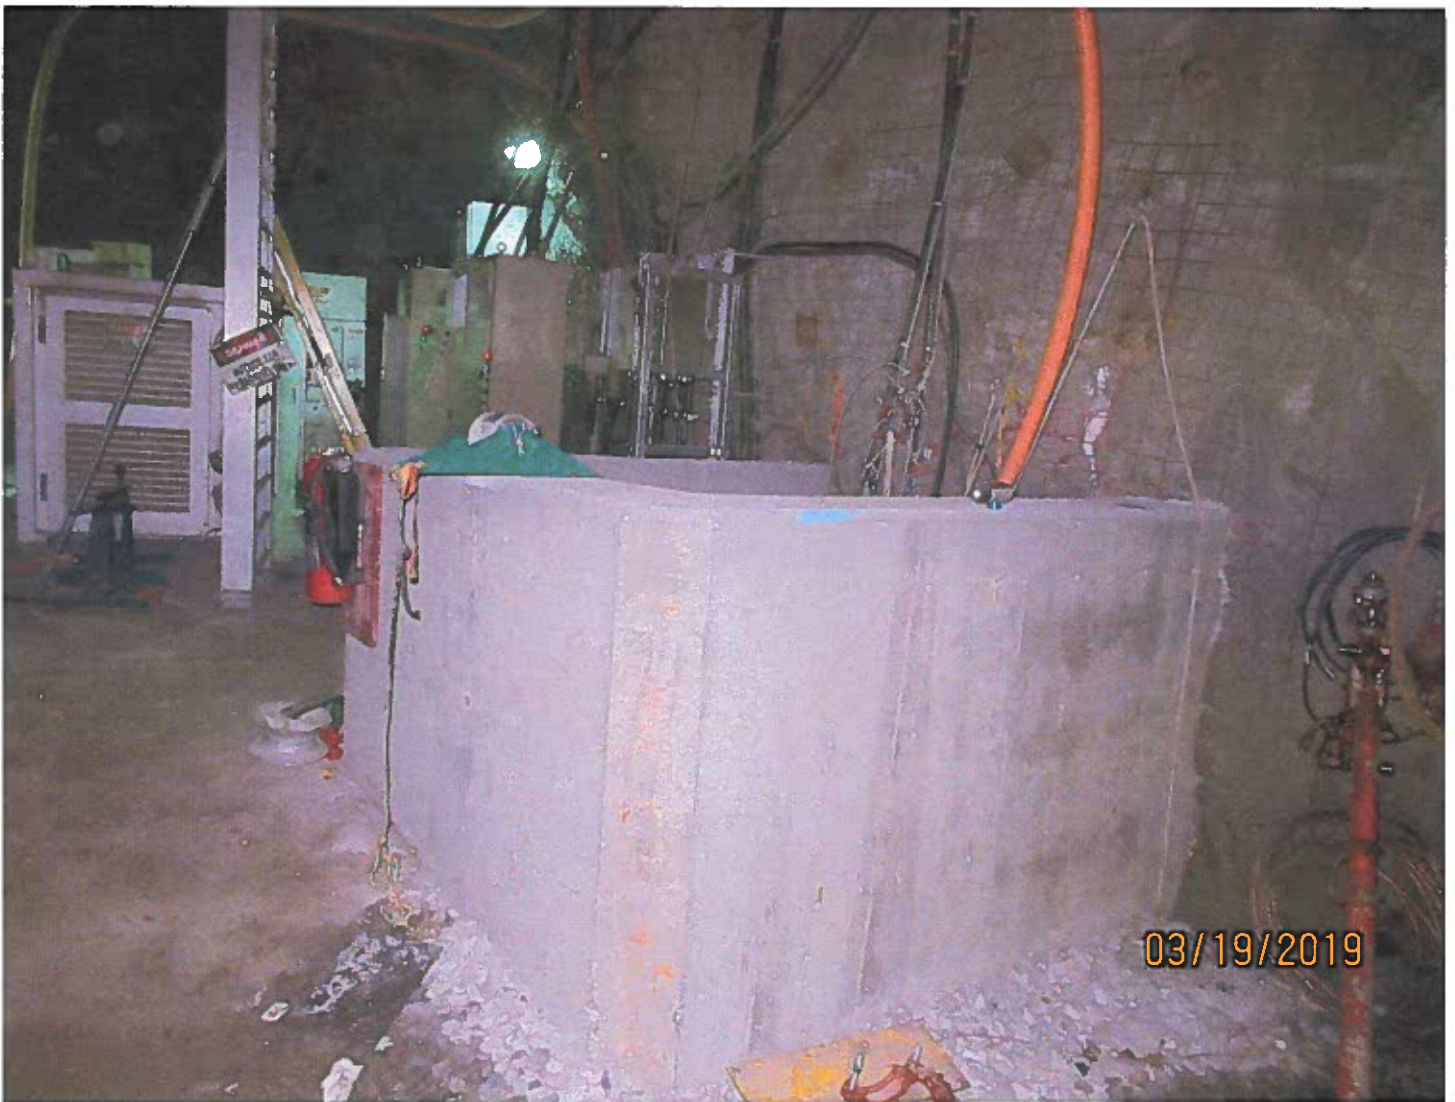
Underground crews were drilling & blasting towards the 2120 Level and establishing infrastructure along the way (Photo #3). At the 2150 Level, areas were being developed that will be used for a MudWizard Mud Treatment System (used in the recirculation of underground minewater), a compressor pad (Photo #4), an electrical room and a power distribution centre. Also located in the area is the decline towards the manway on the level and the staging area where the raise bore will begin drilling towards the surface. A dewatering drift was being established at the 2155 Level and the drift will be used to access and dewater the bottom of the Misery Pit (Photo #5).

Photo #3 - W2017D0004 MUG Project
Underground infrastructure including the installation of this 4160 electrical line was ongoing.

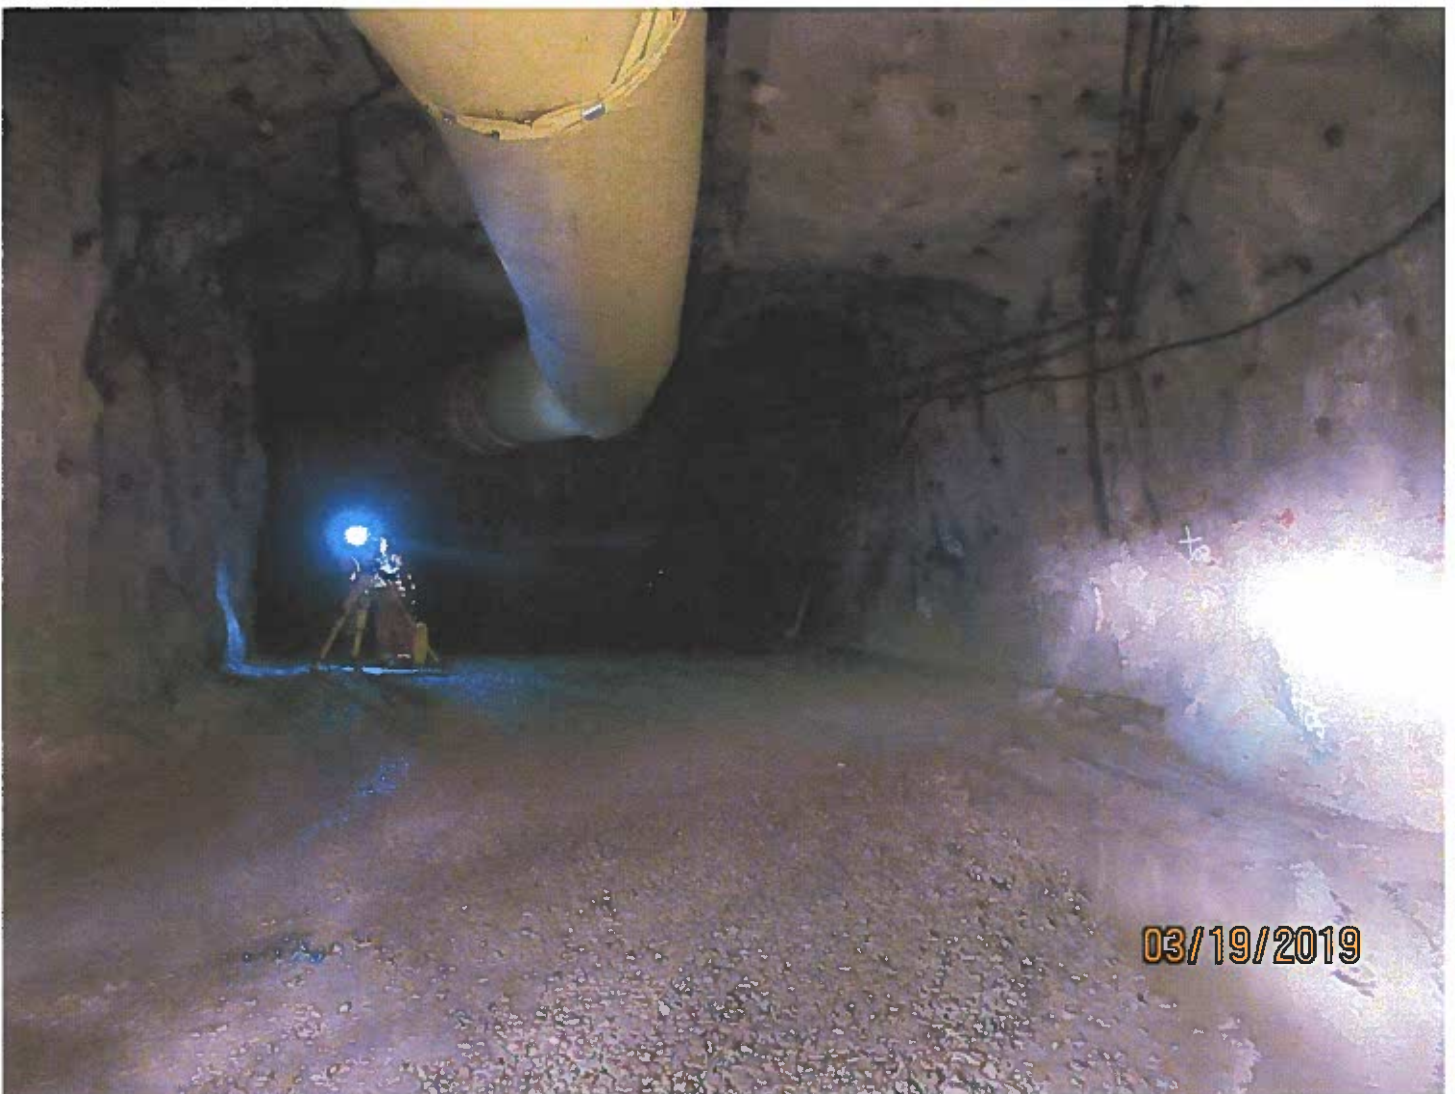
Photo #4 - W2017D0004 MUG Project
Crews surveying the area for the compressor pad at the underground 2150 Level

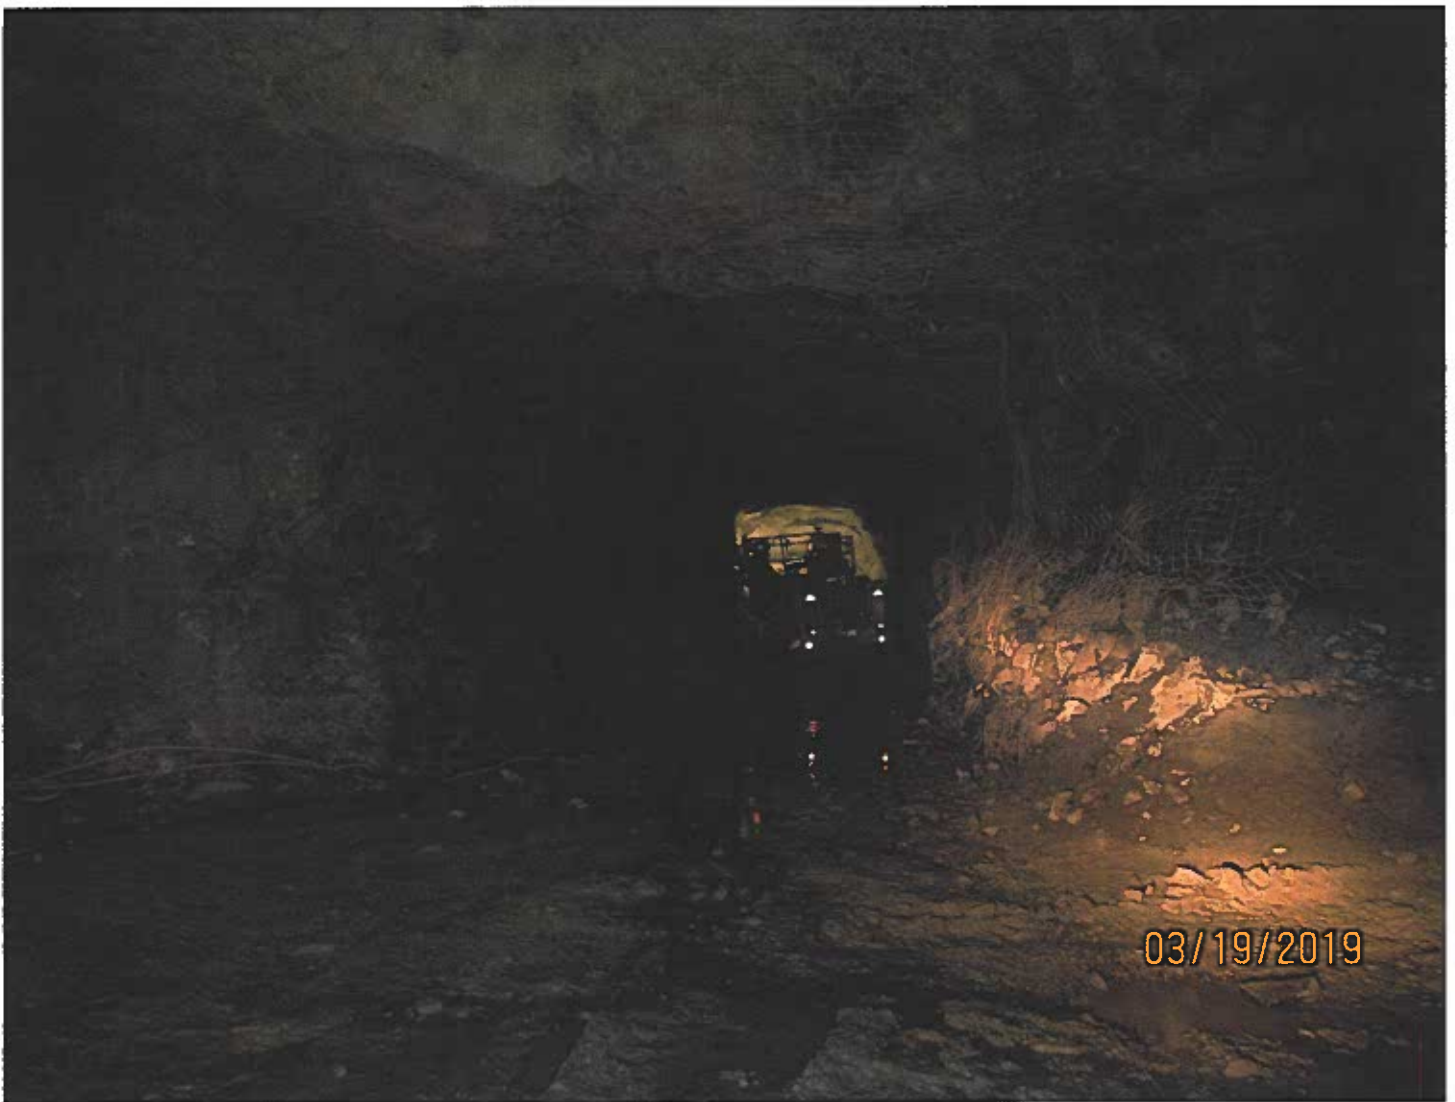
Photo #5 - W2017D0004 MUG Project
Crews were establishing this dewatering drift on the 2155 Level.

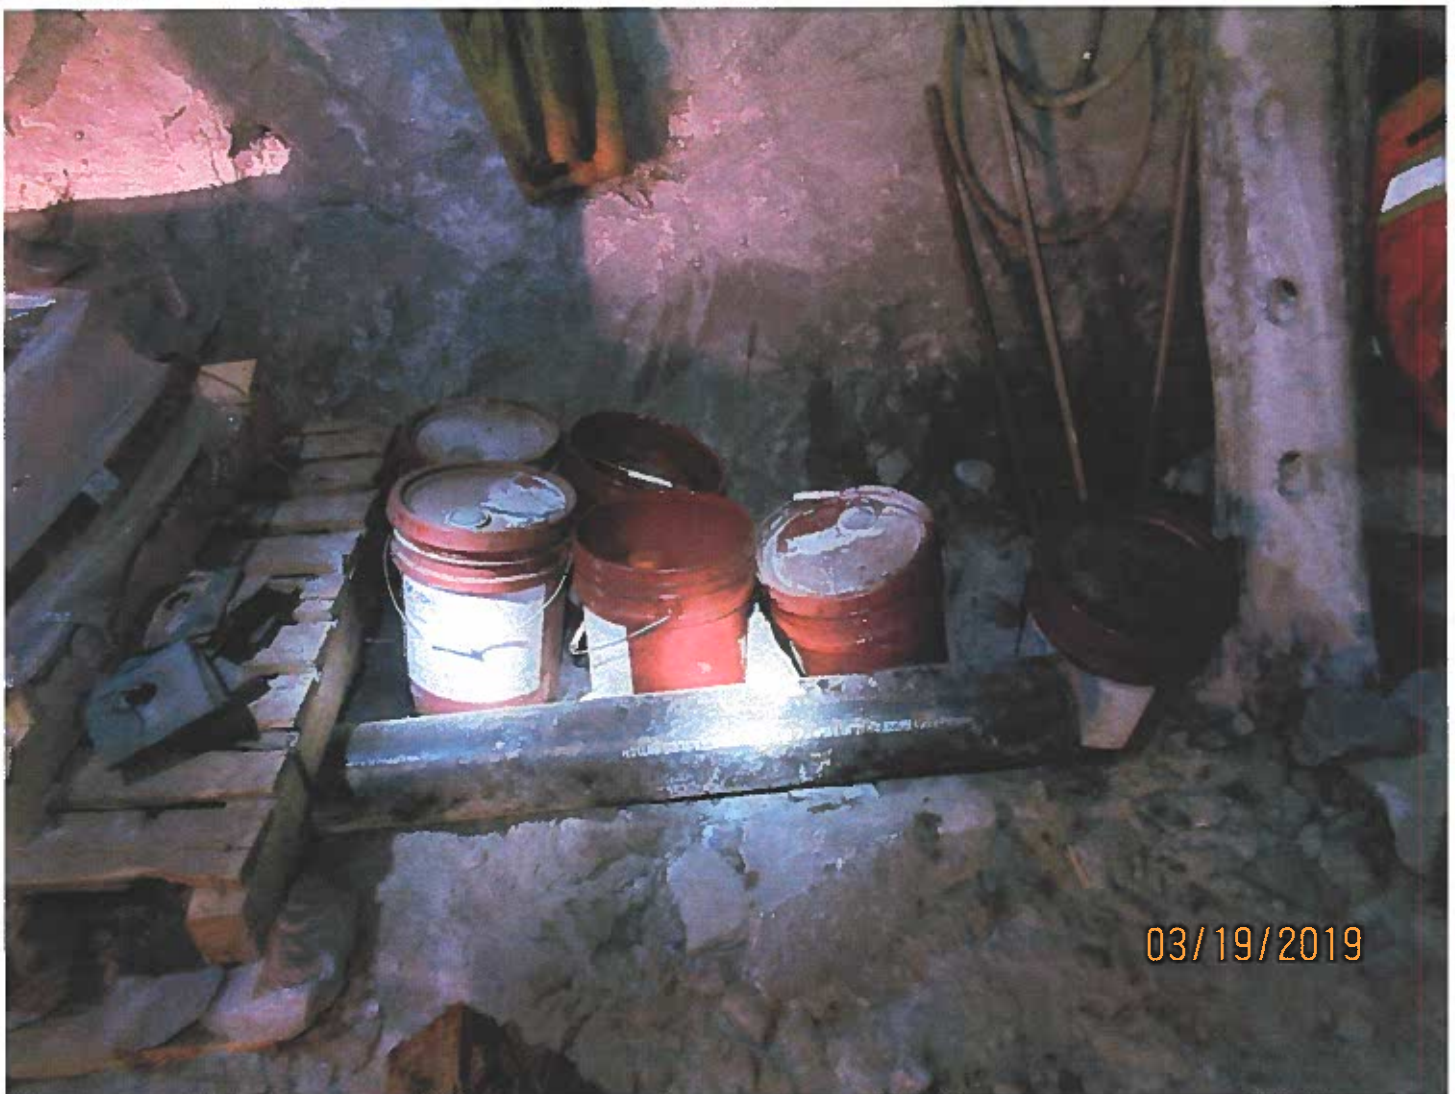
In the underground, the Inspector noted hydrocarbons were being improperly stored at the 2175 Level Escapeway (Photos #6 & #7). As a result, there were spilled hydrocarbons from one of the containers on the ground. To comply with Conditions #33 & #38 of the land use permit, all hydrocarbons must be stored within secondary containment and spills must be cleaned up and properly disposed of at approved facilities to prevent impacts to the surrounding environment.

Photo #6 - W2017D0004 MUG Project
Hydrocarbons were being staged out of containment on the 2175 Level.

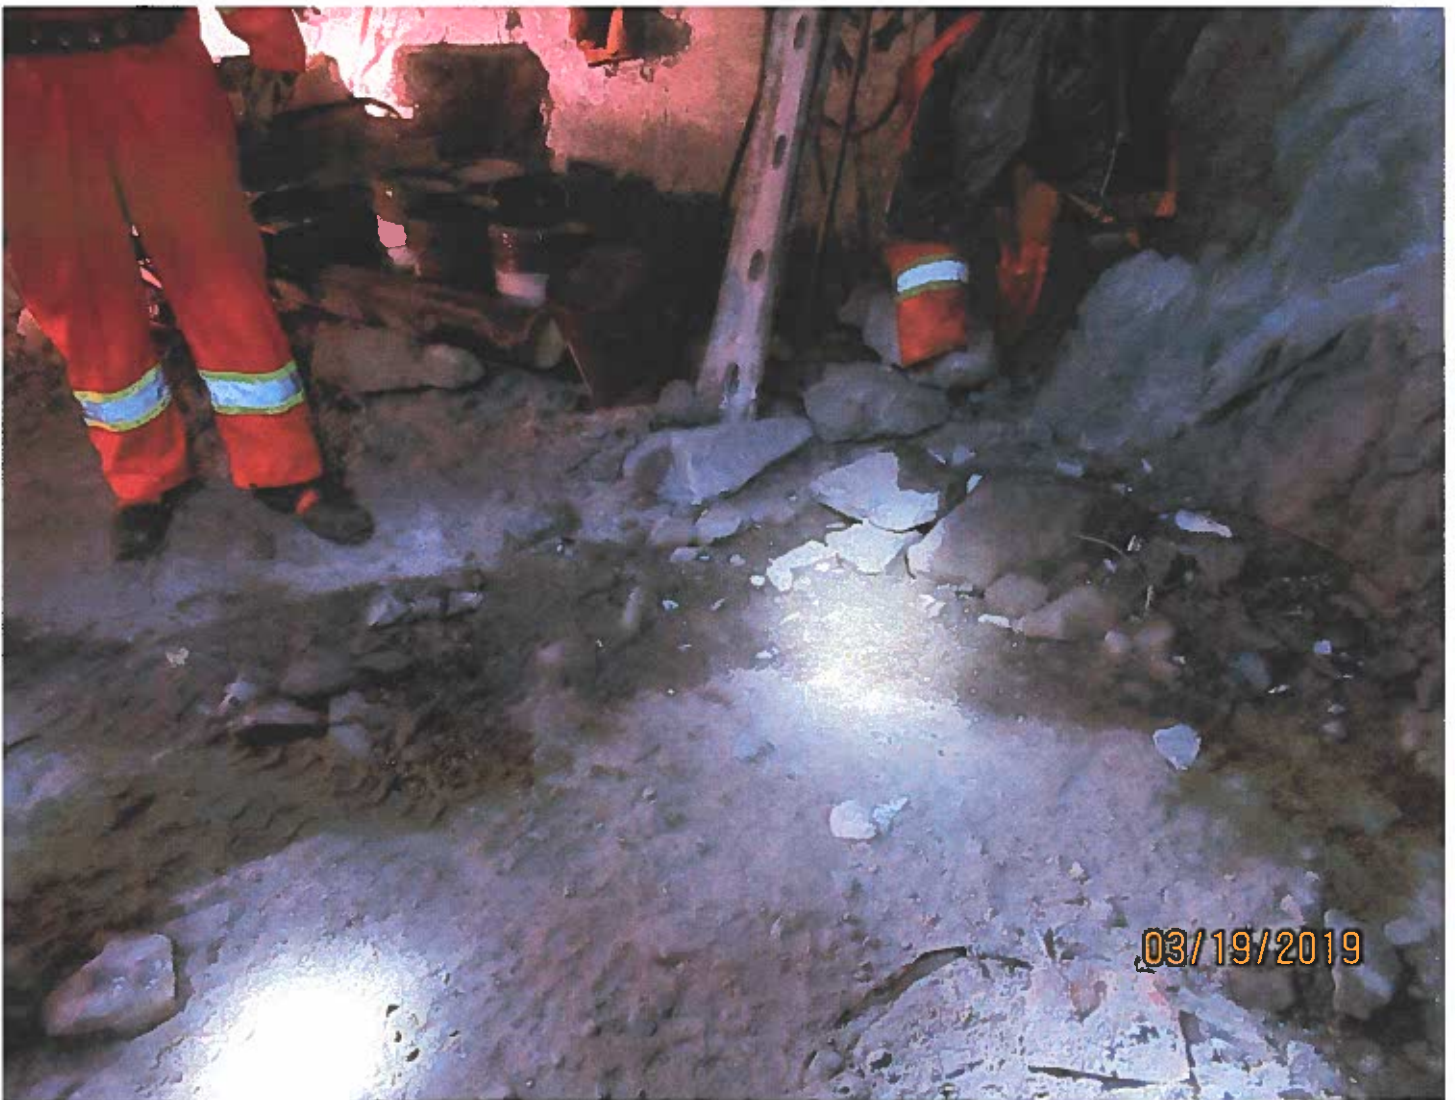
Photo #7 - W2017D0004 MUG Project
Hydrocarbons were spilled on the ground as a result of improper storage.

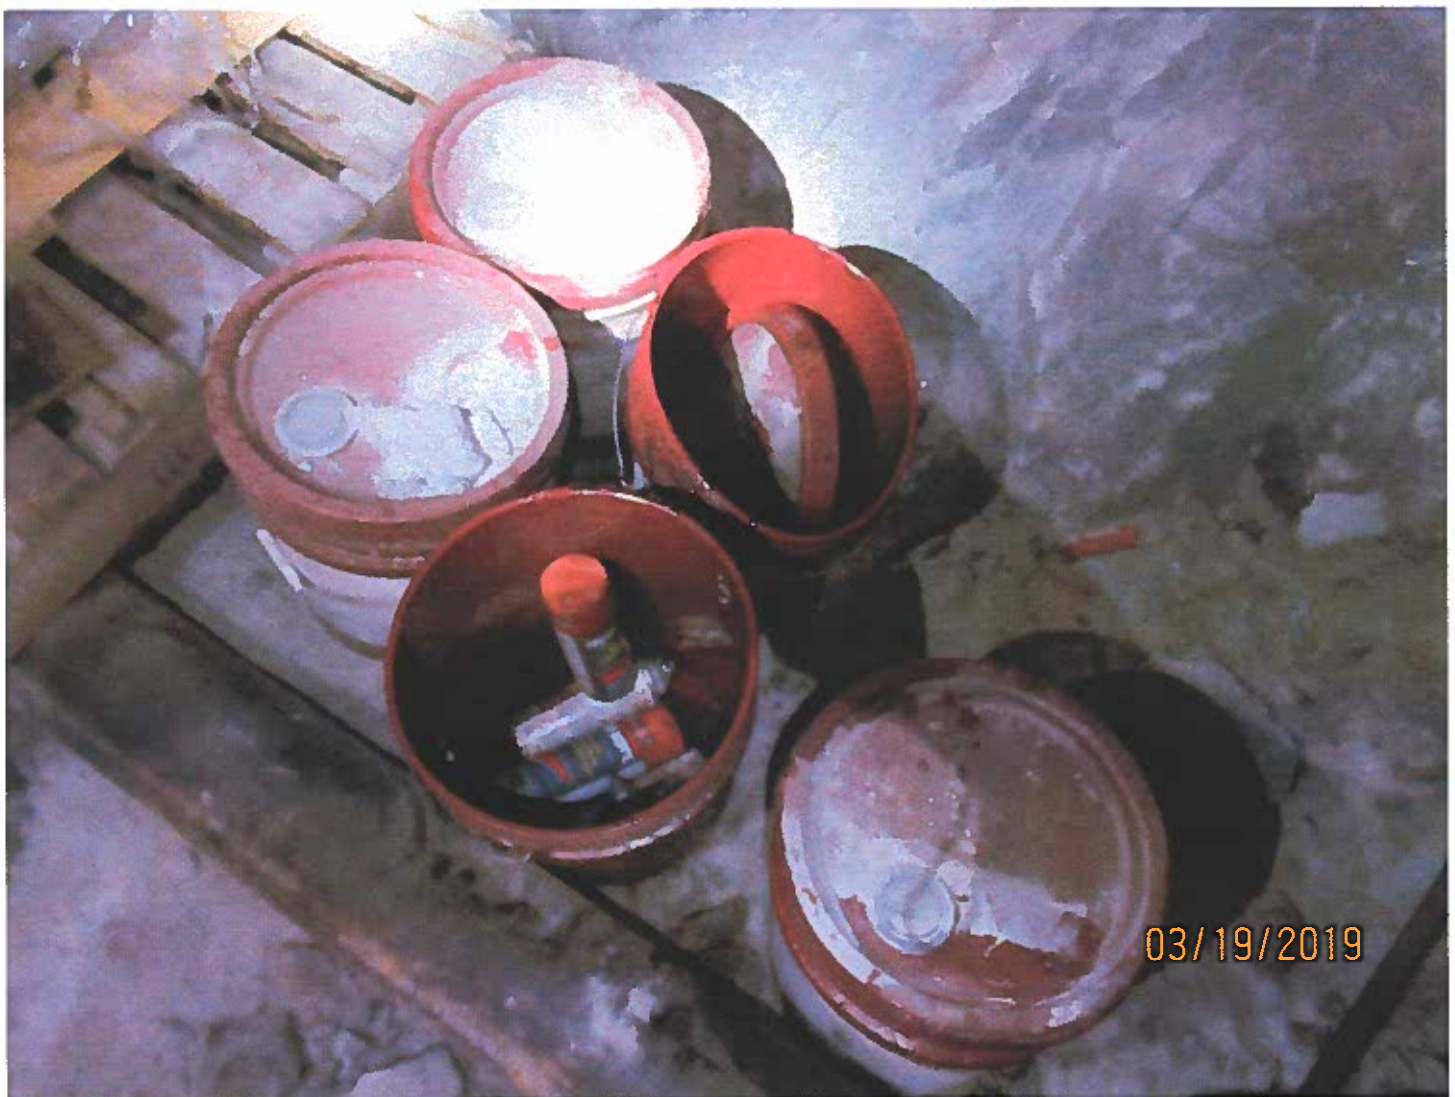
Waste generated during the underground operations must also be sufficiently managed (Condition #23). As seen in Photo #8, empty aerosol cans were being placed in empty hydrocarbon containers at the 2175 Escapeway. Waste must be placed into properly labeled, staged and sealed containers as per Ekati Mine *Waste Management Plan*. The practice of using improper containers to manage waste streams must not occur under the Land Use Permit W2017D0004 authorization.

Photo #8 - W2017D0004 MUG Project
Empty aerosol cans were being stored in inappropriate containers.

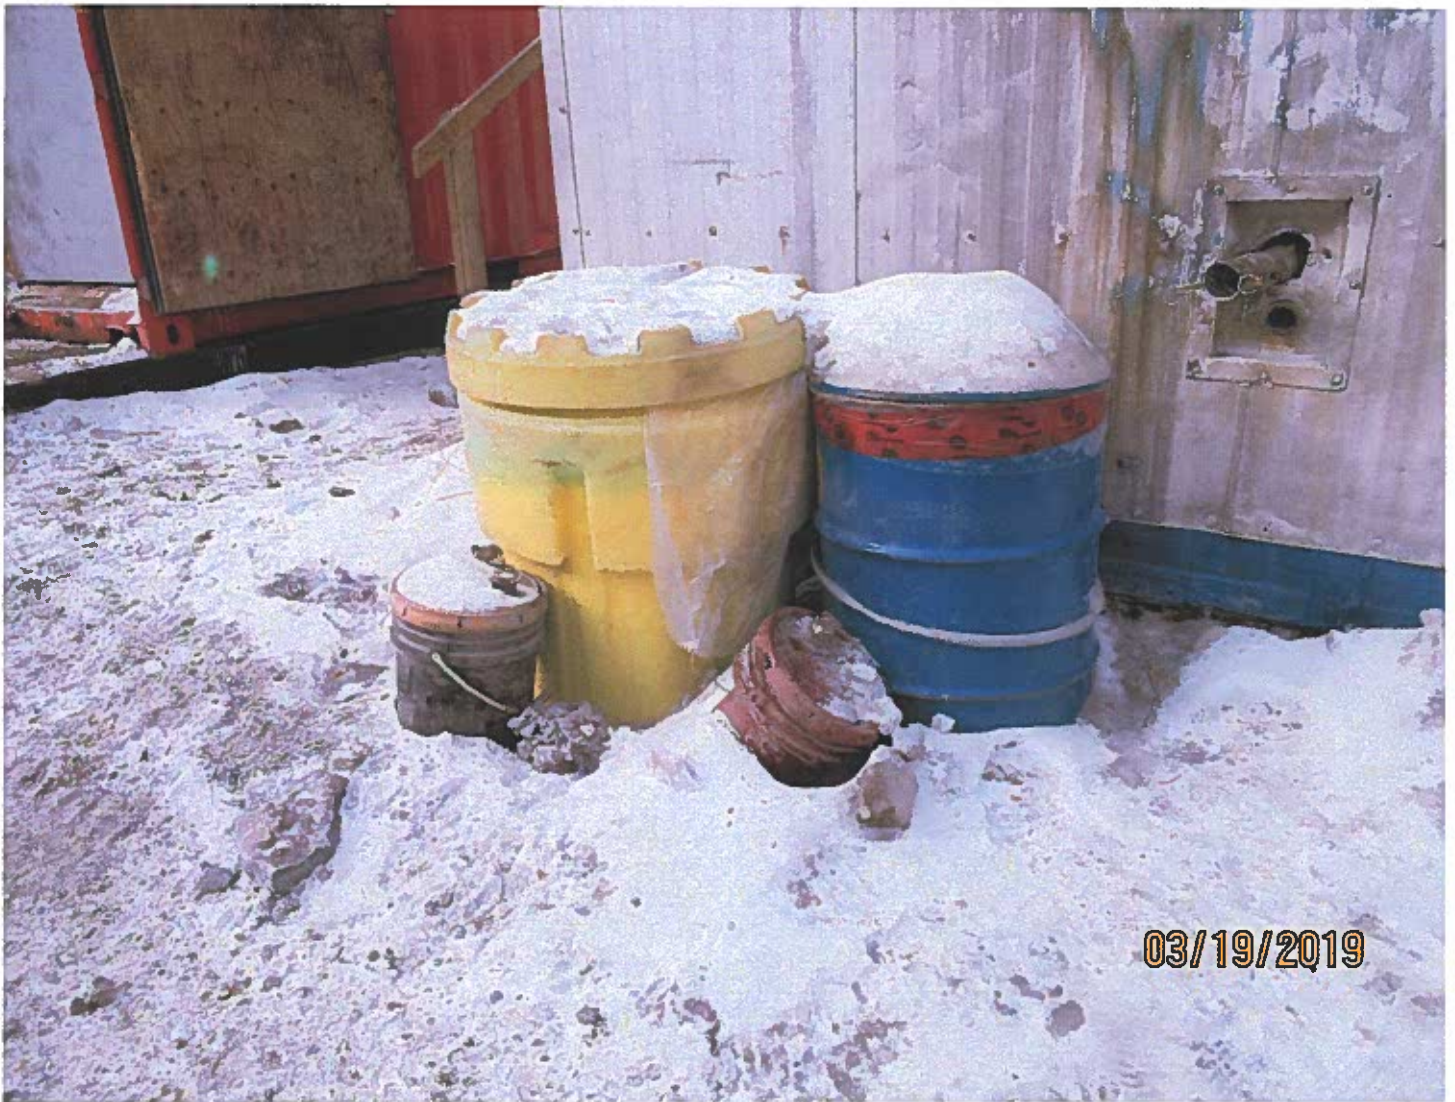
Photo #9 - W2017D0004 MUG Project

The Inspector noted improperly stored hydrocarbon containers (Condition #33 - Photo #9) on the ramp adjacent to the 2235 Portal that were present during the January 22nd, 2019 inspection were still in place. In addition, it appeared there were overtopped hydrocarbons on two portable heaters on the ramp (Condition #32 - Photos #10 & #11). After discussing the issues onsite with Mr. Amy, the concerns were properly addressed and follow-up photos were provided to the Inspector. As a follow-up, the Permittee has posted the Land Use Permit in visible locations so the permit is available for review by underground employees (Condition #42).

Though identified as a concern during the previous inspection, these hydrocarbon containers were still present on the 2235 ramp.

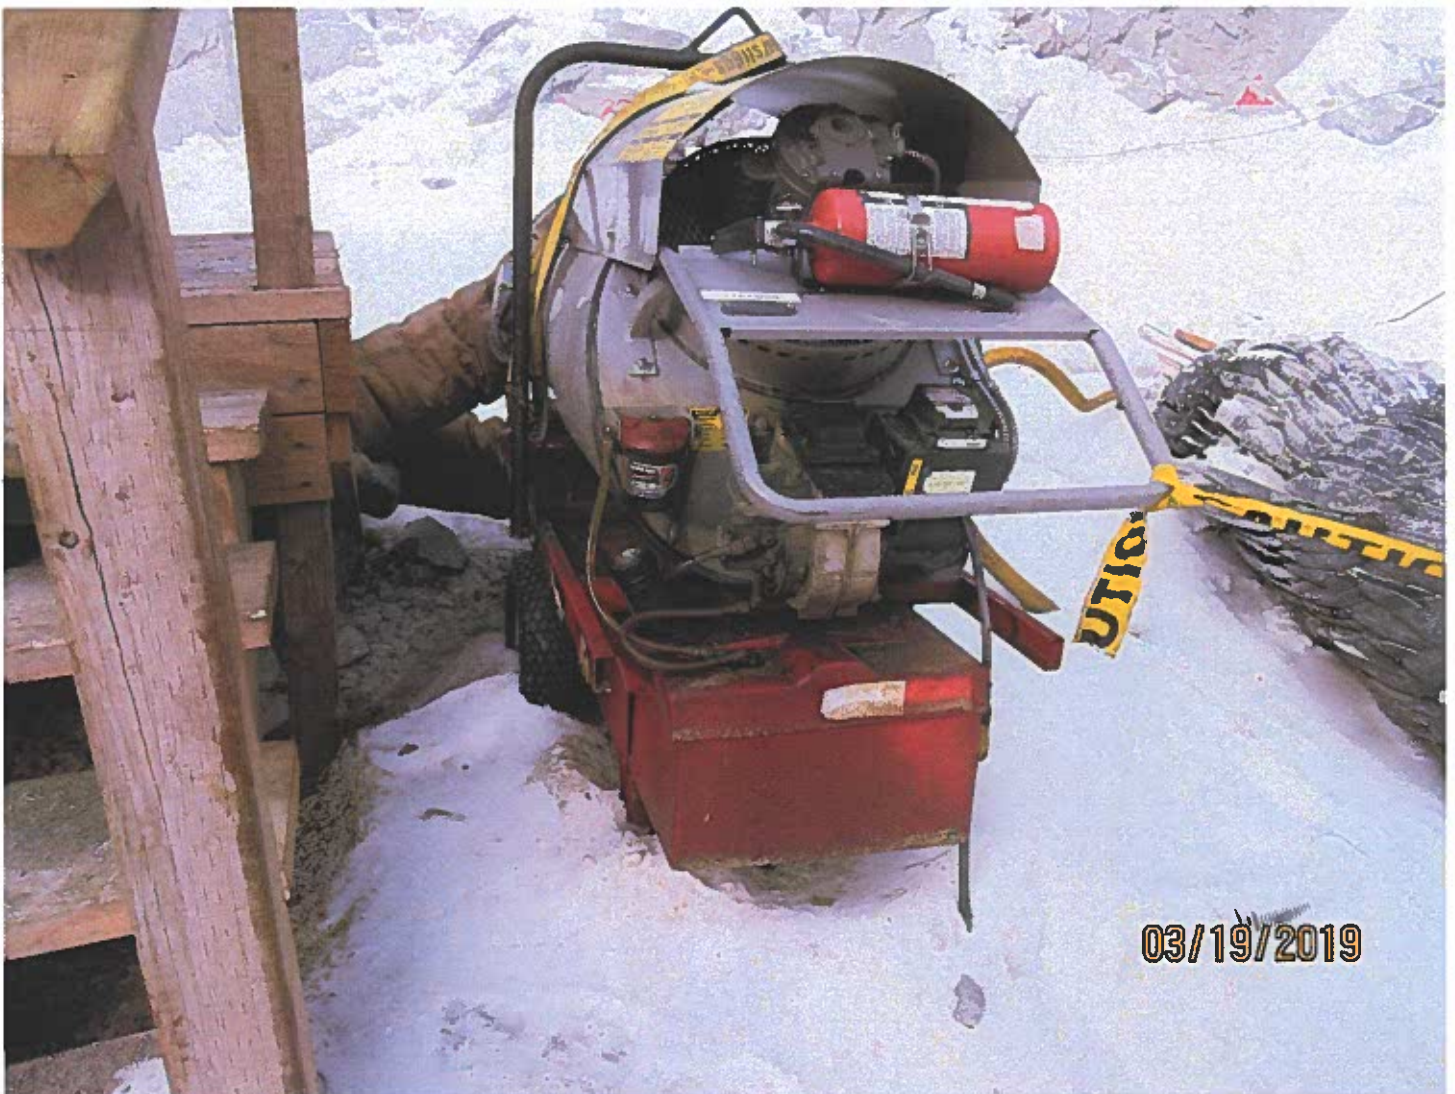
Photo #10 - W2017D0004 MUG Project

As seen in the photo, there were spilled hydrocarbons under this portable heater.

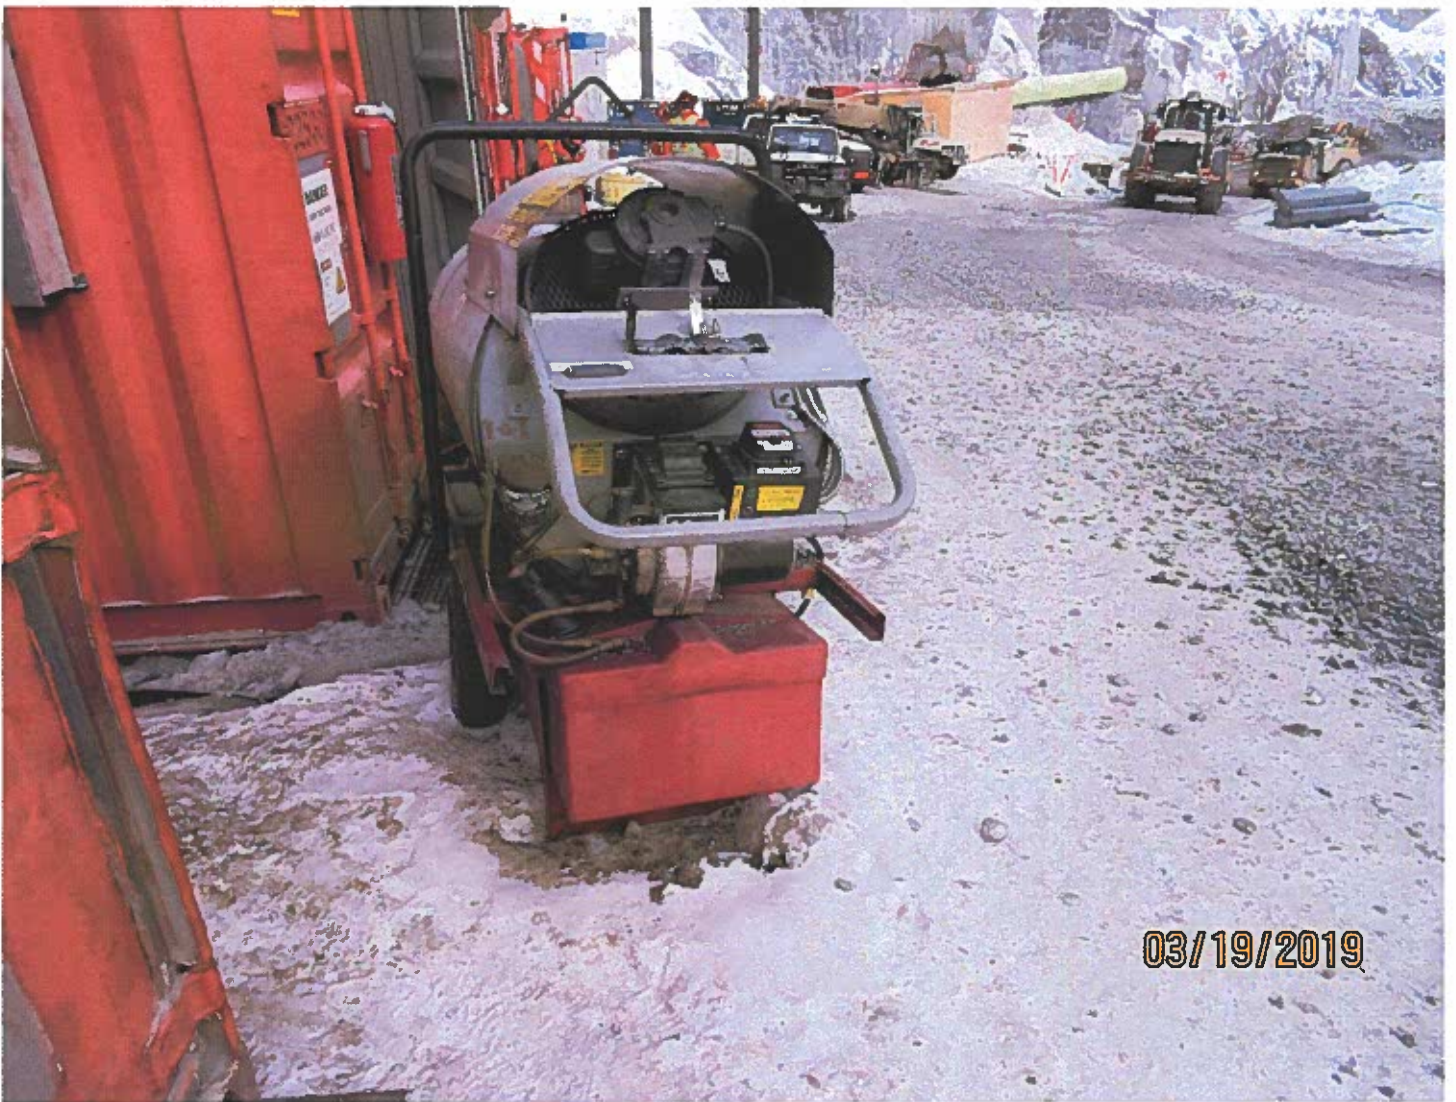
Photo #11 - W2017D0004 MUG Project
More spilled hydrocarbons under a portable heater on the 2235 Portal ramp.

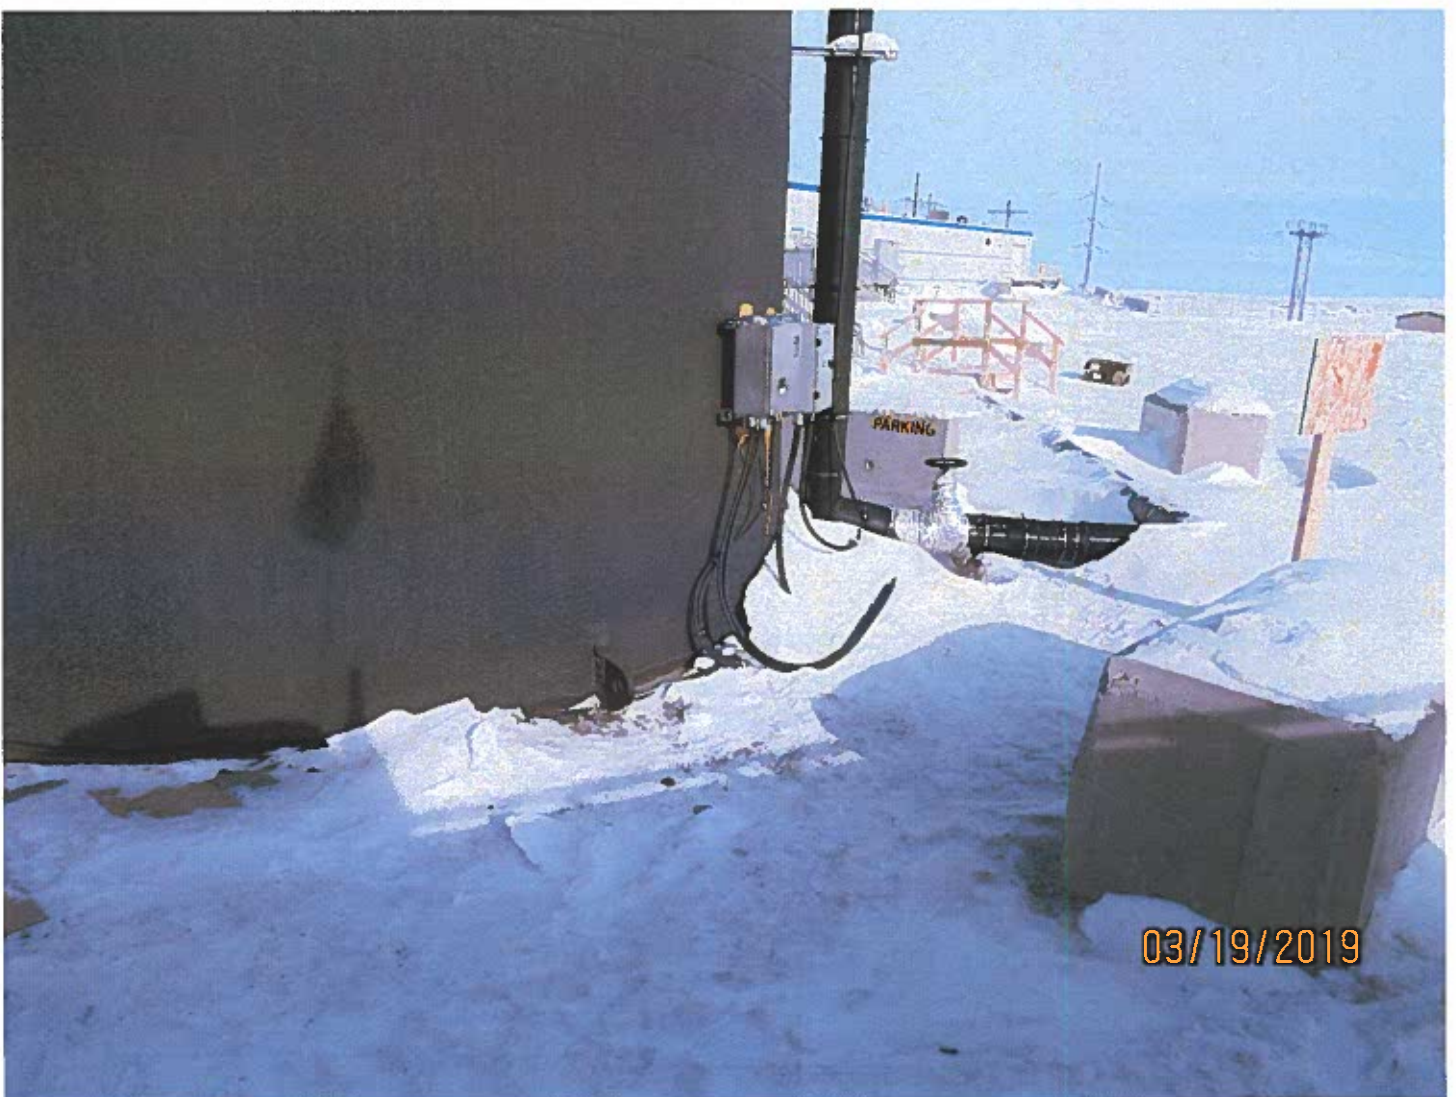
The Misery Camp is fully operational and it appeared waste & sewage management practices were adequate. Waste was being properly staged & segregated onsite and site sewage lines to the sewage holding tank were intact (Photo #12). There were no spills noted from the lines of the camp storage tanks for freshwater, fire suppression water or sewage. All waste produced is disposed of at the Ekati main camp or is removed from site for disposal at approved facilities. Sewage & greywater is removed from Misery Camp and is treated at the Ekati Sewage Treatment Plant prior to its disposal. No concerns were noted regarding waste or sewage management at the Misery Camp.

Photo #12 - W2017D0004 MUG Project
Lines at the Misery Camp sewage holding tank appeared intact.

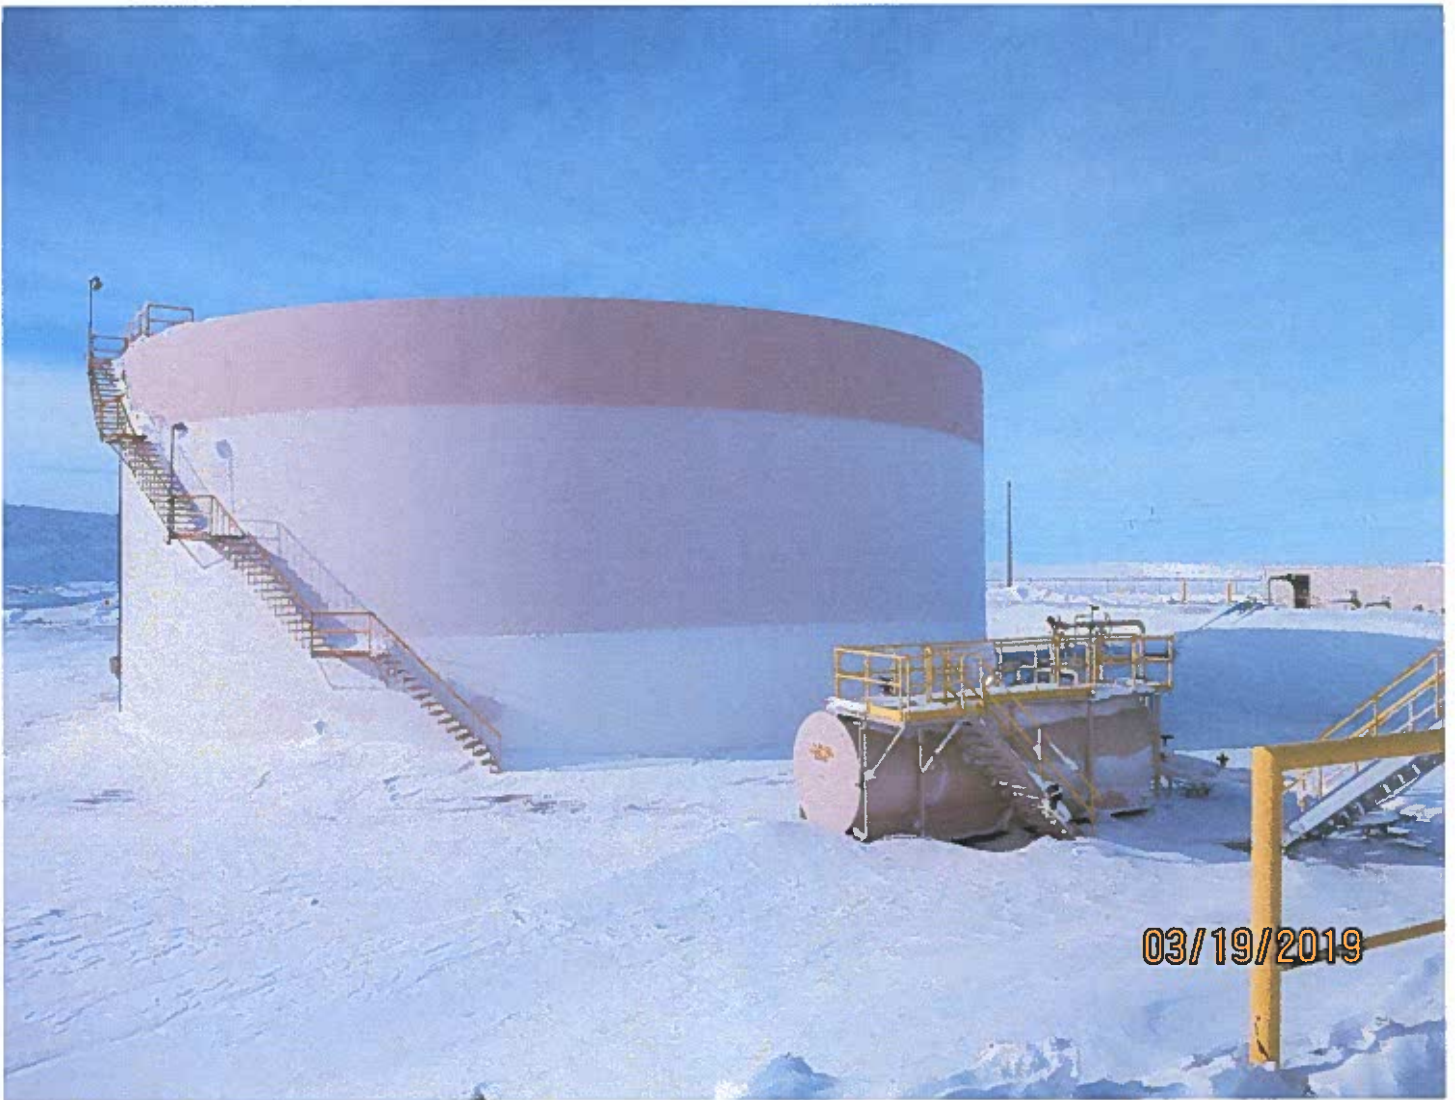
Photo #13 - W2017D0004 MUG Project
The fuel tanks at the Misery Camp fuel transfer facility.
